**Plot 2, Church Farm, South St, N. Kelsey, Lincs.
Archaeological Watching Brief**

Archaeological Watching Brief

LAS Report No: 911

March 2006

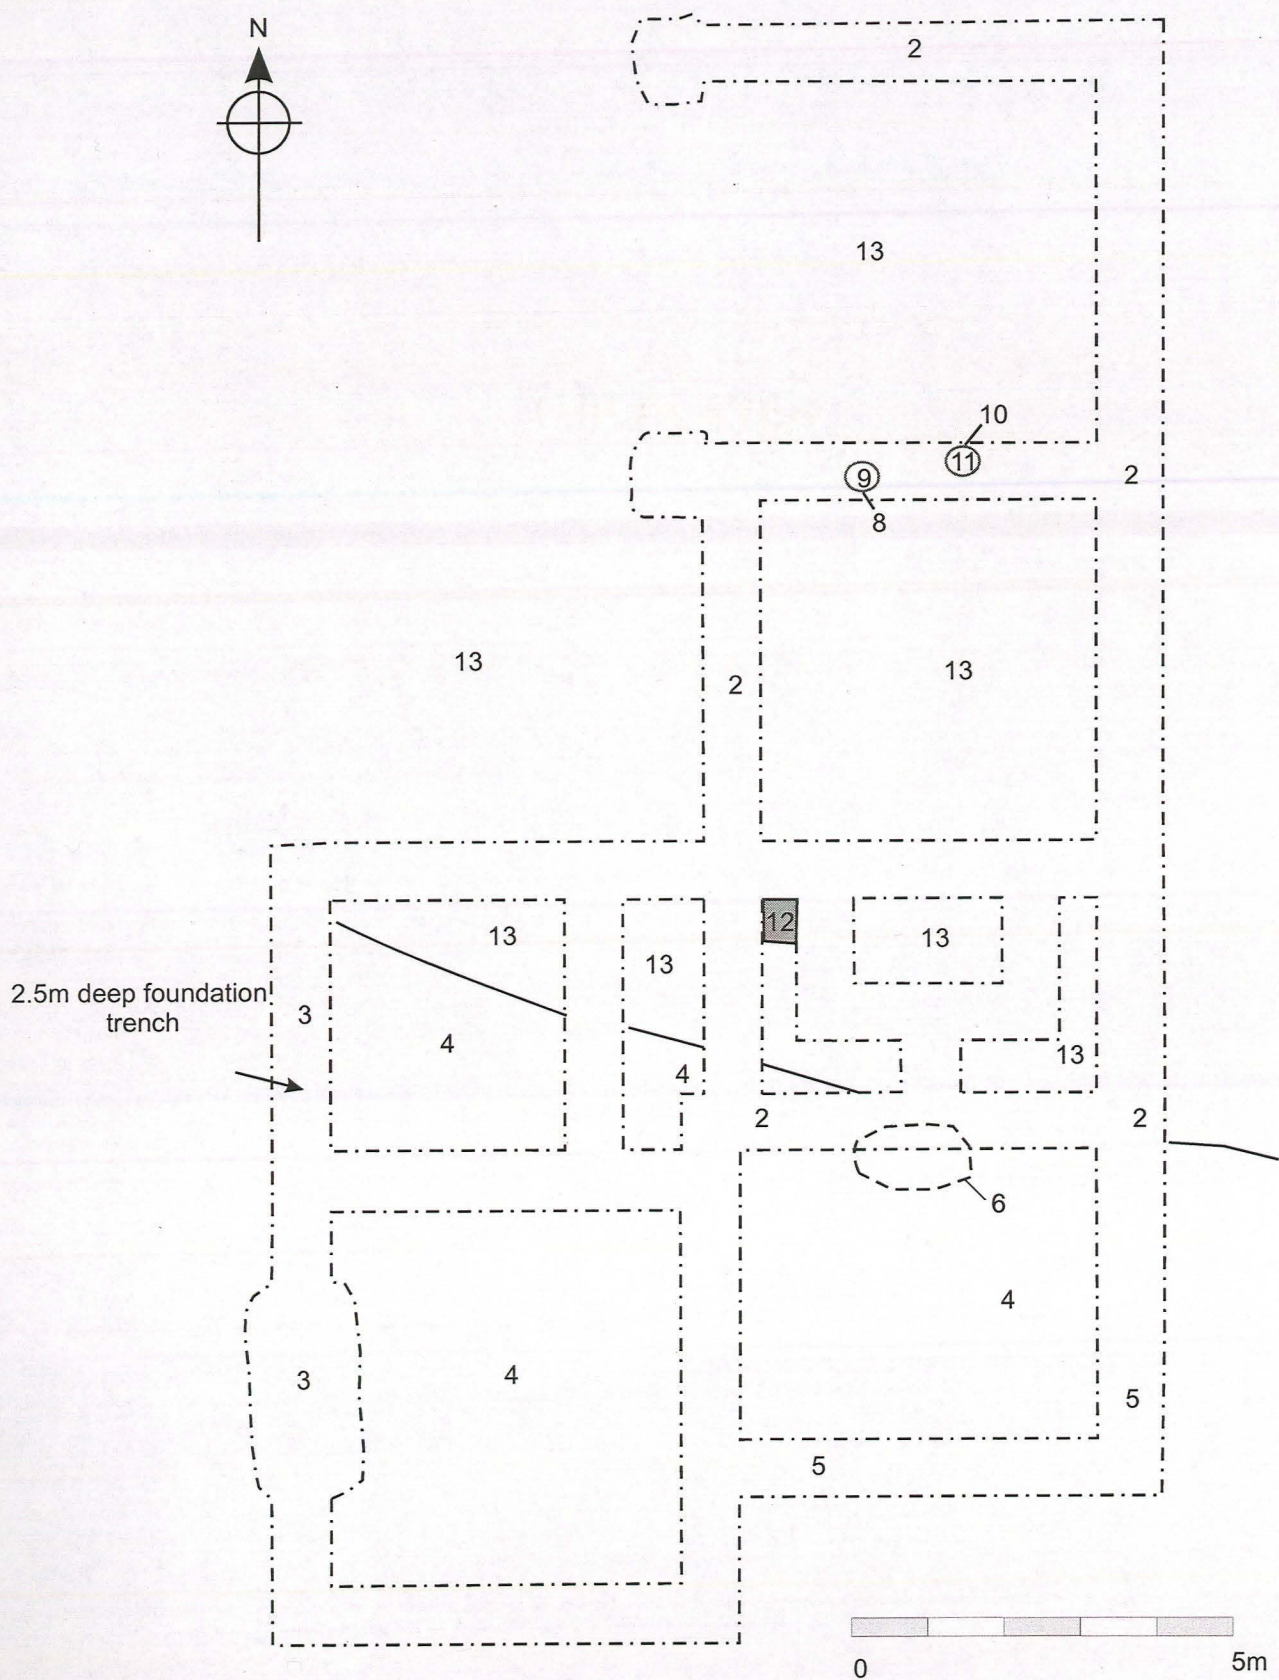
Fig. 5 Plan of Plot 2 foundations after plan supplied by the client (Martin Tucker Ltd Architects)

The Watching Brief (Fig. 5; Pl. 1 & 2)

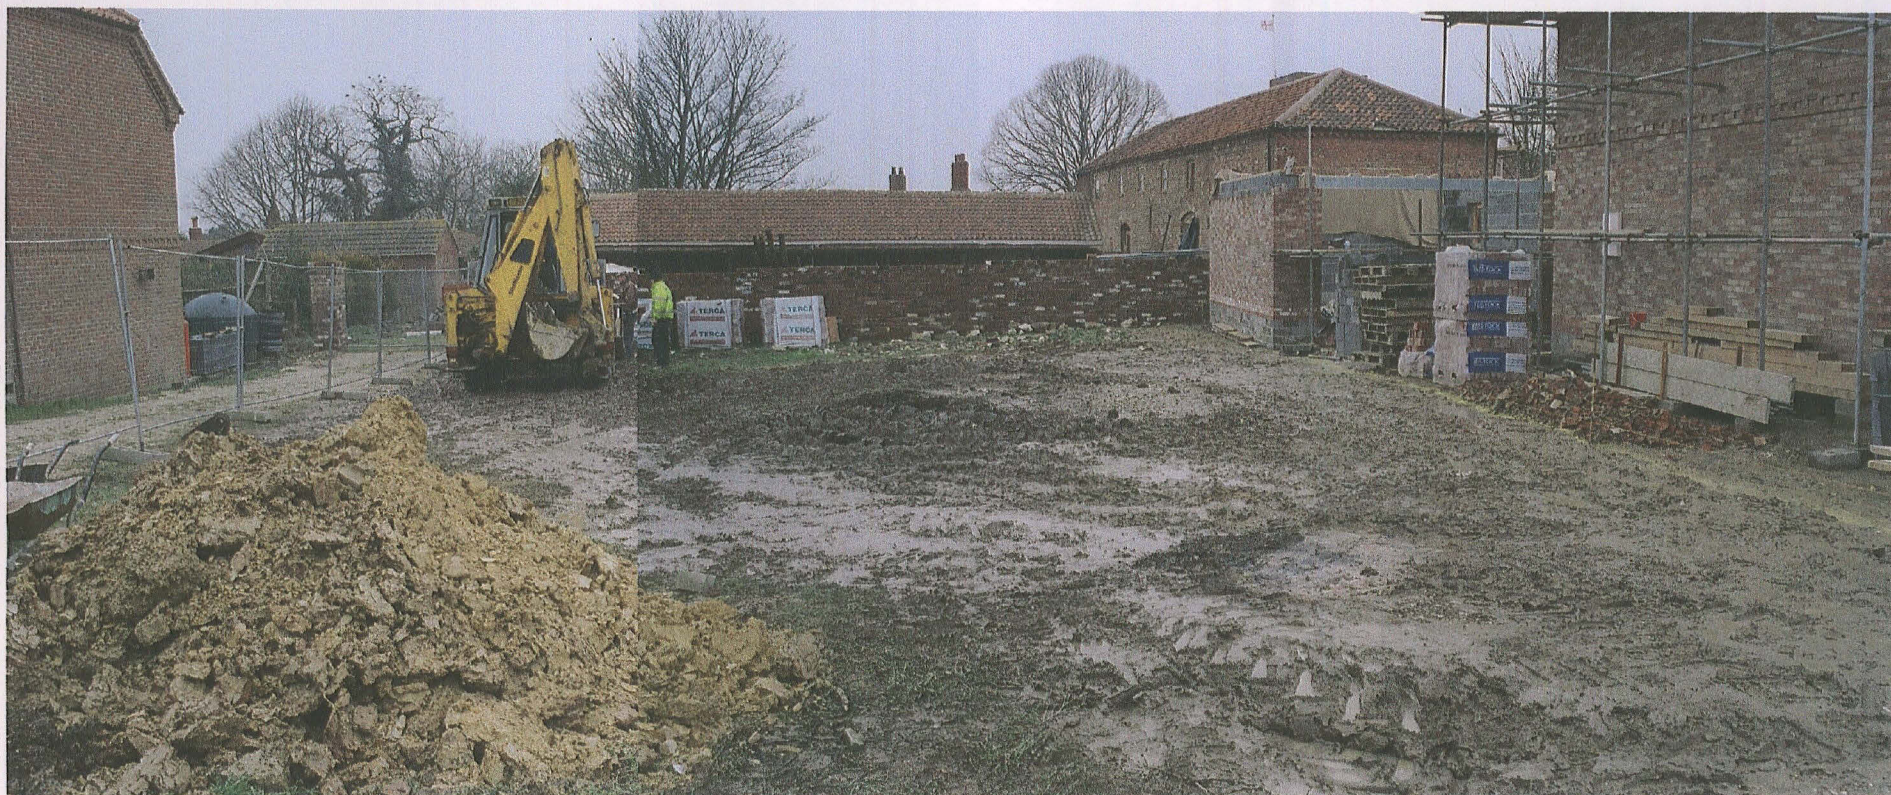
Pl. 1 View of Plot 2 site looking north.

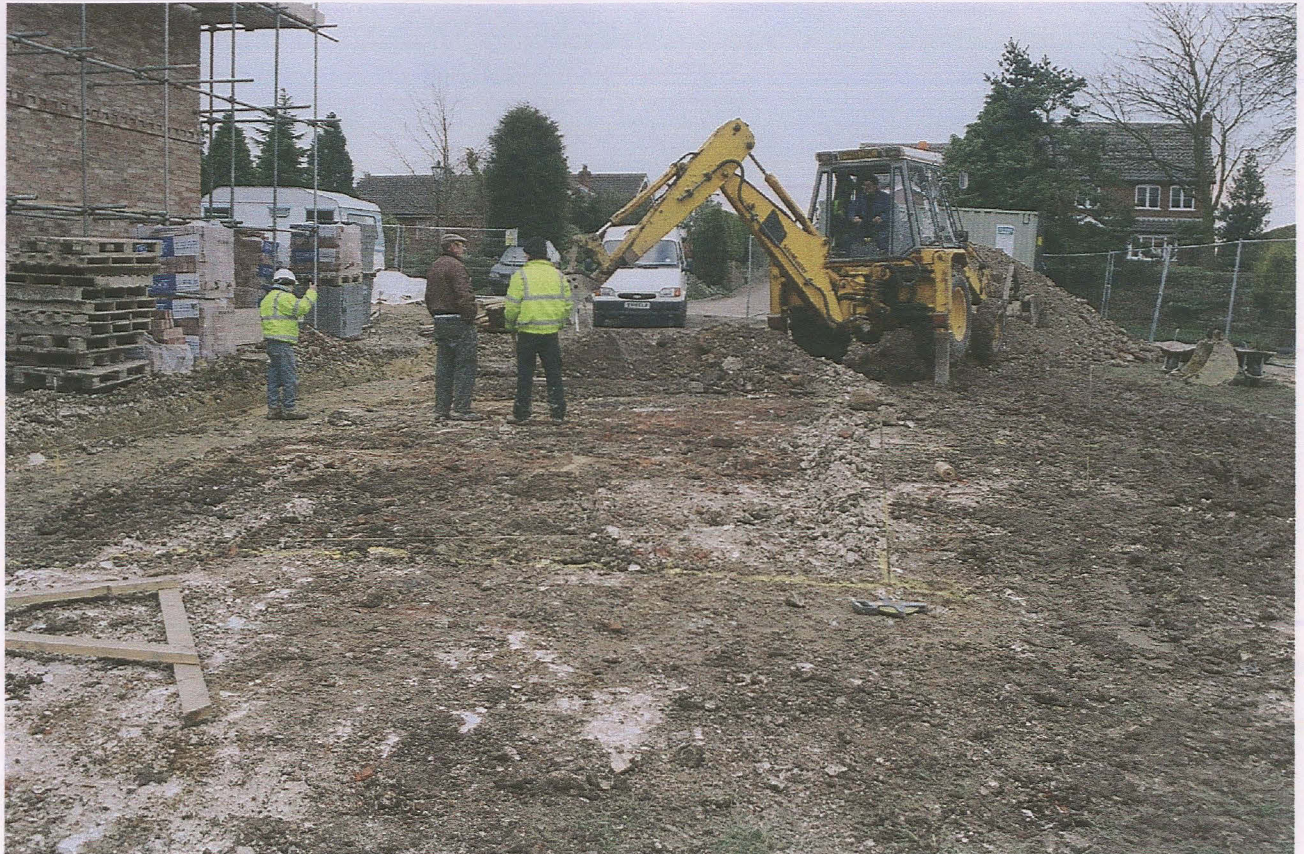
Pl. 2 Looking south during topsoil stripping with layers 4 and 13 exposed.

The southern footings exposed a thin layer of stone and crushed brick which appeared to be the remnant of a 0.05m thick yard surface (4) beneath topsoil 1 and above clay 5. Layer 4 produced two sherds of modern pottery (**Appendix 1**). To the north of the plot the ground had been disturbed by demolition and consisted of approximately 0.45m of mixed dark grey silt clay with large fragments of chalk and brick, coal, charcoal and some asphalt (13) (**Pl. 2 & 5**).

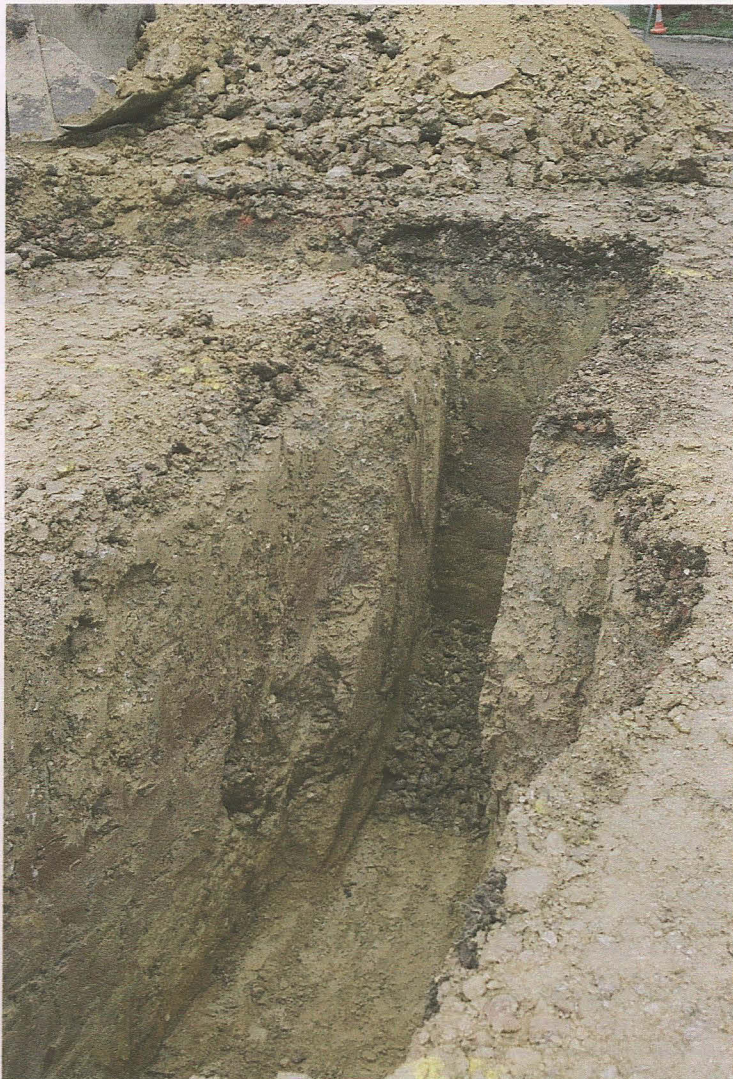
Pl. 3 (left) Looking southeast at the southwest foundation trench. Depth of trench 2.5m.

The majority of foundation trenches were excavated to a depth of 1m below the existing surface with the exception of the south-western trenches which were stepped down to a maximum depth of 2.5m to avoid disturbance from the roots of an adjacent hedge (**Pl. 3**). Excavations for the footings exposed the same profile of natural clays as were found in the trial hole.

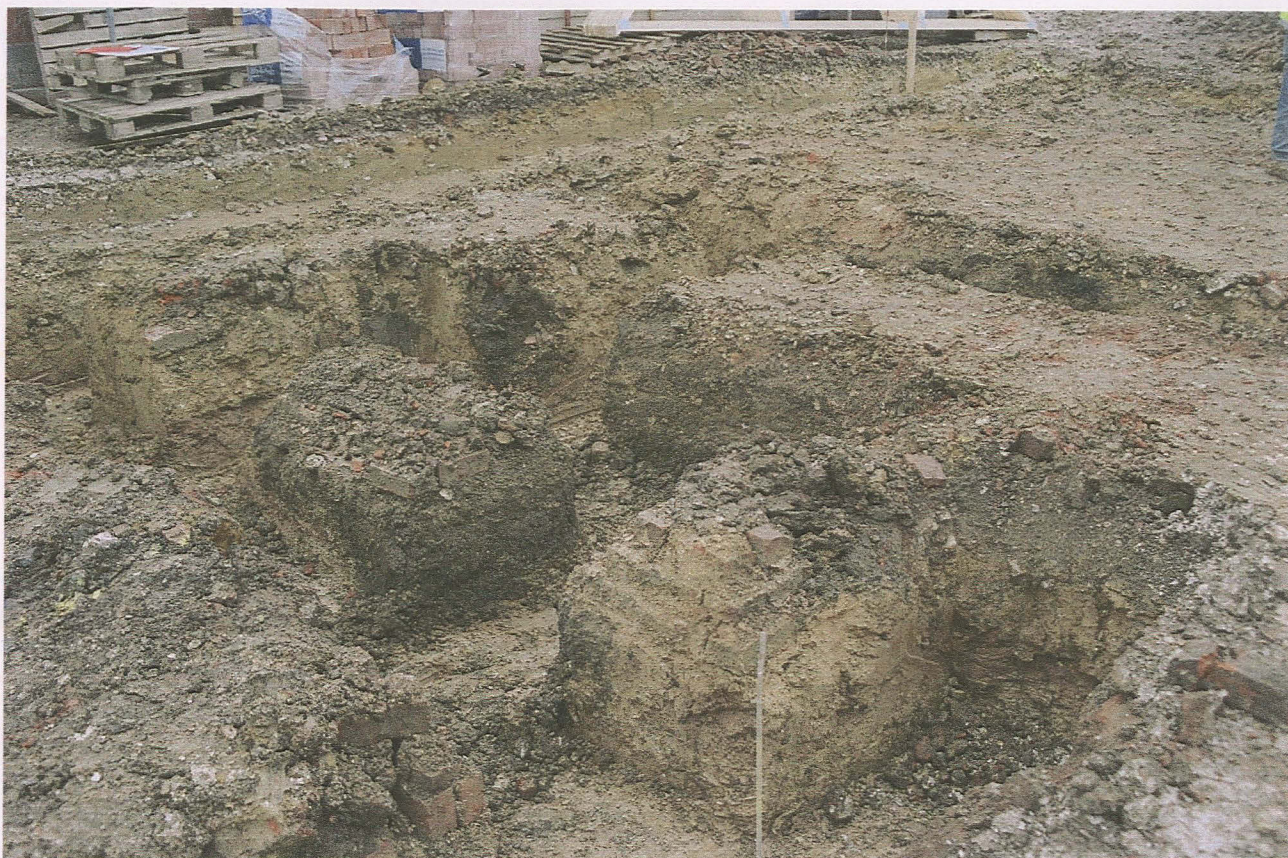
Pl. 4 Looking southeast at surviving brickwork foundation 12.

Scant surviving remains of the previous buildings could be discerned beneath layer **13**. The remnant of a stepped red brick footing for a column (**12**) survived near the centre of the plot (**Pl. 4**). It is possible that this is a remnant of an early open barn associated with the Church Farm complex in a similar style to the extant north wing of the farm (**Pl. 1**). Two post holes (**8** and **10**) were evident beneath **13** which were filled with decaying wood posts (**9** and **11** respectively).

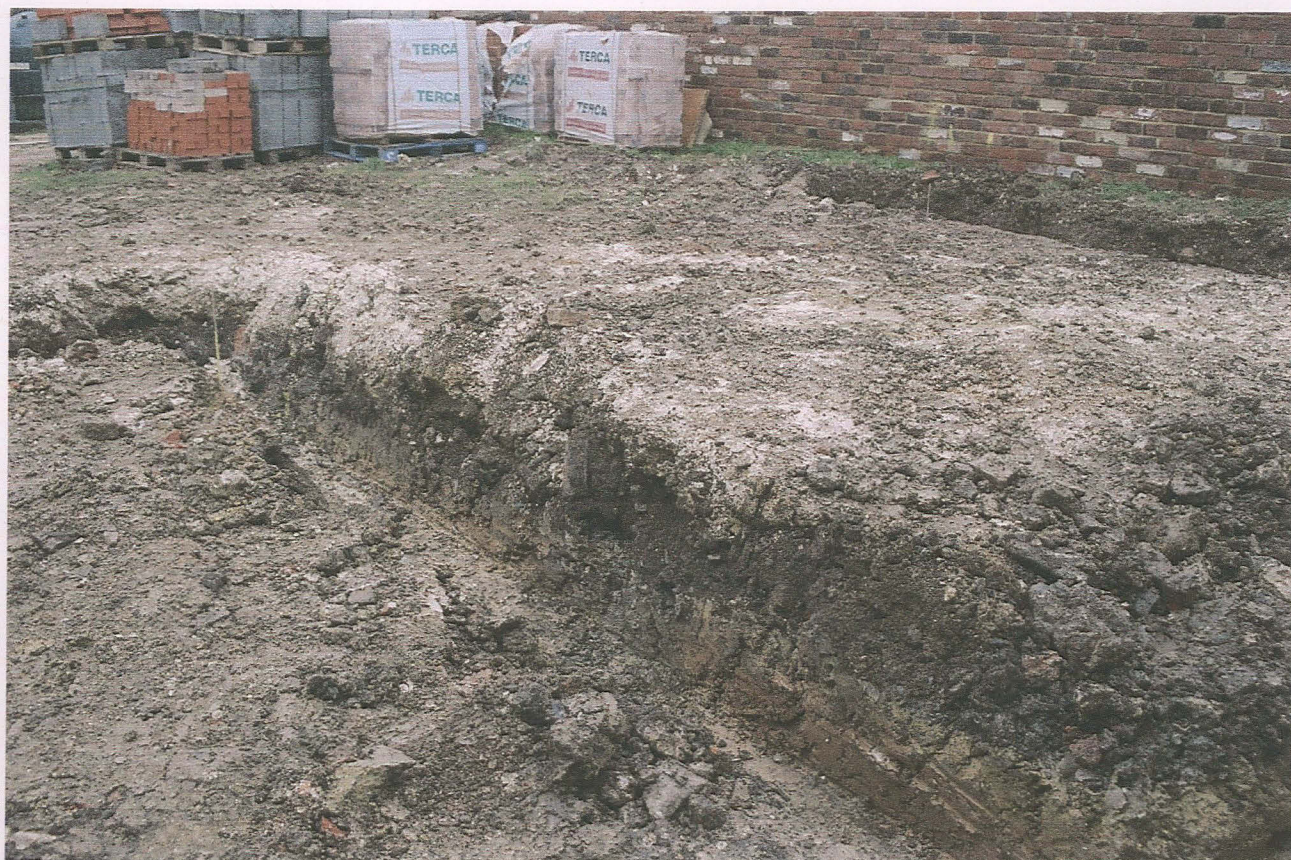
Pl. 5 Looking northwest at layer 13 exposed in section.
