**Land to the south of the Tap & Spile Public House,
Hungate, Lincoln
Archaeological Evaluation**

**NGR: SK 97499 71477
Site Code: LTAP 06
LCNCC Accession No.: 2006.57
Planning Application: N/A**

**LAS Report No: 910
April 2006**

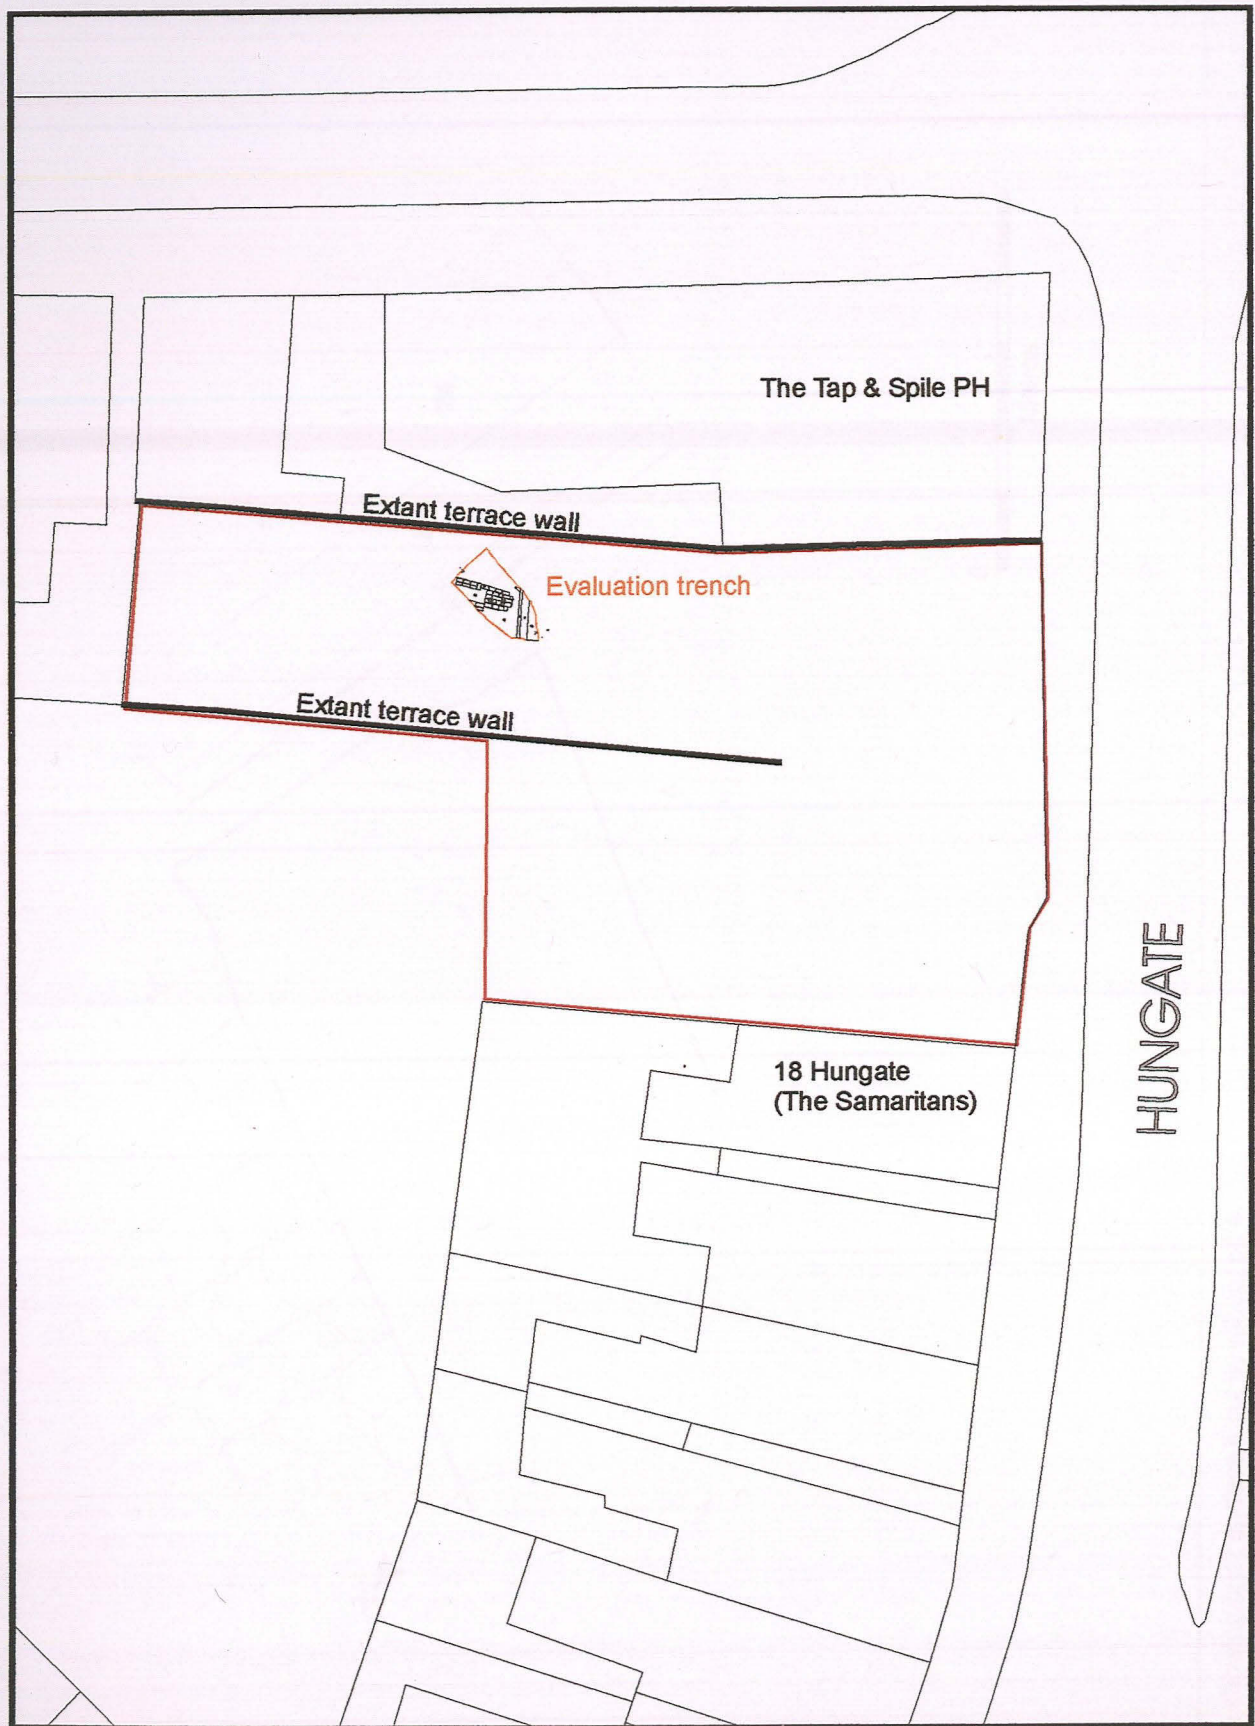
Fig 2 The proposed development site showing the location of the evaluation trench and the current layout of the terrace walls. Scale 1:250.

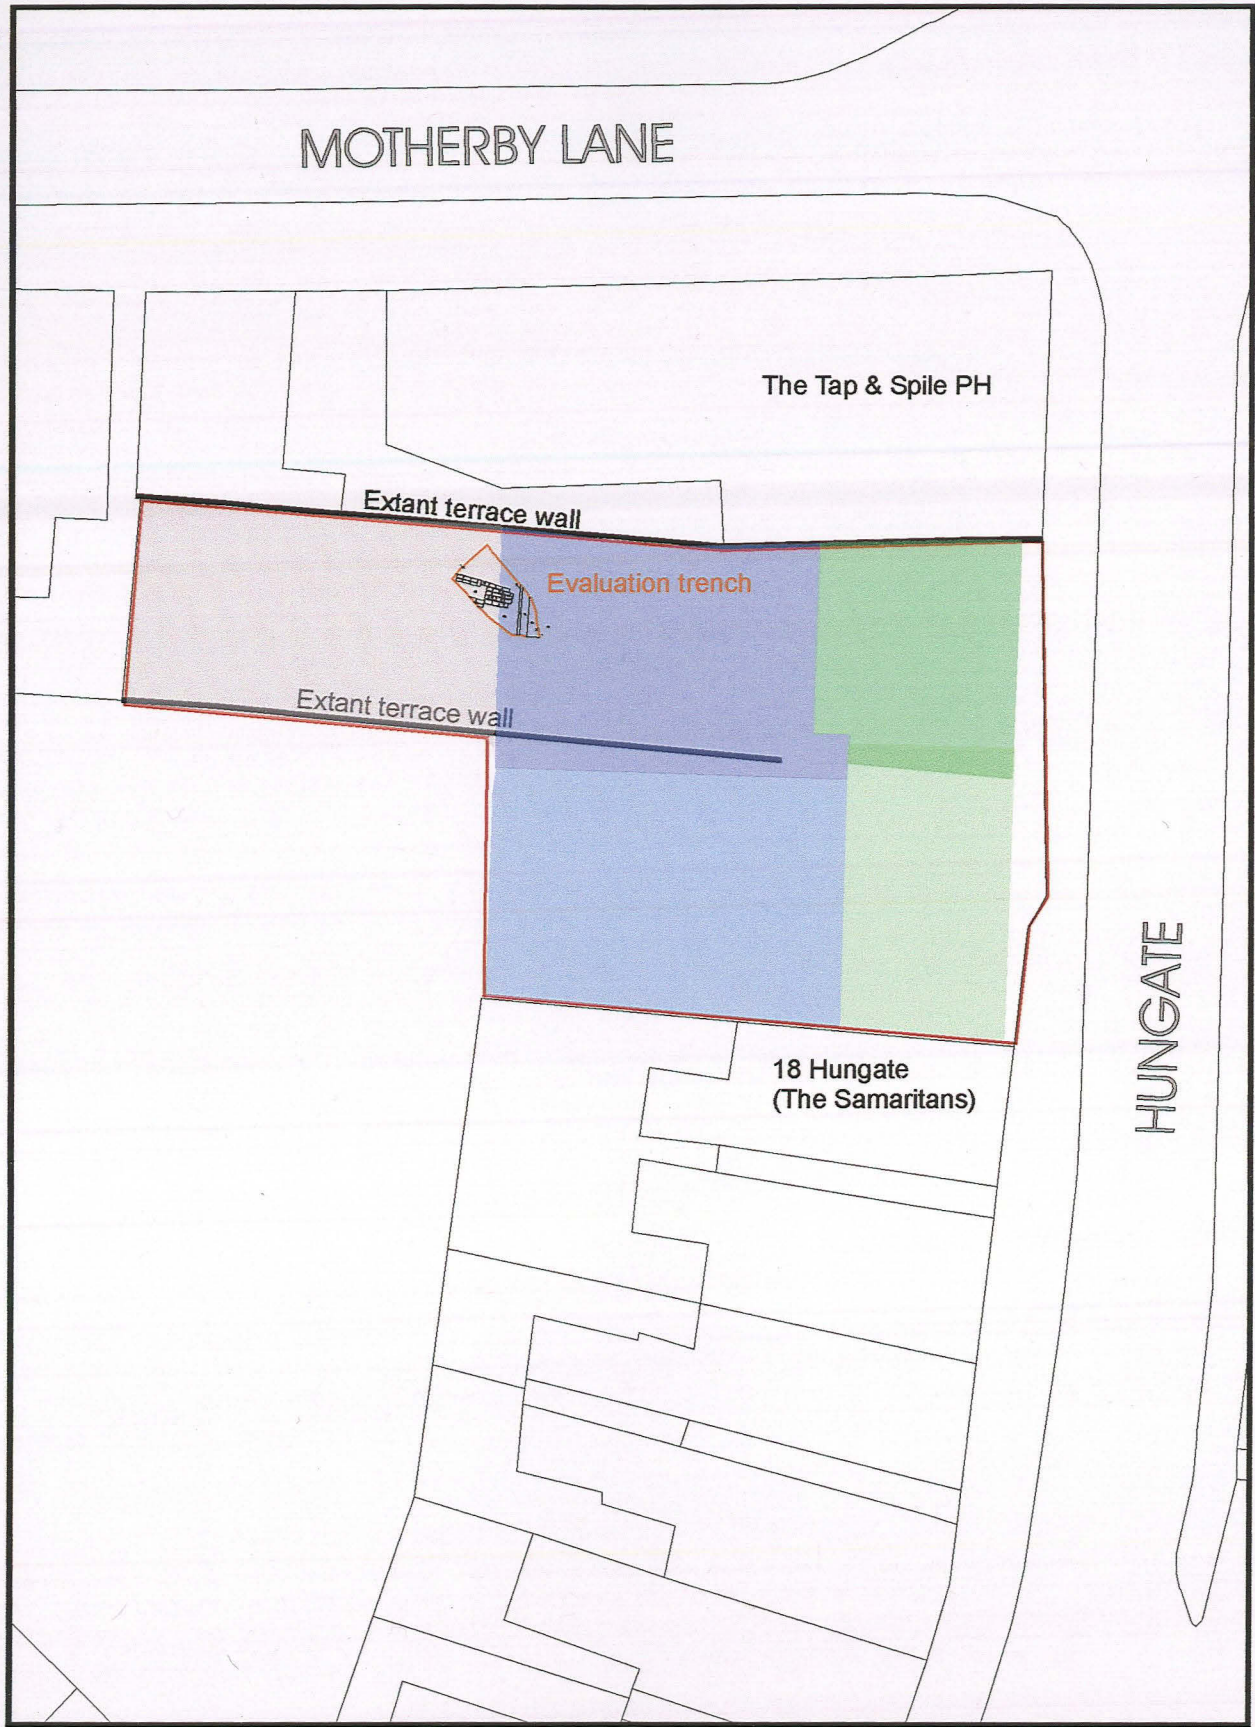
Fig. 10 Plan showing full extent of potential impact zones. Scale 1:250 (after Fig 2 & 8).

The construction of the both basement flats will have the combined impact set out in options 2 and 3 (Fig. 8-10, all blue and green areas).

The proposed use of the remaining western portion of the upper terrace is not yet decided (Fig. 10, Pl. 10 grey area). Construction of the dwellings on the Hungate frontage will leave an area of approximately 12m x 3.5m. Access for parking would only be retained by reducing the 2m height difference between the existing upper and lower terrace surfaces. A reinforced terrace wall on the north side of the plot would also be required. The evidence from the evaluation suggests that a reduction of level in this area would remove archaeological deposits with a thickness of between 0.85m to 1.10m across the area.

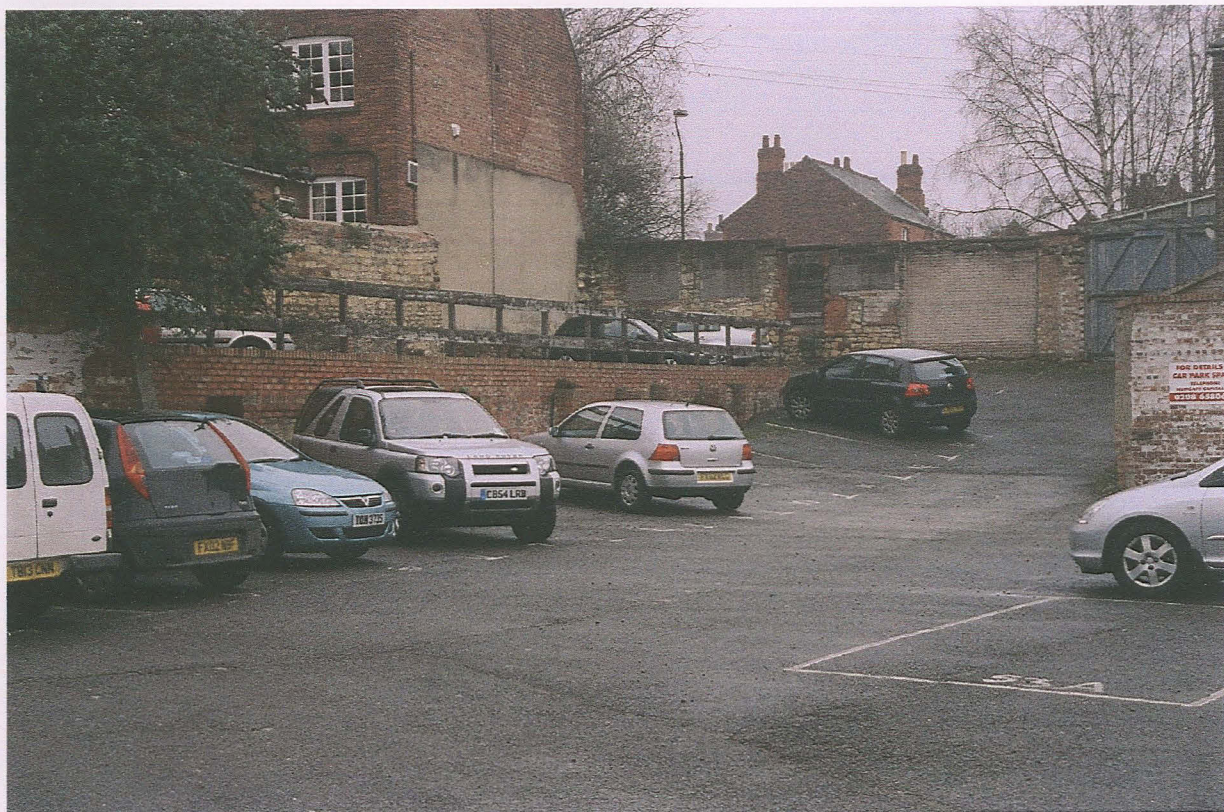
PI. 2 The car park looking northeast towards Hungate showing the current terrace walls. (06/23/28)

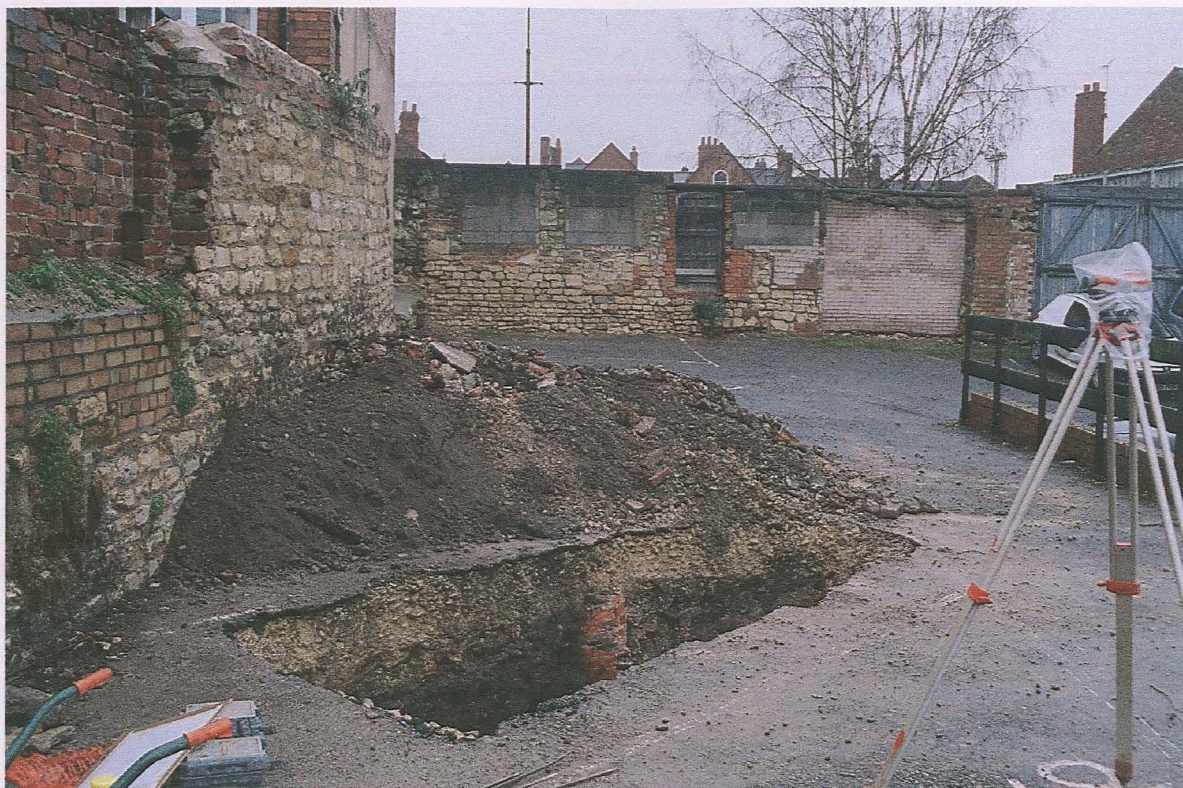
PI. 3 The evaluation trench during excavation looking east towards Hungate. (06/17/6A)

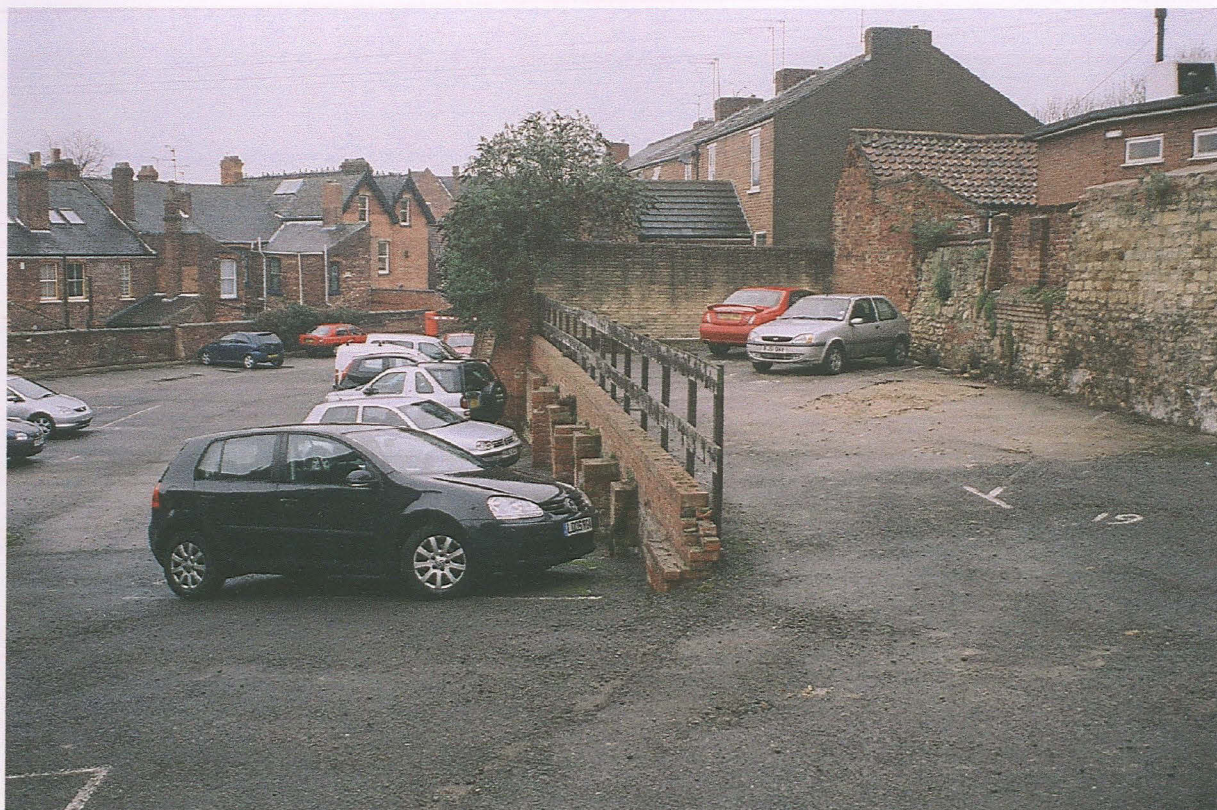
PI. 4 Looking west across car park showing the backfilled evaluation trench (car parking bay 17, in front of the silver car on the upper terrace). (06/23/23)

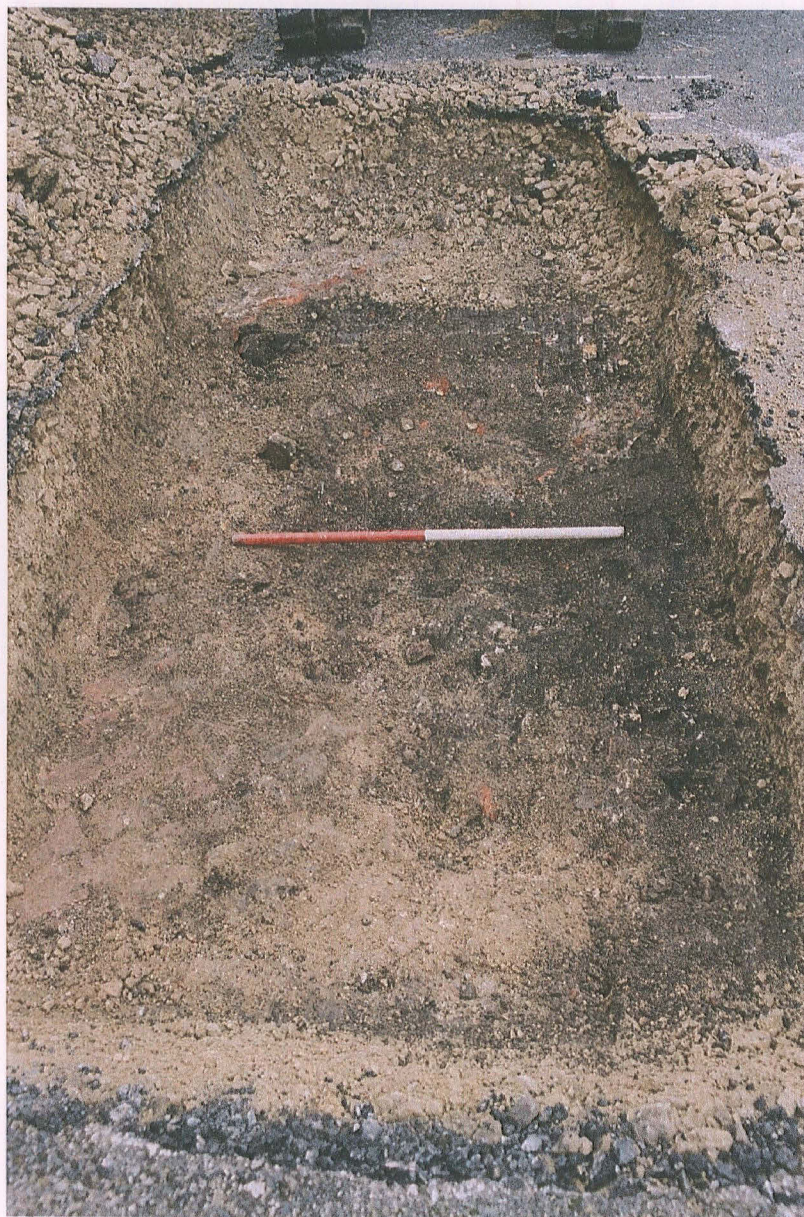
PI. 5 The evaluation trench during machining showing brick surface 6, looking southeast. Scale 1m. (06/18/21)

Beneath the car park surfacing layers was part of a backfilled cellar (wall 5) (Pl. 5-6). Abutting wall 5 was a dark grey layer which may have been formed during the demolition of the buildings (3) which produced material dating to the late 18th- mid 19th century (Appendix 2). The cellar had been in filled with mixed light grey and dark grey silt sand with limestone and brick fragments (24). Beneath layer 3 was a brick surface (6, Fig. 3, Pl. 5) which had been constructed of handmade bricks. Cutting through the brick floor was a robber pit (4) which had removed the majority of the walls associated with a brick built coal cellar (wall 13) and was backfilled with a mixed dark grey-black silt sand(8).

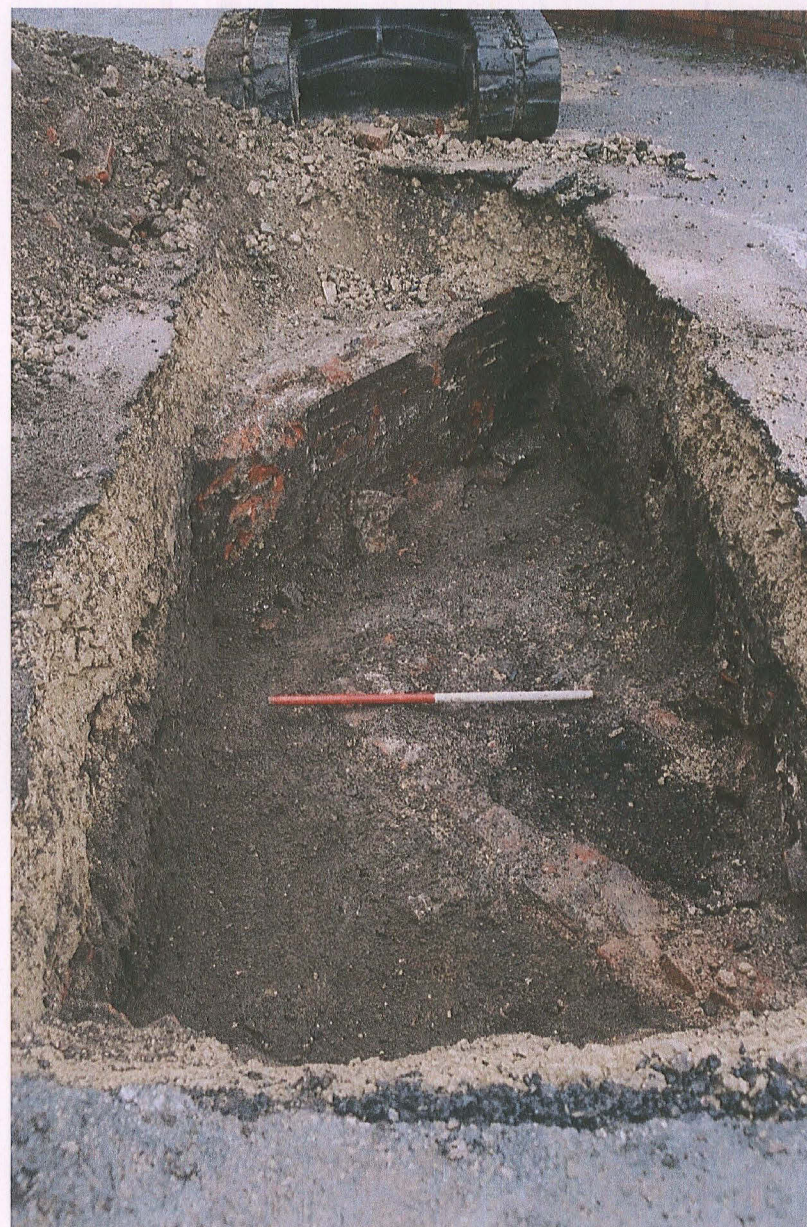
PI. 6 Coal cellar 13 and wall 5, looking southeast. Scale 1m. (06/18/23)

To the north of the trench was the smaller coal cellar (wall 13) which had been robbed by pit 4. Pit 4 had been backfilled with a mixed dark grey-black silt (8) which was dated to late 18th to early 19th century. The walls of the cellar (13) were heavily truncated with the majority of the surviving wall was only exposed in the sections of the trench (Fig 4, Fig 6 B & C). The wall was constructed of red bricks bonded with a light grey-white mortar within foundation cut 25. In contrast to wall 5 wall 13 was built tightly against the construction cut. The cellar construction was probably contemporary with the brick surface 6. It is unclear whether 6 is an internal or external surface. Within the coal cellar was a brick floor (14) and a thin layer of coal and cinders which remained in situ from when the coal cellar was in use (23). It is likely that the removal of cellar walls occurred at the same time as the destruction of an associated building. It is possible that the destruction of these buildings occurred during the levelling of

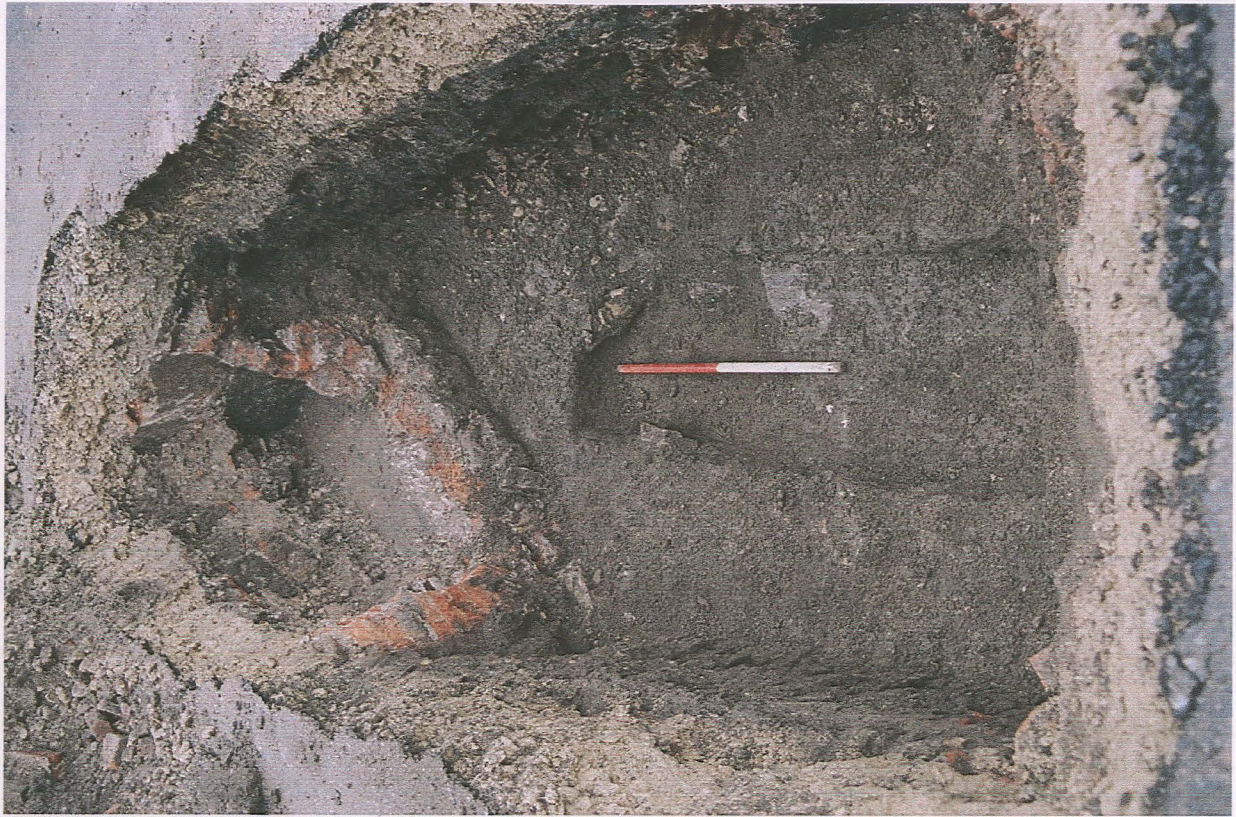
PI. 7 The evaluation trench with wall 5 partially removed and stone filled pit 16, looking southeast. Scale 1m. (06/17/5A)

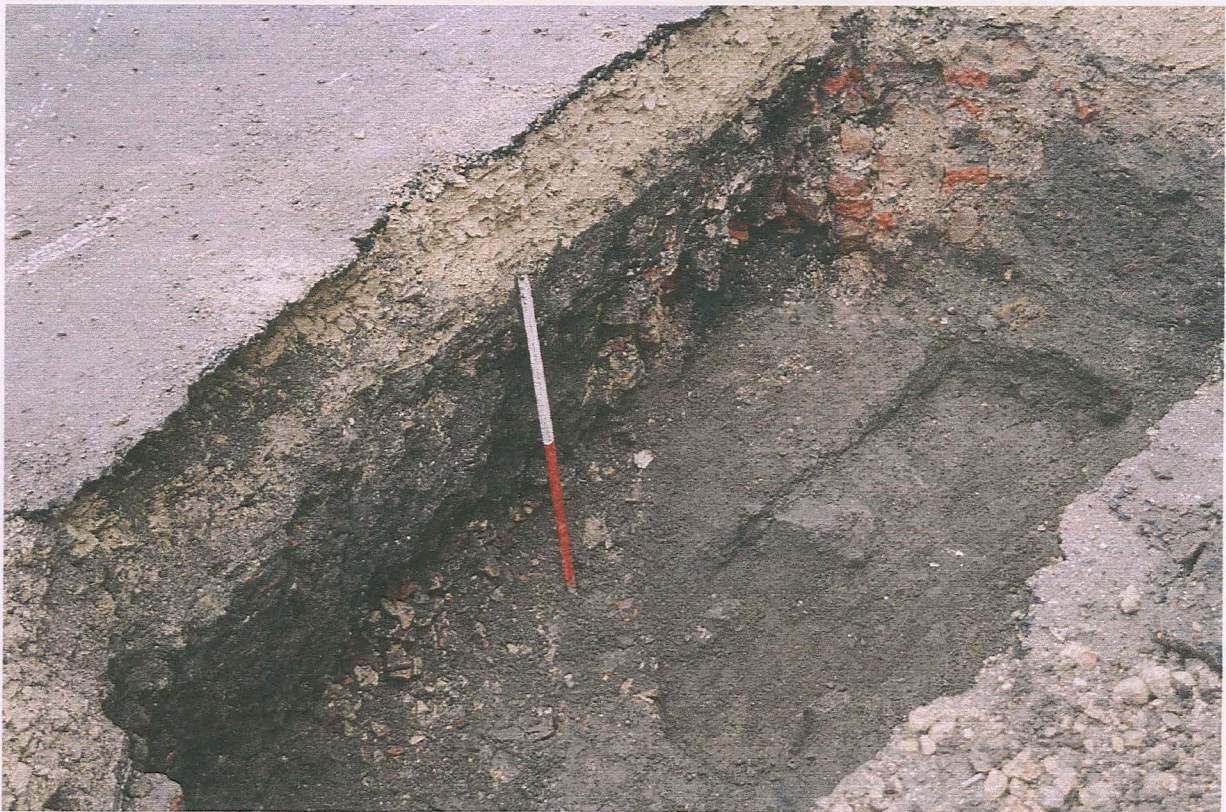
PI. 8 Section of trench with pit 16 in the foreground, looking west. Scale 1m. (06/17/8A)

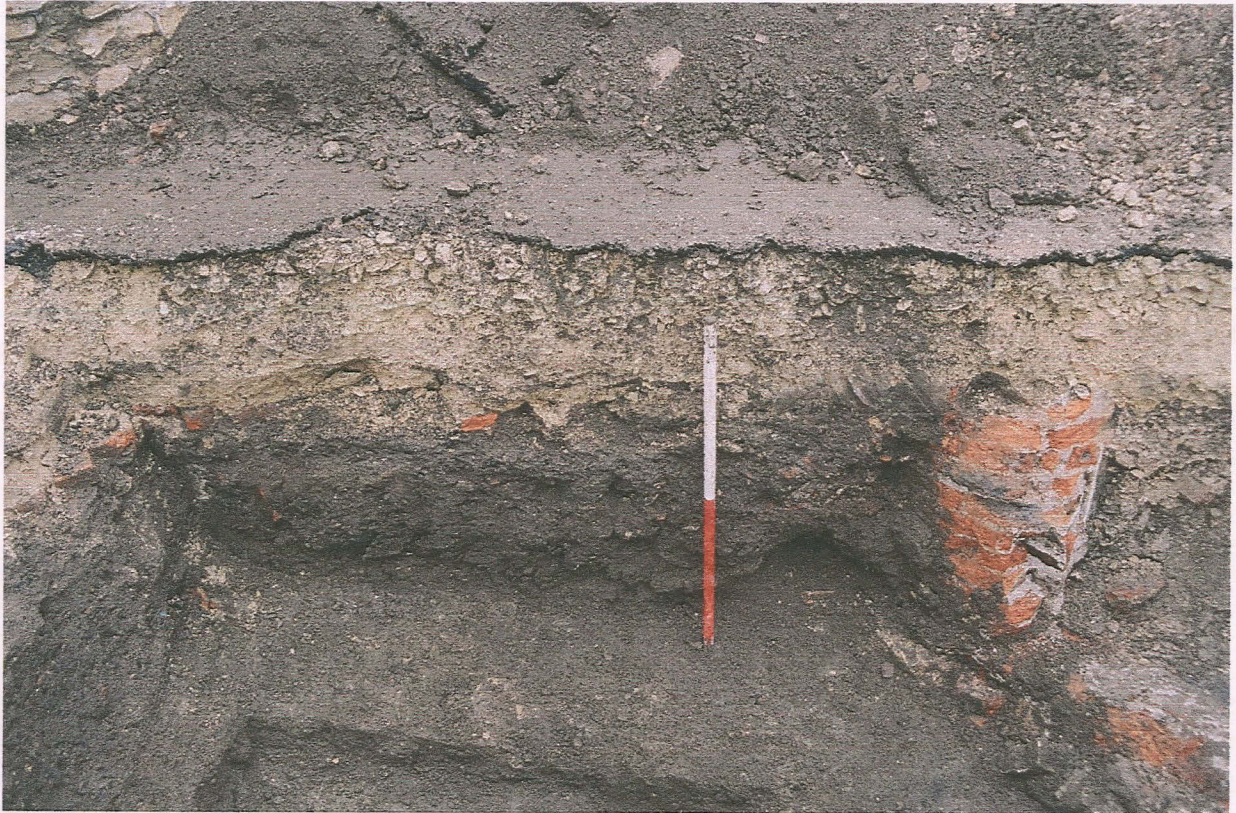
Pl. 9 Trench section looking northwest. Scale 1m. (06/17/9A)
