LINDSEY ARCHAEOLOGICAL SERVICES

**Plot 10 St. Margaret's Close, Alford Road, Huttoft, Lincs.  
Archaeological Watching Brief**

**Report**

**LAS Report No. 918**

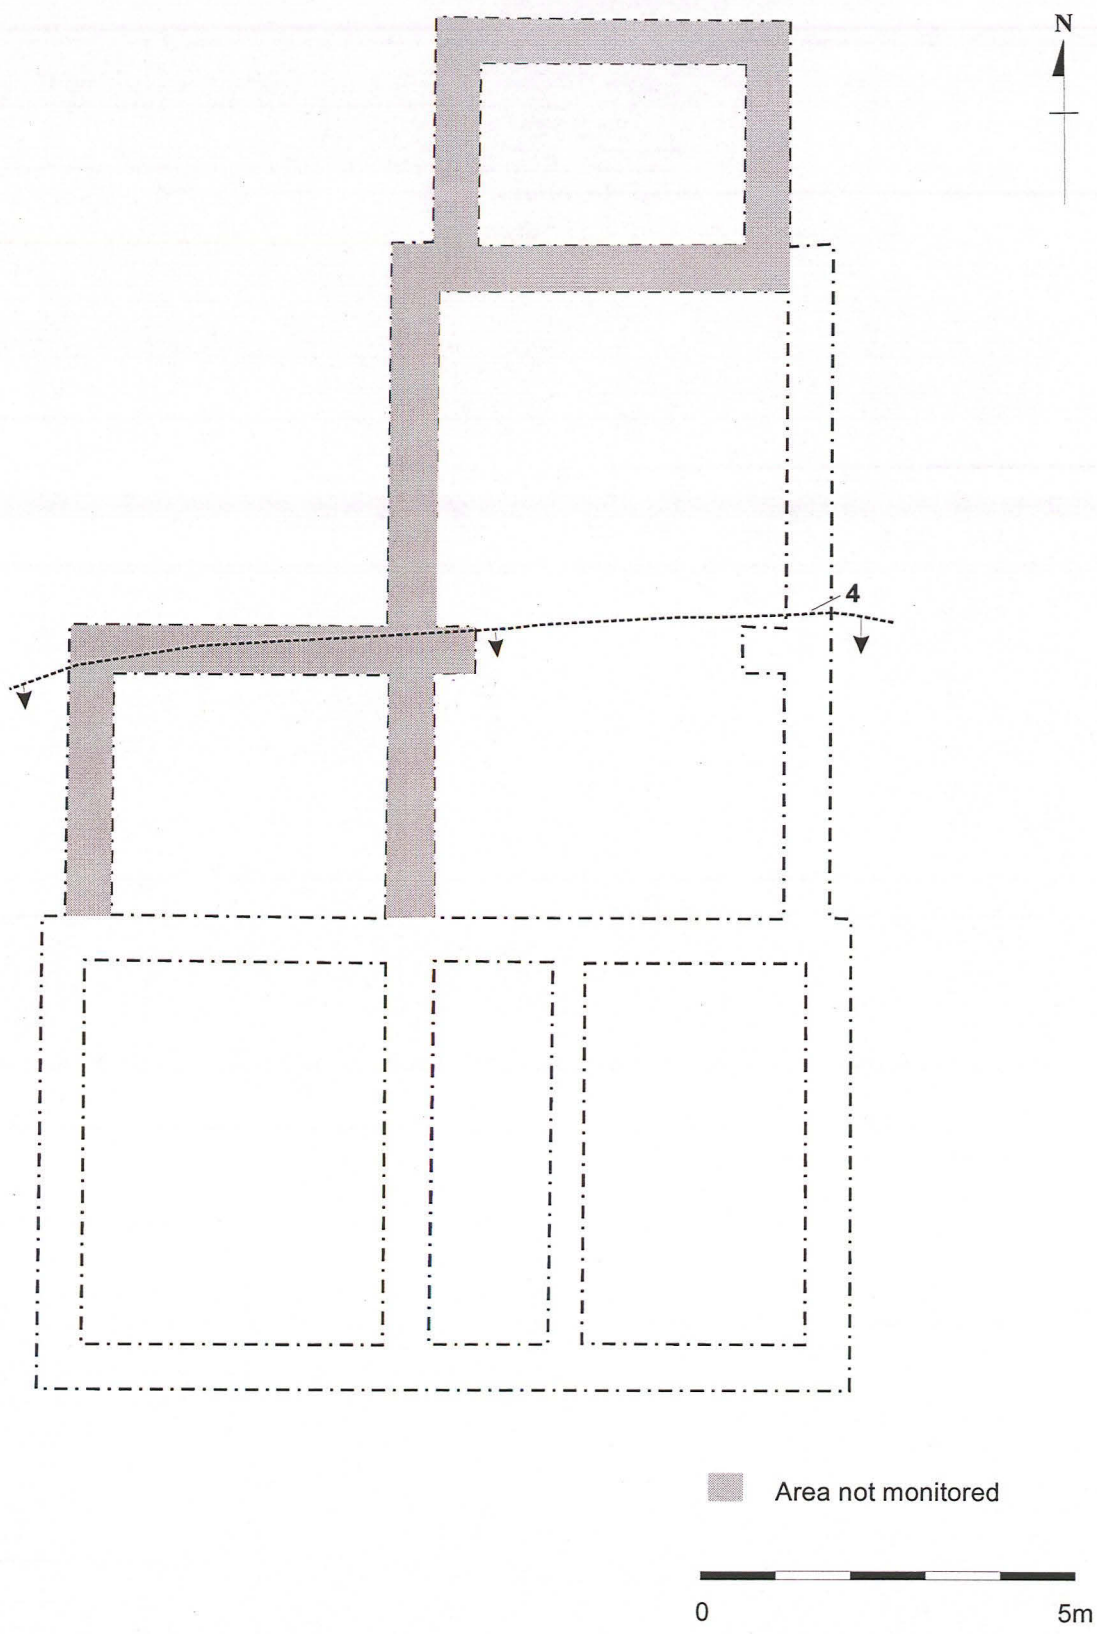
Fig. 3 Plan of monitored area, house Plot 15 (from a drawing supplied by the client).

Excavation of the house footings was monitored by the author on the April 24<sup>th</sup> 2006. A JCB excavator using a toothless bucket opened the foundation trenches to a maximum depth of 2.4m from the present ground surface and 0.60m in width (**Fig. 3**). Machining was monitored during the first day of the groundworks. The watching brief ceased upon agreement with Louise Jennings of the Archaeology Section of Lincolnshire County Council. A full photographic record was maintained during the monitoring.

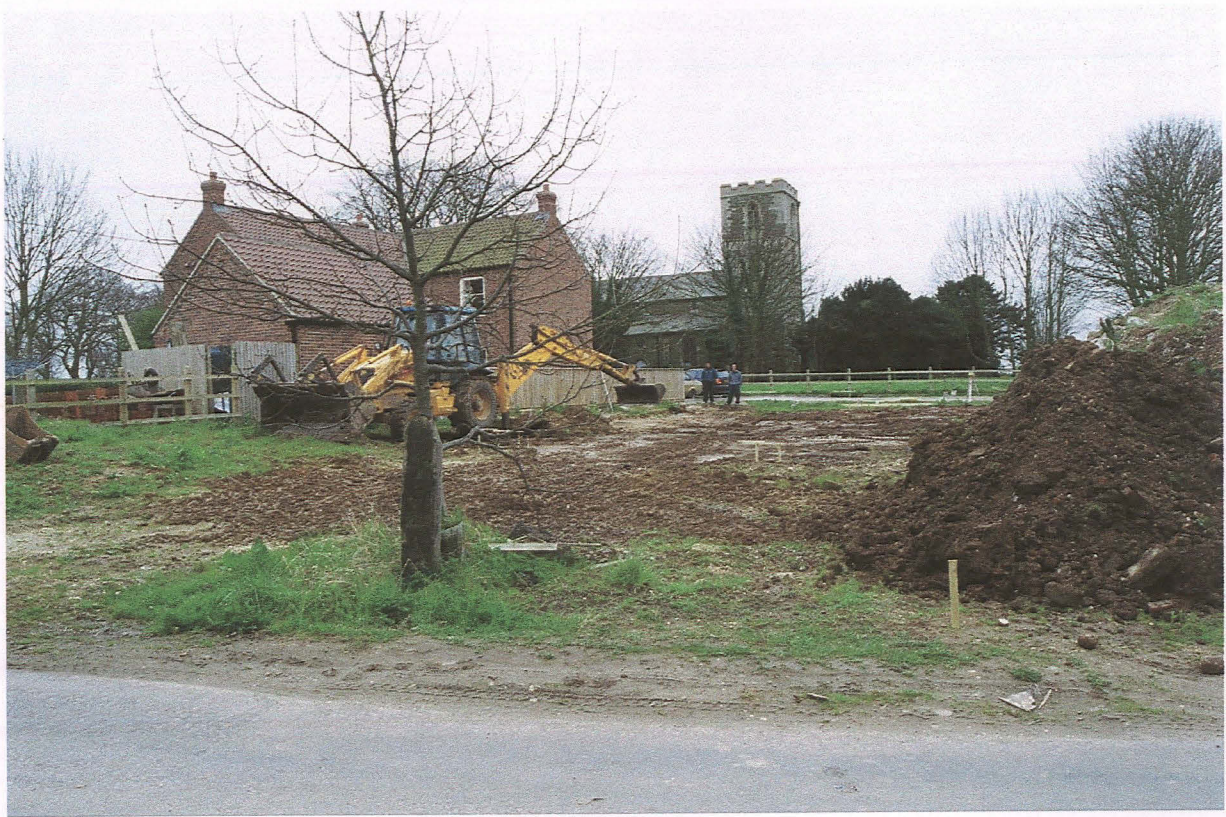
PI. 1 Looking south across Plot 15 with St. Margaret's Church in the background.

After levelling the material which had been dumped from work on other plots the foundations were excavated (**Pl. 1- 2**). The upper layer consisted of a mid brown sand silt clay with frequent bricks reinforced concrete, piles of barbed wire and stones which covered the plot to a depth of 0.6m (**1**). Beneath layer **1** was a 0.3m thick mid grey brown clay layer with frequent stone rubble (**2**). Layer **2** may have been the remnants of a surface but had been disturbed. Beneath layer **2** a large pit was evident over most of the plot (**Fig. 3; Pl. 3-4**) which was a further 1m deep (**4**). The pit contained a dark grey silt clay with fragments of brick (**3**). It is possible that this pit was associated with activity at the farm or a pond shown on the 1856 plan of Huttoft by John Hill (Field and McDaid 1995, Fig 2; LAO ref PAR 23/1). No *in situ* foundations were encountered although a number of bonded brick wall fragments were present in layer **1**. The orange brown natural clay (**5**) was encountered at a depth of between 1- 1.9m in depth beneath the ground surface.

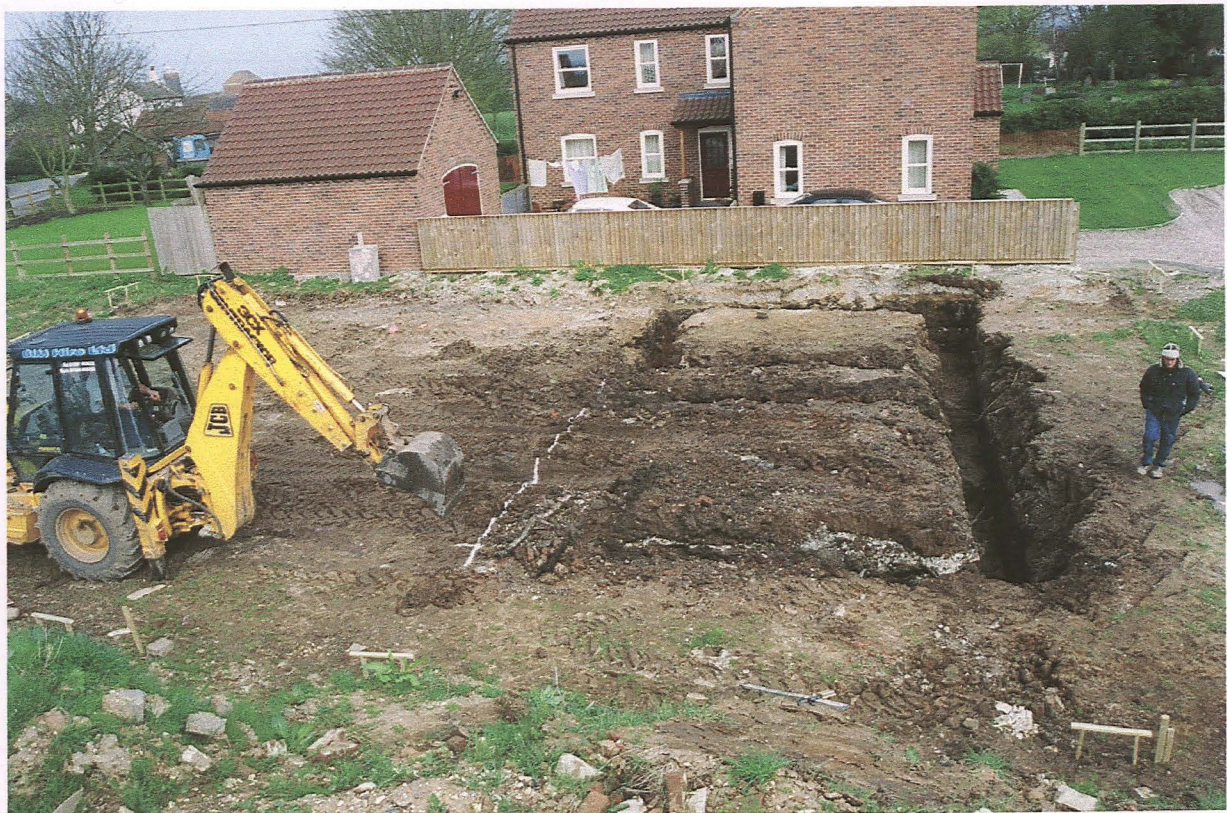
PI. 2 Looking east from the soil heap towards Plot 16 during excavations.

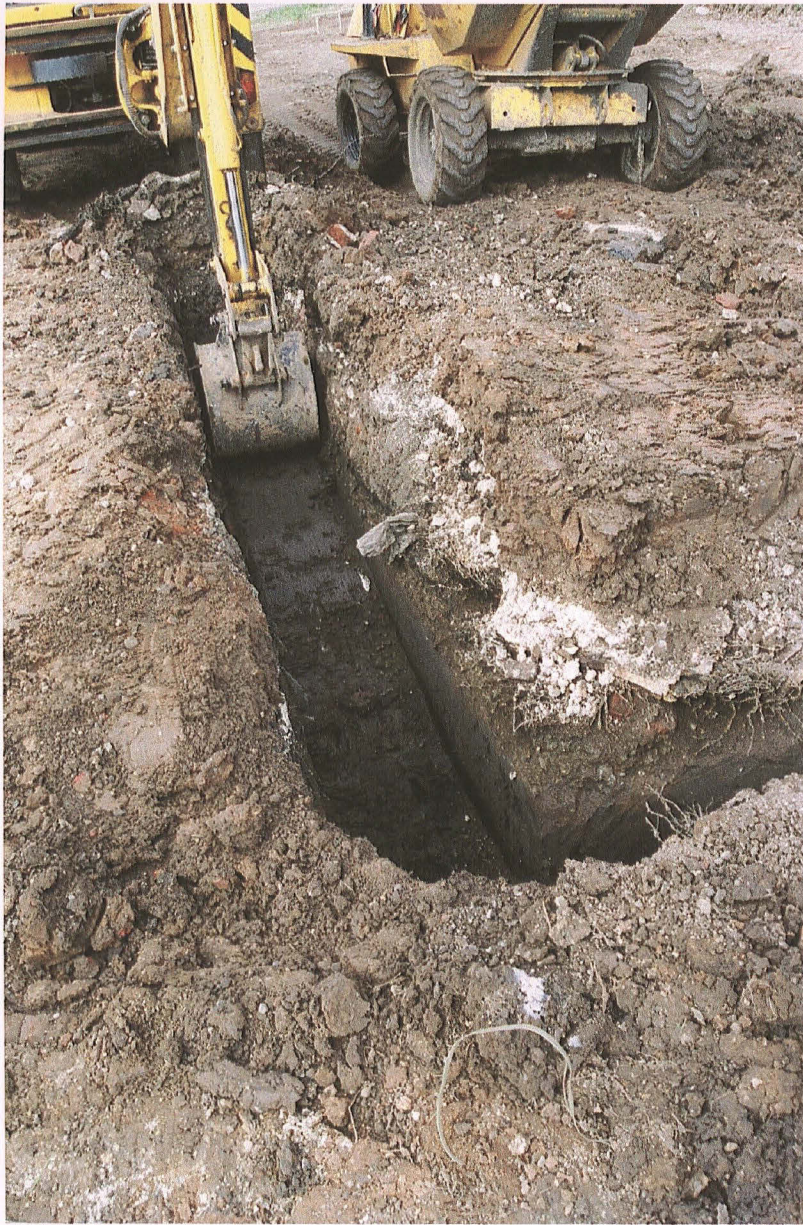
PI. 3 Looking north at the southwest corner foundation trench, showing pit 4.

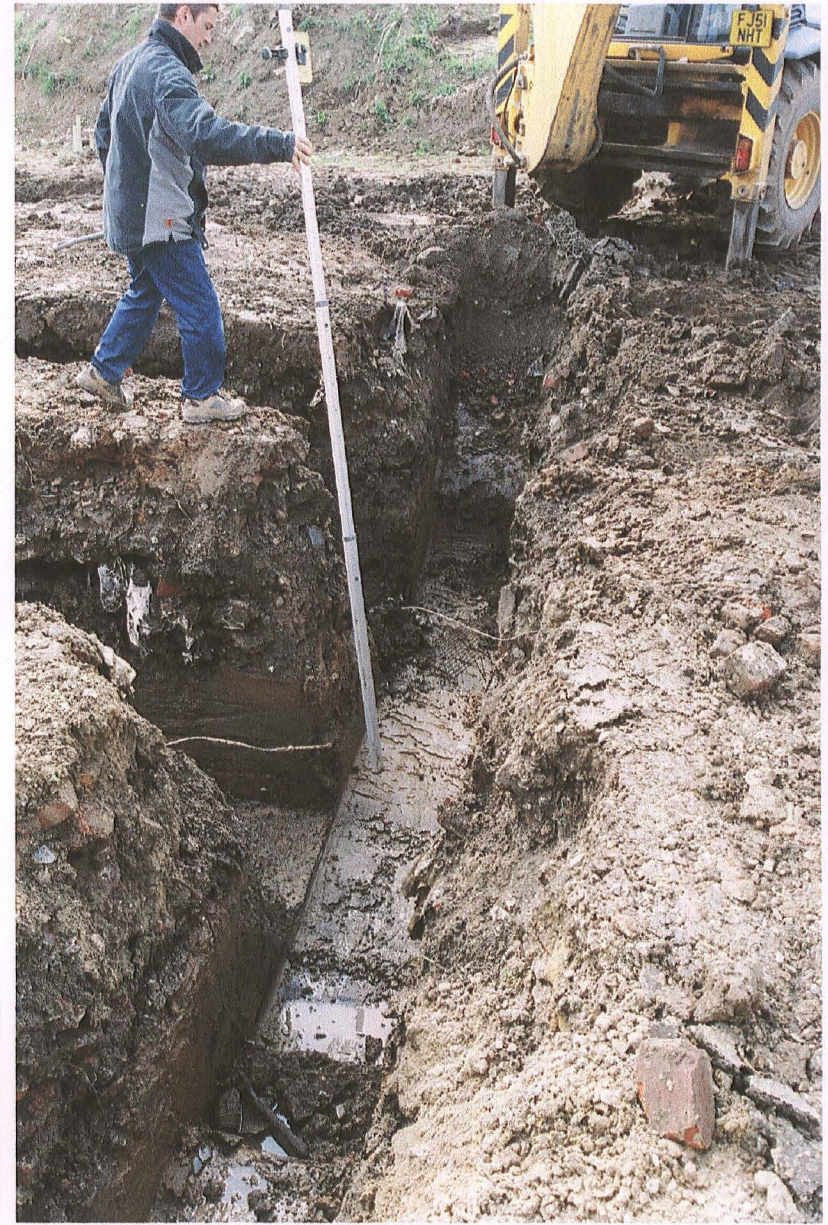
PI. 4 Looking west at during the machining of foundation trenches, showing pit 4.
