**A Report on an Archaeological Evaluation
at
Junction, St Mark Street, Lincoln**

NGR SK 9735 7085

JSAC 943/02/02
Site code: JSM02

July 2002
Accession No.:2002.326

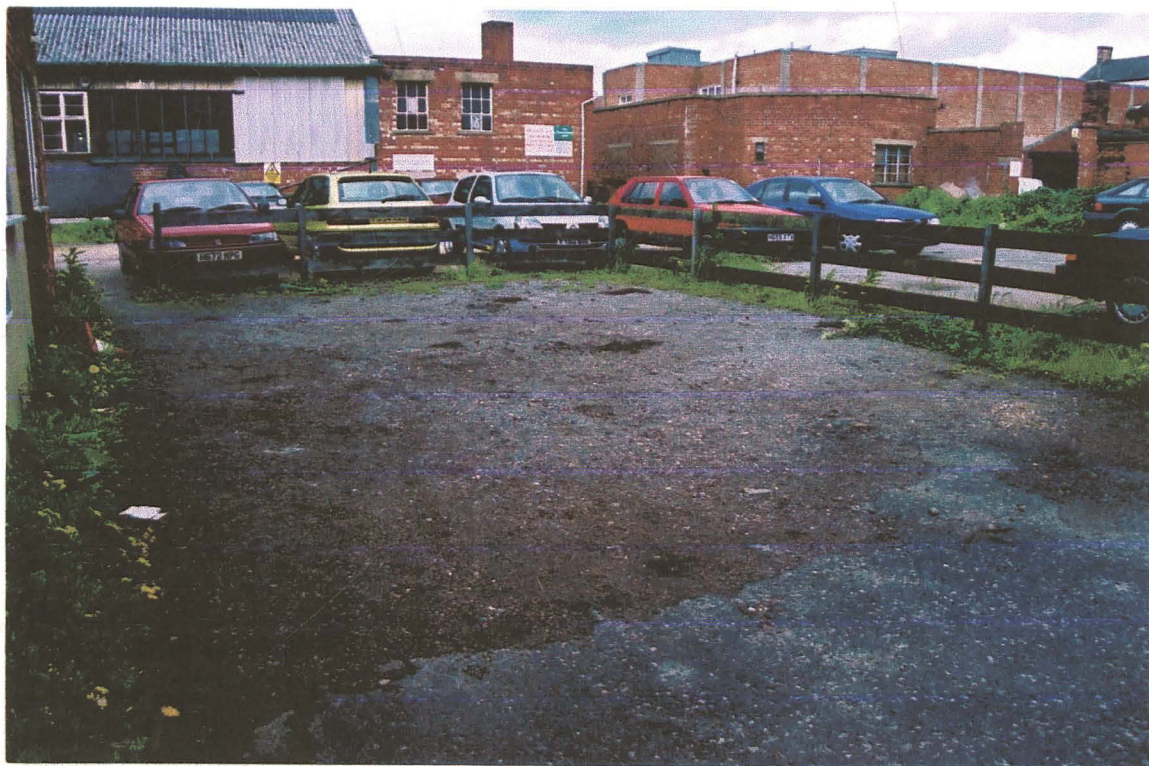
Plate 1.

Location of Trench 1 prior to excavation.

3.1.1 Located within the visitor's car park close to the St Mark's Street boundary (see figure 2) it measured 1.75 x 3.30 metres and was initially excavated using a toothed bucket, following the removal of the car park surface excavation continued to a depth of 2.01 metres below the modern ground surface.

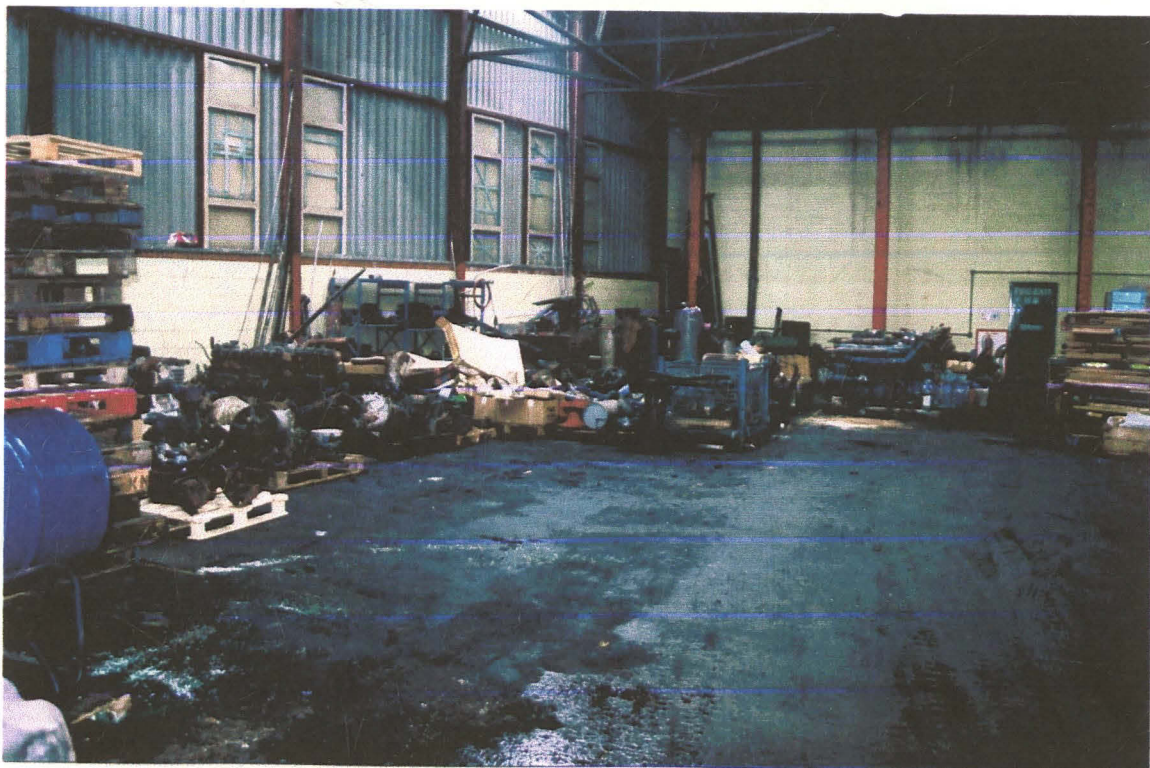
Plate 4. Location of Trench 2, prior to excavation.

- 3.2.1 Located within the existing Road Car Bus Depot close to the Brayford Wharf East boundary (see figure 2) trench 2 measured 1.85 x 2.80 metres and was initially excavated using a concrete breaker and toothed bucket, following the removal of the concrete surface (201) excavation continued to a depth of 2.04 metres below the modern ground surface.

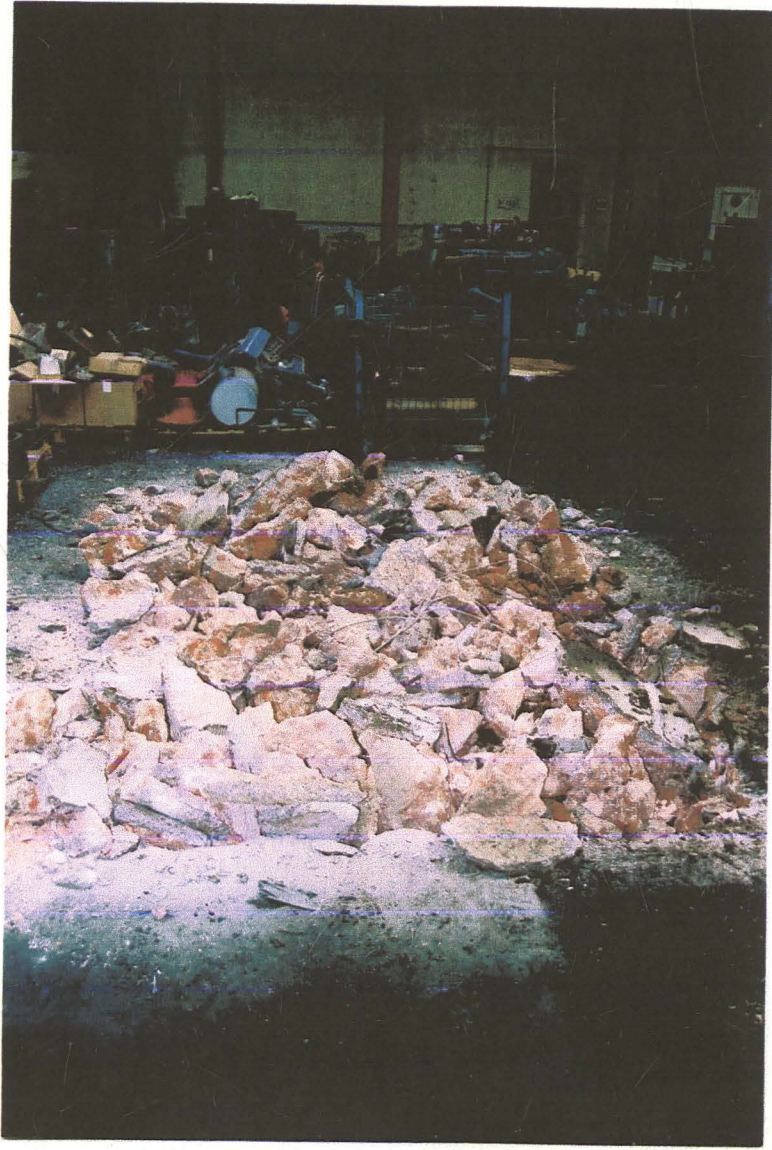
Plate 5.

Trench 2, surface broken.

- 3.2.2 The floor surface 201 was supported on a sub base of orange / red brick rubble in a concrete matrix, reinforced with steel mesh (202). This in turn overlay a make up layer 0.78m in thickness of brick rubble and concrete blocks, with dimensions of up to 0.50 x 0.30m x 0.30m, contained in a dark black / brown loamy matrix (203).
