**The Mount, Wragby Road, Lincoln  
Archaeological Watching Brief**

**Oakwell Construction Ltd**

**LAS Report No. 928**

**June 2006**

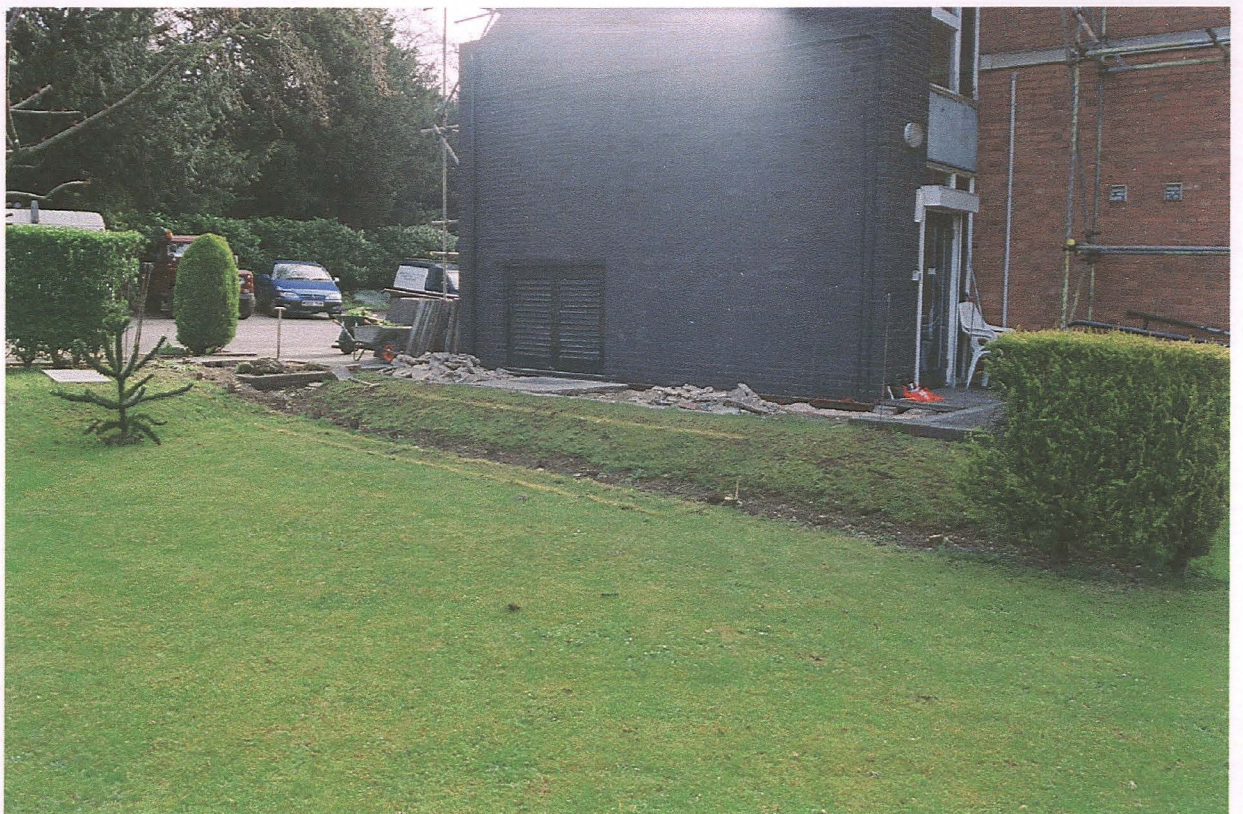
PI. 2 Location of the retaining wall trench, The Mount (looking north-east).

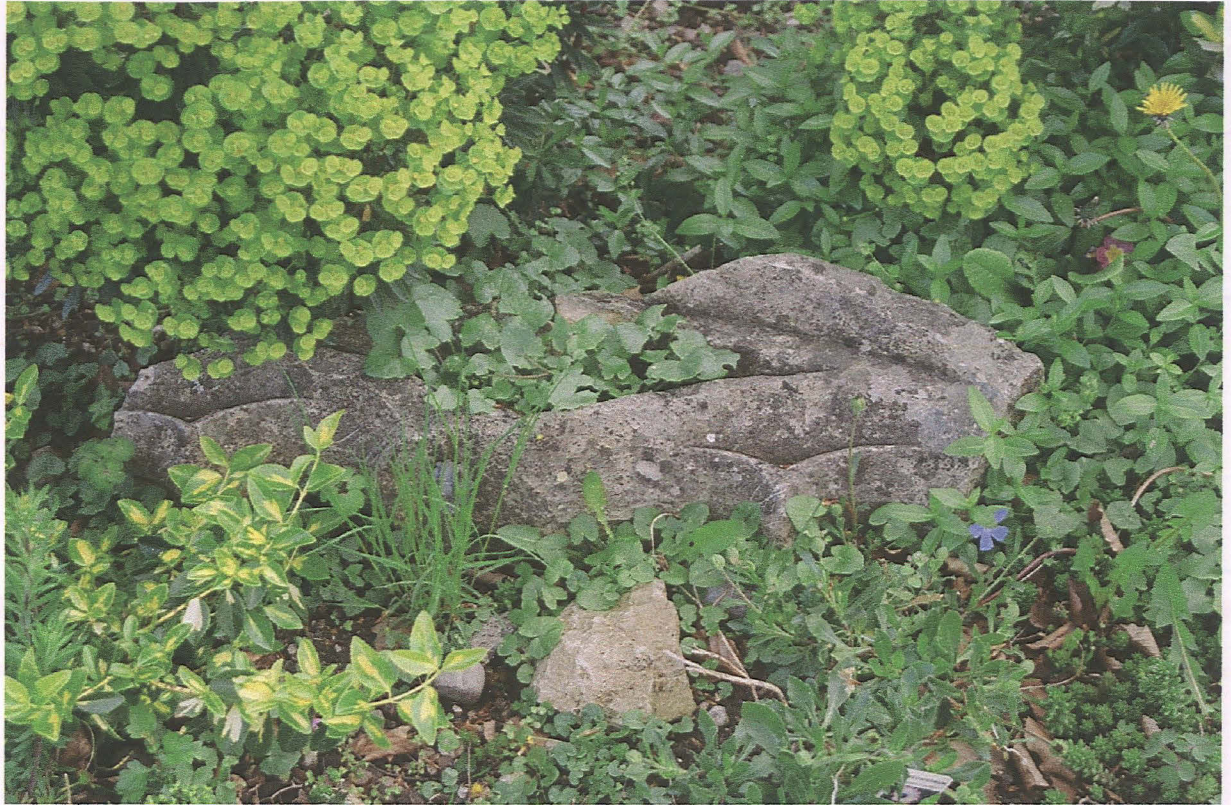
During monitoring of the retaining wall trench, several pieces of carved stone were seen in the garden, including pieces of window moulding and a City of Lincoln crest (Pls. 5-8). The source of these architectural fragments is not known.

Pl. 5 Architectural fragment in garden border at The Mount.

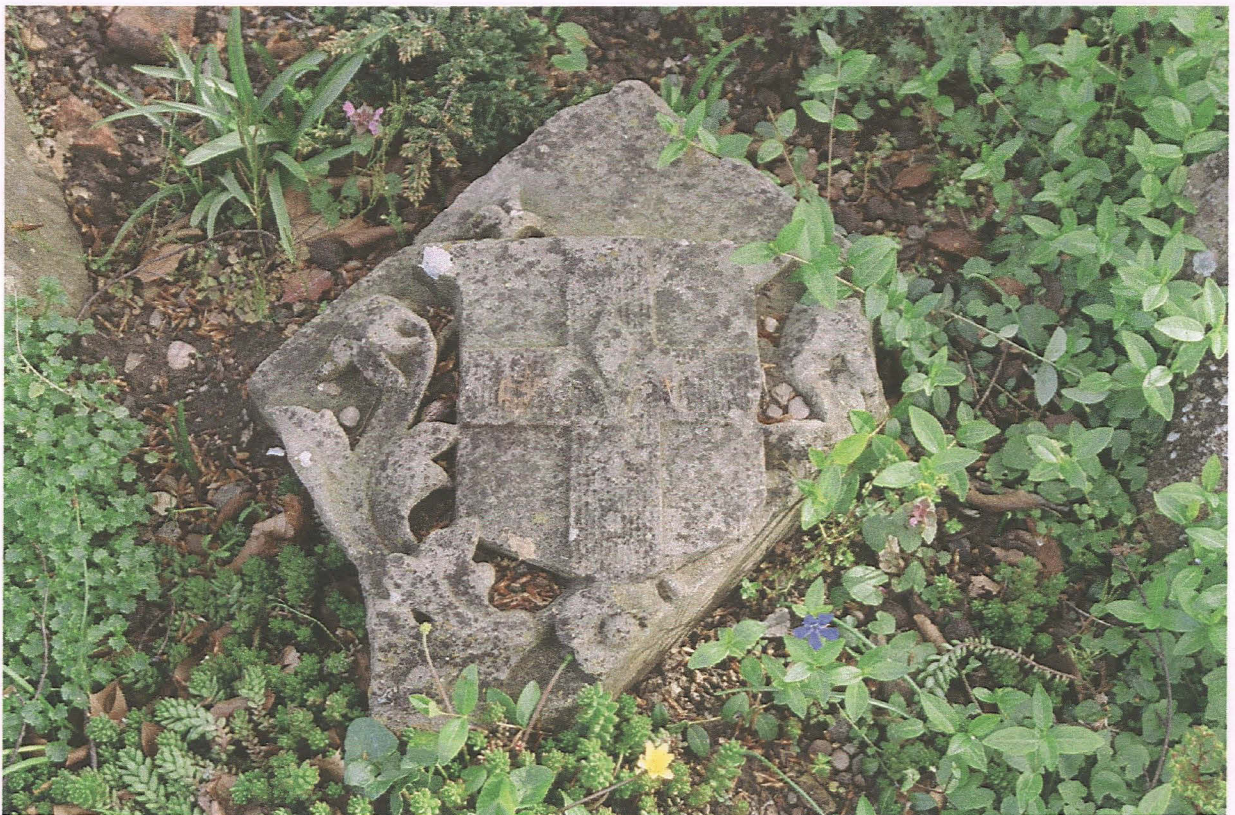
Pl. 6 Architectural fragment with City of Lincoln crest, in garden border at The Mount.

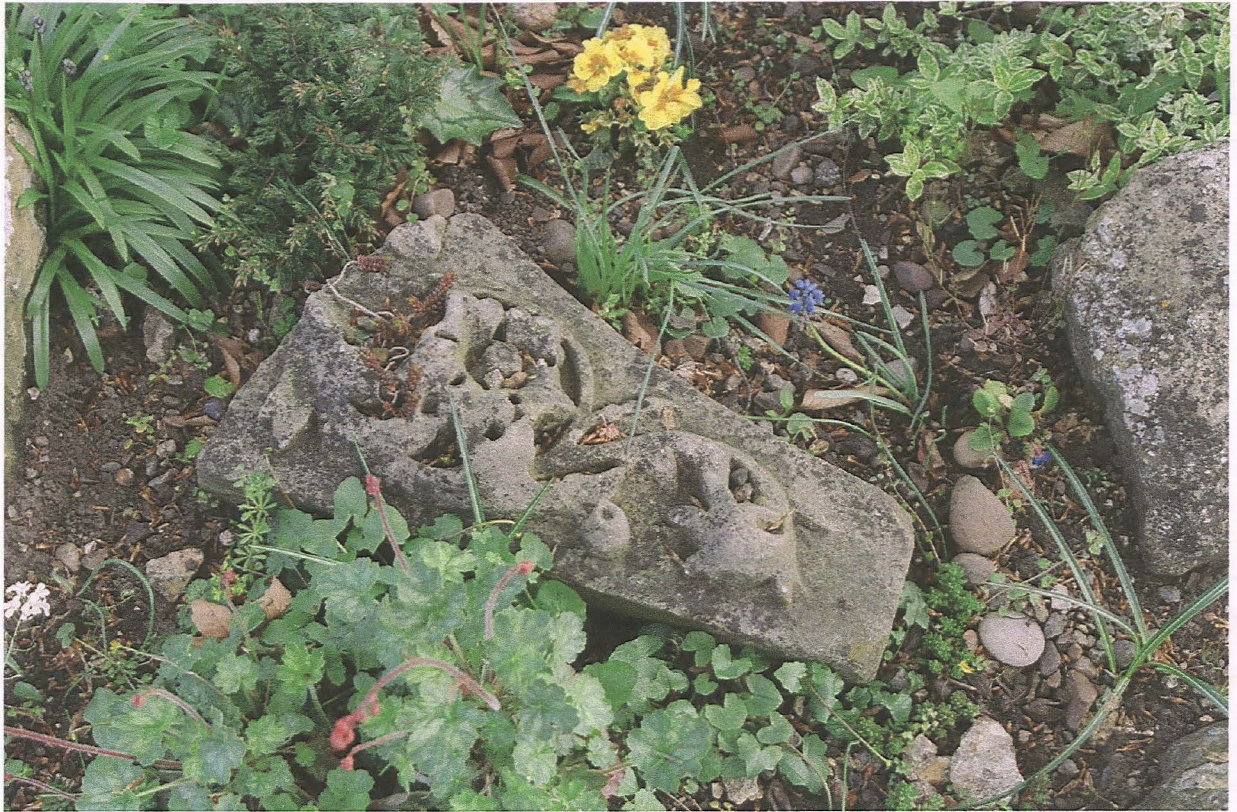
PI. 7 Architectural fragment in garden border at The Mount.

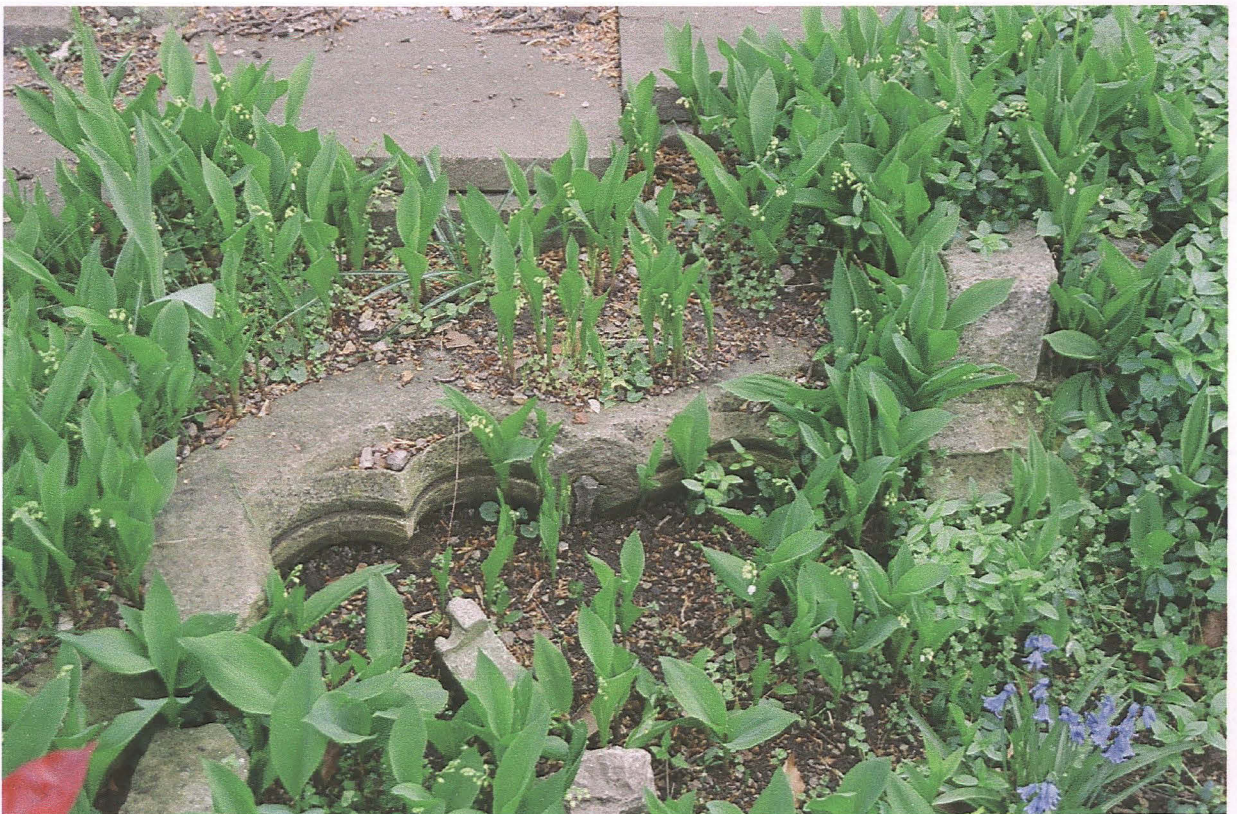
PI. 8 Architectural fragment in garden border at The Mount.
