**Sandars Yard, Bridge Street,
Gainsborough, Lincs.
Archaeological Watching Brief**

Site Code: GSYB 06

Report N°. 913

June 2006

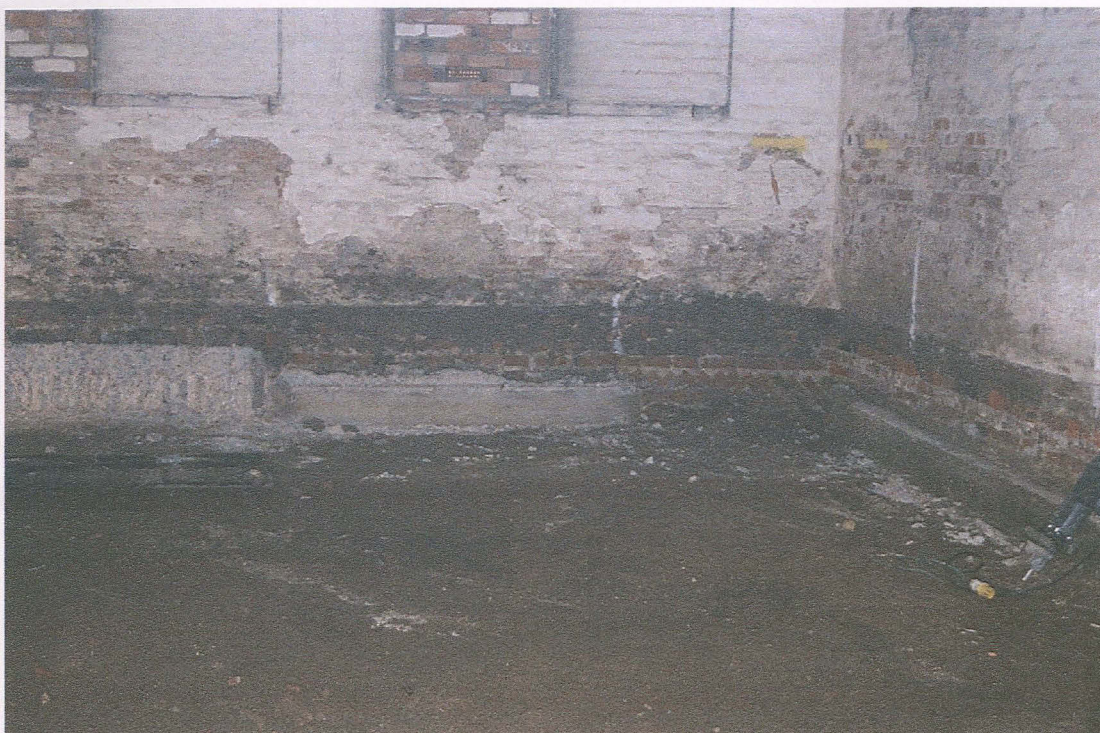
Pl. 3 Concrete flood protection along west wall of Building A, partially removed

During initial groundworks for the development, test pits around the northern and western walls of Building A revealed substantial foundations with a depth in excess of 1.20m. Along the length of the west wall, a c.1.80m wide concrete slab had been installed during the 1960s-70s as flood protection (Pl. 3). The remainder of the floor had mostly been removed before the inspection was made. This comprised a tile floor **101** on a bedding of crushed mortar, **102**, later covered with the thin skim of concrete (0.1m thick in total). Visible at the north end of the building, against the north wall were remnants of an earlier floor surface **110**, comprising rounded river pebbles and bricks 230mm x 115mm x 60mm (Pl. 4). A brick-lined culvert **103** crossed the interior of Building A at its southern end, originally emptying surface water from the yard to the east of Building A, into the river. It had been cut through by the concrete flood barrier on the west side of the building. Its internal dimensions were 0.25m wide x 0.40m deep. Iron frames crossing the width of the culvert, measuring 0.40m x 0.10m wide and 5mm thick were overlain with sandstone capping stones, with perforated malting bricks at intervals along its length (Pl. 5). Slates were used to level the capping stones. A second culvert, 0.30m wide and containing a ceramic pipe, **104**, also crossed the width of the floor to the south of **103** and

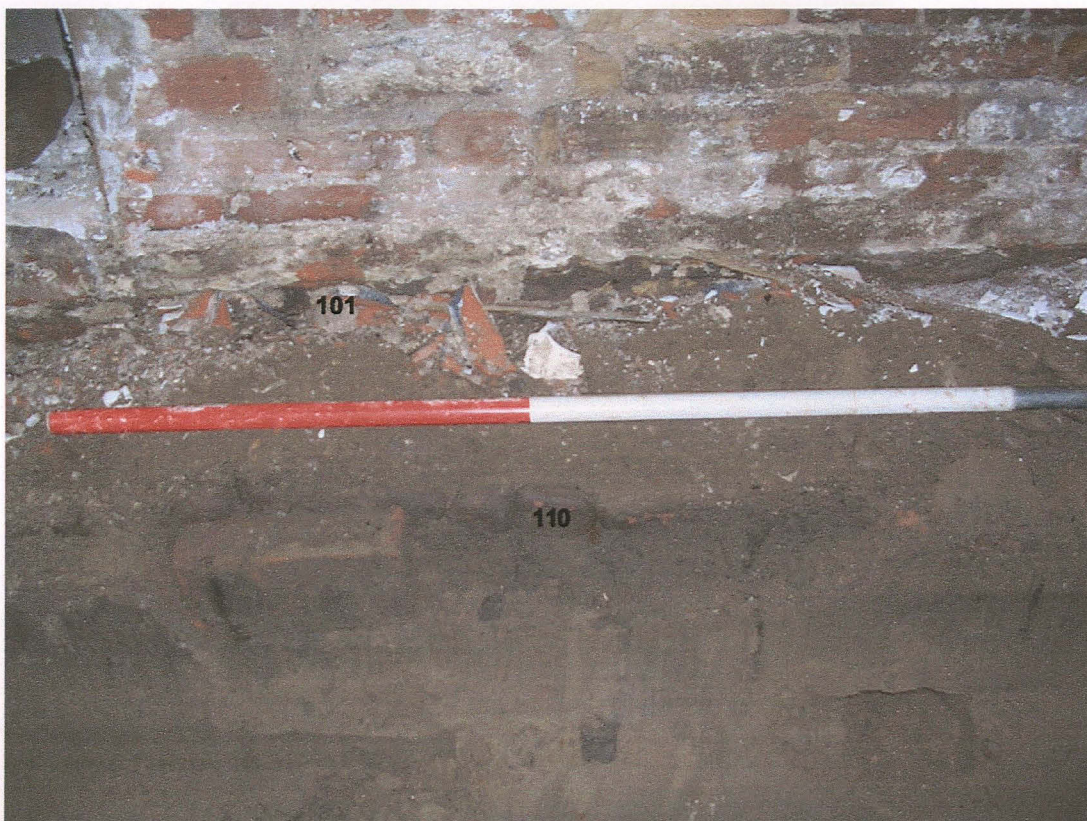
Pl. 4 Building A, north end. Remnant of cobbled surface 110, beneath tile floor 101 (removed)

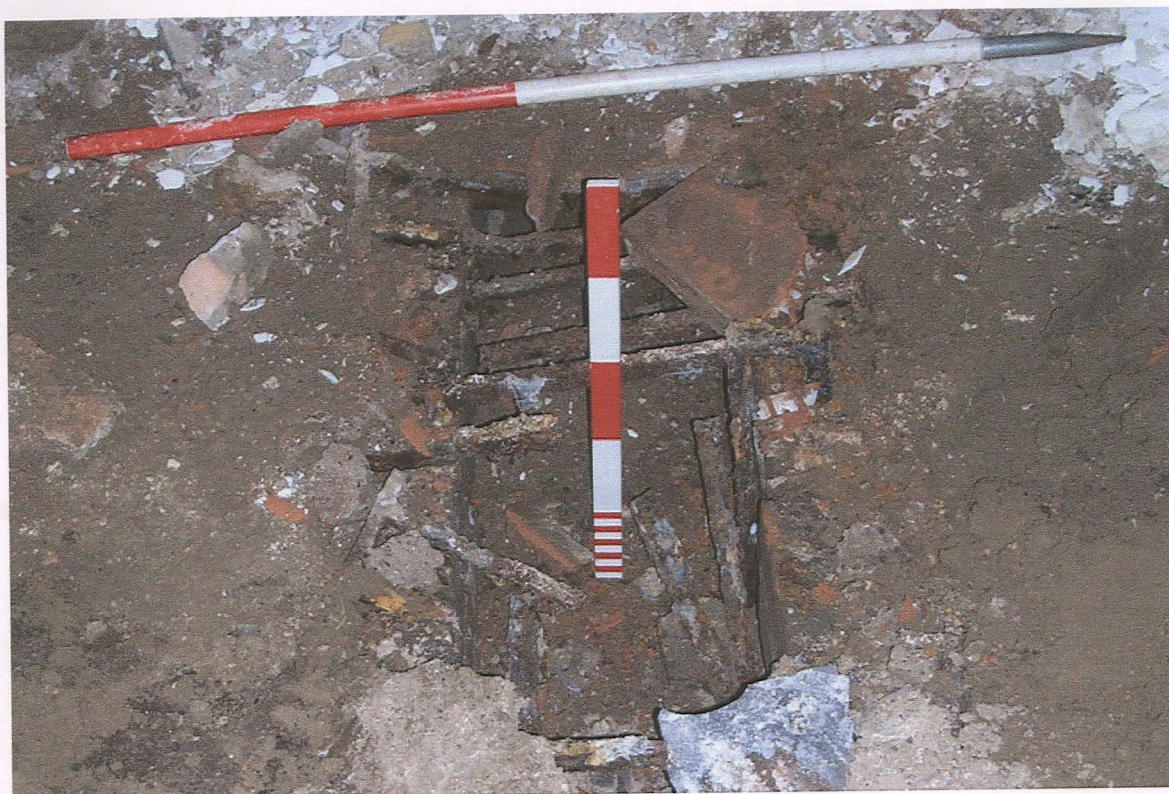
Pl. 5 Drain 103, looking west. Scales 1m and 0.50m.

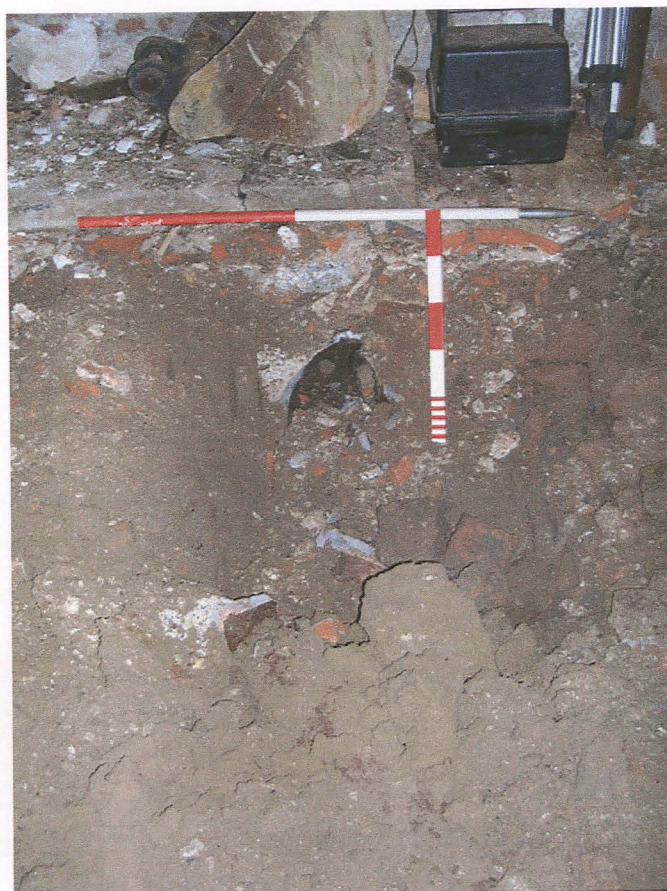
Pl. 6 Brick-lined ceramic drain 104, looking east. Scales 1m and 0.50m.

was probably a 20th century replacement (Pl. 6). The earlier drain was probably contemporary with the tiled floor.

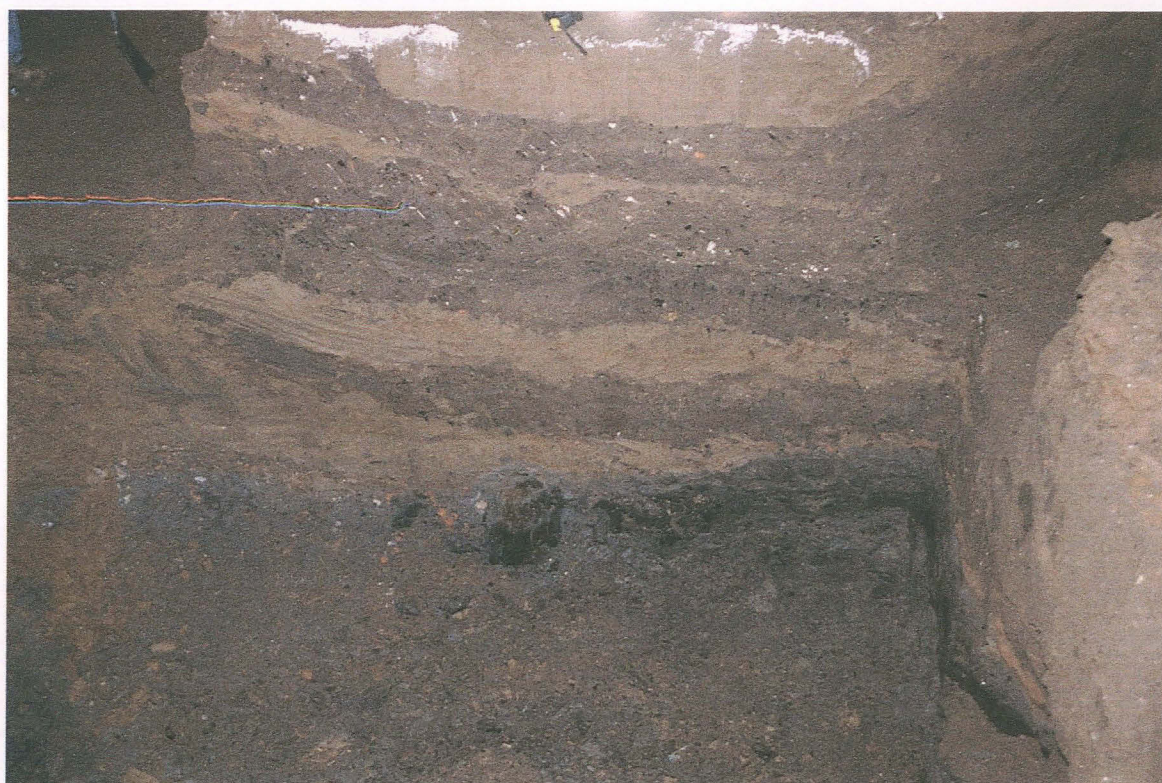
Pl. 8 Lift shaft 1 showing timber post at base of pit.

Layer **107** directly sealed a second 0.45m thick layer of riverine warp **108**, similar in consistency and colour to layer **100**. No finds or features were noted in **108**. Layer **108** sealed a thick dark grey clay/silt **109** that appeared at a depth of 1.4m and was only visible in the base of Lift Shaft Pit 1. Layer **109** continued below the trench base at 1.50m below ground level (Fig. 5, Pl. 8).

Two wooden stakes **105** were noted during the excavations for the lift shaft, at a depth of c.1.00m below the present ground surface (Pl. 8). The stakes were surrounded by layers **107**, **108** and **109**, continuing below the developers' trench. Their stratigraphic relationship to those layers was unclear.

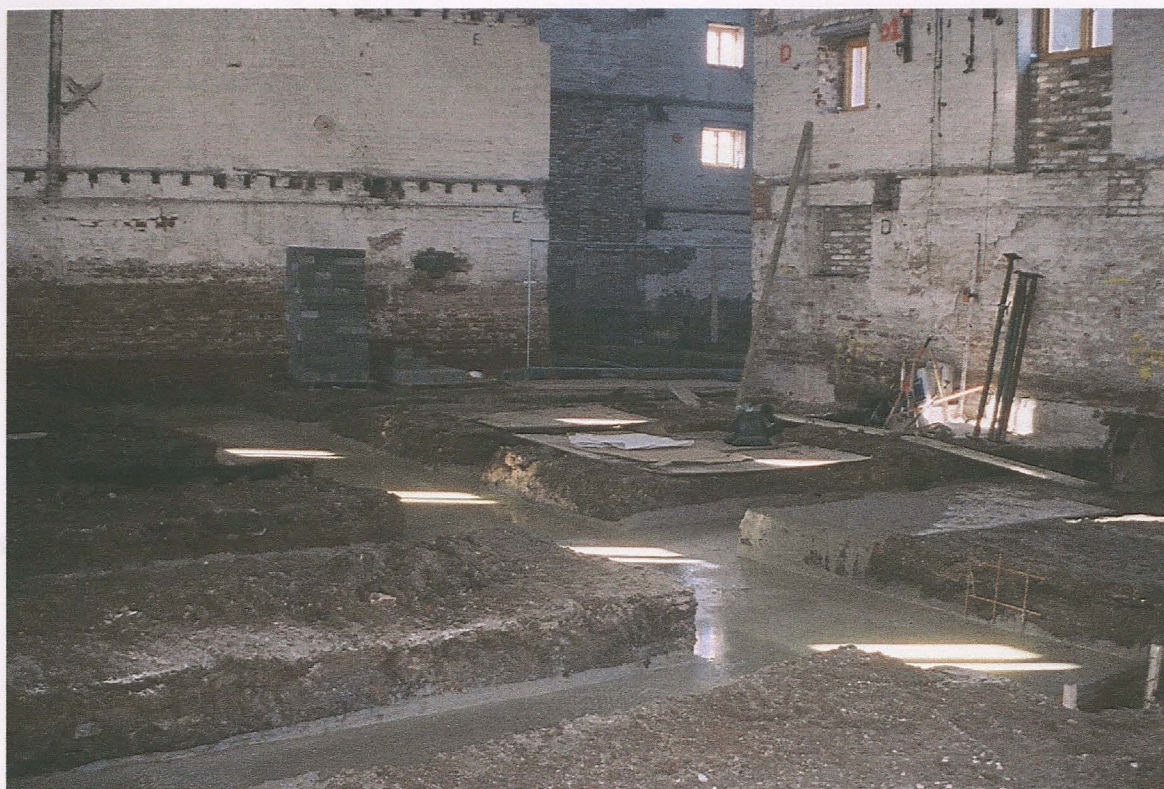
Pl. 9 Looking north-west from Building B through into Building A after excavation and concreting of internal foundations.

Building B was added to Building A in around 1840 (RCHME 1992) (Pl. 9). The foundations on the eastern side of this building, adjacent to Bridge Street, were found to be only two brick courses in depth. These inadequate foundations required underpinning and alternate sections c.1.50m long were excavated beneath the walls and filled with concrete.

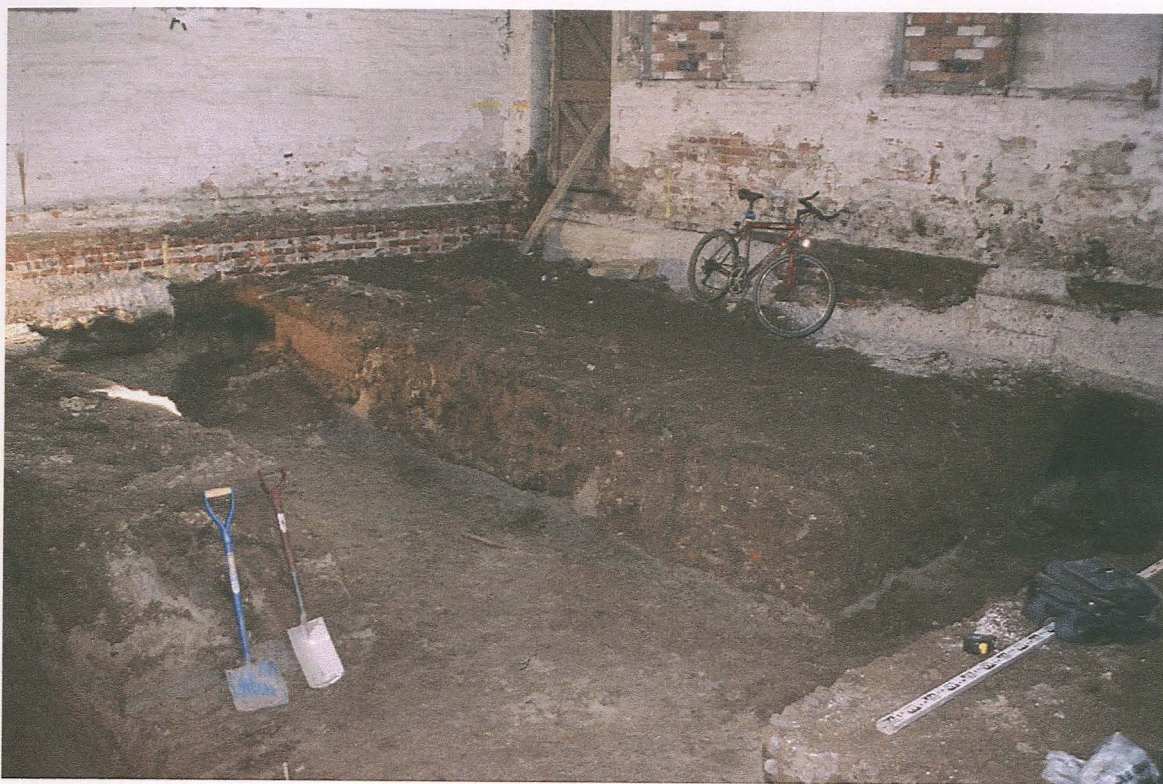
Pl. 11 Building B. Intercutting pits, 218, 221 and 223 in section. Looking north east.

Layer **203** overlay a further flood warp layer **204** (similar in consistency and colour to **200**), which sealed a several pits noted in section, but not in plan during the excavation of partition wall foundation trenches at the east end of Building B. They all cut **206**, a 0.40m thick mid grey silt clay layer. Two shallow features, possibly pits, **207** and **210** contained similar single mid to dark grey brown silt clay fills, **208** and **209** respectively (Fig. 6, Pl. 10). Four brick fragments were recovered from the fill of **209**, all dating from the 14th to the 16th centuries. To the south of **210**, was a slightly larger pit **215** (Fig. 7). To the east of these pits, also cutting **206** were three intercutting pits **218**, **221** and **223**, all sealed by **204** (Fig. 8, Pl. 11). It is not clear if some, or all, of these features predated the construction of the warehouse as only **209** contained finds, which were probably residual.

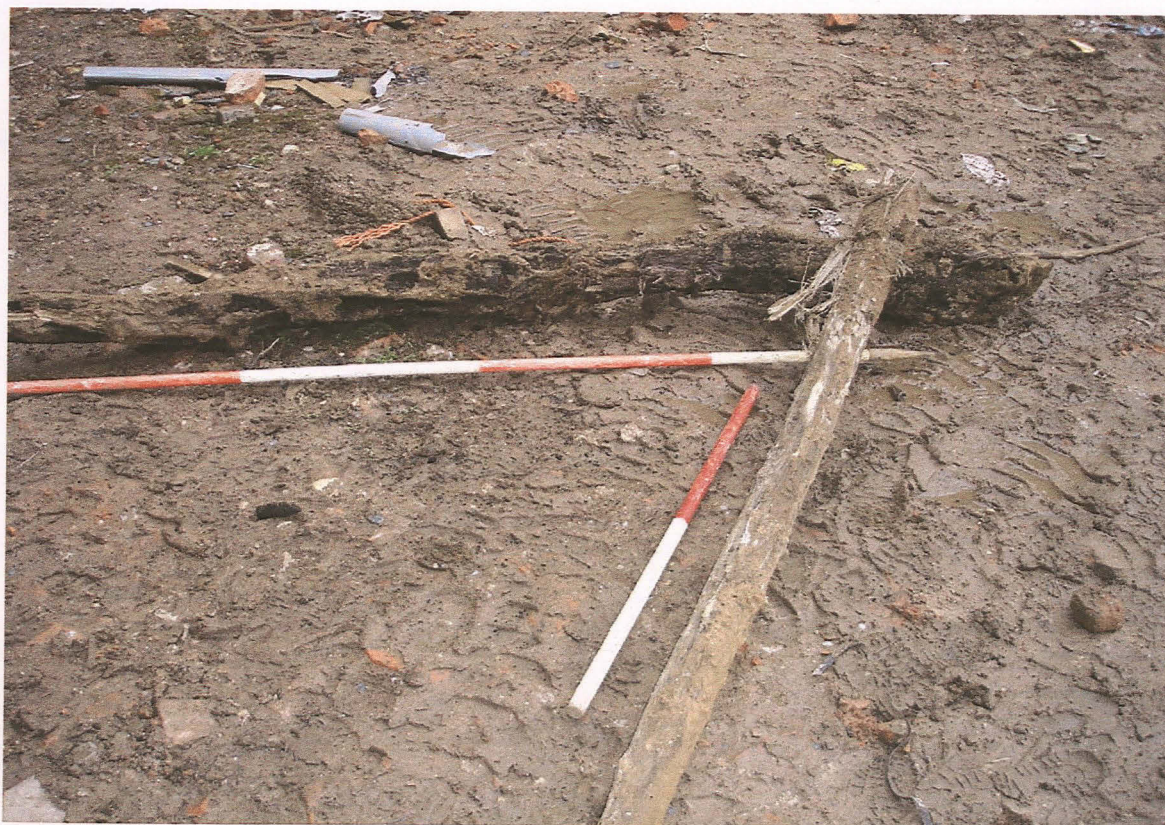
Pl. 12 Two timbers joined with iron pin, from layer 206.

Two fragments of brick, with a broad date range from the 14th to the 18th centuries, were recovered from layer **206**, as well as a pair of timbers joined at the apex with an iron pin. The timbers retained sapwood and bark, and were about 1.20m long (Pl. 12). Layer **206** sealed a clean light grey/blue clay layer **211**. This was tentatively identified as the natural geology on the site.
