**26/28 Dear Street Market Rasen, Lincs.  
Archaeological Observation and Recording**

**NGR: TF 104 892  
Planning Application: M04/P/0650  
Site Code: MRDS 06  
LCNCC Accn No.: 2006.116**

**LAS Report No. 932  
July 2006**

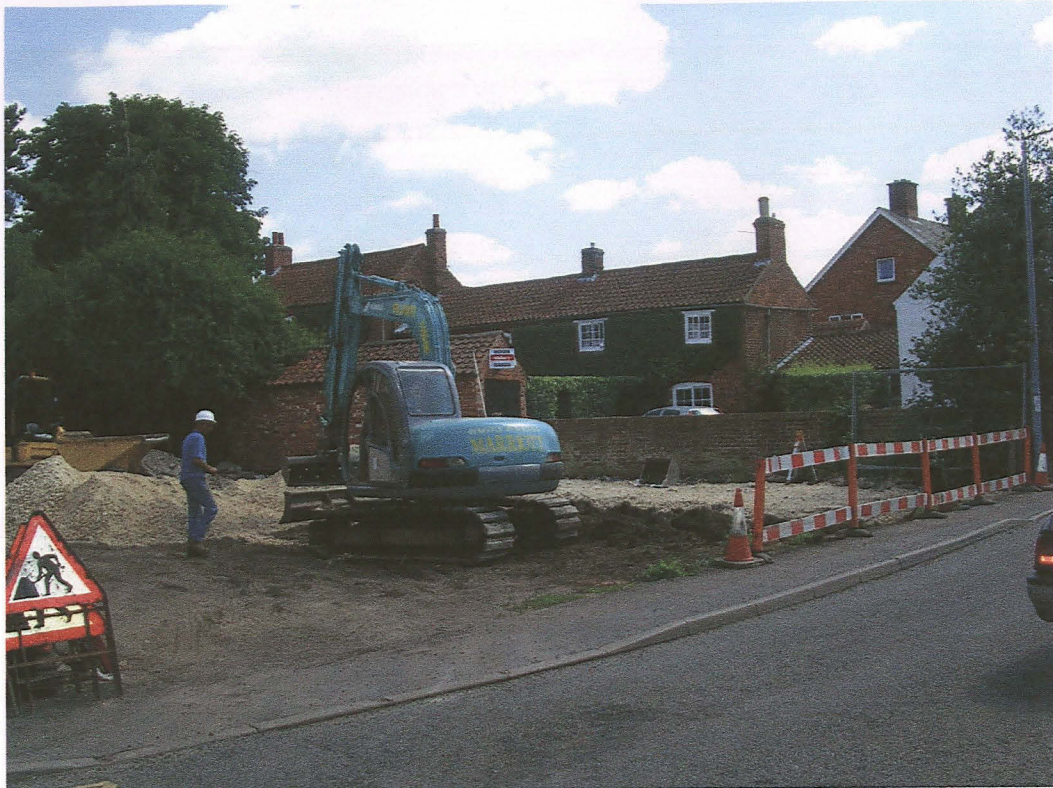
Pl. 1 26/28 Dear St Market Rasen, general view of the site looking north-east.

The site was visited on July 10<sup>th</sup> 2006. The development comprises two semi-detached houses at the front of the plot, with access on the east side leading to parking at the rear. The site was stripped of topsoil to a maximum depth of 200mm in order to level the site (Pls 1 and 2). The area of the access road had previously been covered in tarmac. This was broken up but not removed prior to being covered in limestone aggregate so this part of the site was not observed.

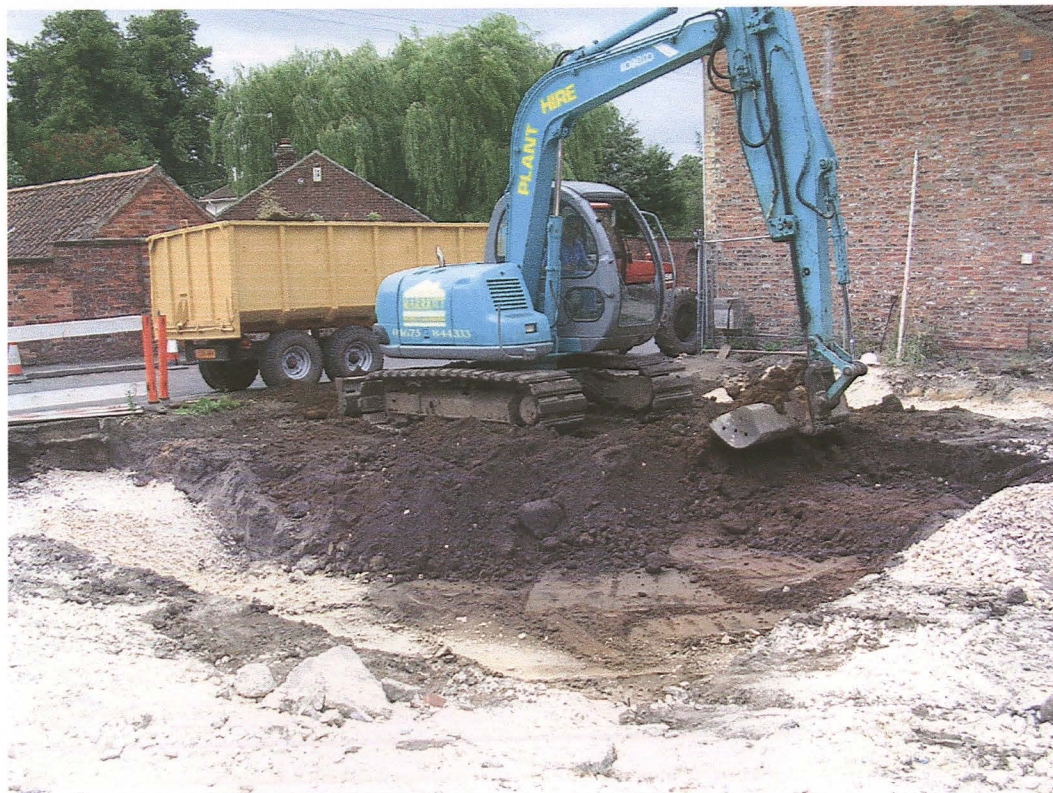
Pl. 2 26/28 Dear St Market Rasen, general view of the site looking south-west

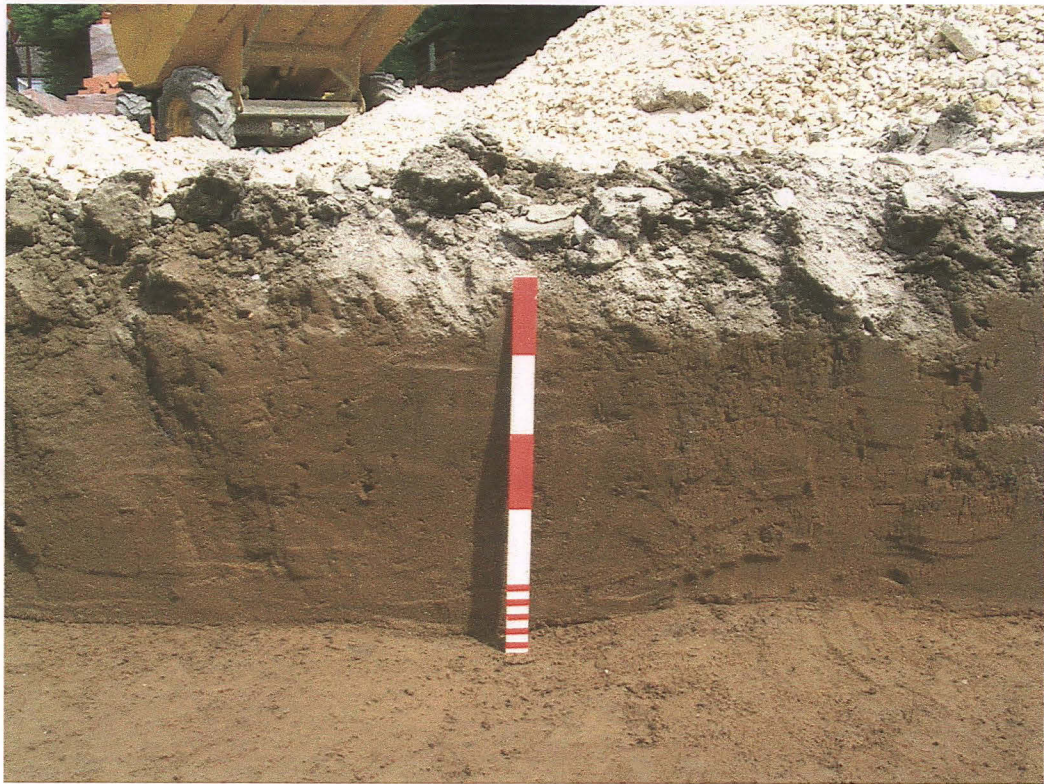
Beneath the topsoil was a thick deposit of mid-brown sandy clay silt (101) which was slightly

mottled with iron pan but had no inclusions (Pl. 3). The base of this layer was not reached by the excavations. A single 17-18<sup>th</sup> century pottery sherd was retrieved from this deposit.

Pl. 3 Typical section at rear of excavations, looking north. Scale 0.50m

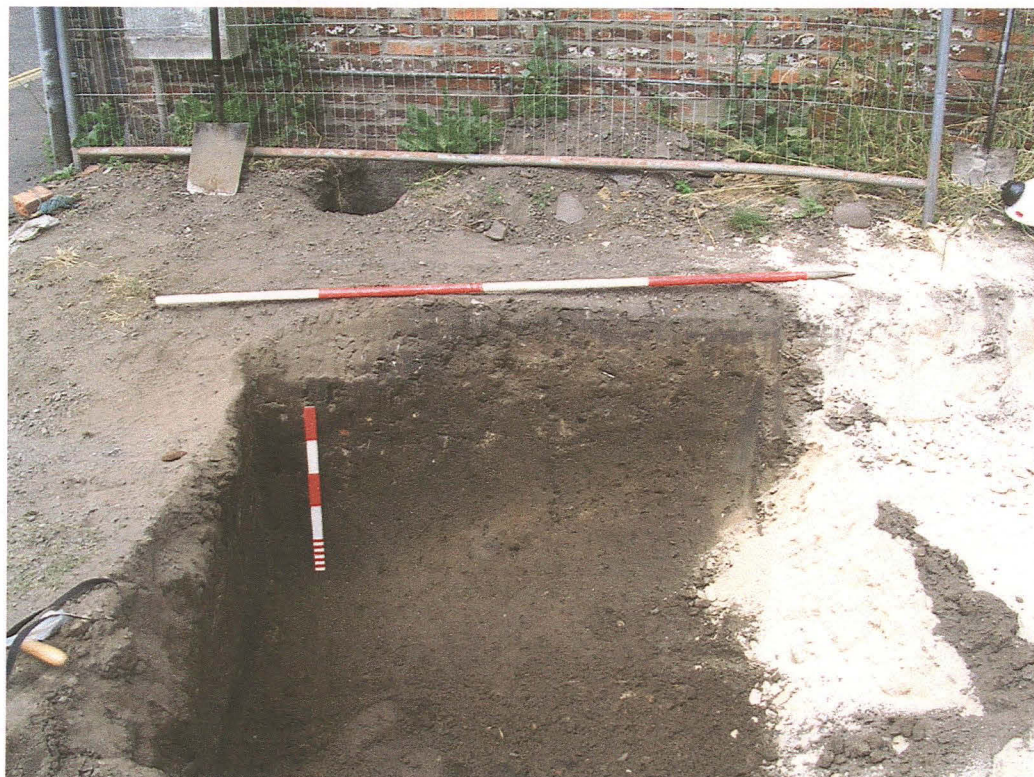
A modern service trench for disposal of surface water had been dug along the street frontage. Evidence for the edge of this trench was seen within the stripped area (Pl. 4).

Pl. 4 West side of excavations showing fall in ground at edge of street. Scales 2m and 0.50m
