**SS Peter and Paul Church
Owmbly by Spital, Lincs.
Archaeological Watching Brief**

Report

LAS Report No. 930

July 2006

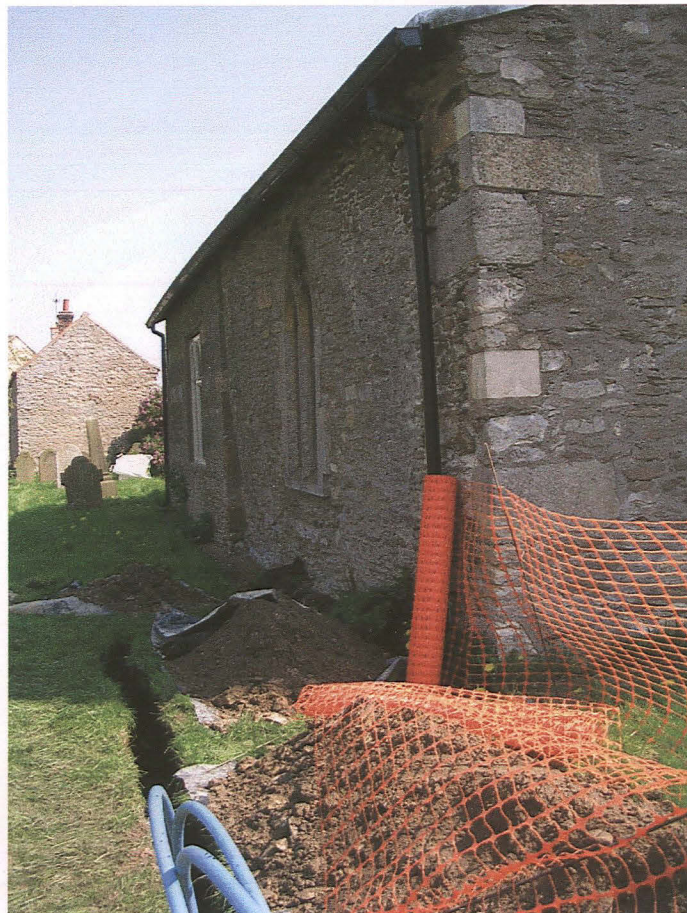
Pl. 2 General view of the excavated pipe trench. View looking east.

A trench approximately 0.20m was hand-excavated to accommodate a new water feed pipe to the church (Pl. 2). It followed the east side of the footpath which enters the churchyard at its north-west corner. It was originally intended to run the pipe approximately 3.20m along the north wall of the aisle, and cutting a hole through a blocked doorway in the aisle wall to bring the pipe into the church. The initial excavation of the trench uncovered the top course of a very substantial limestone wall. This made it necessary to widen the trench and re-route the water pipe to the north side of the buried wall. This made it possible to establish the size and alignment of the wall and to record the related deposits.

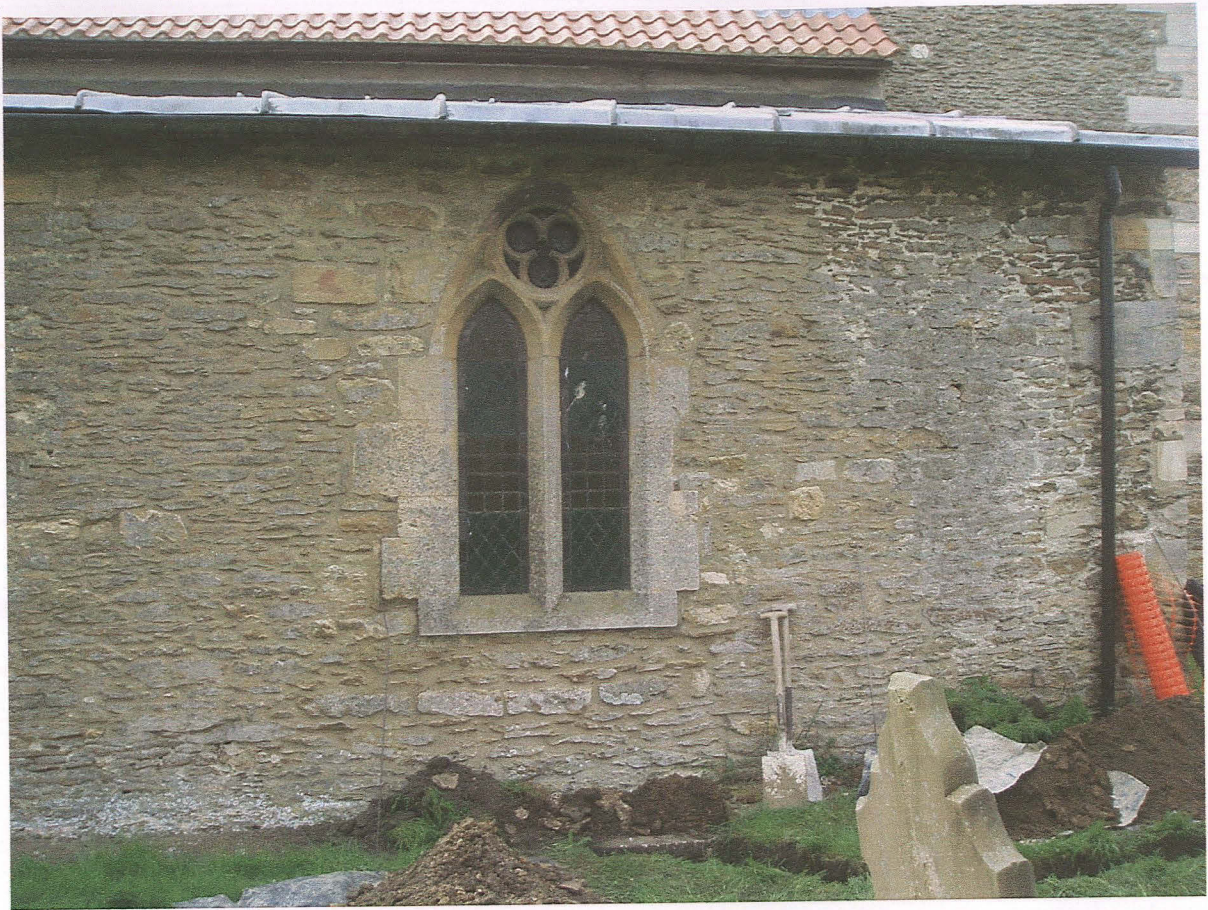
Pl. 3 The excavated pipe trench and its junction with the north aisle wall.

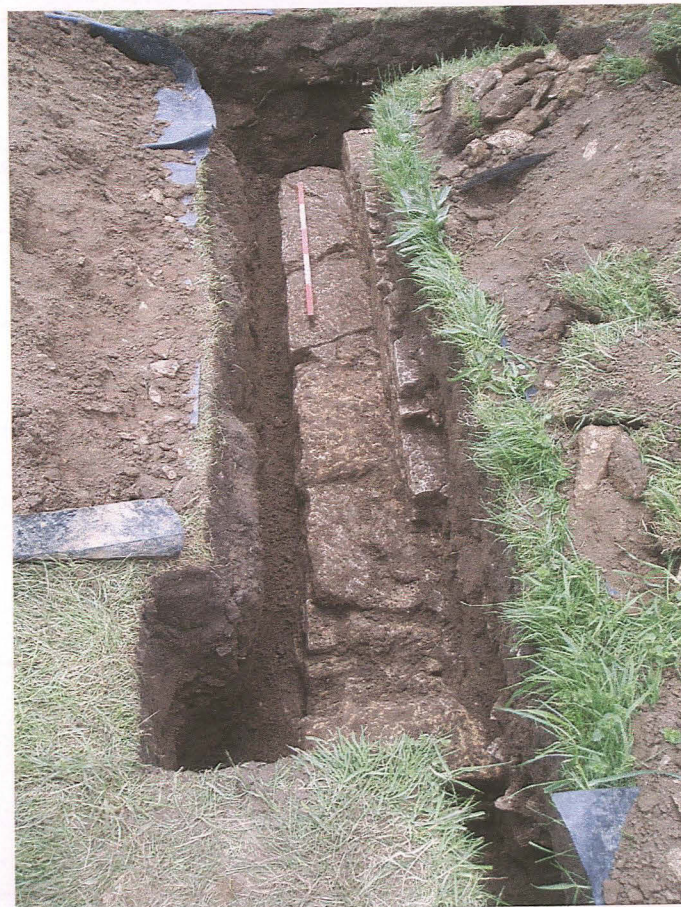
Pl. 4 The original north aisle wall within the east end of the excavated pipe trench. Scale 0.50m. looking east.

The wall itself is 0.74 m wide and constructed in flat rough limestone slabs and bonded with a cream lime mortar. It sits on footings 104, 1.10m wide and bonded in clay. It is offset to north side of the wall by 0.26m but by only 0.08m on the north (internal) face. (Fig. 3; Pls. 4-6). The base of

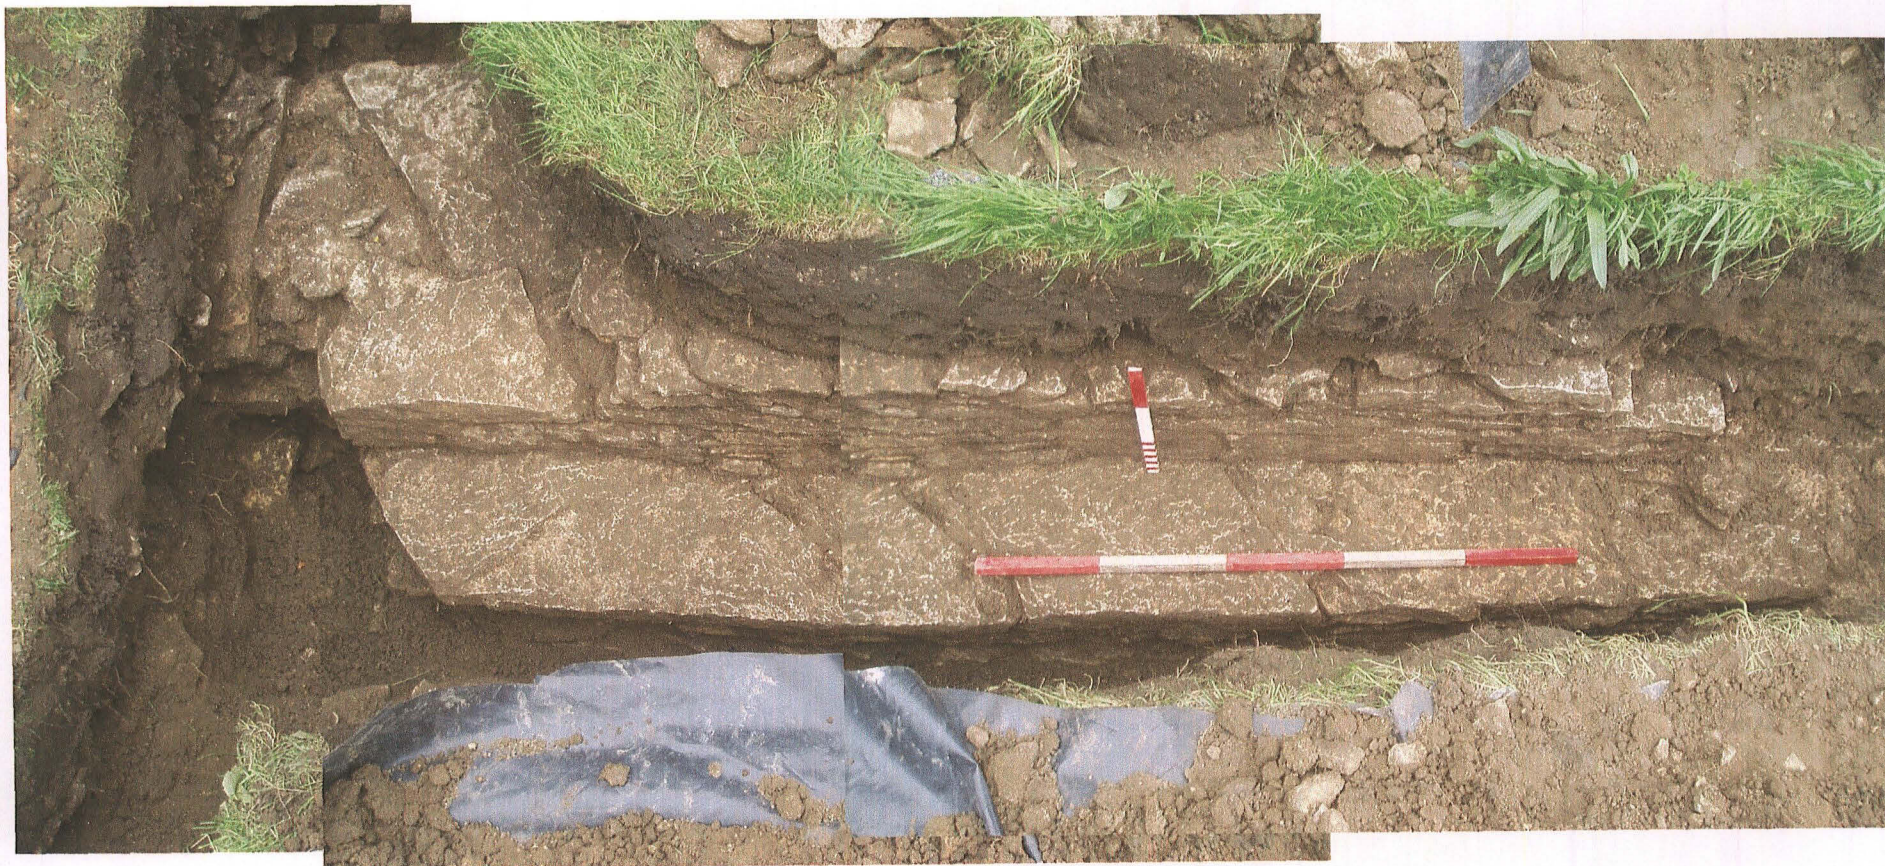
Pl. 5 Composite view of the original aisle wall 103 and its offset foundations 104 exposed in the pipe trench, with disturbed area 106 to the left. View looking south. Scales 1m and 0.30m

the foundations continued below the base of the excavated trench. A 3.25m length of the wall was exposed. Its north-west angle was revealed in the trench and it turned south in line with the western limit of the existing aisle. The wall continued east beyond the limits of the excavated trench. An area of disturbance on the north side of the wall (105) whose fill 106 contained 2 pieces of pottery of mid 18th to 19th century date.

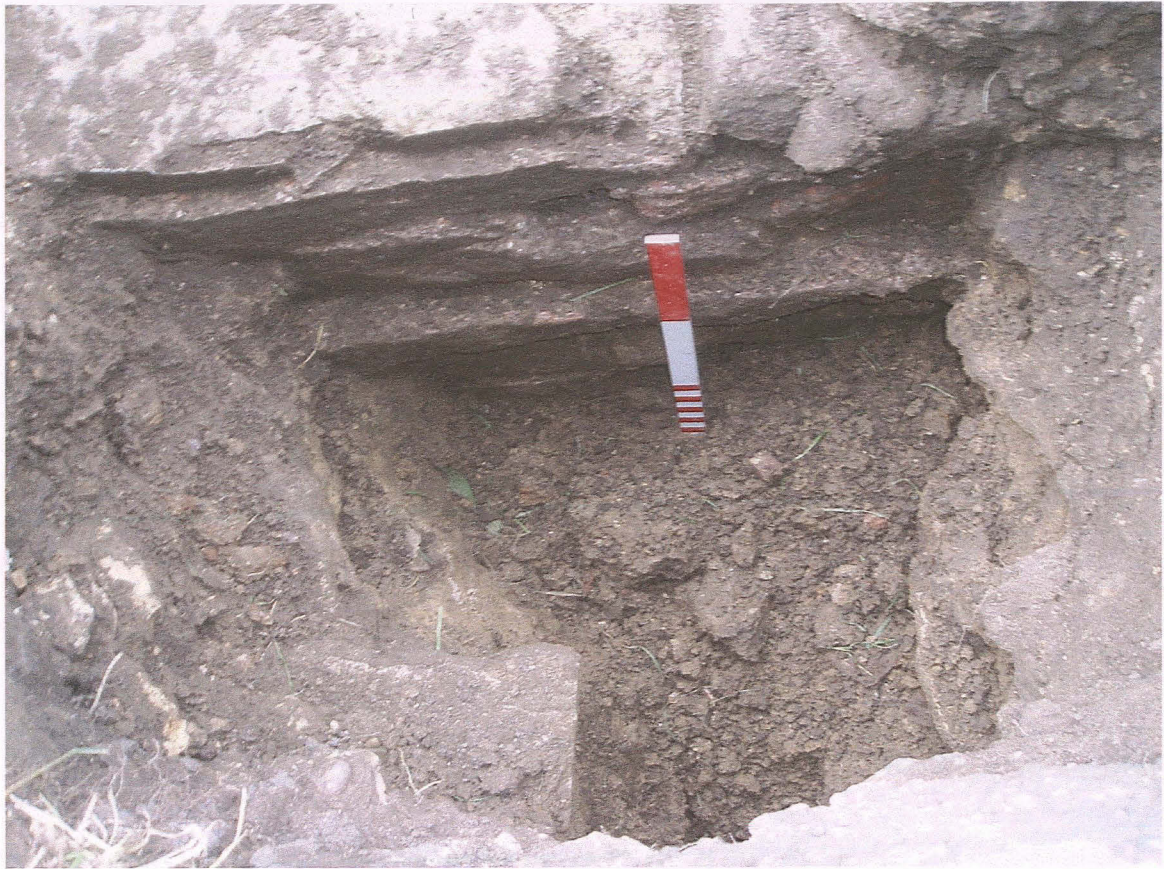
Pl. 6 Foundations 104, on the south side of wall 103, looking north. Scale 0.30m

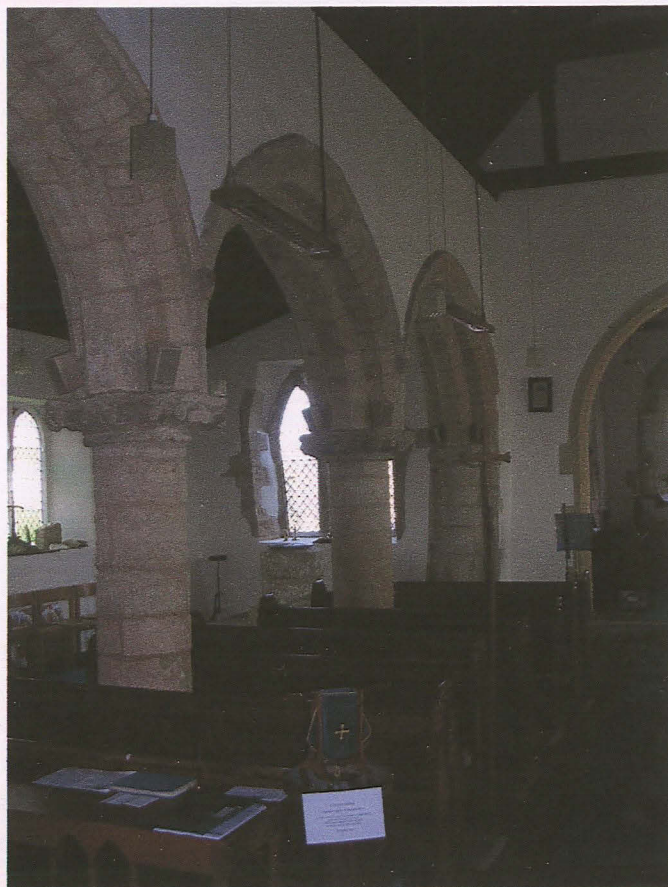
Pl. 7 The late-12th century north aisle arcade, looking east.

The aisle arcade is probably of late 12th century date (Pl. 7) but all the windows are much later in date. There are structural cracks in the west and east aisle walls indicating that movement of the building is a continuing problem (Pl. 8). It is possible that the aisle was reduced in width because this was a problem in the past and it had become structurally unstable. A reduced width would reduce the weight of the roof on the walls. The present north aisle of the church is approximately 4m wide and 12.4m long (external dimensions). If the wall exposed during the excavations is the original north wall of the aisle this would have made it 5.6m wide. It is not known when this work might have taken place but associated pottery from disturbed ground next to the wall was predominantly of 12th -13th century date. The windows in the current aisle are Early English, later in style than the arcade. The date of rebuild is uncertain, especially as one of these windows is inserted into a blocked door raising the question of reuse. Both windows in the west and east walls of the aisle are badly damaged due to continuing movement of the walls. (Repair of the west window led to the discovery of a corbel fragment possibly of similar date to the arcade, now on display in the church (Pl. 9).

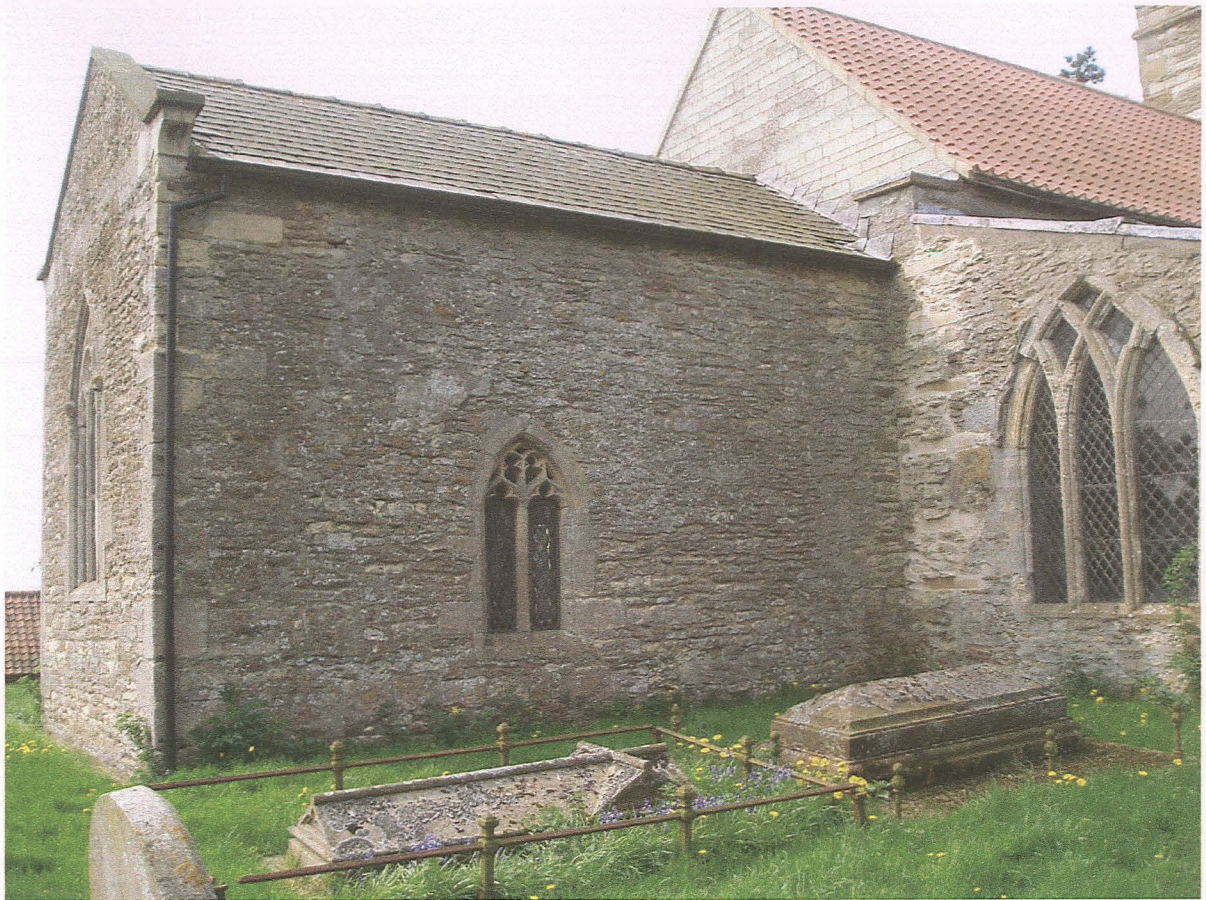
Pl. 8 The north aisle east wall showing structural cracks above the window and and recent repairs at the junction between the aisle and nave.

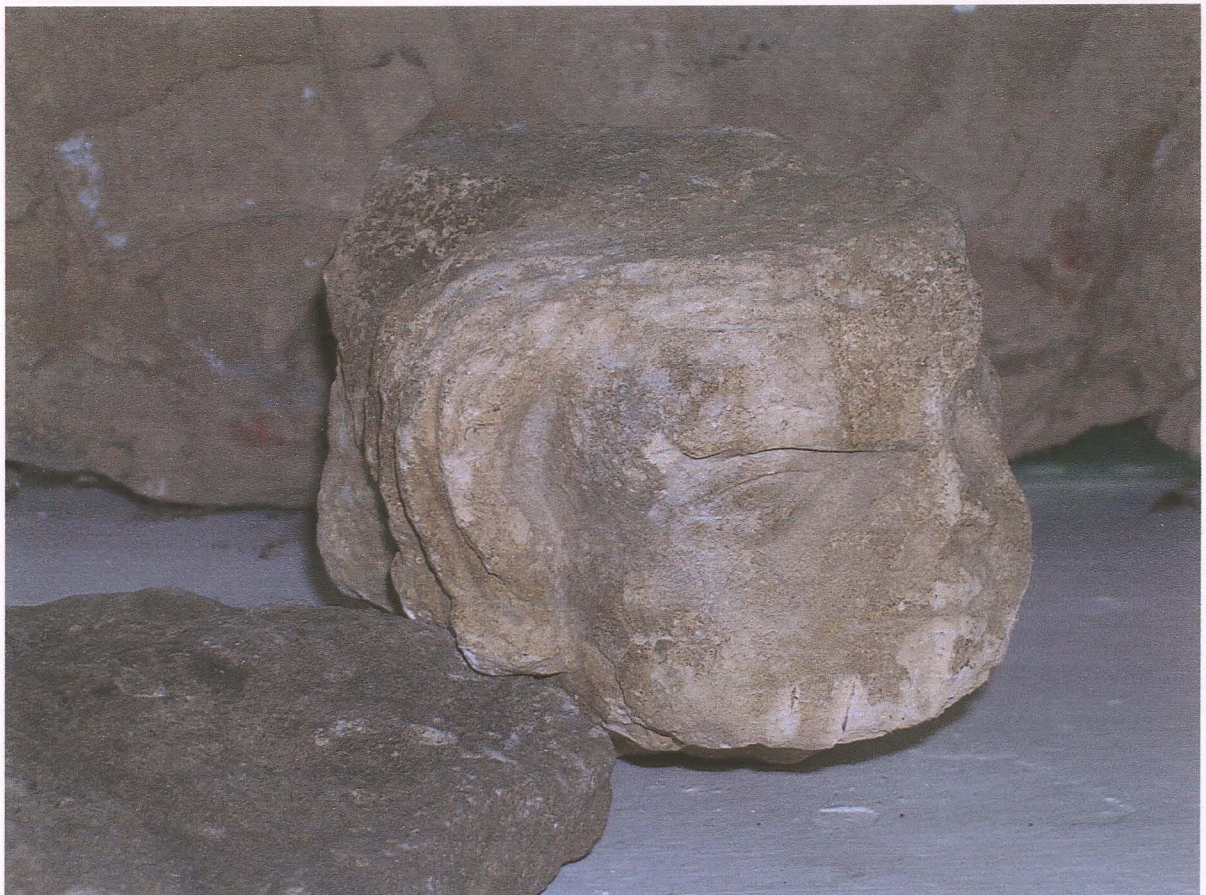
Pl. 9 Corbel found in west wall of north aisle above window
