**ELLIS' MILL, MILL ROAD,
LINCOLN, LINCOLNSHIRE**

**ARCHAEOLOGICAL
WATCHING BRIEF REPORT**

Site code	ELML 06
NGR:	SK 970 722
LCCM Acc No:	2006.147
Planning refs.	N/A

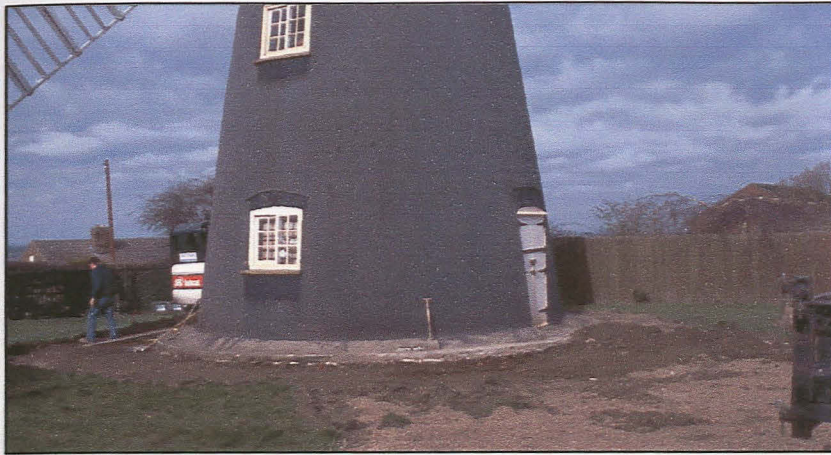
Plate 1: View of windmill, looking northwest

The site is situated within a small enclosure with adjacent residential properties to the north and south, a steel security fence to the west and an open entrance to Mill Road on the east (Fig. 2, plates 1-2).

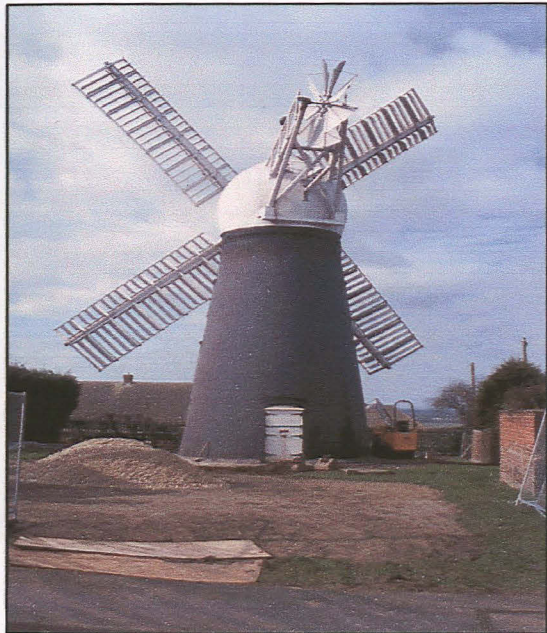
Plate 2: View of windmill, looking west

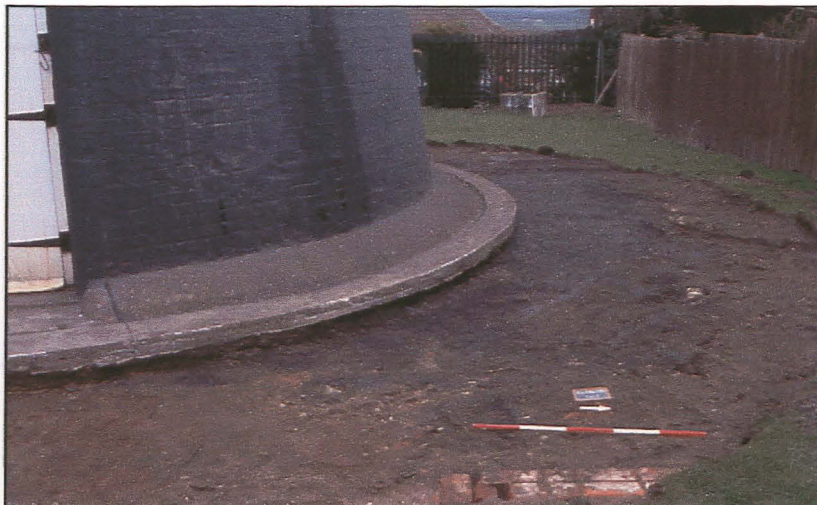
Plate 4: Stripped area, north of windmill

On the 31st of March a further monitored topsoil strip was carried out to a depth of approximately 150mm in the northern area of the site and within the area assigned for the new car park.

Cut into the subsoil deposit 003 and situated within the area of the strip for the proposed car park was a second brick foundation [008]. This comprised a rectangular shaped brick built structure that was adjacent to the northern boundary of the site. The structure consisted of a single course of modern frogged bricks and was 5m in length and 3.3m in width. It was evident that this foundation had been built upon an earlier brick structure. Perhaps the earlier version of this structure is featured on Figure 5 as a small rectangular shaped building situated to the northeast of the Windmill.

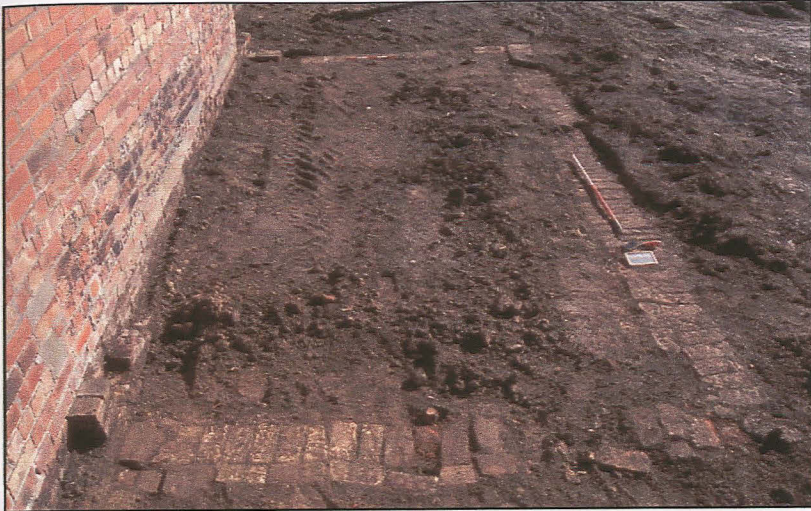
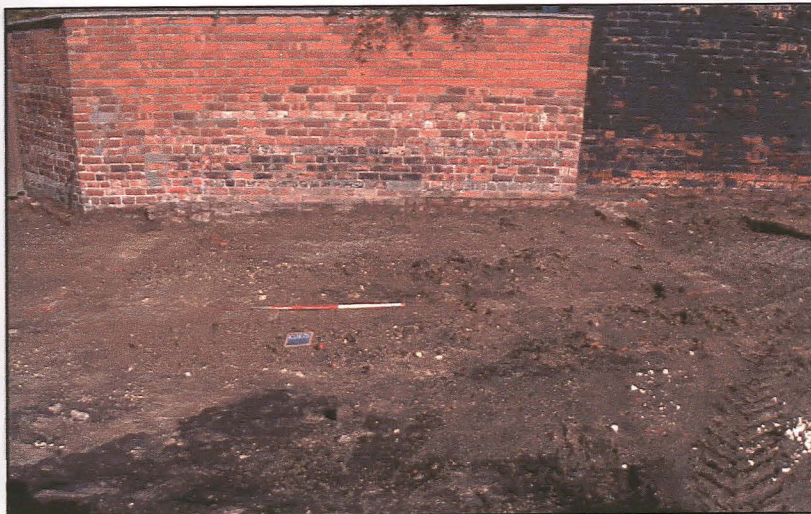
Plate 5: Brick foundation [008], looking east

Plate 6: Brick foundation [008], looking north

- 007 Mid brown sandy clay with occasional angular limestone fragments, natural deposit.
- 008 Brick built foundation adjacent to the northern boundary of the site, 5m in length and 3.3m in width.

The series of three foundations cut into the subsoil consisted of one limestone and two brick footings. The limestone foundation was only partially exposed within the subsoil deposit and the brick footing was similarly partially exposed during the topsoil strip around the base of the windmill. The second brick footing [008] comprised a rectangular shaped structure that adjoined the northern site boundary. All of these structures post-dated the construction of the Windmill in 1798 and were probably ancillary buildings associated with the Windmill complex. This is confirmed by the fact that the structure [008] is featured on the enclosure map that comprises Figure 4 in this report.
