**ARCHAEOLOGICAL WATCHING BRIEF
OF DRAINAGE TRENCHES AT
ST. MARY THE BLESSED
VIRGIN CHURCH,
SUTTERTON,
LINCOLNSHIRE
(SSM 06)**

**Work Undertaken For
St Mary's PCC**

June 2006

APS Report No. 48/06

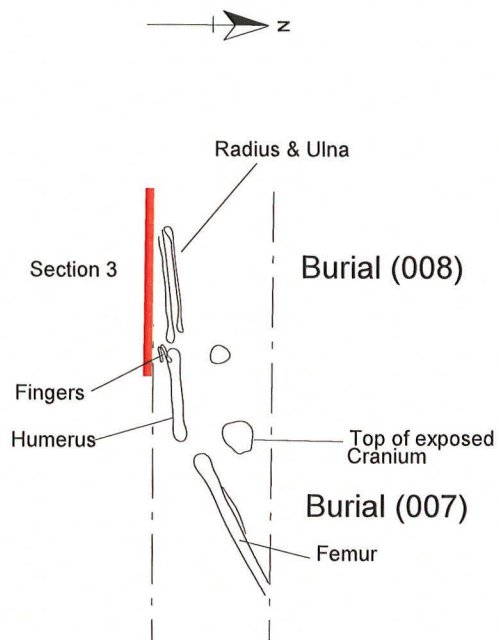
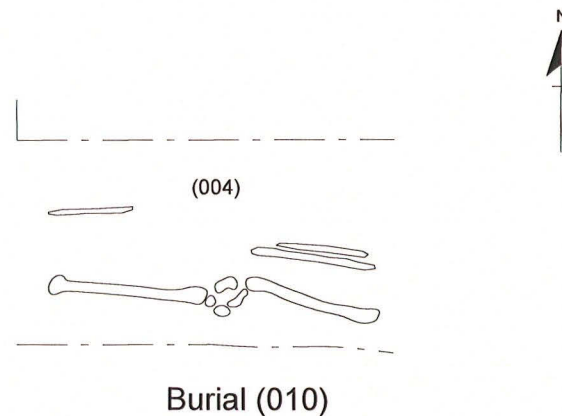
Figure 4 Burials (007), (008) and (010)

Underlying the post-medieval landscaping and former graveyard soil deposit (004) were three inhumation burials (007), (008) and (010) (Figs. 3 and 4, Section 3; Plates 4 and 5). These were stratigraphically earlier than the Phase 5.3 deposits, but were probably partially disturbed as a result of the subsequent landscaping associated with this phase.

Burials (007) and (008) were situated at the western end of Drainage Trench 1 (Fig. 3). Burial (007) consisted of a complete adult skull exposed at the base of the drainage trench and probably extended beneath the southern trench edge (Fig. 4). Burial (008) was situated close by. This was clearly articulated and also extended into the southern trench edge (Fig. 4). It consisted of a radius/ulna, fingers, a femur and tibia/fibula. Both burials (007) and (008) were exposed at depths of 0.50m below modern ground levels.

To the east and also within Drainage Trench 1 was the third burial (010) (Fig. 3). This was also clearly articulated consisting of two femurs and tibia/fibulae partially exposed at the base of the trench (Fig. 4).

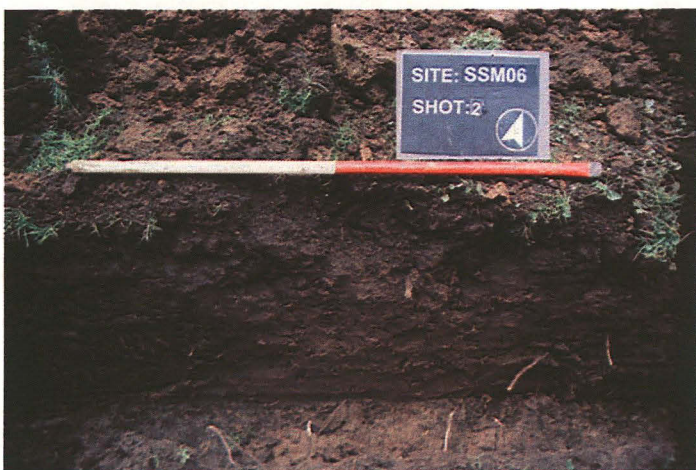
Situated to the north of the nave and underlying the topsoil (001), deposit (002) was a firm mid brown clay silt with occasional small sub-rounded stones and a depth greater than 0.40m. Fragments of disarticulated human bone were recovered from this deposit.

Plate 3: Representative Section 1, looking north

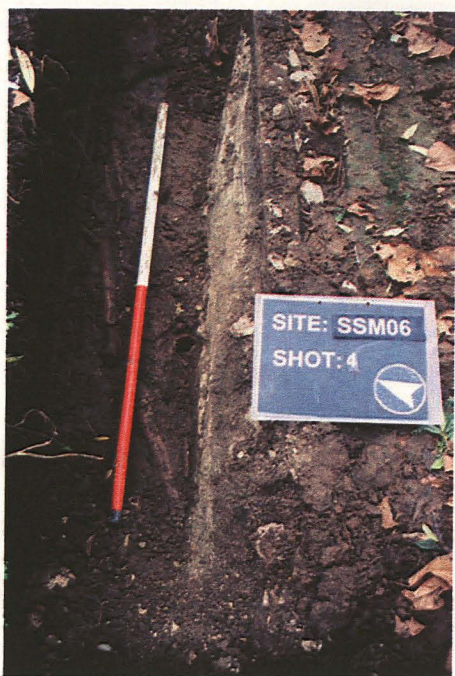
Plate 4: Burials (007) and (008),
looking north

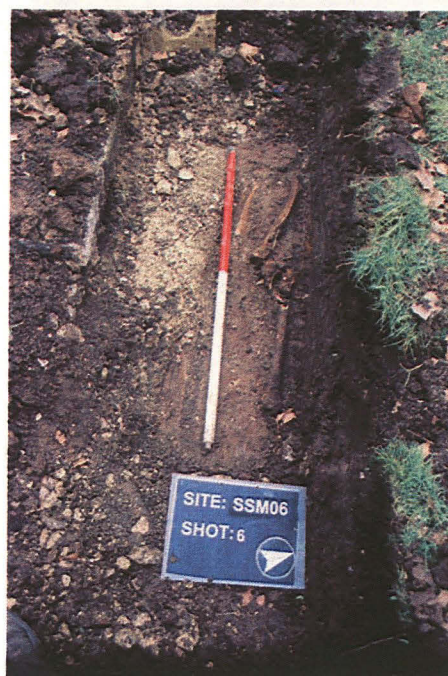
Plate 5: Burial (010), looking
west

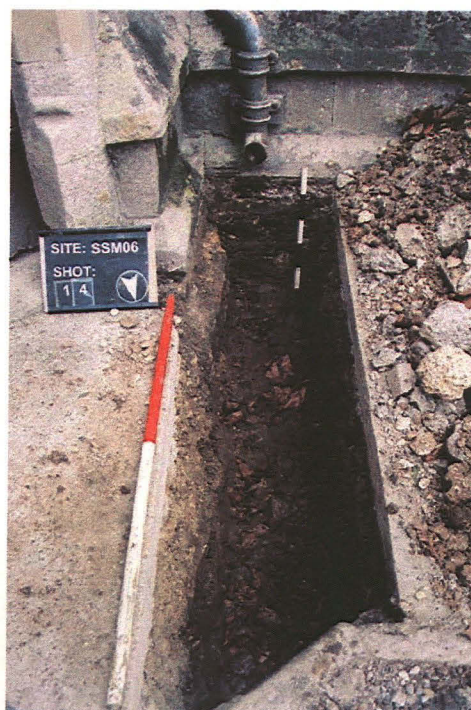
Exposed within Section 7 in Drainage Trench 4 were two make up deposits (015) and (016) that probably predated the construction of the church in the early medieval period (Figs. 3 and 7, Section 7; Plate 7).

Plate 7: Section 7, looking east

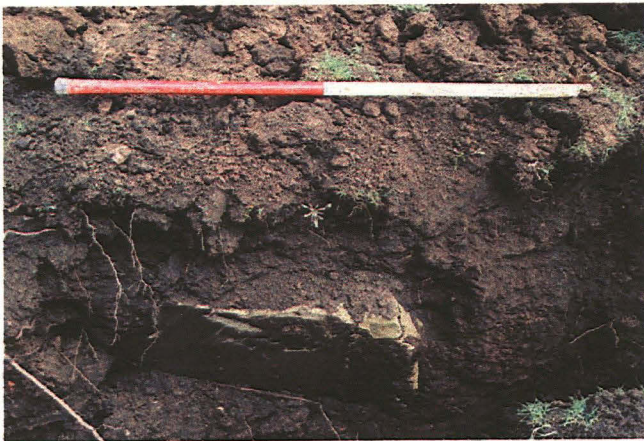
bone including two skulls and a femur that were clearly disarticulated and exposed at the base of Drainage Trench 1 (Fig. 3). In addition two displaced fragments of stone coffin or coffin lid were also observed within Drainage Trenches 1 and 2 (Fig. 3, Plate 10). These items were clearly residual and displaced and were not assigned individual context numbers.

Plate 10: Displaced grave slab,
Drainage Trench 2, looking east

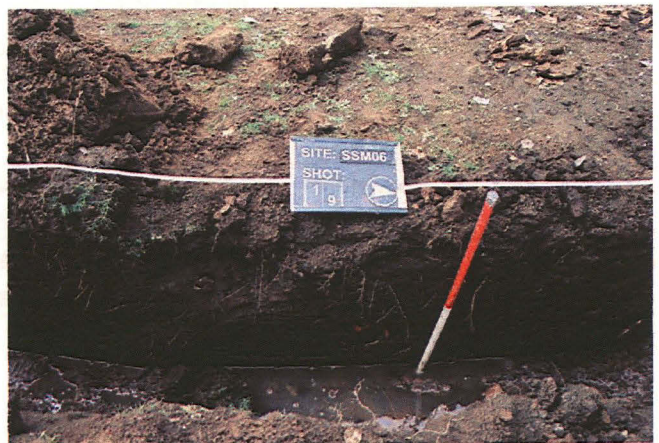
Within Sections 5, 6, and 8 the topsoil deposits comprised (011), (013) and (017) respectively (Figs. 3, 6 and 7). These deposits were all identical in colour and composition consisting of a soft dark grey brown silt with varying thicknesses of 0.16m-0.17m. All of these deposits yielded disarticulated fragments of human bone.

Plate 11: Representative
Section 8, looking west
