**ARCHAEOLOGICAL EXCAVATION AND WATCHING  
BRIEF ON LAND AT 18 – 19 NEW ROAD,  
SPALDING,  
LINCOLNSHIRE  
(SPRN03)**

Work Undertaken For  
J.D. Wetherspoon

A.P.S. Report No. **65/05**

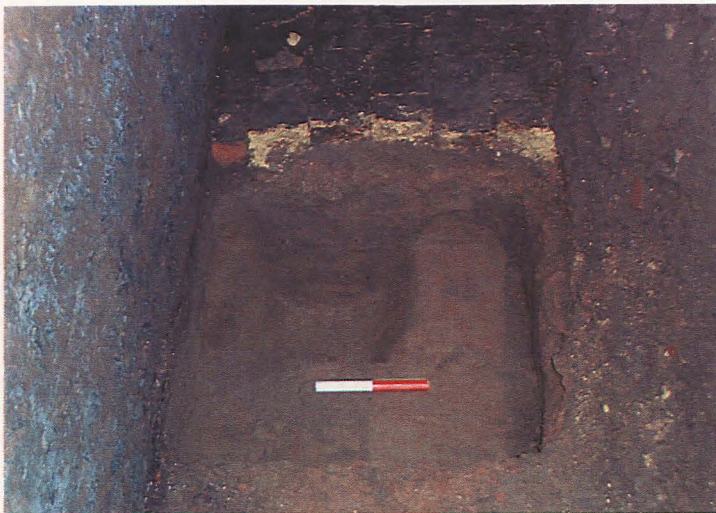
Plate 5 9th - late 10th century ditch (1406), looking west

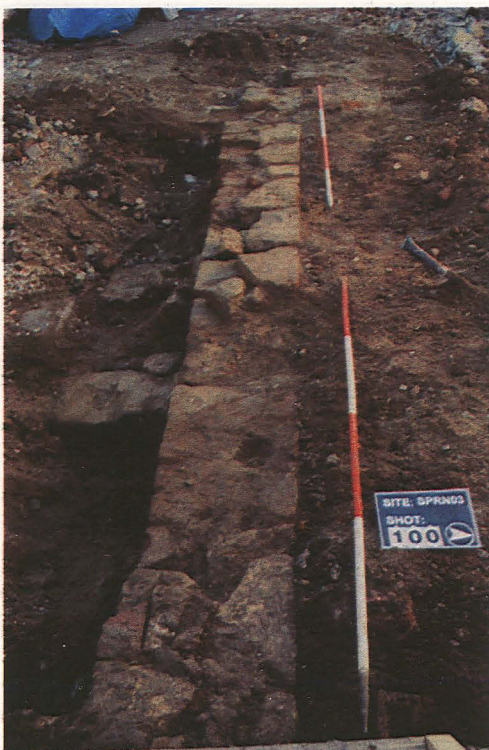
Plate 6 12th - mid 13th century wall (1001) as first revealed, looking north.

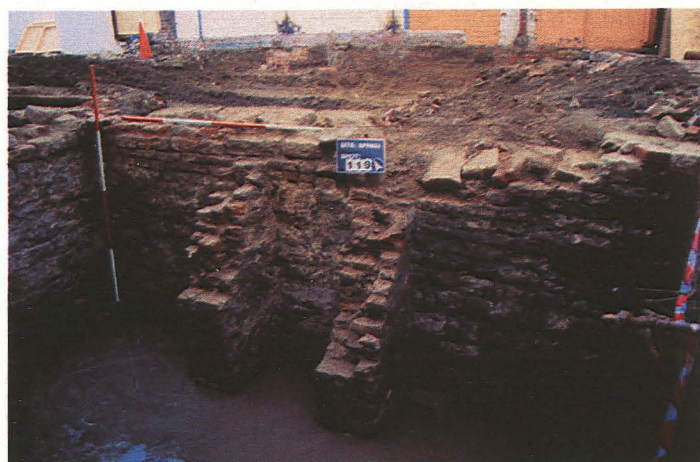
Plate 7 12th - mid 13th century wall (1001) and late 17th - 18th century buttresses (1006 & 1007) after excavation, looking northeast.

constructed to support the eastern wall (1001) (Plate 7). Recorded in section only, the southern wall of building (1369) had been subject to a repair or modification using mortared brick (1367) and butting up to this was the terminus of a north-south orientated brick and stone wall (1366) (Figure 29, Section 170).

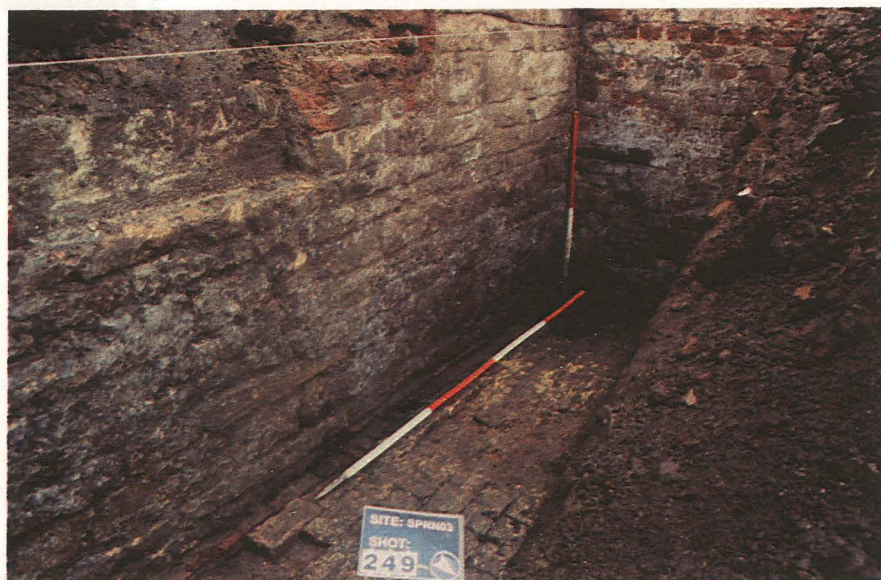
Plate 8 12th - mid 13th century wall (1369) and post-medieval modifications, looking southwest.

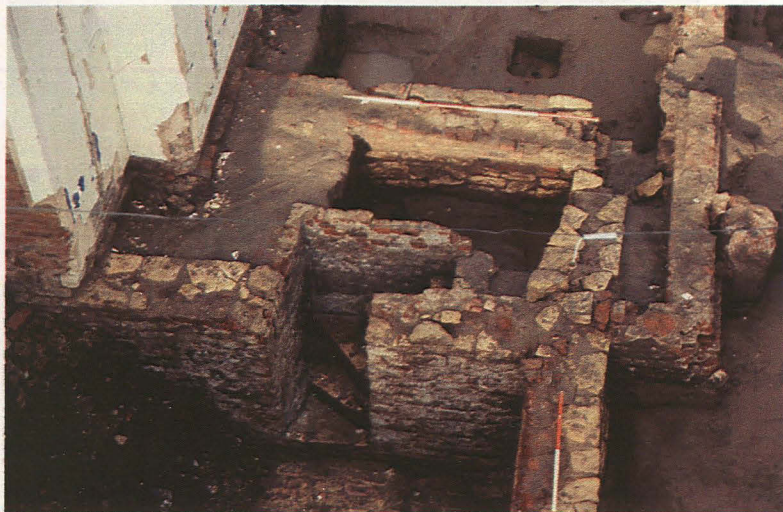
Plate 9 Aerial view of 12th - 13th century wall (1043) showing 13th - 15th century extension (1019) and modern stairway (1045), looking north

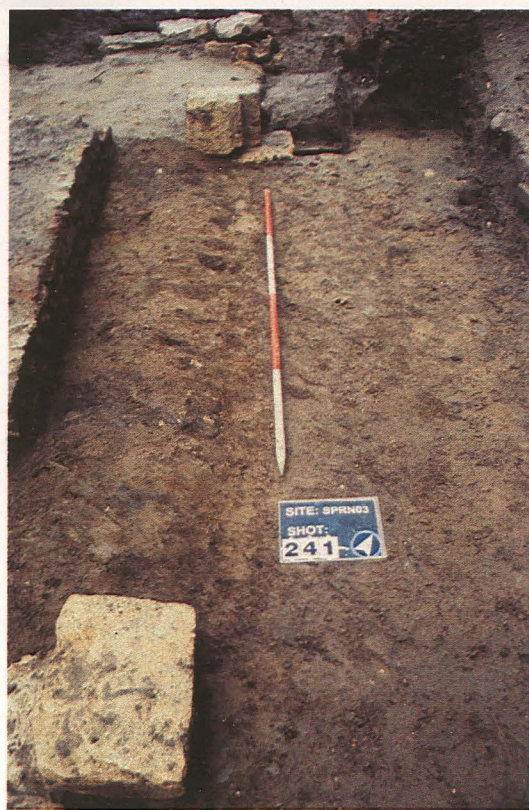
Plate 10 Remains of 13th - 15th century studs (1416 - 1428) prior to excavation, looking north

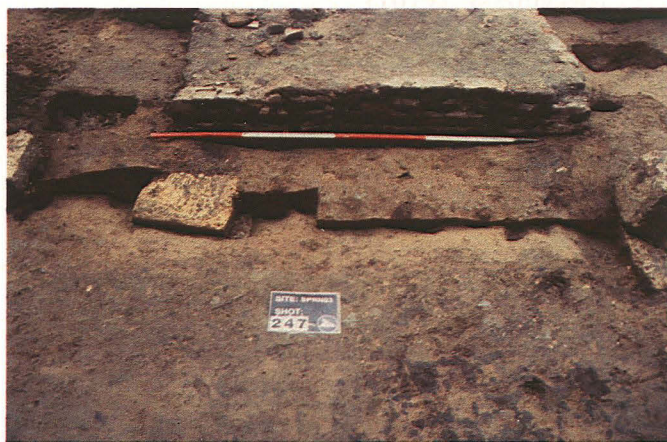
Plate 11 Remains of 13th - 15th century studs (1416 - 1428) after excavation, looking west

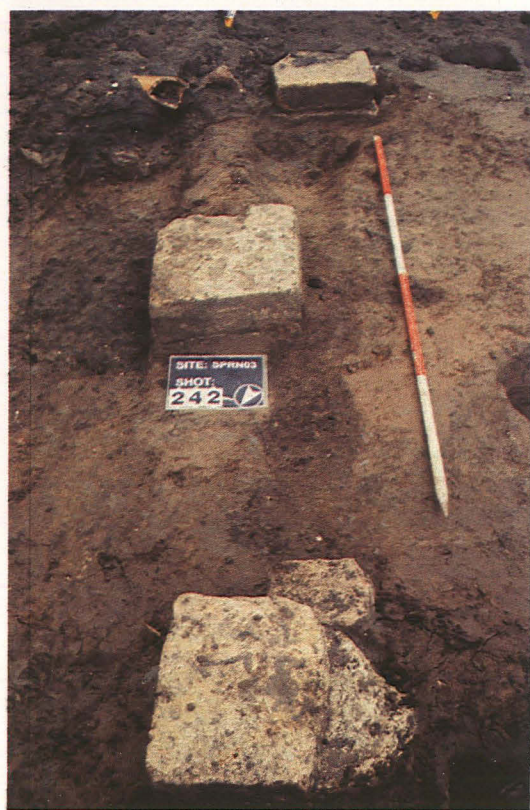
Plate 14 General view of 13th - 15th century pad stones (1051, 1052 & 1259) showing post-medieval demolition cuts, looking south

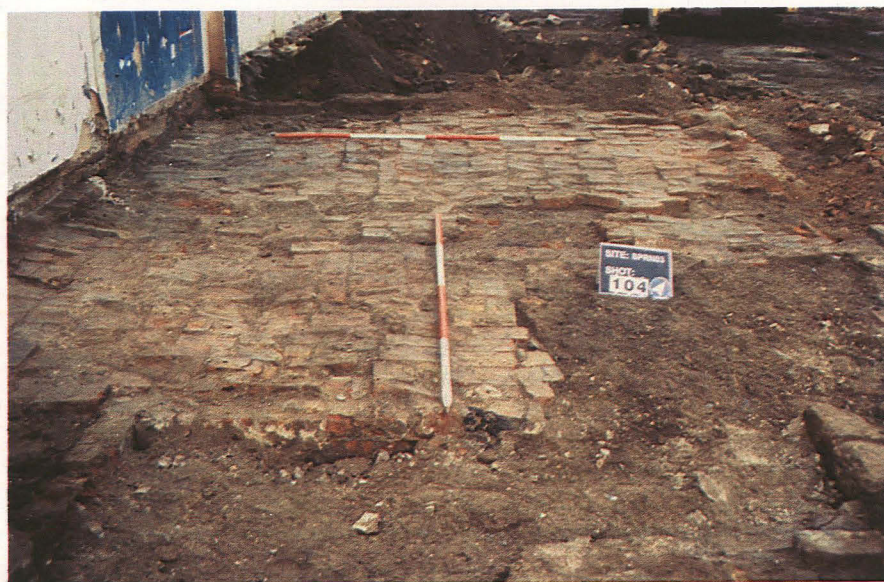
Plate 21 Modern floor (1005)  
overlying 13th - 15th century  
extension (1019), looking  
north
