An Archaeological Desk-based Assessment for land at Old Post Office Farm, Church Farm and land to the north of Church Farm, Horbling, Lincolnshire (TF 11 35).

For Crown Estate Commissioners

ULAS Report Number 2002-050 ©2002

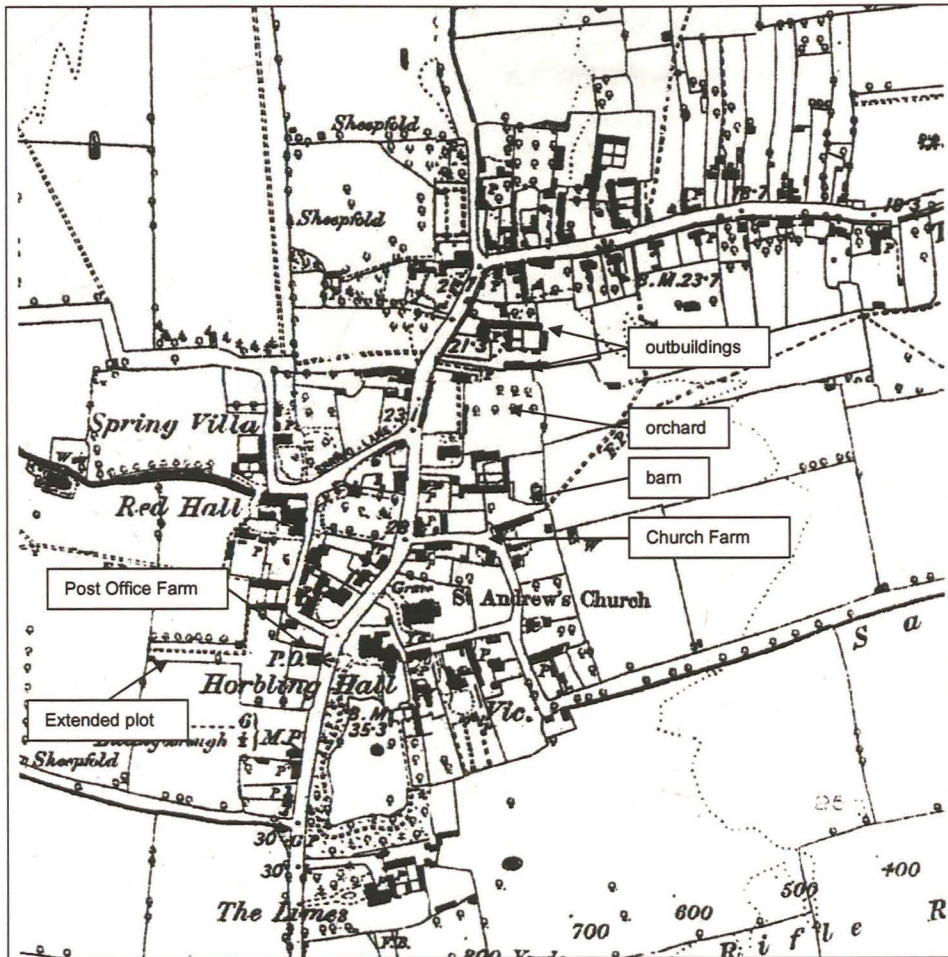
Figure 6: The first edition 25" to the mile Ordnance Survey map, dating to 1891, Horbling, Lincolnshire. University of Leicester Geography Map Library.

The first edition 25" to the mile Ordnance Survey map, dating to 1891 is the next depiction of the development area. By that time the village had almost doubled in size, developing to the west around Spring Lane and to the east along the Donington Road.

The farmhouse at Post Office Farm remains in the same location as that shown on the Tithe Award map, although outbuildings had been added along the northern boundary and the 'square' plot appears to have been divided (possibly into the farmyard, garden and pasture areas that can be seen today, Figure 2). The track behind the farm has disappeared and the plot has extended to the west.

In the farmyard at Church Farm a (?)barn can be seen in the farm yard. To the north of the yard appears to be an orchard in what is now pasture. No.22 the High Street appears to be in the same location. Many of the outbuildings associated with No.22 have also appeared by this time.

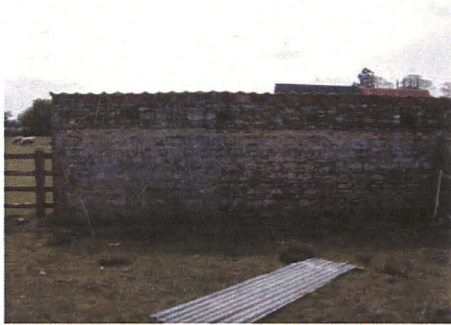
In the land north of Church Farm three stone walls survive bounding a small field. The walls include large, well-dressed blocks and the ends of first floor timber joists suggesting the wall was once part of a standing building. Cartographic evidence indicates that the building must pre-date the 1765 Tithe Award map. A scatter of stones within the field suggests further wall foundations may survive below ground.

Illus 1: Southern boundary of northern pasture field. Note the surviving first floor joists within the wall.

Land north of Church Farm. The standing walls surrounding the small field to the south of this development area may be the surviving remains of a substantial building. Scattered stones within the field suggest further subterranean foundations may also exist. The stonework may also be of intrinsic interest to vernacular architects. No.22 High Street is a c.18th century farmhouse, with possibly earlier origins. The c. 19th century brick outbuildings may also be of interest to vernacular architects and, if demolished, should be more thoroughly assessed.

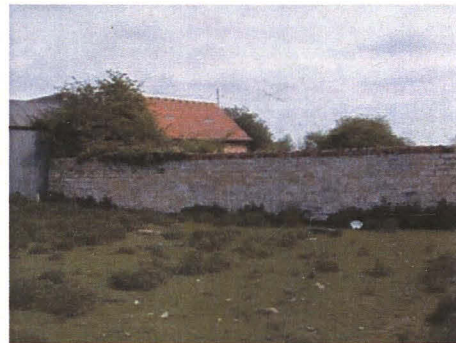
Illus 2: Eastern boundary wall of northern pasture field including many large well dressed blocks. Note also the scatter of stones within the field.

The standing stone walls in the development north of Church Farm appear to be of a high quality (too well-built for boundary walls?) and surviving floor joists suggest a former standing building. Loose stones within the field suggest the possibility of further foundations.

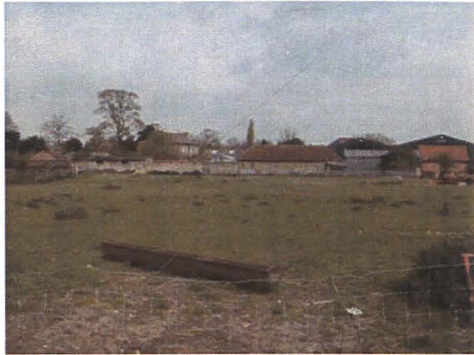
6.4.1 Church Farm farmyard was largely an open yard surfaced with concrete and/or hardcore with a modern barn towards the east of the plot and 19th century brick outbuildings in the northwest corner of the yard. Ridge and furrow on an east-west alignment could be seen to survive in fields to the east of the development area. To the north of the yard were two small fields which are currently under pasture. The northern portion of the more northerly field was bounded on three sides by segments of stone walls. The segment of wall along the southern boundary of the field included first floor timber joists embedded in the stonework (Illus 1). The stone wall forming the eastern boundary of the field included large, skilfully dressed stones (Illus. 2). The northern boundary of the field was also partly bounded by a stone wall, again including some large stone blocks. Changes in the stonework suggest an entrance way has been filled-in. This wall currently forms the rear wall of a cart shed and barn (Illus. 3).

Illus 3: View looking north across the pasture fields to the north of Church Farm. The rear stone wall of the cart shed can be seen towards the centre of the picture.

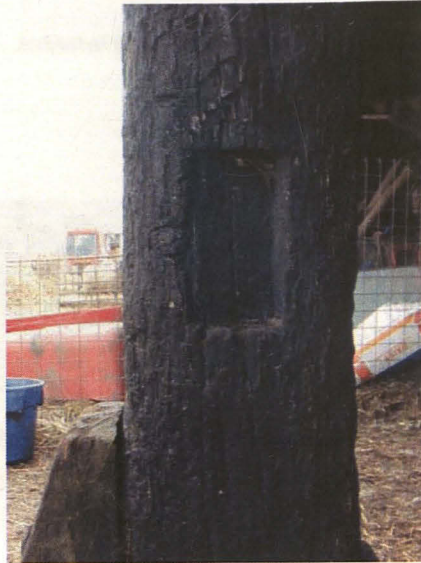
Finally, within a c. 19th century cart shed a group of five unusual oak posts were noted. The posts appeared to have been re-used in their current setting but contained a series of chase mortices with large wooden dowel pegs that suggest much earlier origins. The joints may represent a local tradition, or even the work of a particular craftsman but it is also possible that they are a very rare example of the survival of Saxo-Norman carpentry. Parallel joints have been seen on a timber bridge structure in Leicestershire constructed some time after 1097 AD.

Along the front elevation of the cart shed the roof was supported by 5 large oak posts (c.1' diameter). The posts were all 'in-the-round' (*i.e.* they had not been converted into 'timbers'). Down each side of the posts were a series of joints, *c.* 50cms. apart, which appeared to be early forms of chase tenons (a wedge shaped cut that would have completely housed a brace). Some, but not all, of the joints were secured with large (c.1") wooden dowels (Illus. 4). Joints of this type are rarely attested but similar joints have been noted on a Saxo-Norman timber bridge in Leicestershire (Cooper and Ripper *forthcoming*). Detailed examination of all the joints was not possible within the restrictions of a site visit, but the joints did not appear to be regular. This suggests that each joint was cut as it was needed rather than as part of a prefabricated structure.

Illus 4: Upright, un-converted oak post with early (possibly Saxo-Norman) chase mortice. Note the use of large wooden dowel pegs which suggest the joint was cut before the timber was seasoned. The post is currently supporting the roof of the cart shed to the rear of No.22 High Street.

The re-used timber posts within the cart shed could possibly have very early origins. If dated they could prove to be an important addition to the rarely attested *corpus* of Saxo-Norman jointing techniques. If they proved to be later woodworking methods they would be equally important to studies of the longevity of carpentry practices.

The oak posts re-used in the cart shed in the development area north of Church Farm may be of national significance if they prove to have an early date. Even as later timbers they are important either as examples of local craftsmanship or as examples of the continuing use of an early joint type.

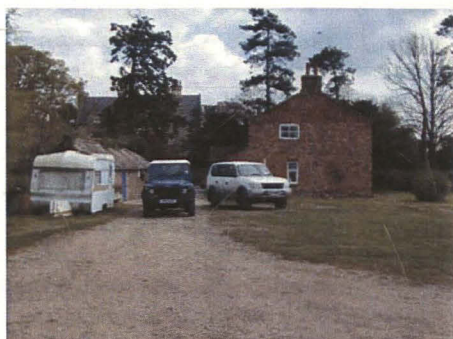
6.4.2 Post Office Farm was a probable 18th century brick farmhouse fronting onto the Billingborough Road (figure 11, Illus. 5). The property is currently occupied and access for a detailed inspection was not possible. To the south of the farmhouse lay mostly lawned gardens with occasional fruit trees. To the west of the garden lay a small area of pasture. Behind the farmhouse lay an open hardcore yard and 20th century barns with concrete floors. A small group of *c* late 19th century brick outbuildings survived along the northern boundary of the property. To the west of the barns a narrow strip of ridge and furrow survives, separated by a hedge and ditch (Illus. 6). The ridge and furrow was on a north south alignment and could be seen to extend northwards into neighbouring fields.

Illus 5: Rear (west) elevation of Post Office Farm.

Old Post Office Farm. Medieval properties and plot boundaries could survive within the development area, particularly fronting along the Billingborough Road. Ridge and furrow survives as earthworks to the rear of the property and form a standing monument to the historic landscape. Old Post Office Farm farmhouse is a probable 18th century building with possible earlier origins. The brick outbuildings are c.19th century.

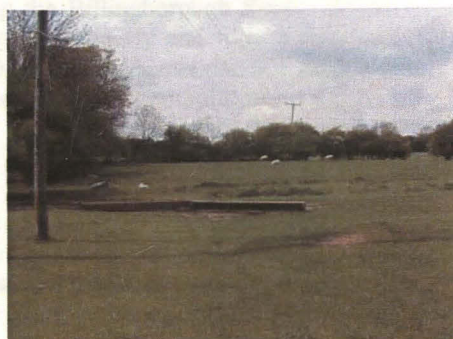
Illus 6: North-south ridge and furrow surviving in land to the rear of Post Office Farm.
