**LAND ADJACENT TO CORNER HOUSE FARM, KNAITH
ARCHAEOLOGICAL WATCHING BRIEF**

NGR: SK 8295 8479
Site Code **CHK 95**
Museum Accession No. **91.95**

MR J. STORRY

August 1995

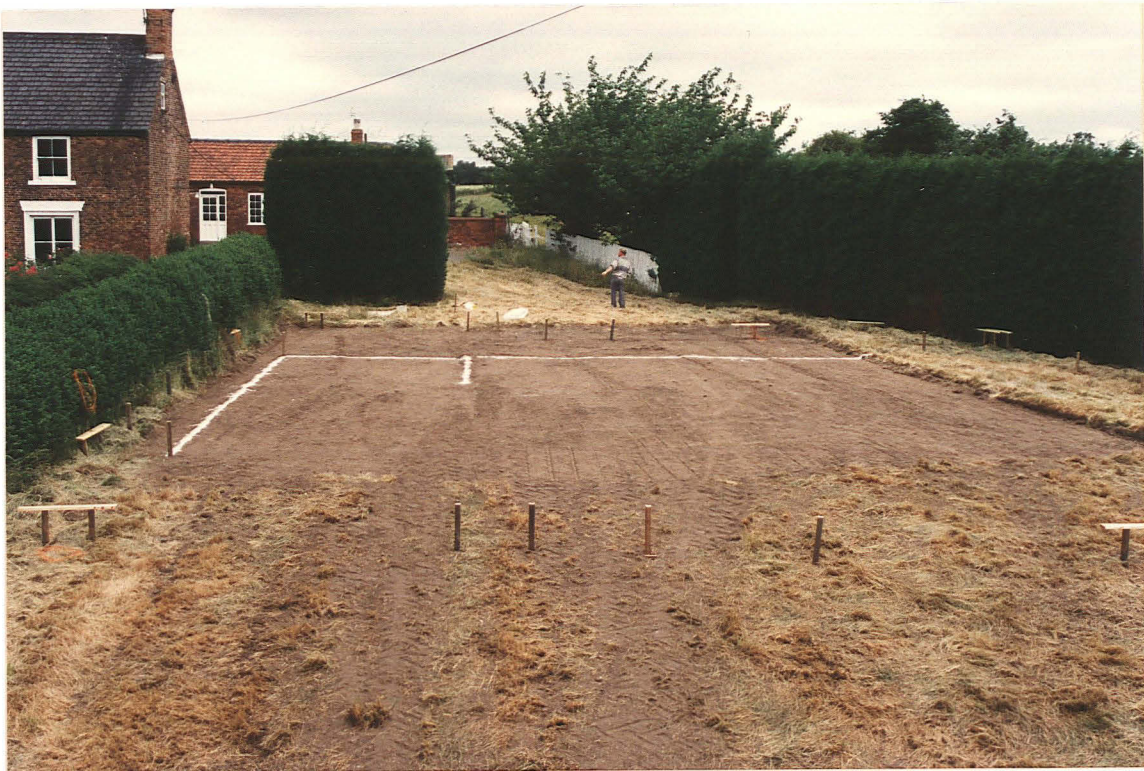
Pl. 2 Development plot after removal of vegetation, looking north.

An area 13.10m x 9.55m was cleared of vegetation by machine revealing a sandy red-brown soil (Pl. 2). This material was imported to the site to level the area for the construction of a tennis court.

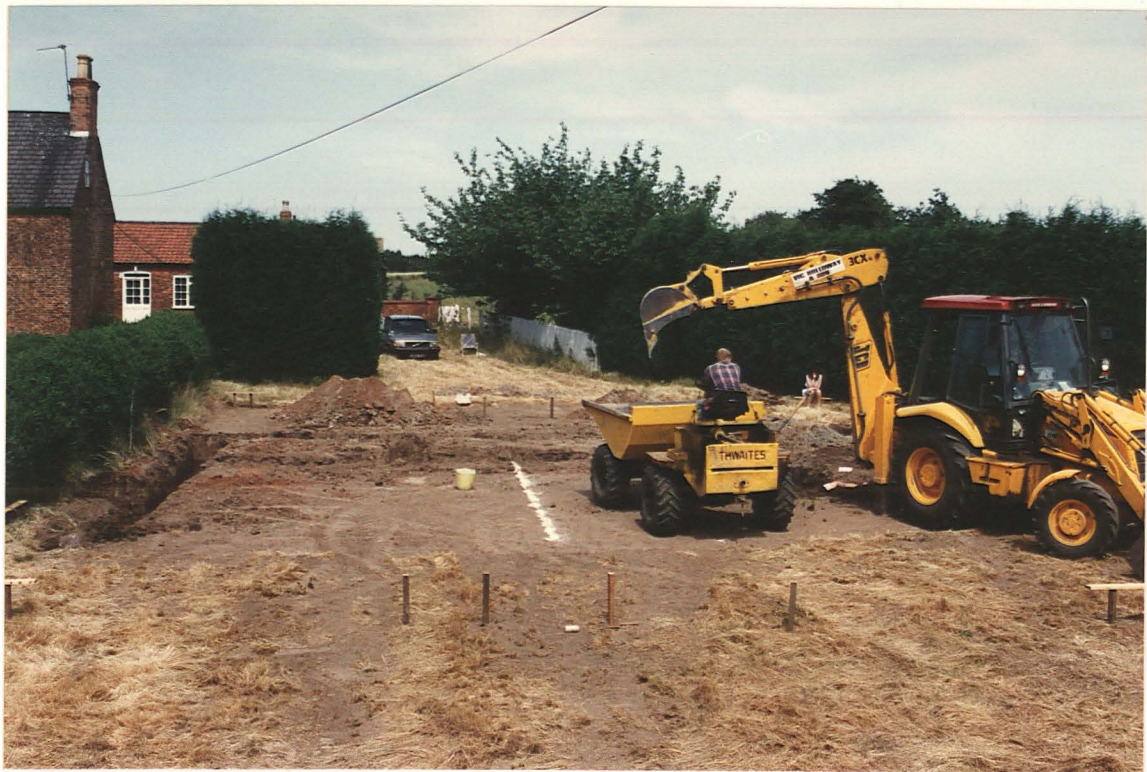
Pl. 3 Development plot during excavation of foundation trenches, looking north.

Excavation of the foundation trench along the north wall of the house revealed a simple sequence of deposits (Pl. 3). The dumped soil was clearly distinguishable and contained brick and tile debris which was a maximum of 0.40m thick. No finds were retained from this material because its provenance is unknown. It overlay the original topsoil on the site which was a brown clay loam 0.30m thick. No subsoil was distinguishable in the very dry ground conditions. This overlay a blue clay 0.50m thick which was on top of the red clay at the bottom of the trench (Pl. 4).

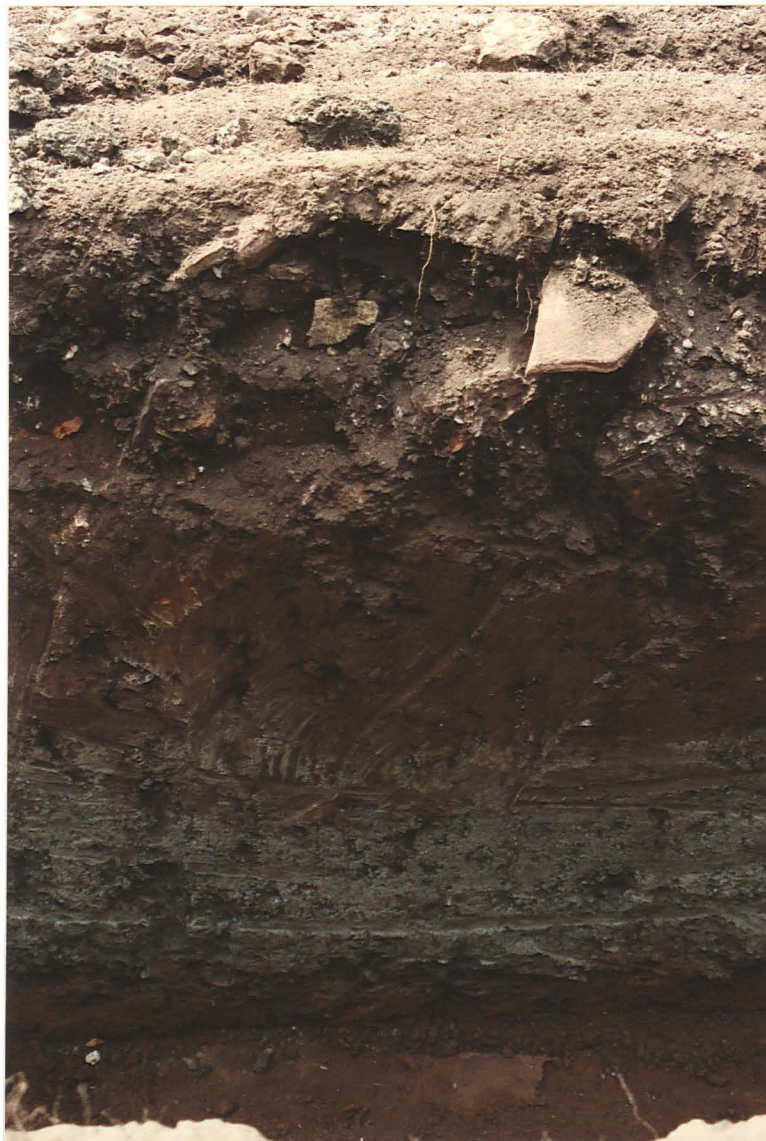
Pl. 4 Sequence of deposits revealed in north wall trench: dumped soil containing roof tile and pottery, sealed topsoil and subsoil, grey clay, red clay at base of trench.

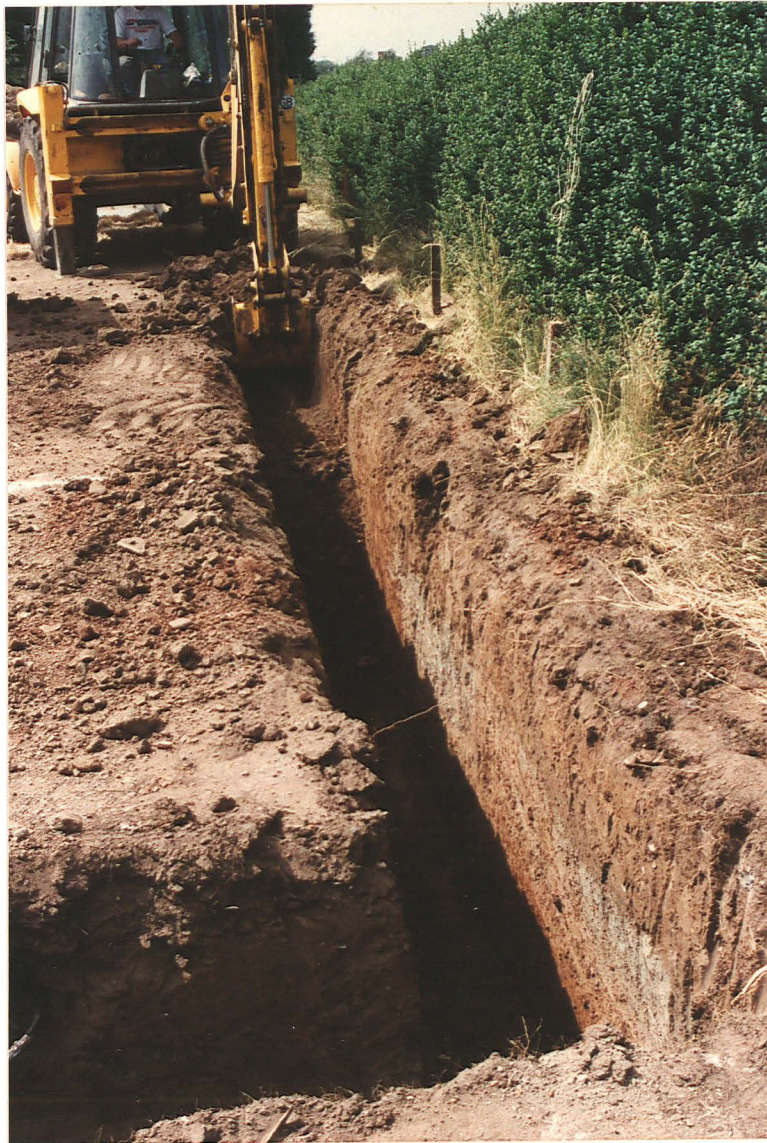
Pl. 5 Excavation of foundation for west wall of house

A similar sequence was observed on the west side of the building north of the fireplace (Pl. 5). However, the edge of the silt deposits seen in the test pit was located at this point deepening to a maximum of 1.10 m at the SW angle of the building. The silts were also seen in the east wall trench of the building but the garage foundation trench missed the silts (Fig. 4).
