# ABBEY FARM, ALVINGHAM

AN ARCHAEOLOGICAL WATCHING BRIEF REPORT

FOR

AE GRAVES & SON

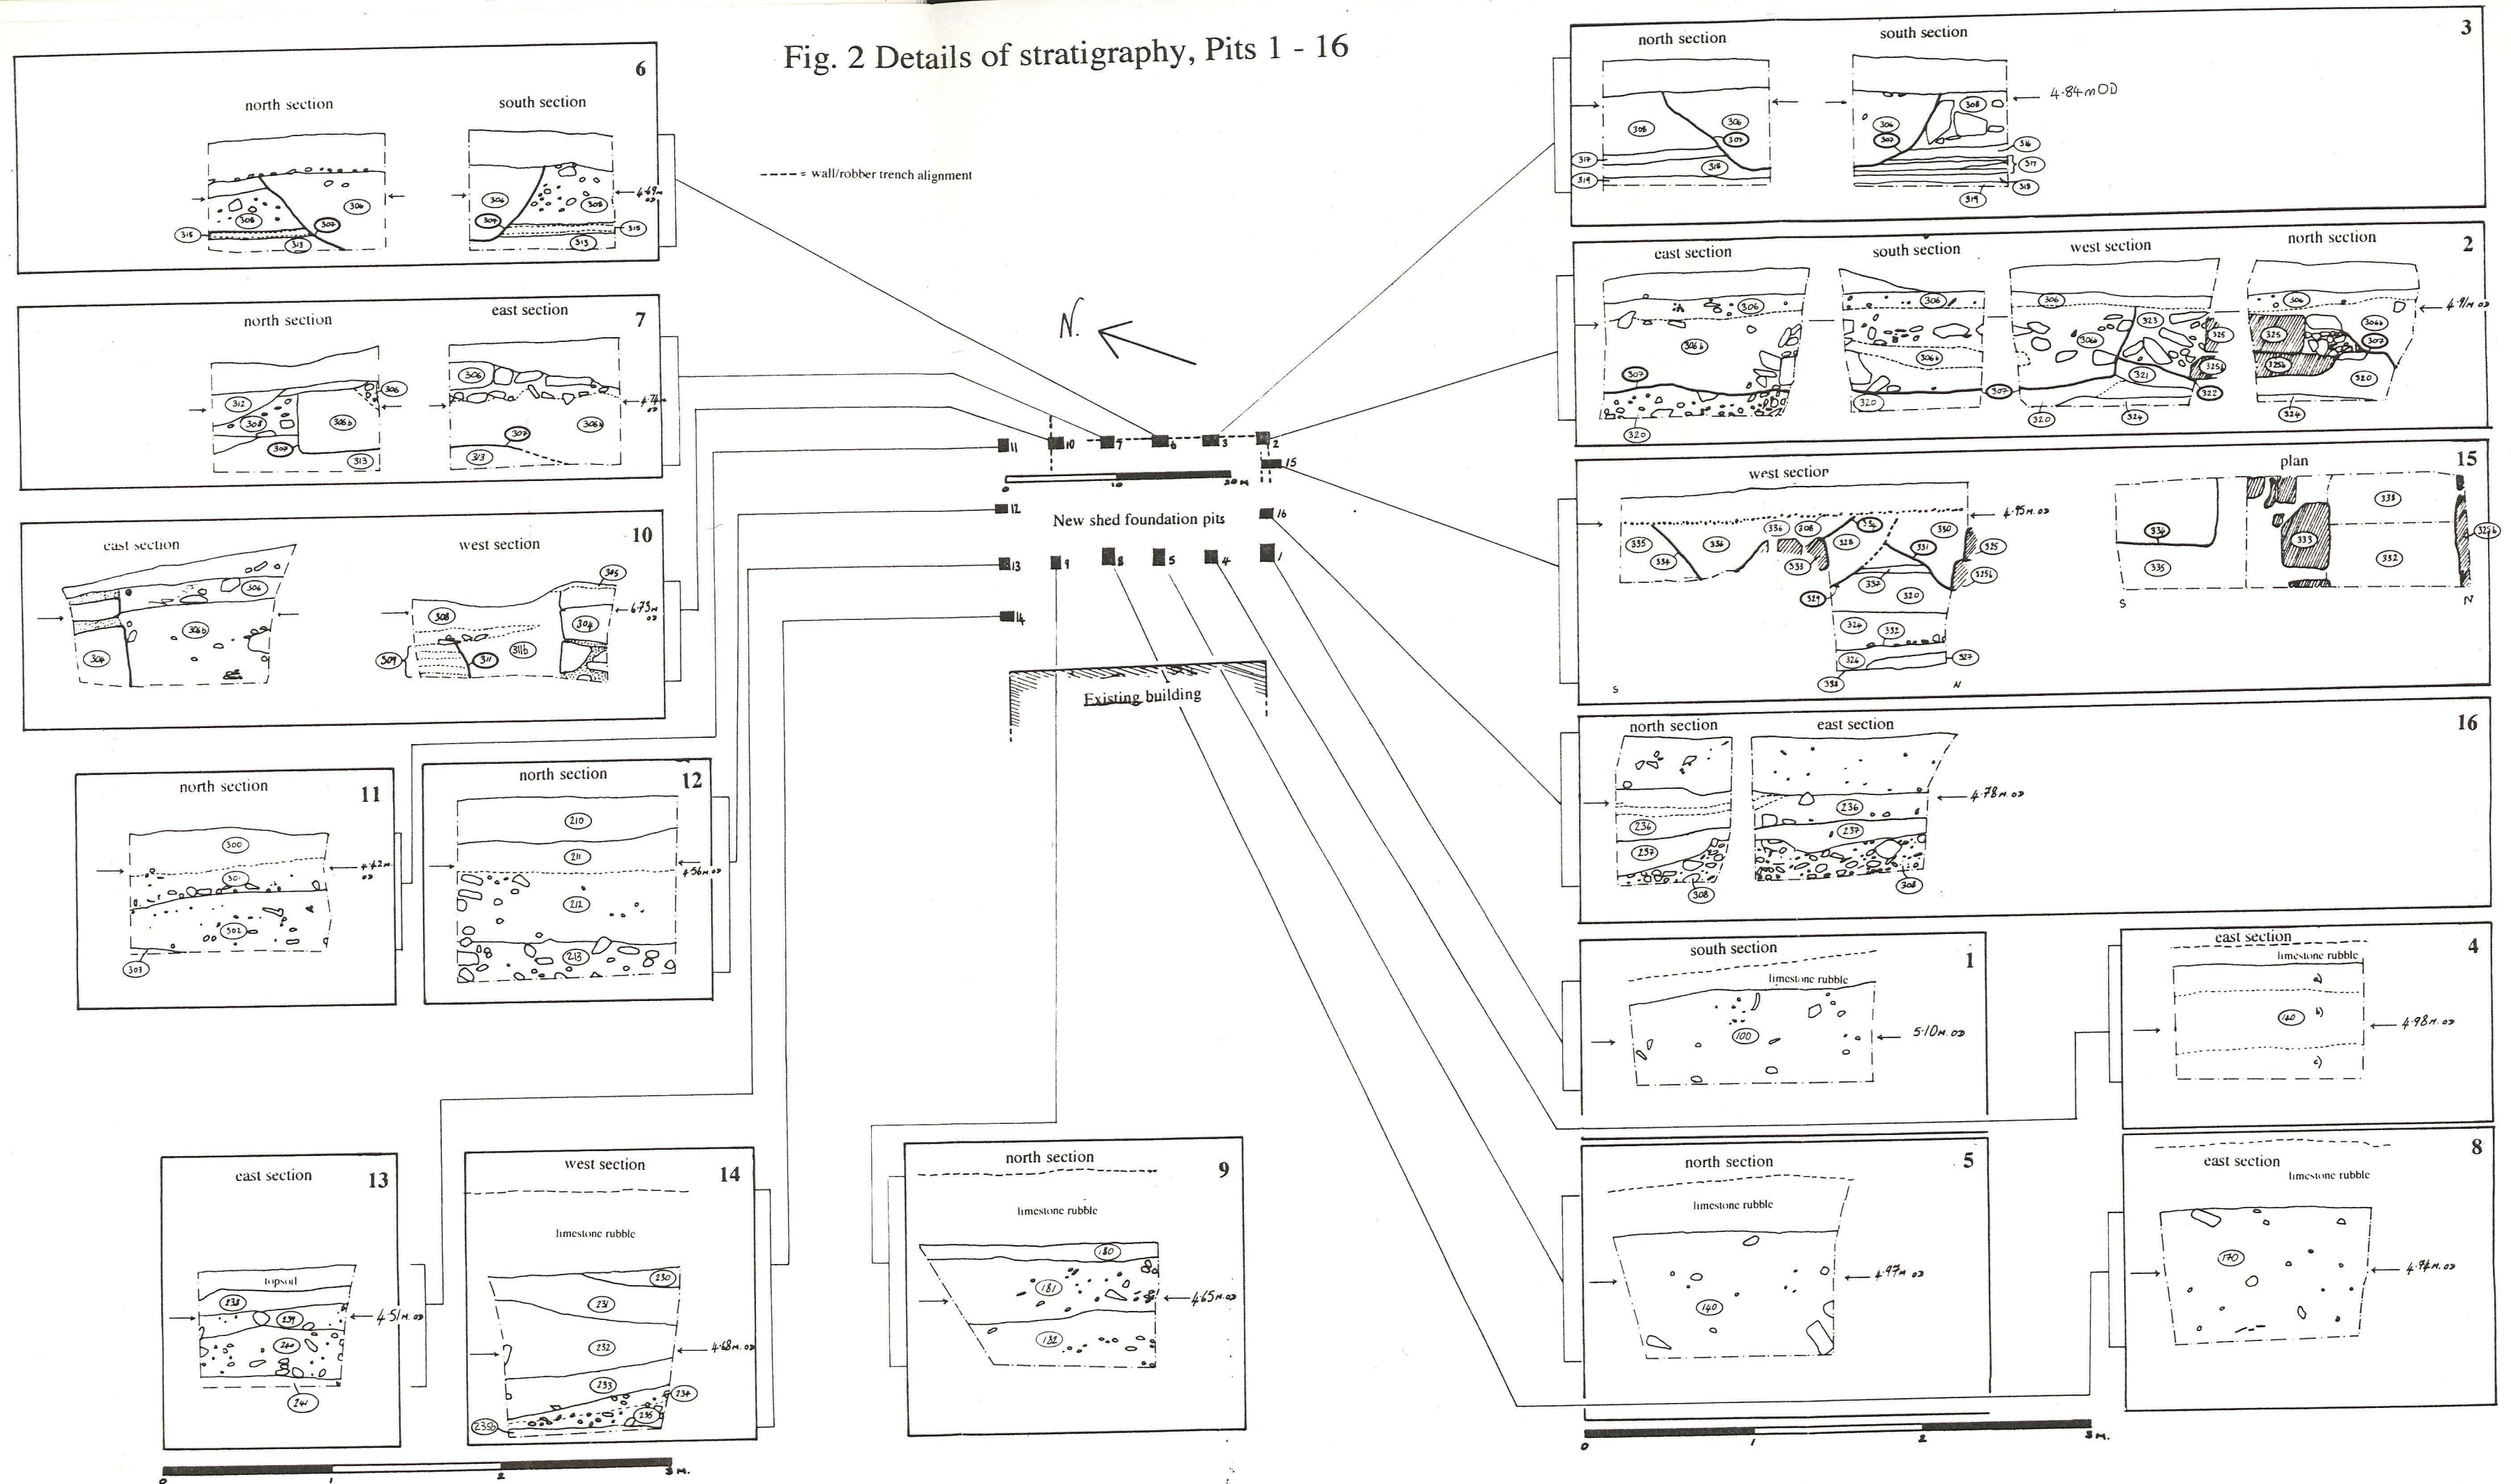
Fig. 2 Details of stratigraphy, Pits 1 - 16

Presented below is a brief descriptive account on the remains exposed and recorded in each of the sixteen foundation pits; which are, hopefully, ordered in a logical, rather than chronological fashion. The text should be followed in conjunction with Fig. 2. A more general, brief, interpretative summary may be read in section 9.0 below.

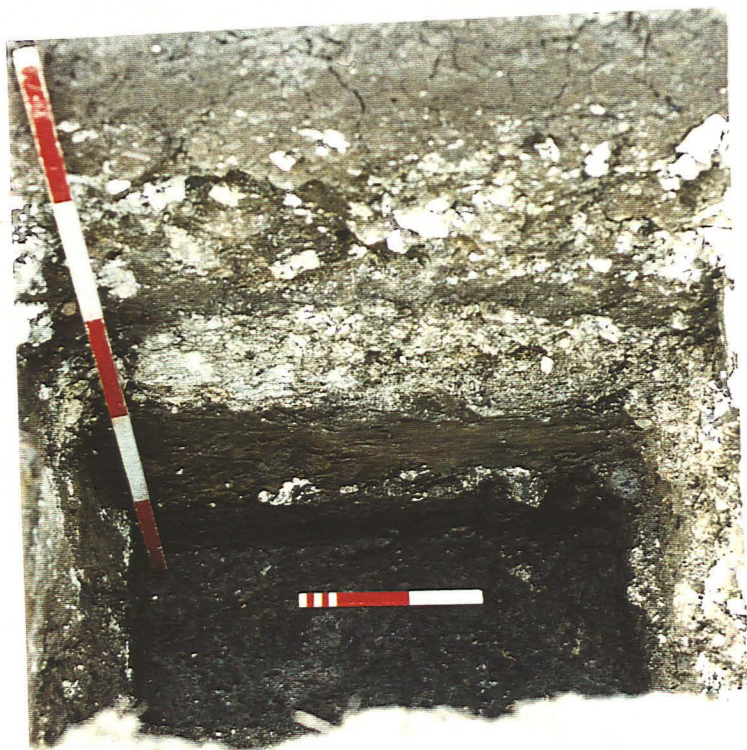
P1. West section, Pit 15; semi-waterlogged occupation layers in base, below levelling/construction deposits

Near the base of the cutting, a dirty, flecked, green-grey clay layer, c. 120 mm. thick, appeared to be a cumulative occupation layer; the green tinge possibly reflecting the presence of cess. Towards its base, was a deposit of charcoal mixed with green-grey clay [327]. It was not determined whether this was hearth remains or just residue; or, perhaps more importantly, whether it was indicative of pre-priory occupation. It was associated with unglazed Saxo-Norman pot sherds which may be dated somewhere between the late C10th and early C13th. Certainly, these were the earliest levels sampled on the site, and contained the earliest stratified material. They were also waterlogged or semi-waterlogged and could therefore contain important environmental remains.

In Pit 15, semi-waterlogged deposits were exposed in the base of the cutting which could pre-date or date within the years during which the priory was founded.

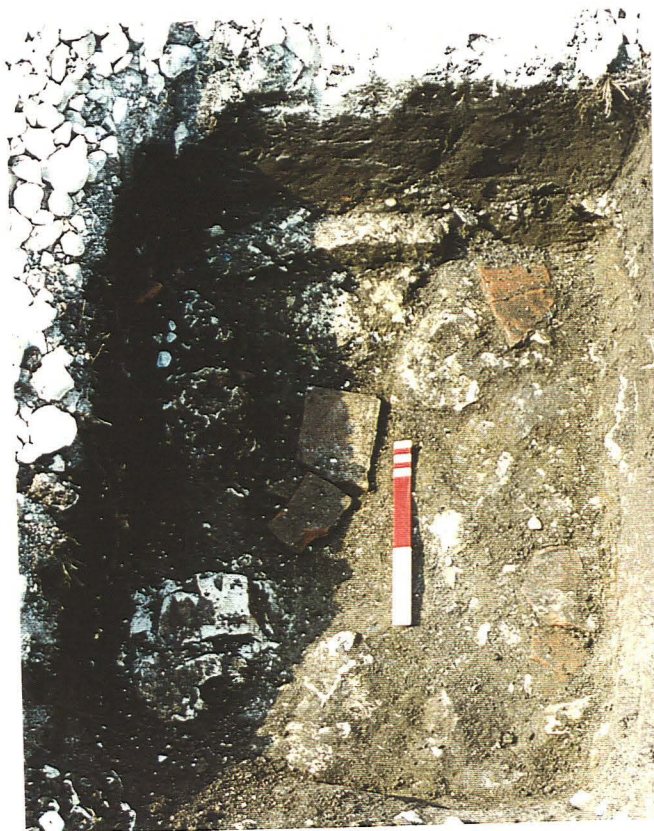
P2. Top of demolition horizon, Pit 15

This was one of the most complex of the sixteen pits monitored during the brief. Within the more widespread destruction horizon, [308], was an amorphous chunk of lead (213x123x18 mm).

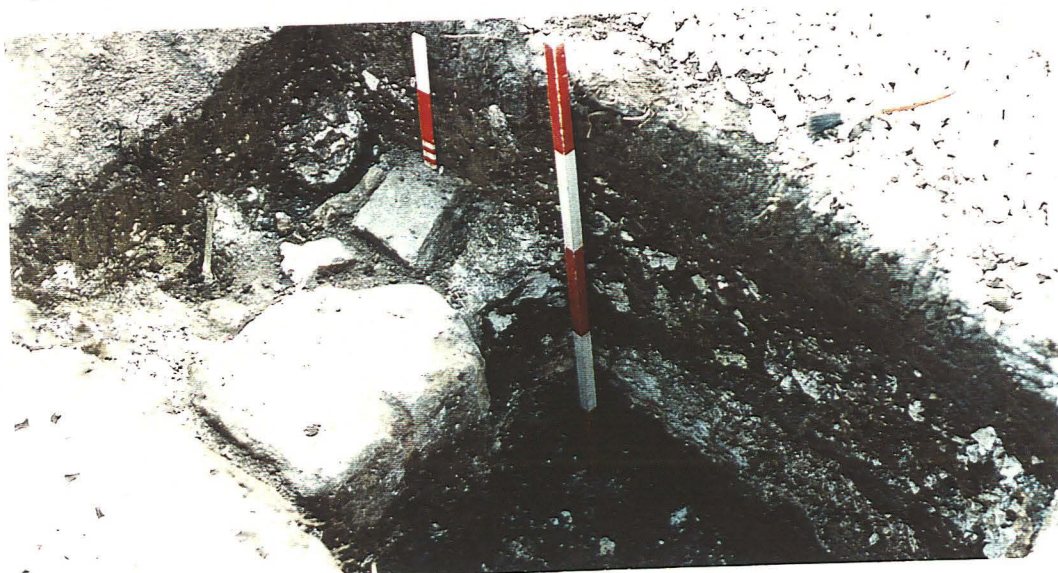
P3. General view, Pit 15; the large stone is part of wall [333]

The wall first seen in Pit 2, [325], was exposed longitudinally in the north section face. Its construction trench, [331]/[322], may have been truncated by the construction of a later wall ( [333] ), which was parallel, c. 840 mm. to the south.

At the request of Mr P Barker (East Lindsey District Council) the pit was extended 1.0m. to the south to determine the width of wall [333]. However, it transpired that the south face had been completely robbed and the true width of the wall was not determined.

The pattern of stone robbing is interesting: emerging from the west section the robber trench followed the course of wall [333] for c. 400 mm. before turning 90° and extending to, and through, the south section face. This implied a further wall, possibly contemporary with [333], aligned north-south - possibly an internal partition.

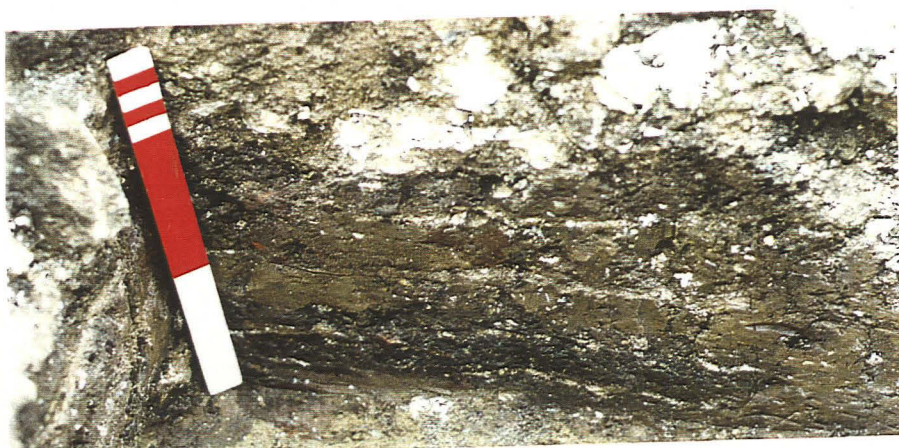
P4. Close-up of truncated floor deposits [309] in south-west corner of Pit 10

The earliest exposure, [310], (which was only visible in the lower south section) was a band of homogenous, light reddish-brown clay: possibly a floor, sealed by [309]G - an occupation horizon 60 mm. deep of dark silty detritus with limestone flecks and **an abundance of fish bone and shell fragments**. Above this lay a sequence of mortar floors (c. 10 mm. deep) and clay bedding layers (c. 60-65 mm. deep), [309]b-[309]f. No datable finds were recovered from these layers, the only artefact being an iron nail.

Sealing the above was a layer of brown flecked clay containing limestone chippings, [309]a. This was clearly associated with a later development; possibly a construction horizon associated with an east-west stone wall, [304], the trench for which had cut through the sequence of floors described above. The wall/foundation consisted of a rubble core between rough ashlar facing stones, bonded with light brown sandy mortar. Its south face, above [309]a, was butted by a substantial demolition horizon, [308]; comprising mainly rubble, mixed with yellow mortar and soil. The same layer was exposed in pits 3, 6 and 7: the latest date suggested for pottery recovered from this horizon was mid-C14th and a post-dissolution date suggested by the excavator is, at best, tenuous.

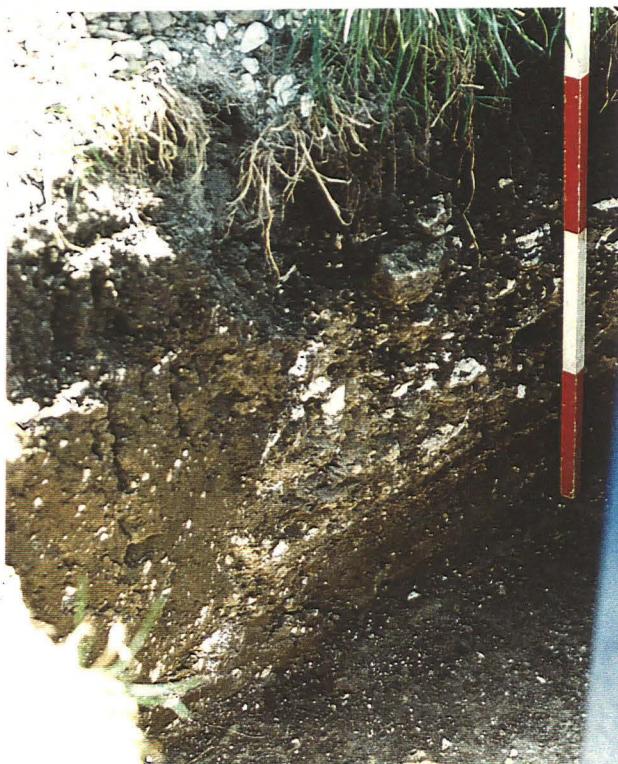
P5. South section, Pit 6, showing robber trench [307] cut through demolition [308], [313], [315]

The earliest stratum, exposed in the base of the north section was [313], the same sandy clay layer seen at a similar level in pit 7. It was beneath a layer of loose sandy grit containing two dark (?leached) horizons, [315]: possibly a path. This ?path was beneath the demolition horizon, [308] which, as before, was cut through by robber trench [307].

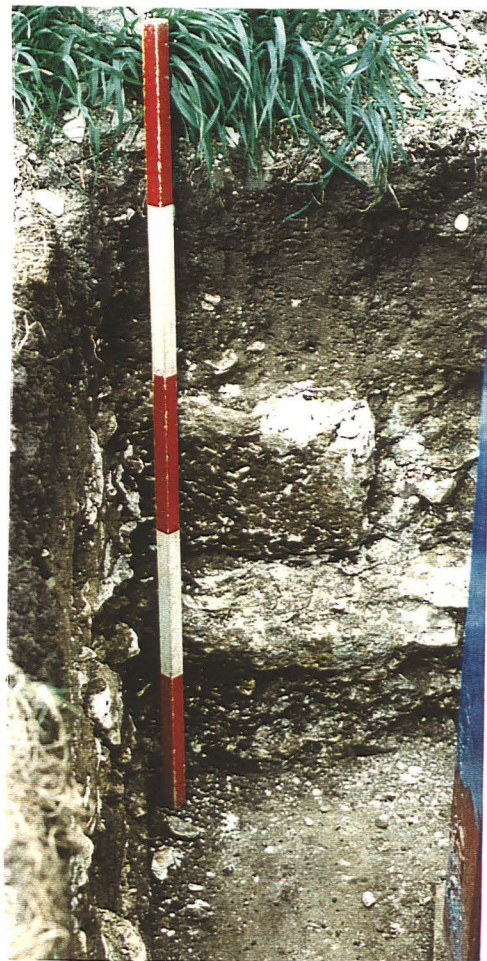
P6. North section, Pit 2, showing wall [325] and off-set foundation [325]b

The base of an east-west wall, [325], (and its off-set foundation [325]b) was observed extending through the north section. It was made of rough ashlar facing stones and a rough rubble core, bonded with yellow sandy mortar. Very little of its fabric remained; it being visible only in the north and west sections, surviving to only one course.

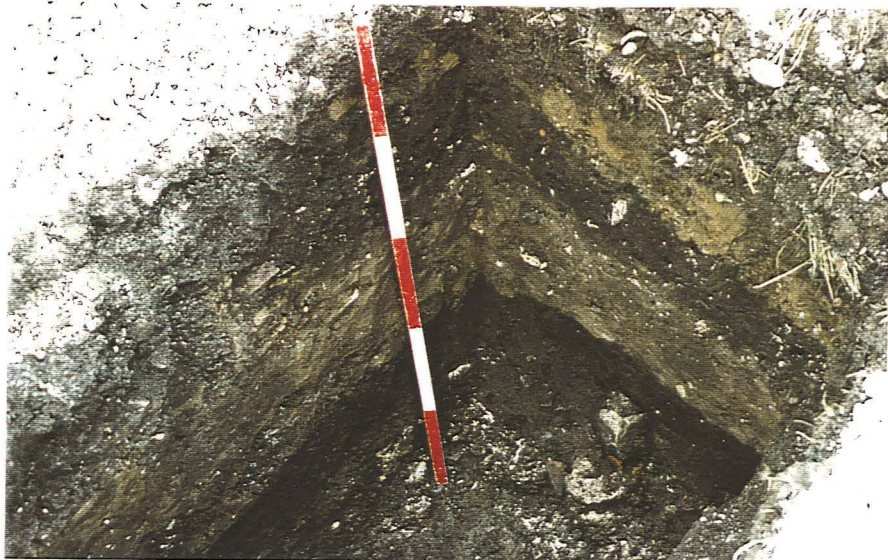
P7. Pit 14, showing buried topsoil horizon/make-up and infill in N + W sections

A series of deposits relating to 1960's soil dumping and ground-raising ([230] - [232]) dominated the upper sequence; amounting to some 800 mm. of mixed soils and rubble. Beneath these lay a uniform, loose, dark soil containing abraded medieval tile fragments, brick and limestone, [233], which sloped noticeably from north to south. Like [237] in pit 16, this was interpreted as the pre-1960,s topsoil.

In the base of Pit 14, below the 'old' topsoil, were primary deposits of mixed soil and rubble, [234] and [235], which also sloped in a southerly direction. Some of the stone rubble inevitably derived from building demolition, perhaps associated with structures located further to the north or west. Context [234] contained early medieval pottery; dating somewhere between the mid-C12th and mid-C13th.

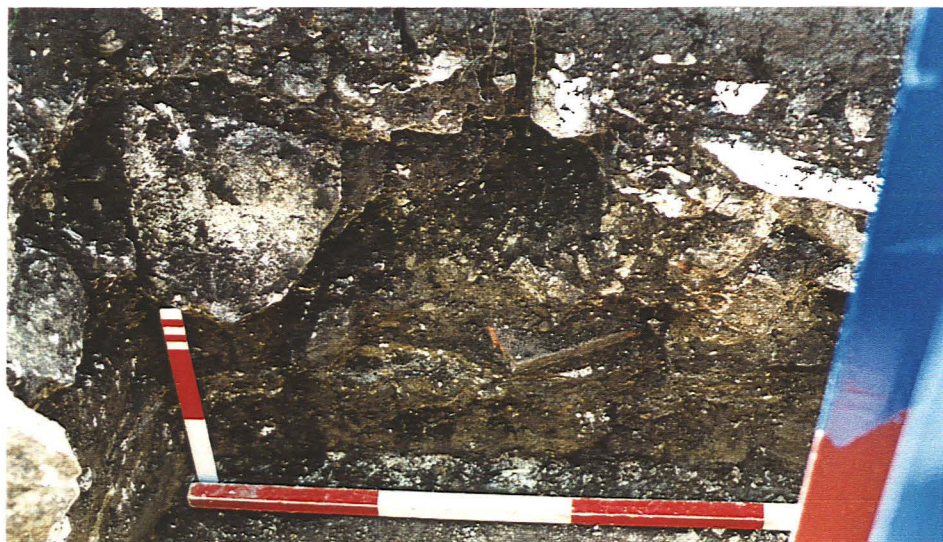
P8. West section, Pit 3, showing floor/occupation horizons [317] below demolition layer [308]

Further structural and occupation strata were exposed in this cutting: [319], a layer of corn yellow sand, was the earliest stratum exposed in section. It appeared to be a levelling horizon which lay beneath c. 40mm of compact grey clay mixed with reddish-brown patches [318]; the latter was deposited as a bedding for a mortar floor, [317]b/c -two distinct, superimposed mortar surfaces. They lay beneath an occupation horizon, [317]a, comprising soft grey-black sandy silt mixed with charcoal and fired clay and an apparent abundance of fish bones. This was beneath the possible remains of a later clay floor, [316]. The archaeology was eventually sealed beneath the extensive demolition layer, [308], and the stratigraphy was cut through by robber trench [307], which lay on the east edge of the pit.
