**St Margaret's Church,
Sibsey, Lincs.
Archaeological Watching Brief
NGR: TF 354 509
Site Code: SSMC 07
Accession No.: 2007.194
Diocese of Lincoln Faculty: 2052**

**Report for
Graham P. Cook Architect
on behalf of
Sibsey Parish Council**

**LAS Report No.: 1012
November 2007**

Paving Work, St Margaret's Church, Sibsey, Lincs. Archaeological Watching Brief

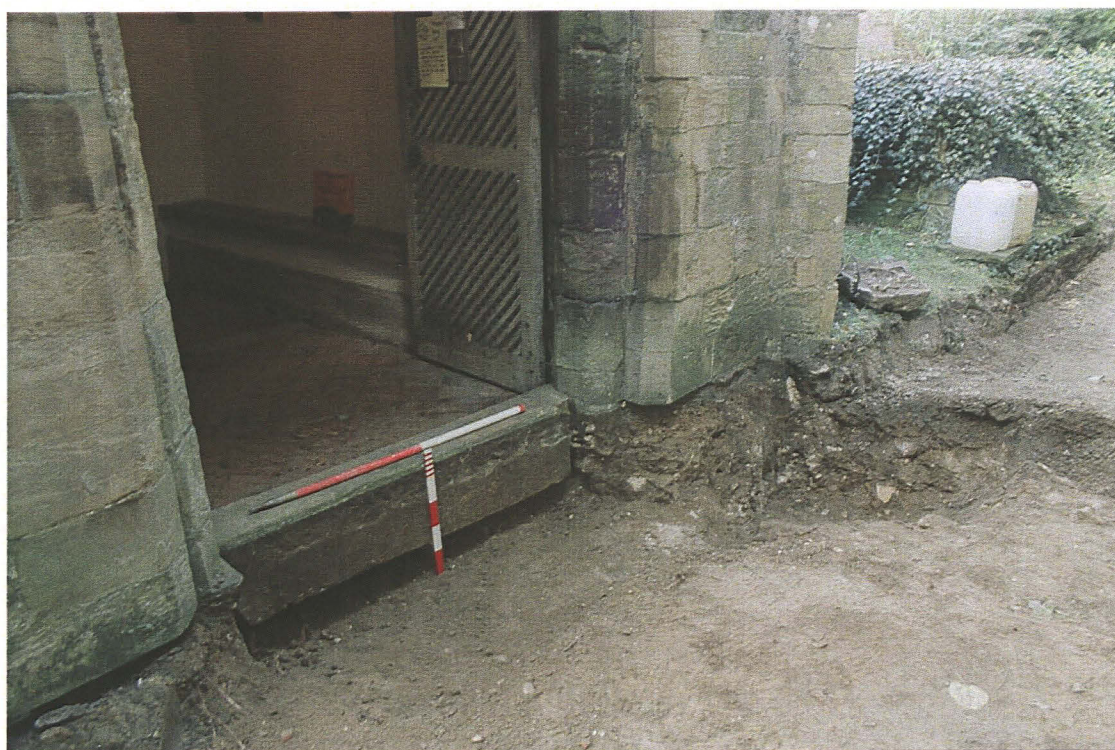
Pl. 2 Area A after the removal of bedding layers 9 looking north-east. Horizontal scale 1m, vertical scale 0.50m.

The threshold was reduced in height to make it flush with the porch floor to improve access for the disabled and wheelchair users. This required removal of laminated path bedding layers, **9**, which were 0.19m deep (Pl. 2). This exposed concrete underpinning, **7** and **8**, beneath the porch which was 0.50m deep (Pl. 3). Below the underpinning were limestone fragments, some worked, within a yellow brown silt sand matrix, **10** (Pl. 4). This deposit was over 0.24m deep and formed the foundations for the porch walls.

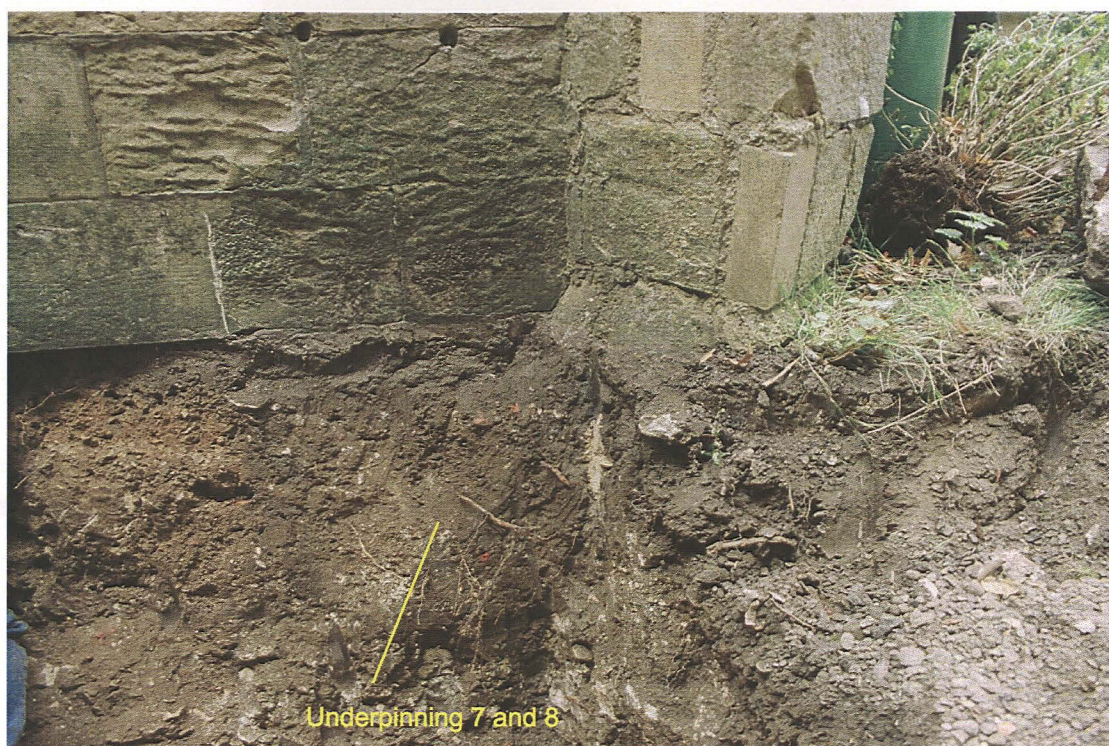
Pl.3 Area A, east end of porch showing underpinning 7 and 8, looking north.

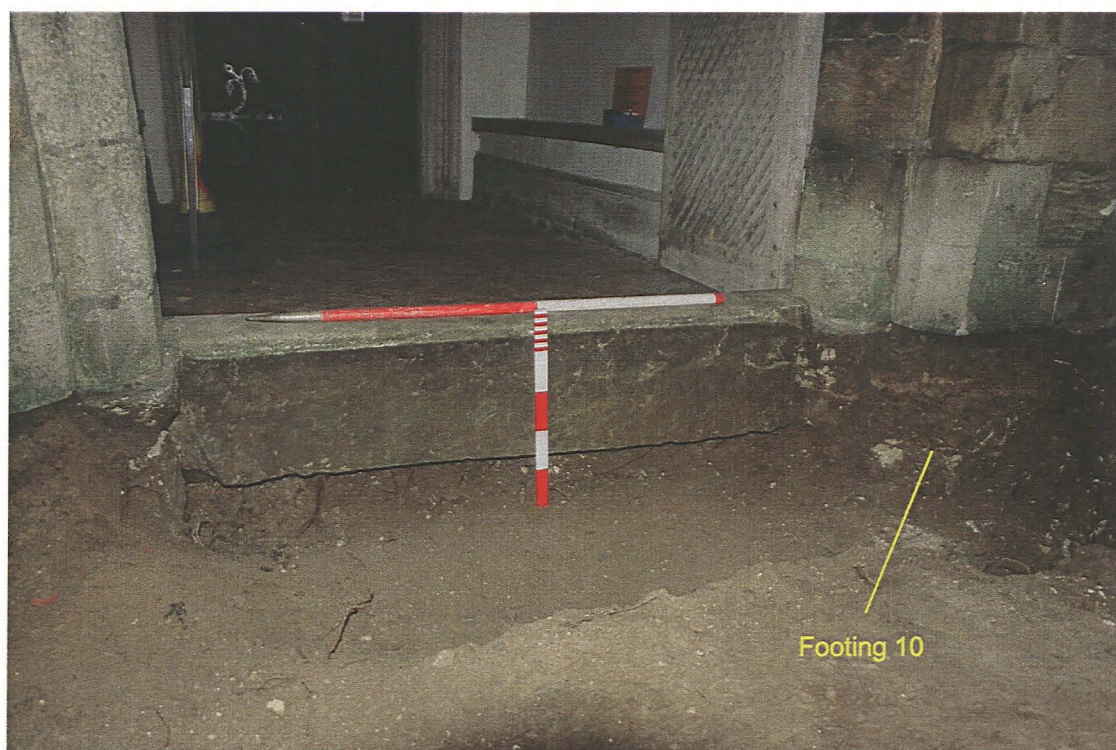
Pl. 4 Area A, foundation 10 in relation to the threshold of the church looking north. Horizontal scale 1m, vertical scale 0.50m.

The only feature of note was the possible foundation for the porch, **10**. As no finds were recovered from **10** it is not possible to say whether they are part of the construction dating to 1699, or if they originally belonged to an earlier porch. Pottery from the path makeup confirmed its 20th date of construction.

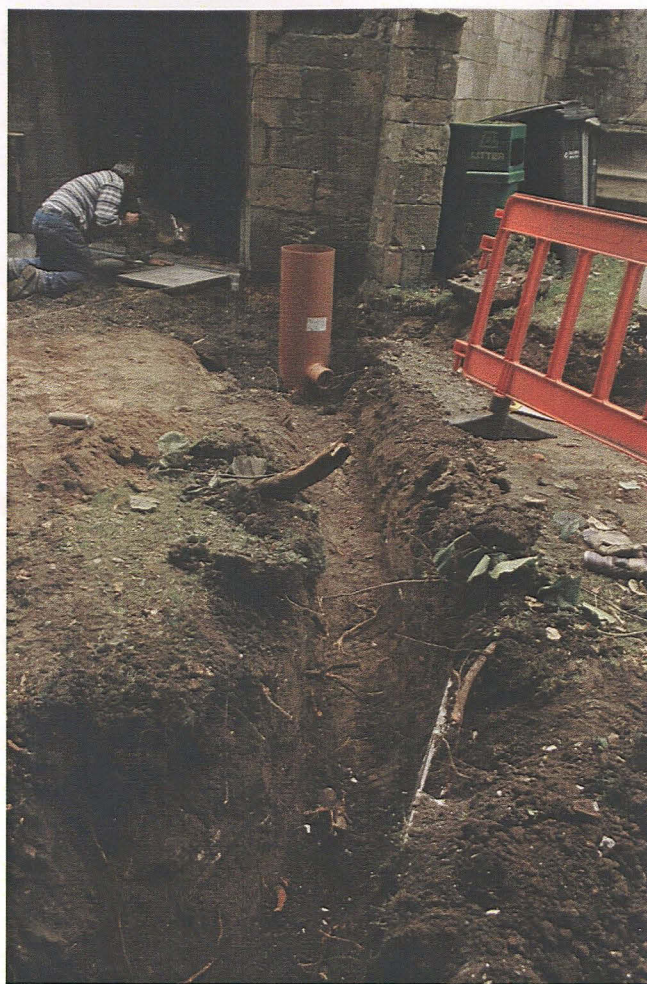
Pl. 5 Area A pipe trench looking north-west

A trench was excavated in a south-easterly direction from the south-east corner of the porch. It ran for c.5m to the soakaway and was 0.30m wide and approximately 0.40m deep (Pl. 5). No archaeological remains were noted within the pipe trench or soakaway, but the limestone slabs belonging to a tomb, **11**, was recorded c.4m from the porch at a depth of 0.14m beneath the topsoil (Pl. 6). A grey brown silt clay layer, **2**, was exposed in the soakaway beneath the topsoil **1**. It was over 0.65m deep, and extended beyond the base of the soakaway pit (Pl. 7). In places a grey brown silt clay, **2** was exposed beneath the topsoil **1**. A single sherd of a Toynton ware jug of mid 15th-16th century date and a fragment of a glazed floor tile of mid 14th-16th century date were found in this layer (Appendix 1).

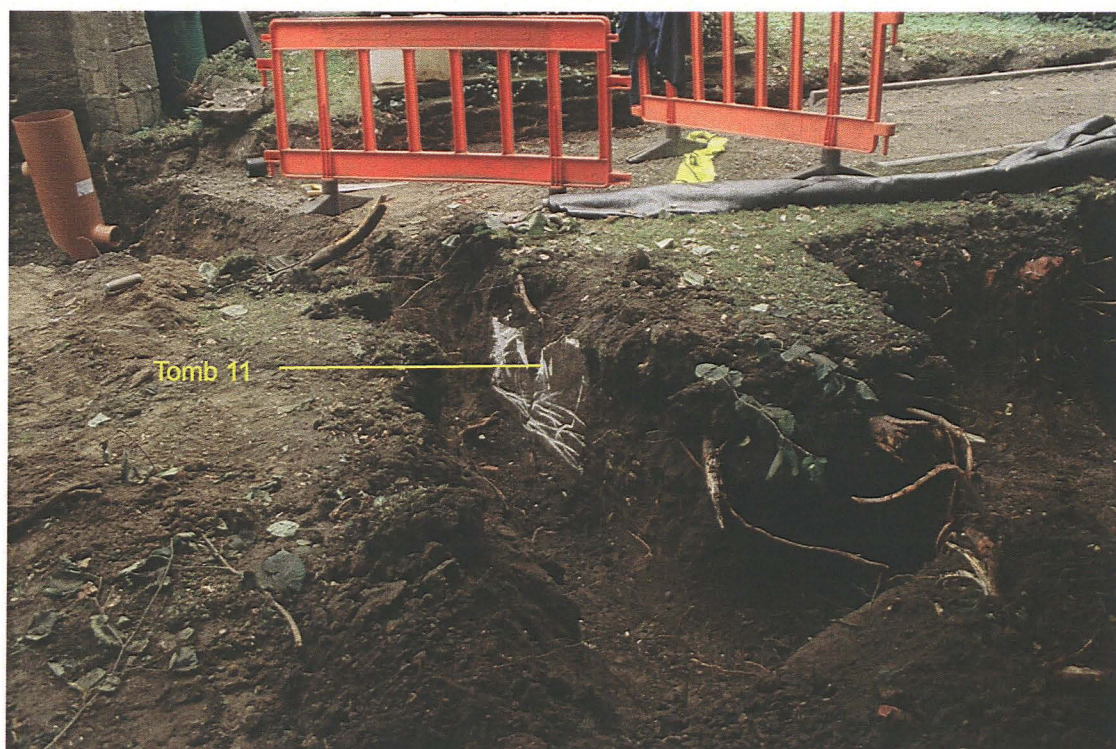
Pl. 6 Area A, slabs of tomb in side of pipe trench, looking north north east

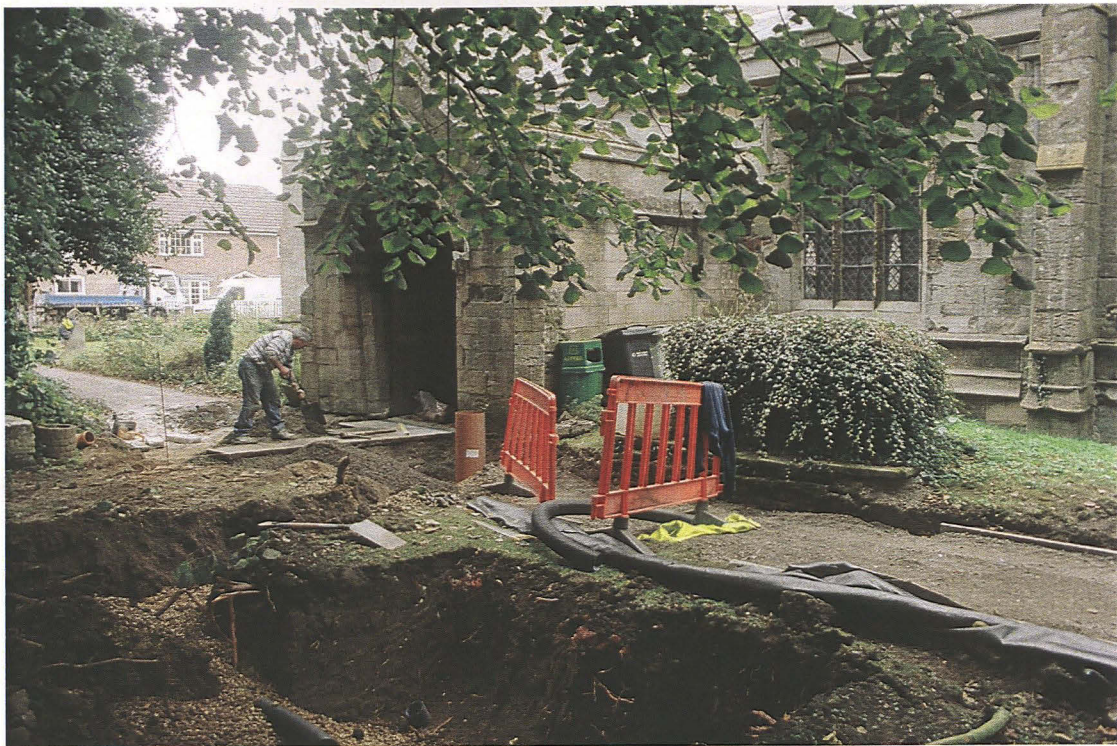
Pl. 7 Area A, location of the soakaway and the deposits exposed within it, looking north-west.

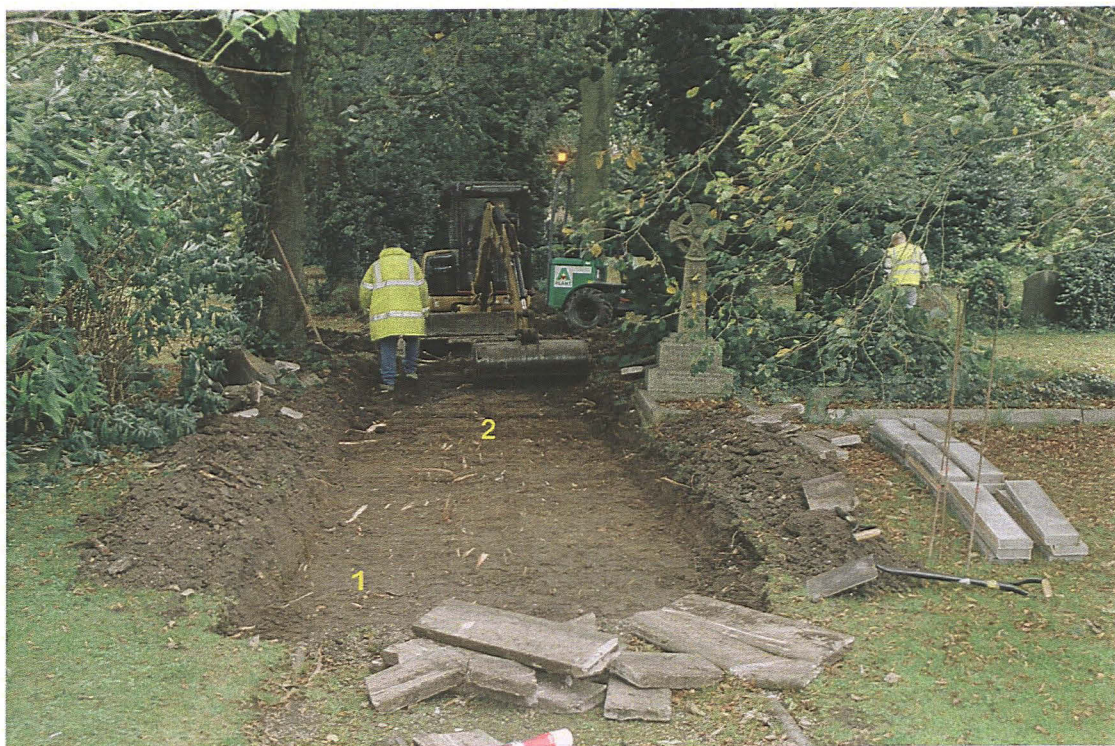
Pl. 8 Area C, exposed deposits after widening of the path, looking east.

Area C, to the east, was widened by 0.25m to either side of the existing kerbed path. The new footpath was 1.60m-2m wide and the excavations 0.23-0.30m deep. (Pls 8 and 9). Between the kerbs of the old path was an upper bedding layer **3** comprising gravel in a matrix of grey brown sandy silt. It was removed by mini excavator to reveal a loose dark brown sandy silt deposit **4** which produced 9 pieces of 19-20th century pottery (Appendix 1). No further archaeological remains were revealed, due to the shallow depth of the excavations.

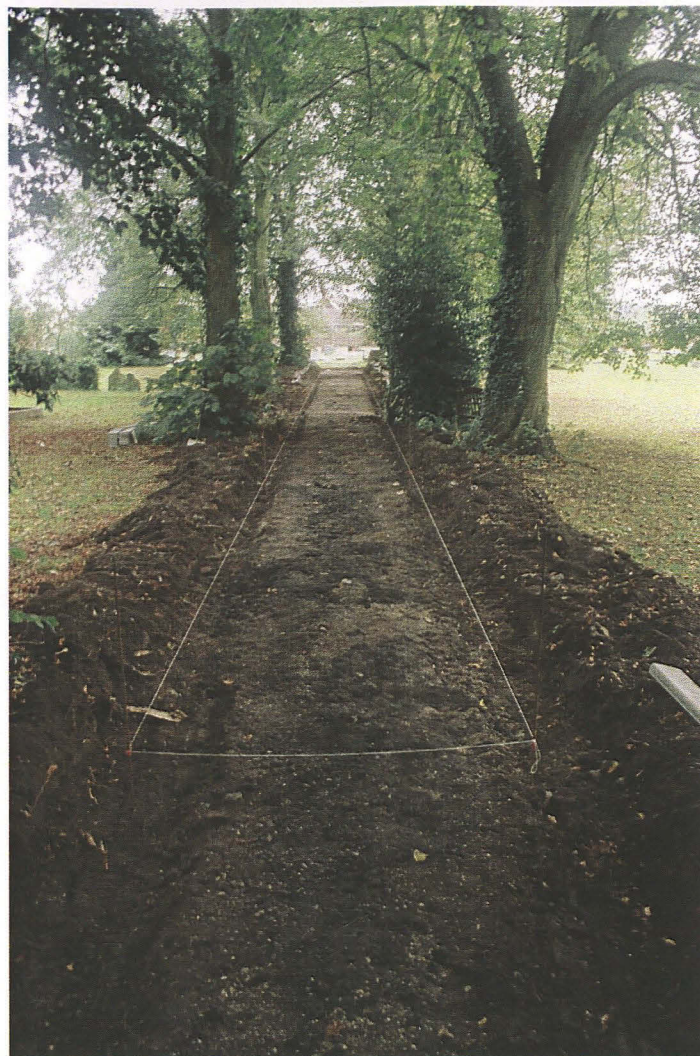
Pl. 9 Area C, footpath looking east showing areas of subsoil revealed beneath the topsoil
