**LAND BETWEEN 38 ROBEY STREET AND
THE REAR OF 49-54 HIGH STREET
LINCOLN
LINCOLNSHIRE**

**PHOTOGRAPHIC BUILDING SURVEY,
ARCHAEOLOGICAL EVALUATION
AND WATCHING BRIEF
REPORT**

Site code: RSL 05
NGR: SK 97172 69996
Planning Ref: 2004/0545/F
Acc Code: 2005.117
PCA Ref: 05/167

Report prepared for
John Bell Civil Engineering
by
E. Rowe

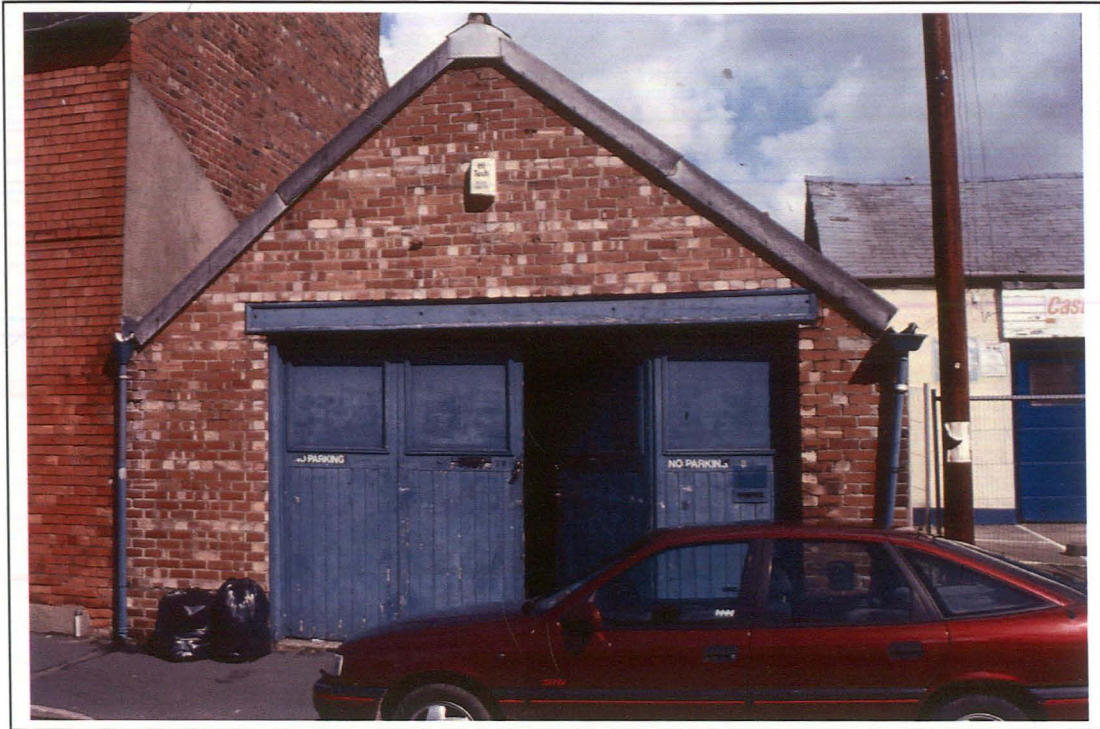
Building 1 is a 20th century brick built single storey structure with a corrugate fibreglass roof and no outstanding features. It has folding garage doors in the southern façade and a skylight in the roof. The metal basin, toilet and possible kitchen space suggests this had been used as an office and rest space.

Building 1; Front façade, looking north

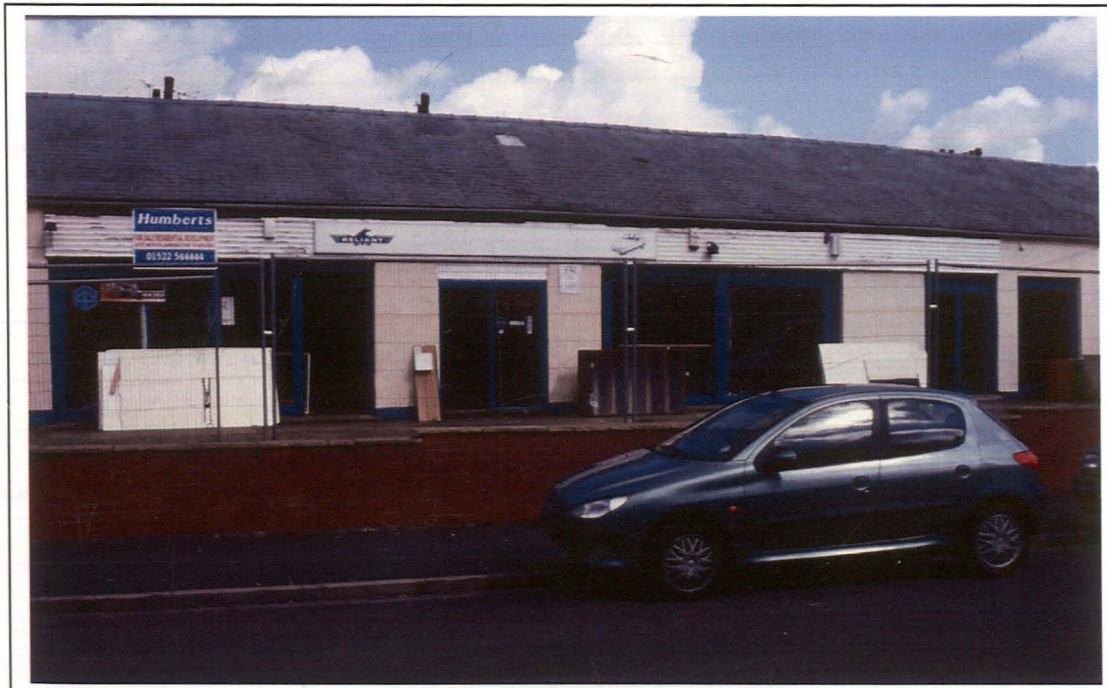
Building 2 is the c. 1900 brick building identified as Industrial Monument 5152. It is single storey with the majority of the frontage glazed, presumably to function as a car showroom. It has a grey slate roof, and there are no outstanding features.

Building 2 (Industrial Monument No. 5152); Front faced, looking north

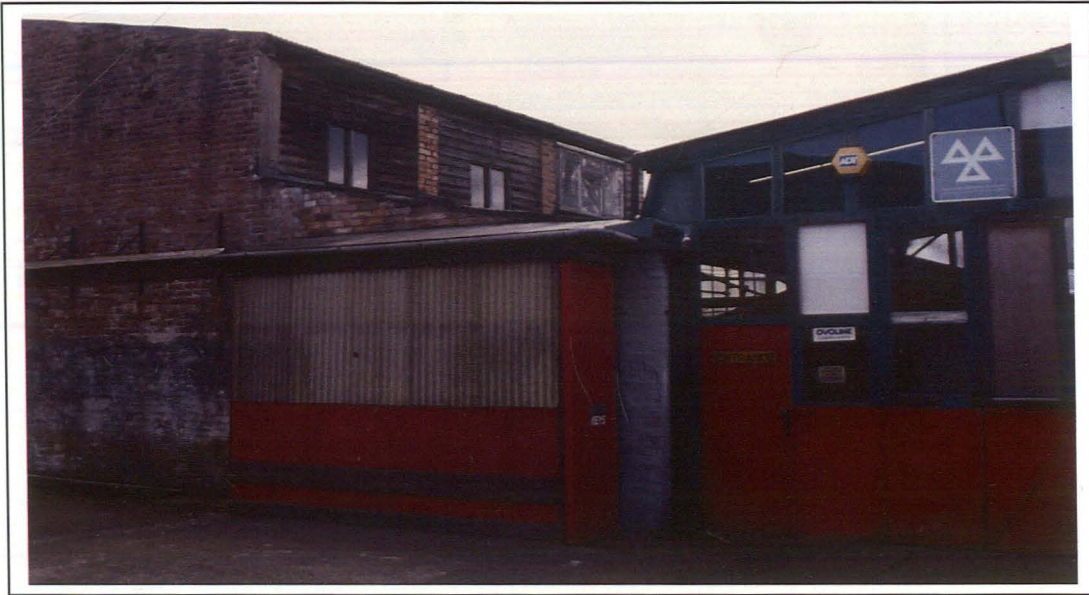
Building 3 is a 20th century two storey brick built motor workshop with corrugate fibreglass roof and no outstanding features. The ground floor was used as a garage with modern wooden partitions to create office spaces. The upper floor was used as an office space with no internal features.

Building 3; Western side of building, looking north-east

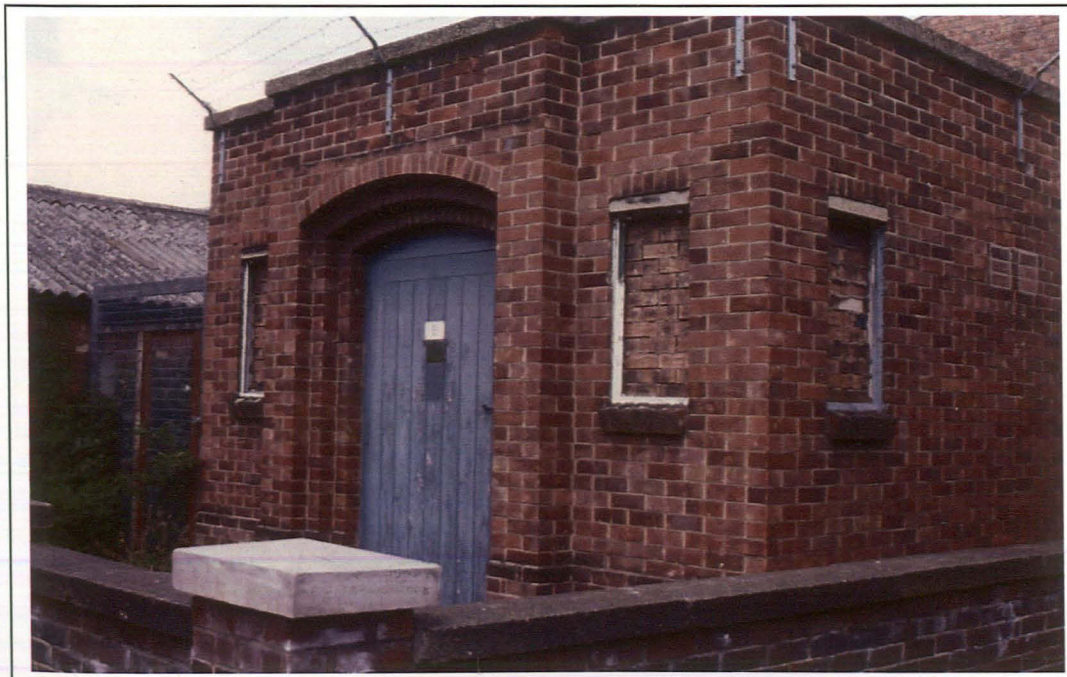
Building 4 is an early 20th century brick built electrical sub station with a flat concrete roof. The doorway is arched with three stepped brickwork insets and the windowsills are of sloped brickwork. An internal survey of this building was not possible for health and safety reasons. This building was not demolished as part of the current works.

Building 4; looking northwest

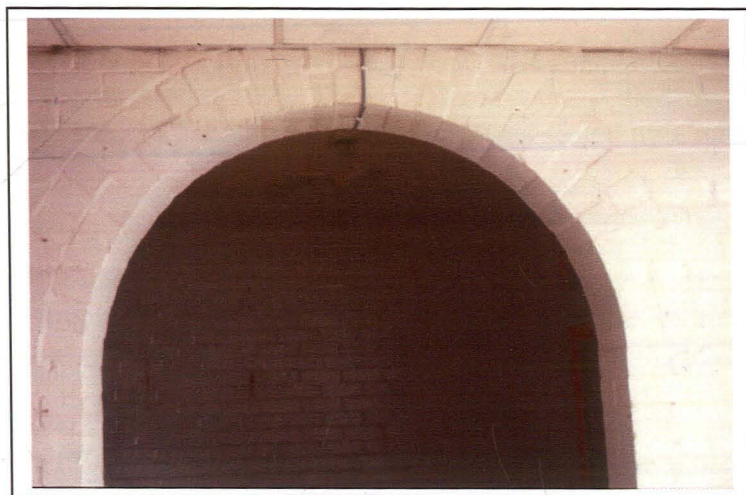
Building 5 is a 20th century single storey brick structure with a corrugate fibreglass roof and no outstanding details. The internal space is largely open with a partitioned off areas for a toilet and office space. A simple brick arch stood between the entrance porch and the main workshop.

Brick arch in Building 5; facing east

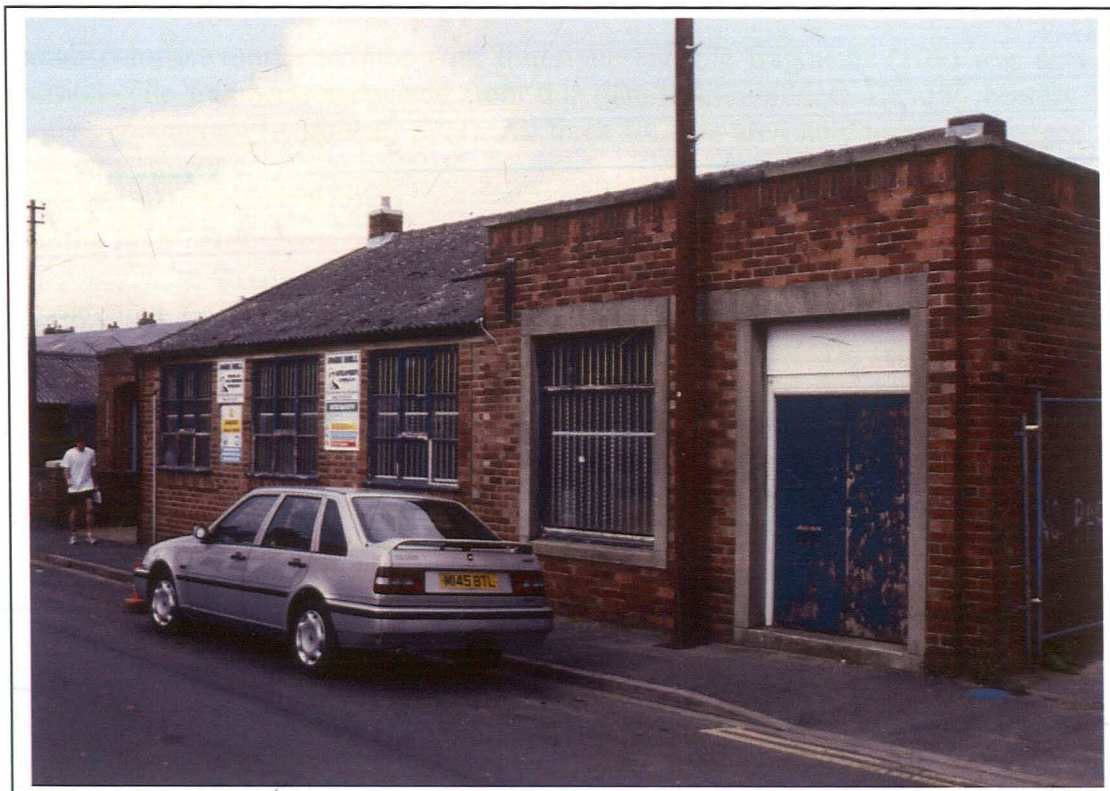
Building 5; looking northwest

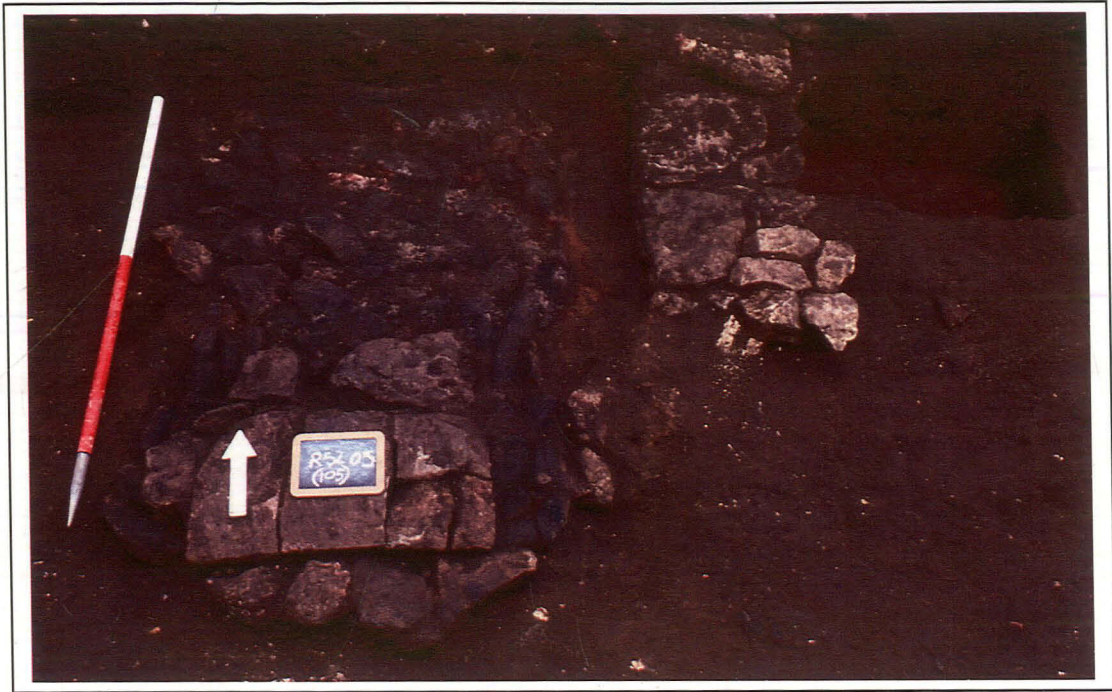
Wall foundation (104) was constructed with roughly hewn limestone blocks of varying sizes laid in irregular courses, of which three survived. A number of pottery sherds and tile fragments were recovered from within the fabric of the wall foundation, dating to the early-mid 13th century.

Immediately adjacent to wall foundation (104), but not directly stratigraphically related, was hearth (106). This was constructed of small limestone rubble with pitched stones around the edge. Towards the southern end of this feature, a large dressed stone (105), which had been fractured by heat, had been placed on top of the rubble. A thin layer of ash (107) sealed the entire structure.

Hearth 106 and wall 104 within evaluation Trench 1, facing north

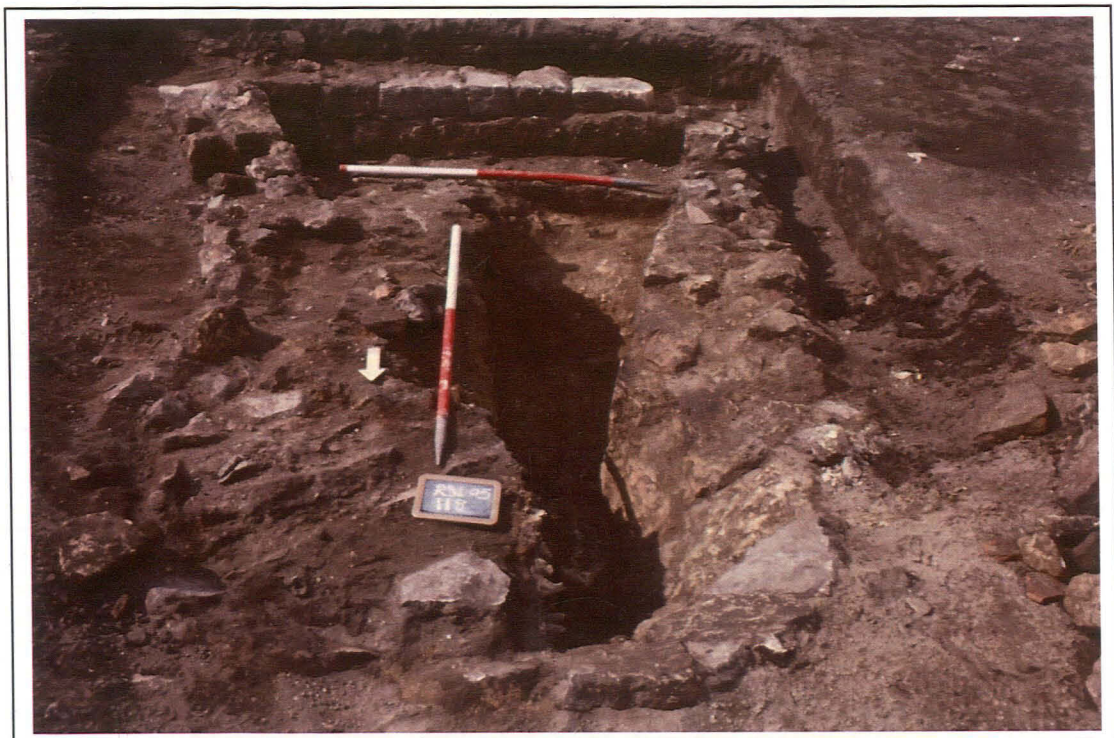
The keyhole shape of structure (118) is similar to other stone structures found in Lincoln which have been interpreted as corn-drying ovens or malting kilns. All of these structures, with the exception of one, are open at one end creating an open 'flue'. Structure (118) had a closed 'flue', as did one other similar structure identified at Wragby Road, Lincoln.

Key-hole oven 118 showing sloped walls and steps, facing south

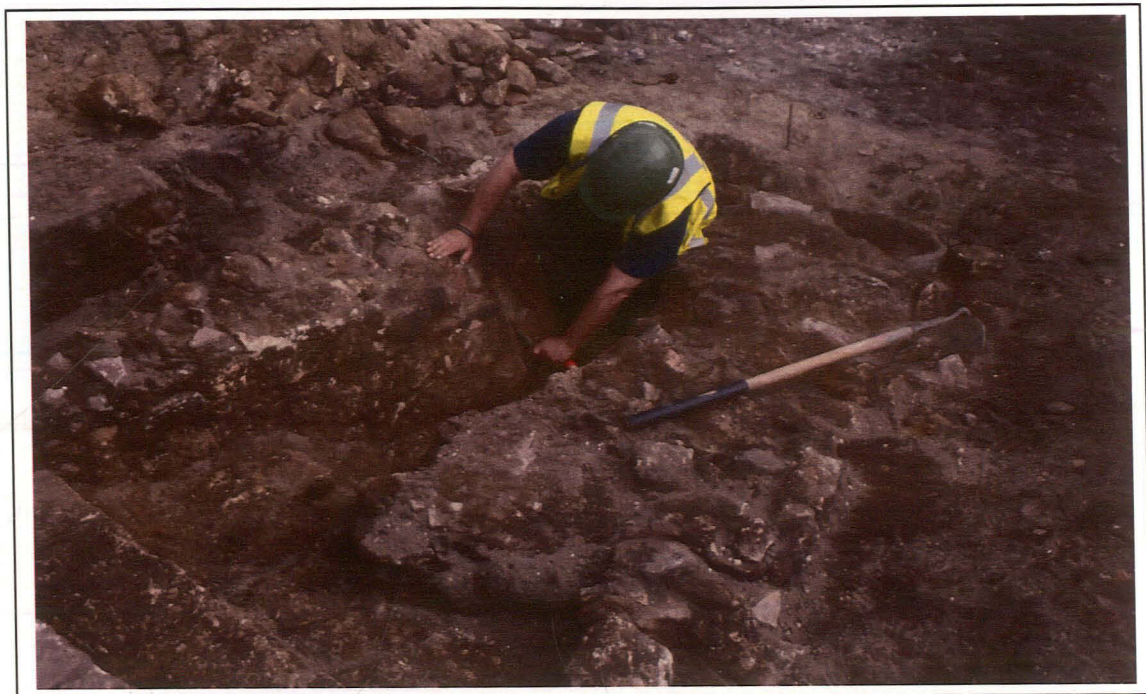
Key-hole oven 118 showing depth of wall and step leading inside, facing north-west

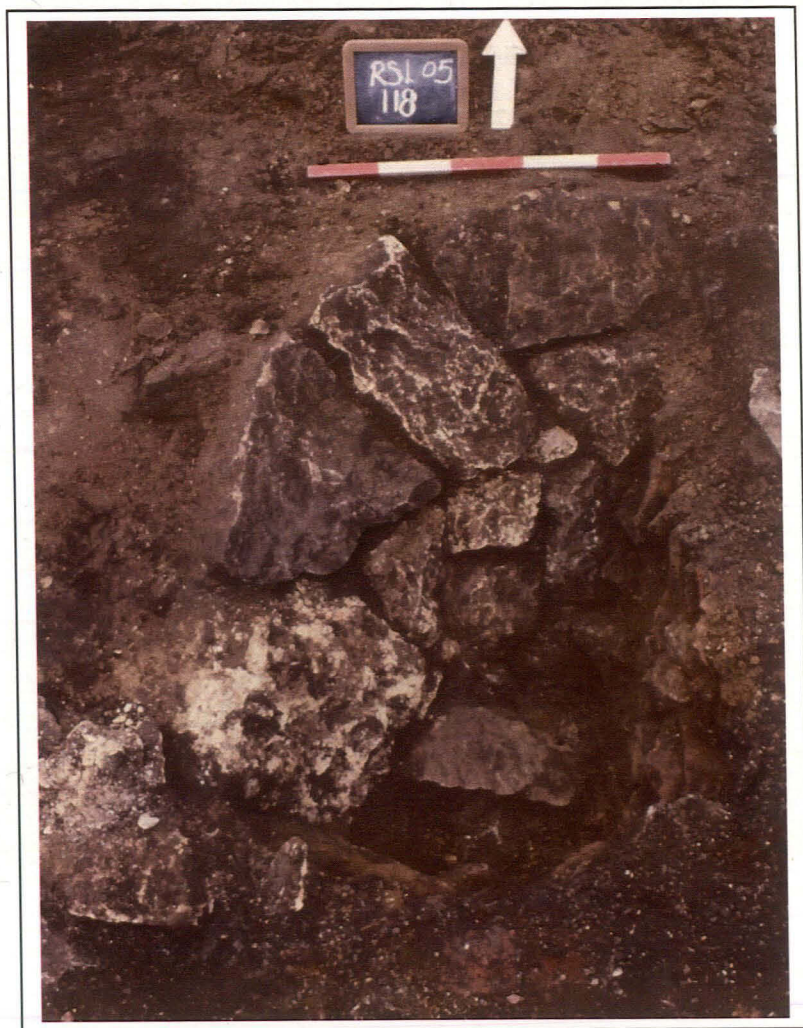
Northern end of Structure 118 showing angled stone, looking north

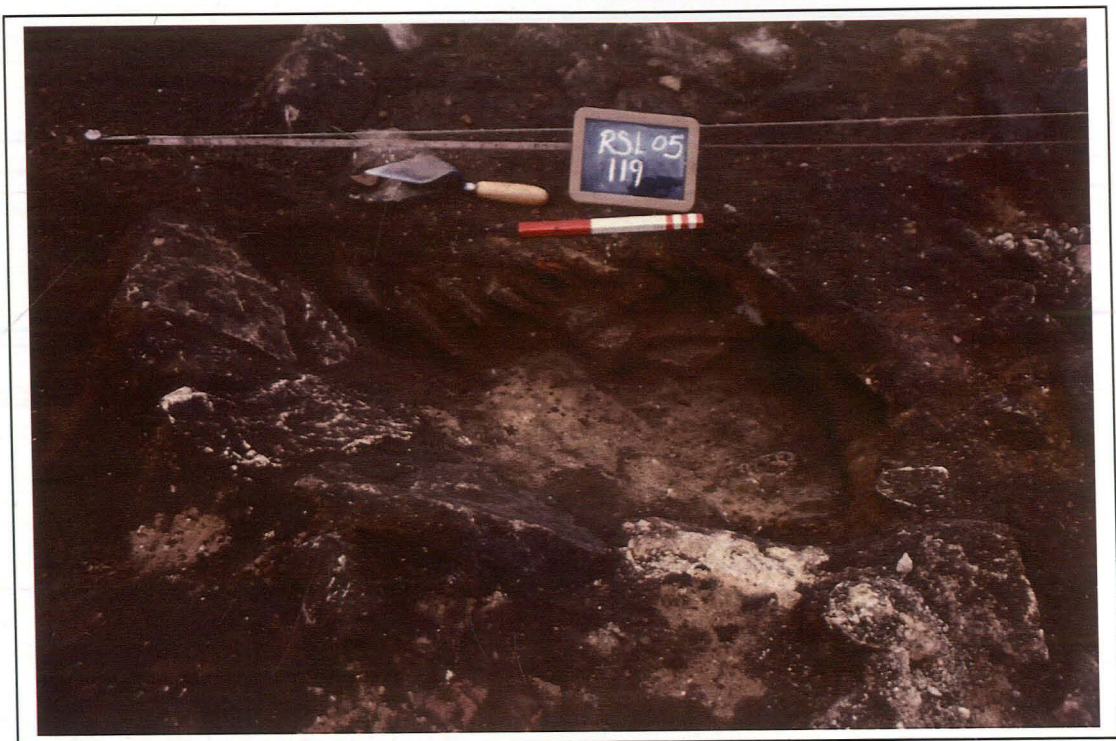
Possible structure 118 capping (deposit 119), looking east

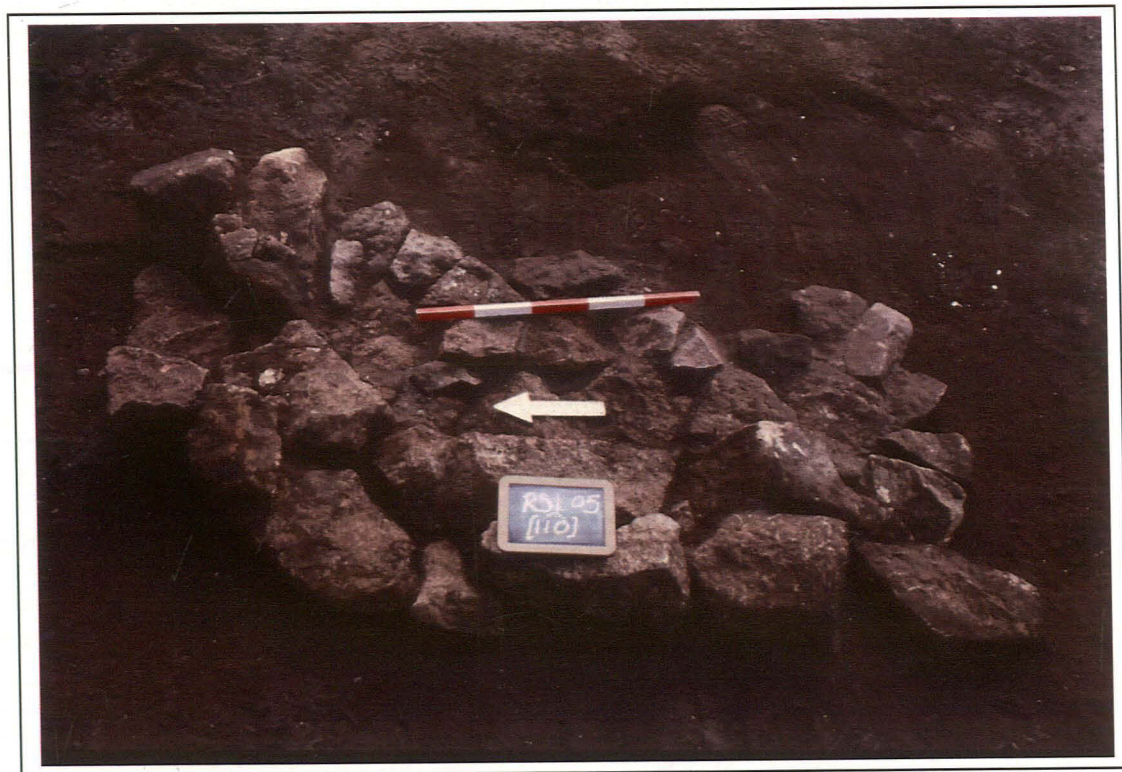
Remains of structure 110, looking east

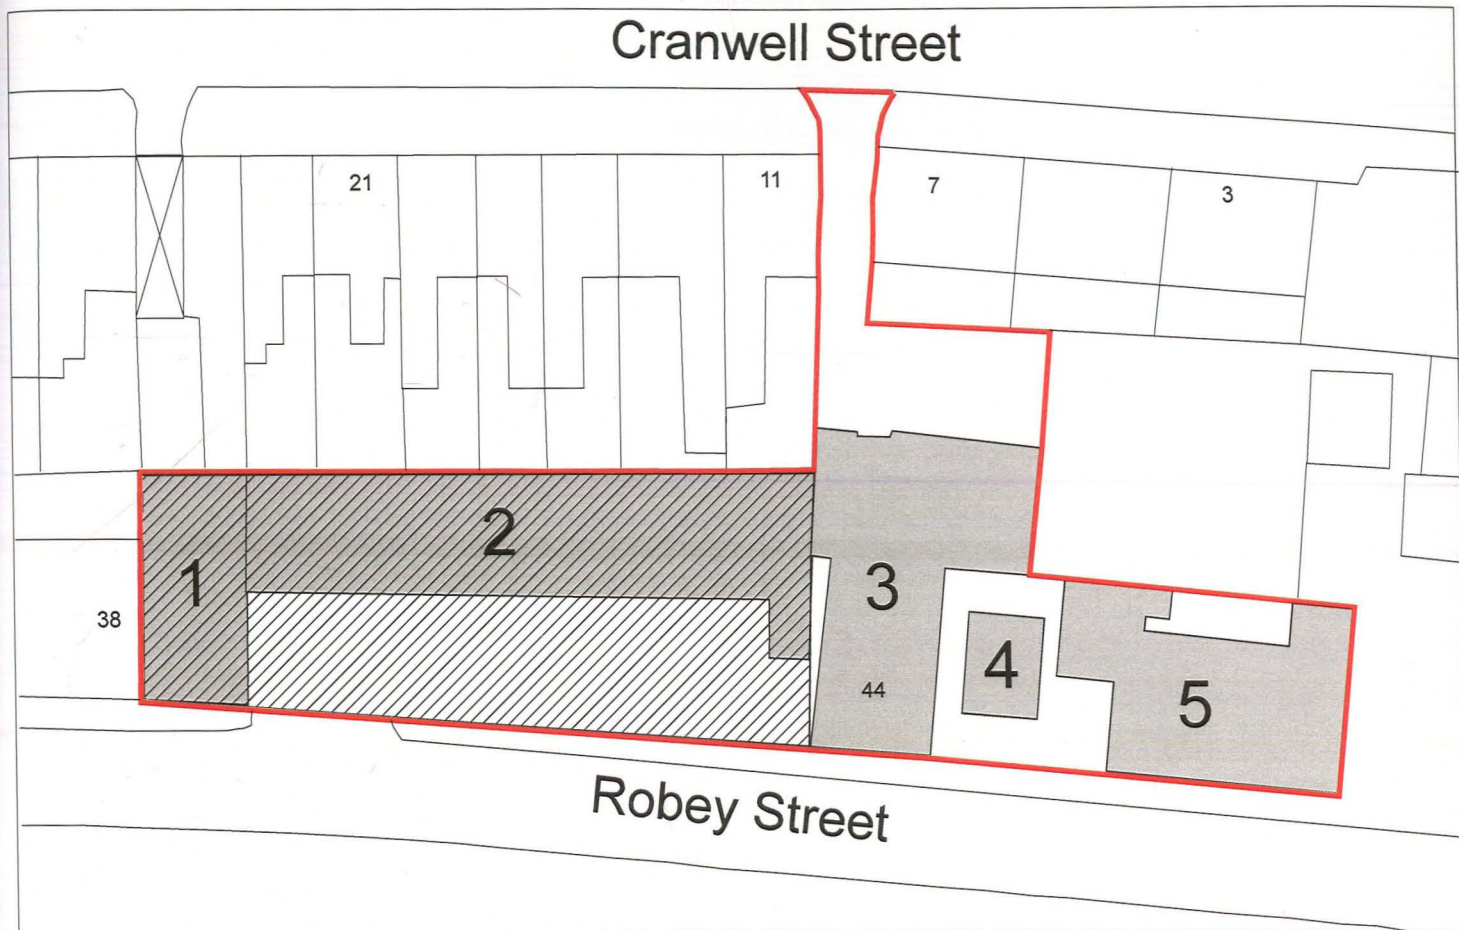
Figure 2 Detailed site location (Scale 1:500)

Site
 Building Surveyed
 Area of Evaluation and Watching Brief

General Site Arrangement (Fig. 2)

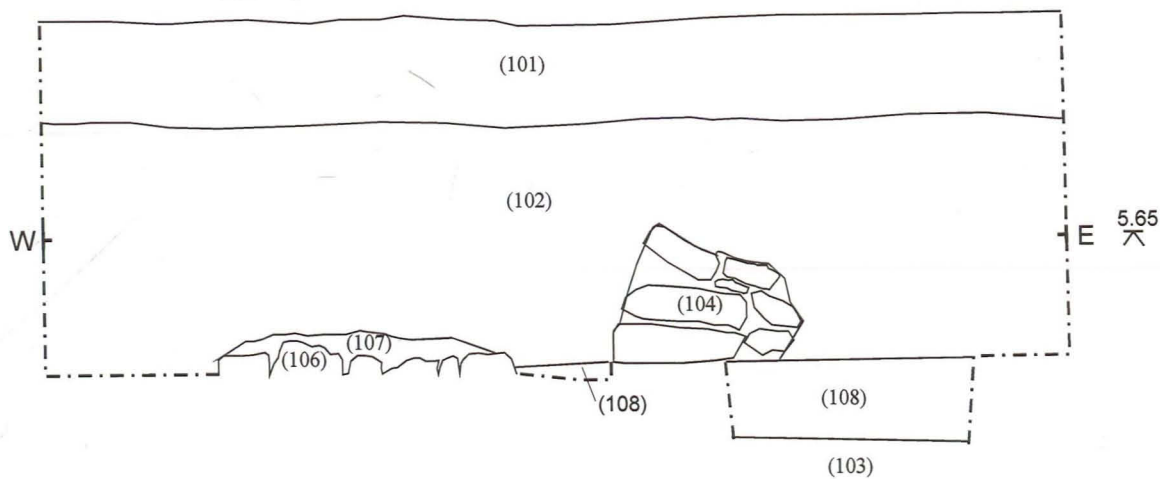
Figure 4 Plan and section of Trench 1

Section 1a South facing section of Trench 1 (Scale 1:20)

Plan Trench 1 (Scale 1:20)

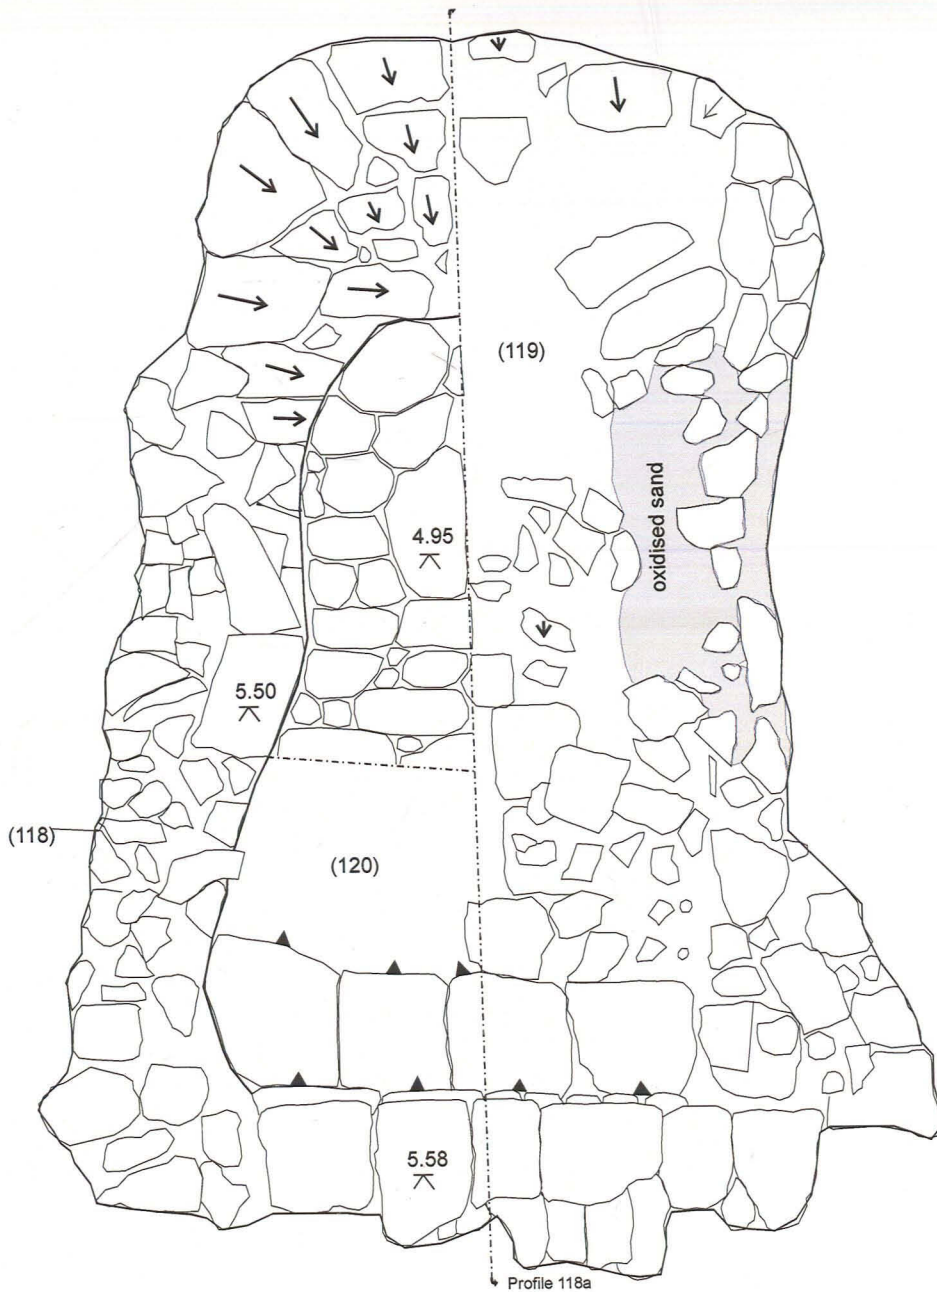
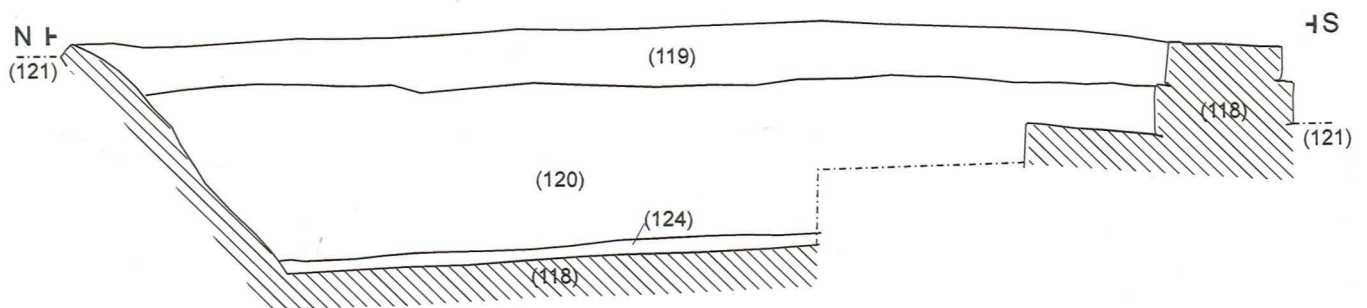
Figure 5 Plan and profile of kiln/oven (118)

Plan Kiln/oven (118) (Scale 1:20)

Profile 118 a West facing profile of kiln/oven (118) (Scale 1:20)

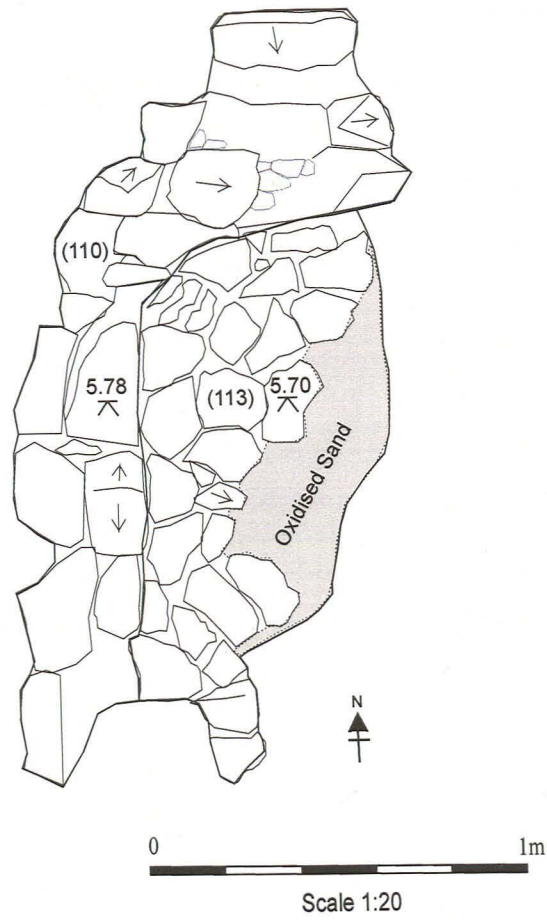
Figure 6 Plan of Structure (110) (Scale 1:20)

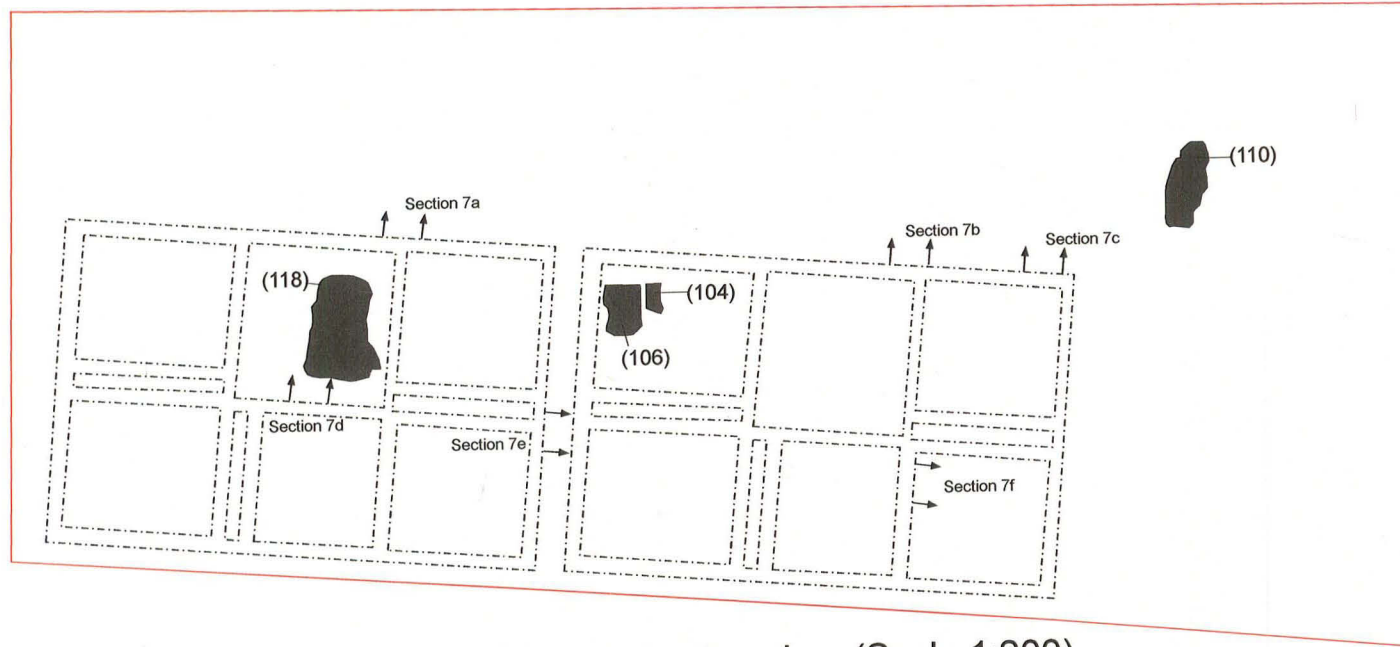
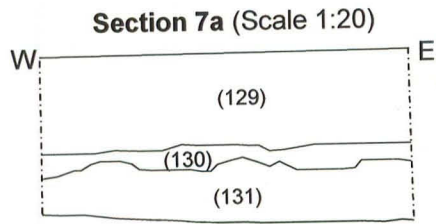
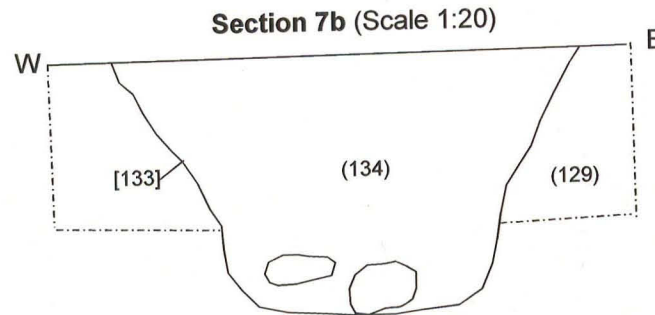
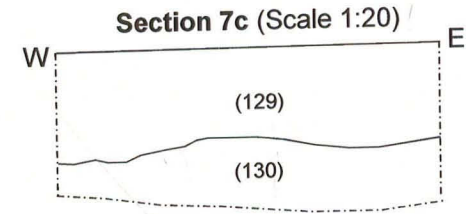
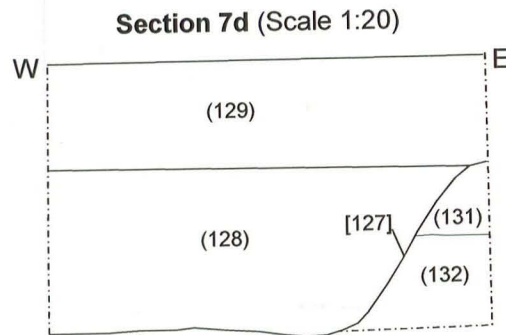
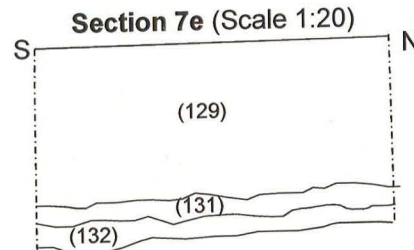
Figure 7 Plan and section of foundation trenches observed in watching brief

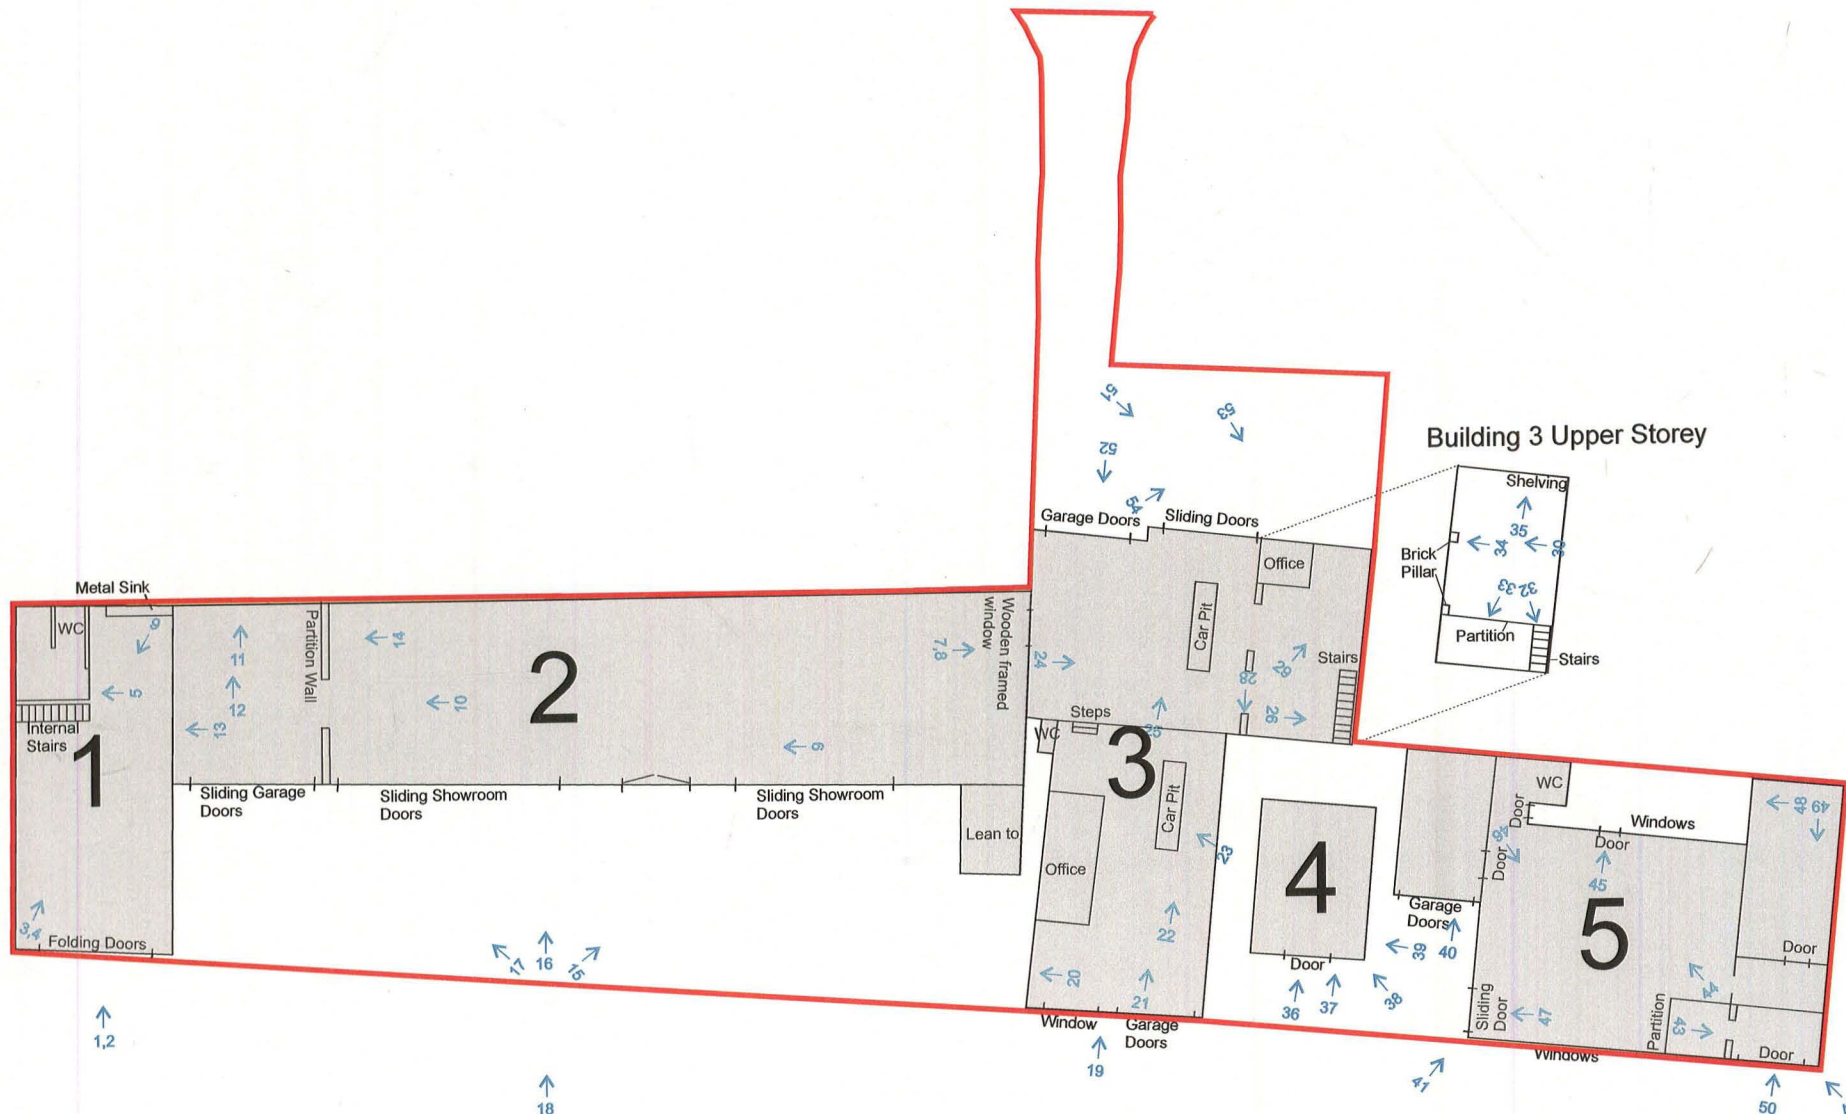
Figure 9 Detailed photograph location plan (Scale 1:400)

↑ Photograph number and direction

Standing Building Photography Survey (Appendix 7; Fig. 9)
