**Caistor, Yarborough School:
Archaeological Watching Brief
during groundworks for a
New Sports Hall**

**NGR: TA 1220 0146
Site Code CYS 95
LCNCC Museum Accn. No. 43.95**

Report prepared for Land and Buildings Consultancy

August 1995

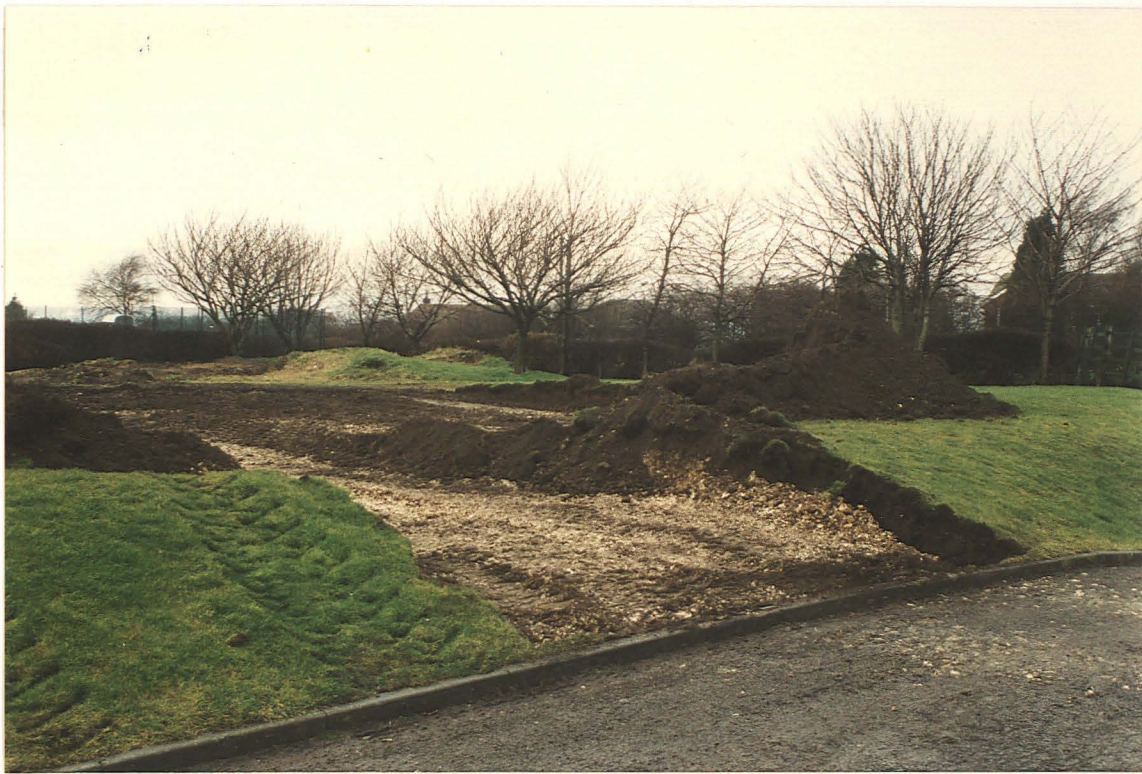
Pl. 1 Ground conditions at the start of the watching brief. The landscaped ridge can be seen in the foreground beside the school access road, with a previous spoil heap in the background close to the road hedge. The tennis court lay behind the hedge at the left of the photograph. Looking NW.

1. When the first visit was made, the landscaped ridge to the west of the school access road had been breached and most of the grassed area had been taken to chalk bedrock (Pls. 1 and 2). It had been intended to examine the horizon below the topsoil for the presence of ditches, pits or artefacts but in practice the mechanical disturbance had left only small areas where this could be done. It seemed that the natural slope, rising to the east, accounted for part of the ridge, but that soil excavated when the access road was constructed had been redeposited as landscaping.

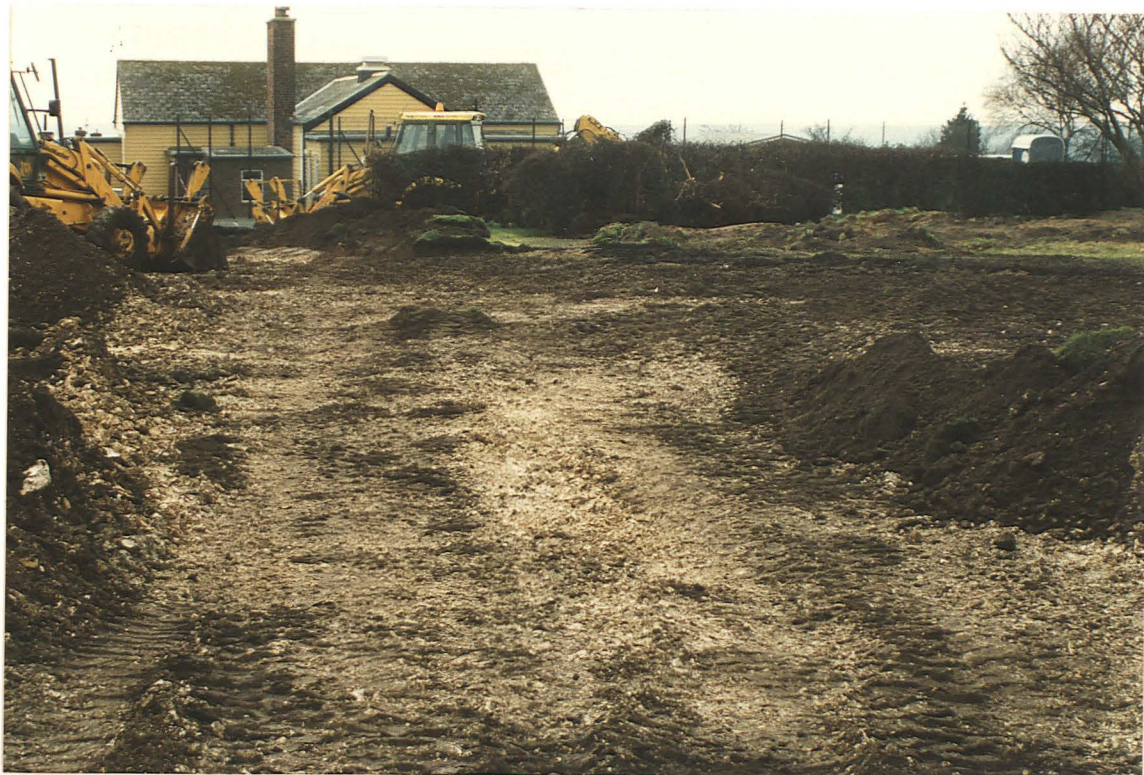
Pl. 2 Ground clearance had disturbed much of the grassed area before monitoring began, removing part of the chalk bedrock as well as topsoil and subsoil. Looking west across the Sports Hall site; a JCB is breaking asphalt in the fenced tennis court.

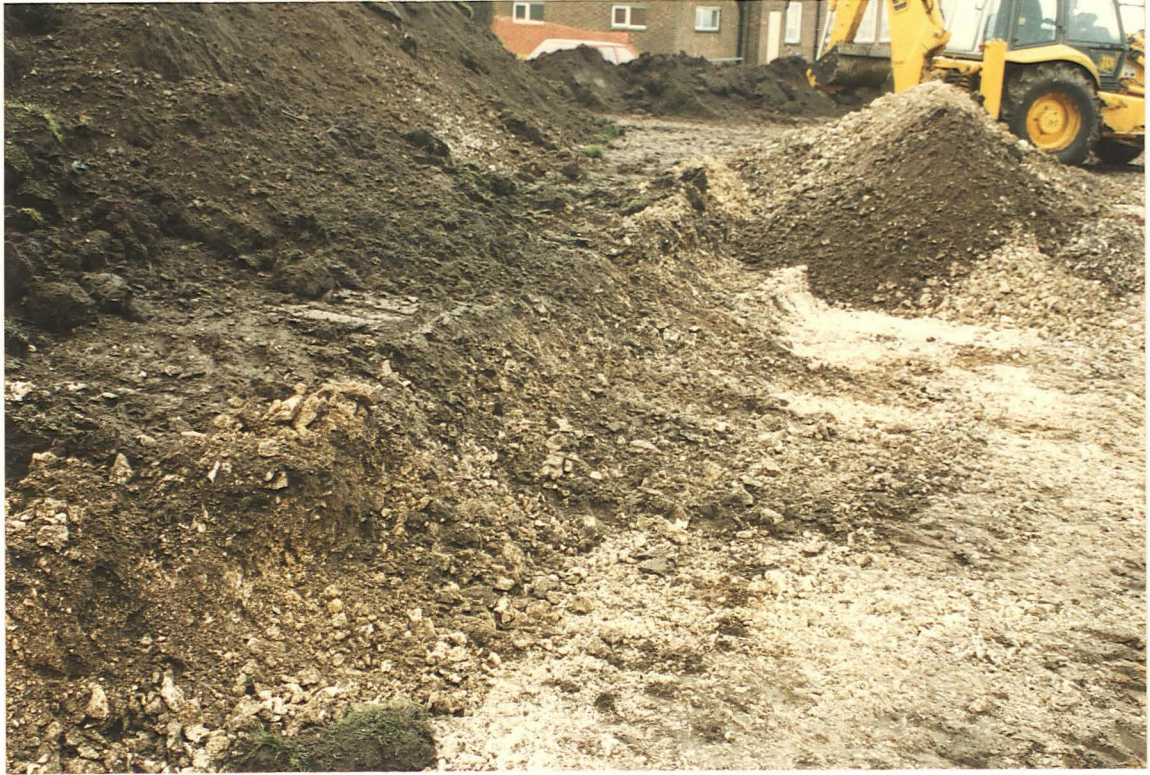
Pl. 3 Slight anomalies were seen in the upper chalk bedrock, with small irregular pockets of brown and orange-brown loam. These were interpreted as either natural peri-glacial features or the trails from bushes and small trees. One example is visible in the machined section near the foreground; parts of others are visible on the stripped surface in front of the small spoil heap. (Looking SW)

The bedrock contained small, irregular pockets of orange-brown loam. These were thought to be peri-glacial natural features but the extent of machine disturbance meant that close investigation was of limited use (Pl. 3).

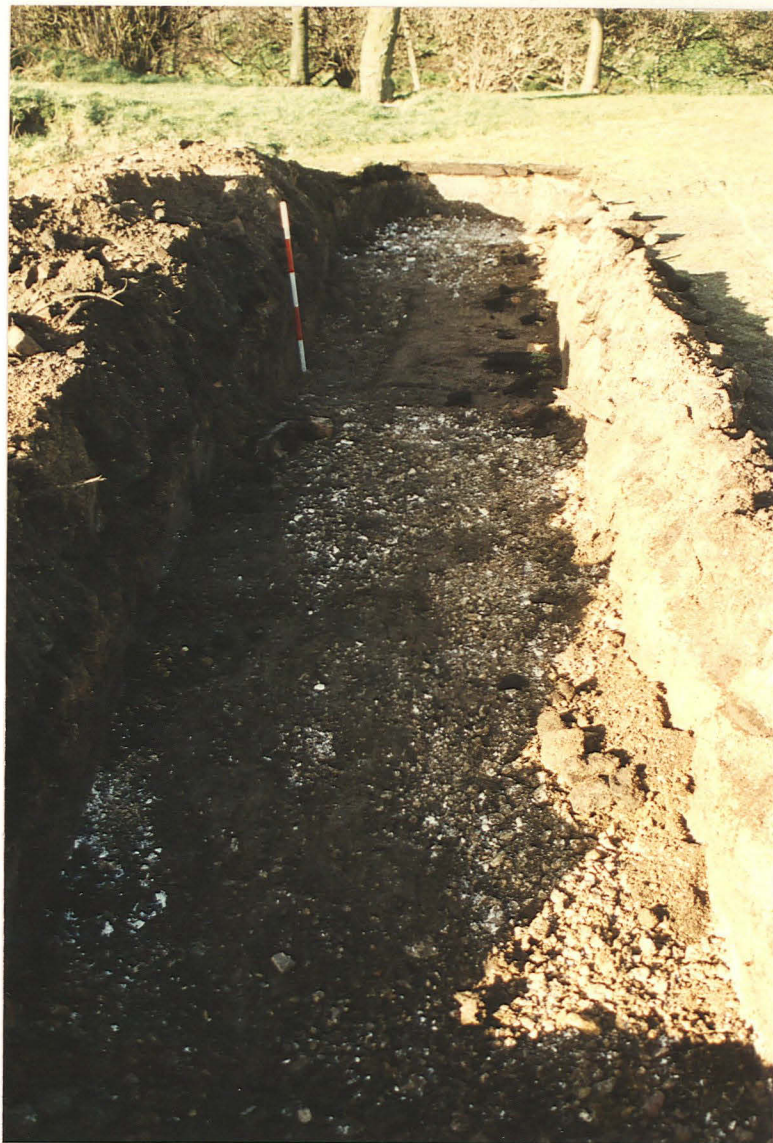
Pl. 4 Loam-filled plough furrow crossing a trench close to the road.
(Looking north; scale divisions 0.2m)

2. A machined trench dug to the north of the grassed area towards the existing hedgeline located a layer of asphalt, gravel and modern tile fragments above an earlier topsoil (Pls. 4-6). There was anecdotal evidence from a workman that this had been part of a long-jump course in the recent past.

Inspection of the trench section located an extensive west-east feature below the topsoil, cut into the chalk. The feature was 1.5m north-south and extended close to the access road. At first this was thought to be a modern service trench or the 'long-jump pit', but it was re-interpreted as a medieval or later plough furrow parallel to the field hedge 8m to the north (Figs. 3 and 4). The hedge includes mature hawthorn bushes and appears to be of some antiquity in its present position. The A1084 road into Caistor is sunken here between the banks on either side and a medieval origin is likely.

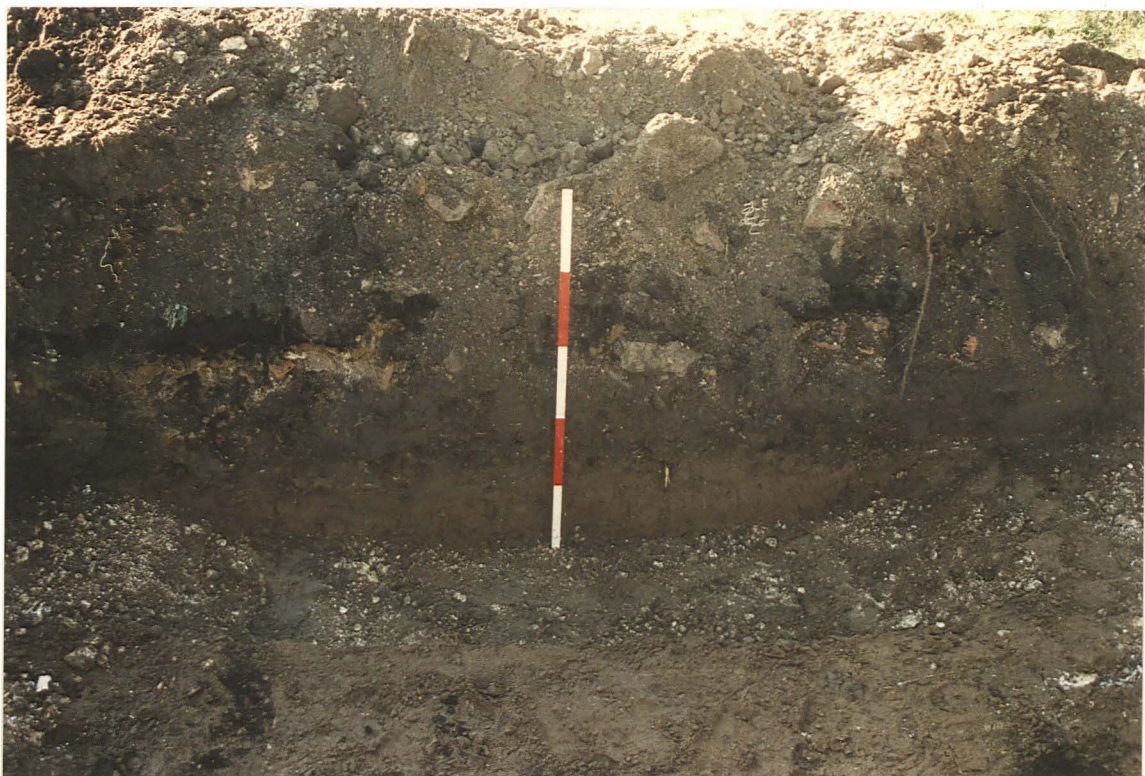
Pl. 5 Section across the plough furrow, showing the layer of rubble
spread over this area after clearance of a long jump course.
(Looking west; scale divisions 0.2m)

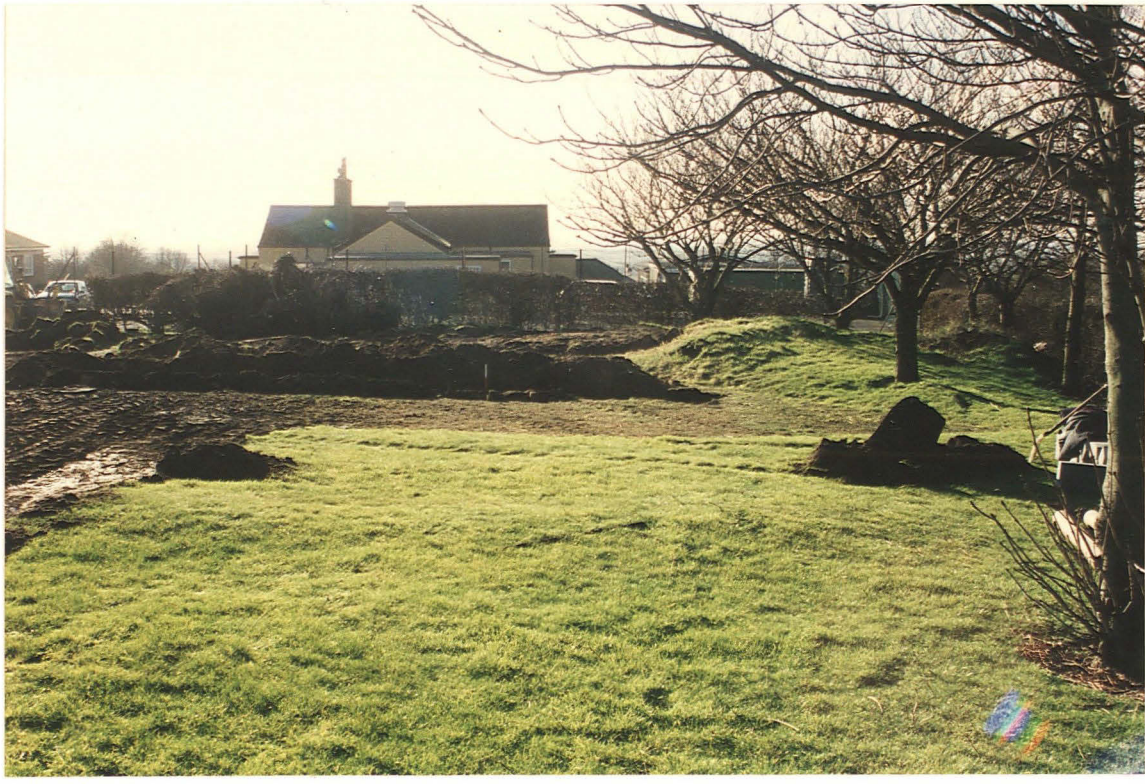
Pl. 6 The site of the Sports Hall Changing Block, with the scale marking the position of the furrow. (Looking west from the access road with the A1084 road on the extreme right)

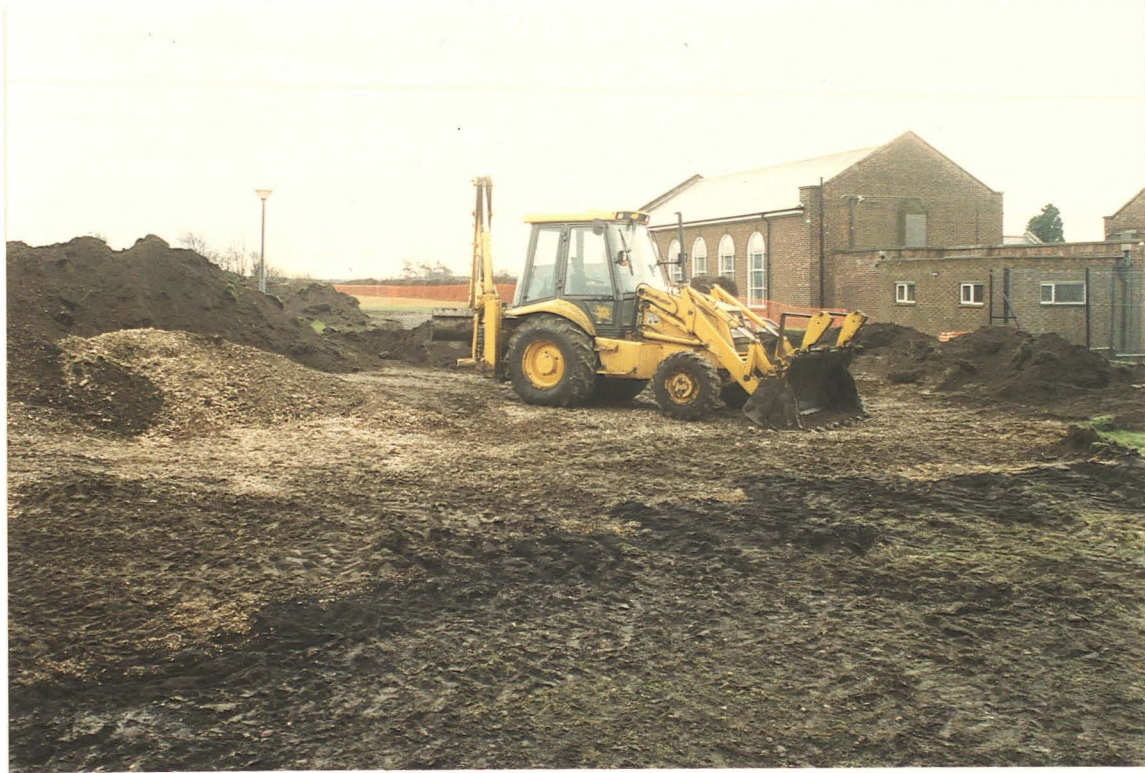
Pl. 7 Stripping of the former tennis court area revealed only previously cleared bedrock cut by a recent service trench (dark material with gravel in the foreground). Looking SE, with compound area fenced with orange plastic.

4. The tennis court area was stripped of asphalt and some clearance of the foundation material took place. This area had been levelled before the court was constructed, by removing soil over the entire area. The anticipated

terracing by burying redeposited soil, protecting part of the area, had not taken place. A recent machine cut service trench represented the only feature below the court (Pl. 7)
