RESULTS OF AN ARCHAEOLOGICAL WATCHING BRIEF: GREYSTONES, 68 ROMAN ROAD, MOULTON CHAPEL, SPALDING, LINCS

PLANNING APPLICATION REFERENCE: H13/0640/04/FULL

Site Code: GRRMC05 Accession No.: LCNCC 2005.57

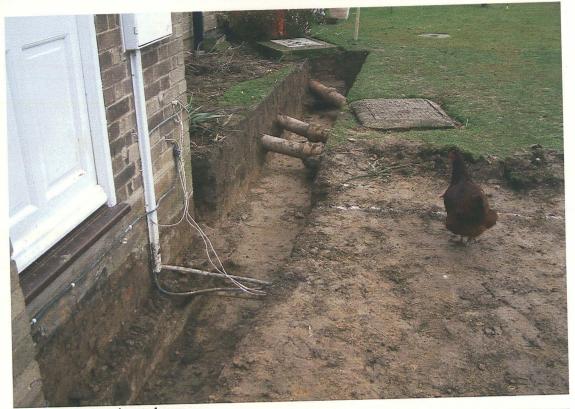
- Plate 1 Footings looking west
- Plate 2. Shot of footings showing mixed re-deposited soil with present drains
- Plate 3. Present services to house
- Plate 4. General shot of footings
- Plate 5. Footings looking northwest
- Plate 6. Showing maximum depth of footings looking north towards old garage
