**RESULTS OF AN ARCHAEOLOGICAL WATCHING BRIEF:
CLAY LANE, CARLTON-LE-MOORLAND, LINCOLNSHIRE**

PLANNING APPLICATION REFERENCE: N18/1196/03

**Site Code: CLCLM 05
Accession No.: LCNCC 2005.73**

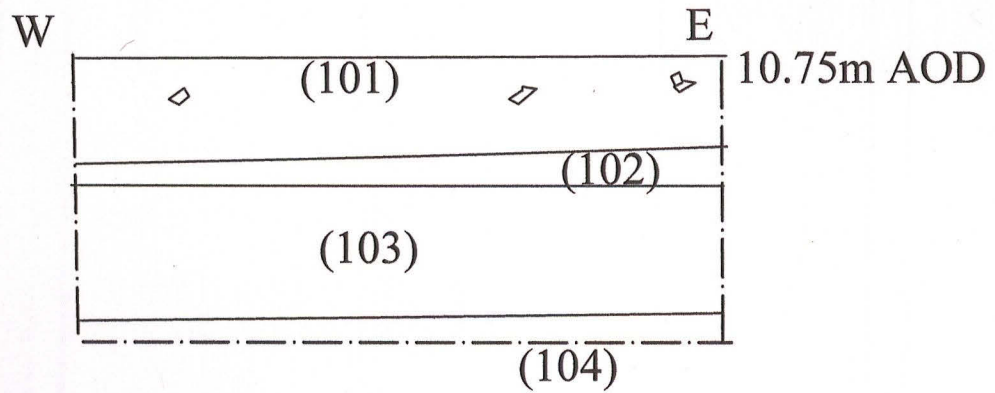
Figure 4. Representative section of footings

M & M Archaeological Services	
Job	Clay Lane, Carlton le Moorland
Title	Watching brief
Scale	As drawn
NGR	TF 490522 357791
Drawn	MG
Date	Aug 2005
Dwg	Figure 3
Site Code	CLCLM 05

Context	Location	Description	Interpretation
101	O/A	Black silty clay loam	Top-soil
102	O/A	Red orange gravels	Iron panning
103	O/A	Yellow brown sandy clay	Natural geology
104	O/A	Yellow green grey silty clay	Pond deposits.

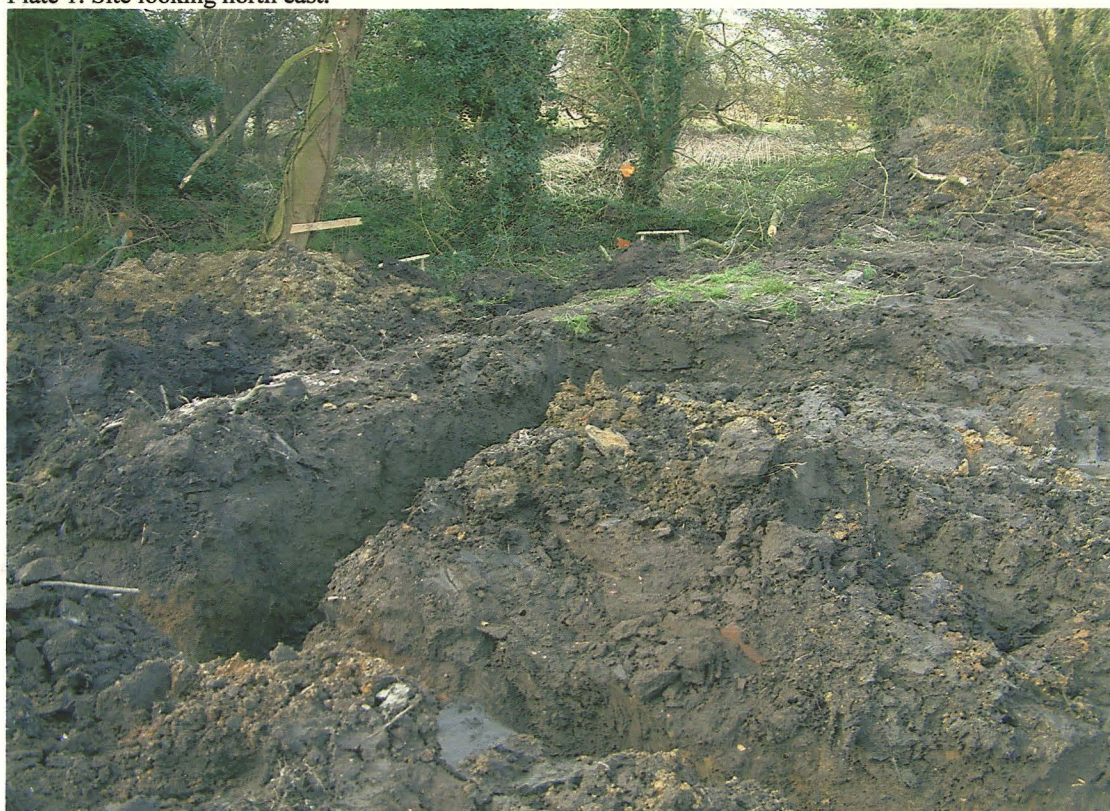
Plate 2. Plot 1 showing area of old pond in north west of site.

6.2 Plot 1 (see Plates 1-4) was excavated to a depth of around 1.2m into yellow green grey silty clay (104) at the western end of the plot. The area appears to have been an in-filled pond and local residents speak of a pond on the site in living memory. A small pond is still in existence adjacent to Plot 1. The remainder of the plot was excavated to a depth of 0.9m into yellow brown sandy clay (103) which was reached at 0.5m below the present ground surface. This was sealed by a 0.10m layer of red orange iron panning (102). The plot was sealed by a black silty clay loam representing top-soil (101). This layer was badly disturbed by construction traffic but was approximately 0.3 - 0.4m in depth. It is possible that this layer had been brought in to fill the old pond.

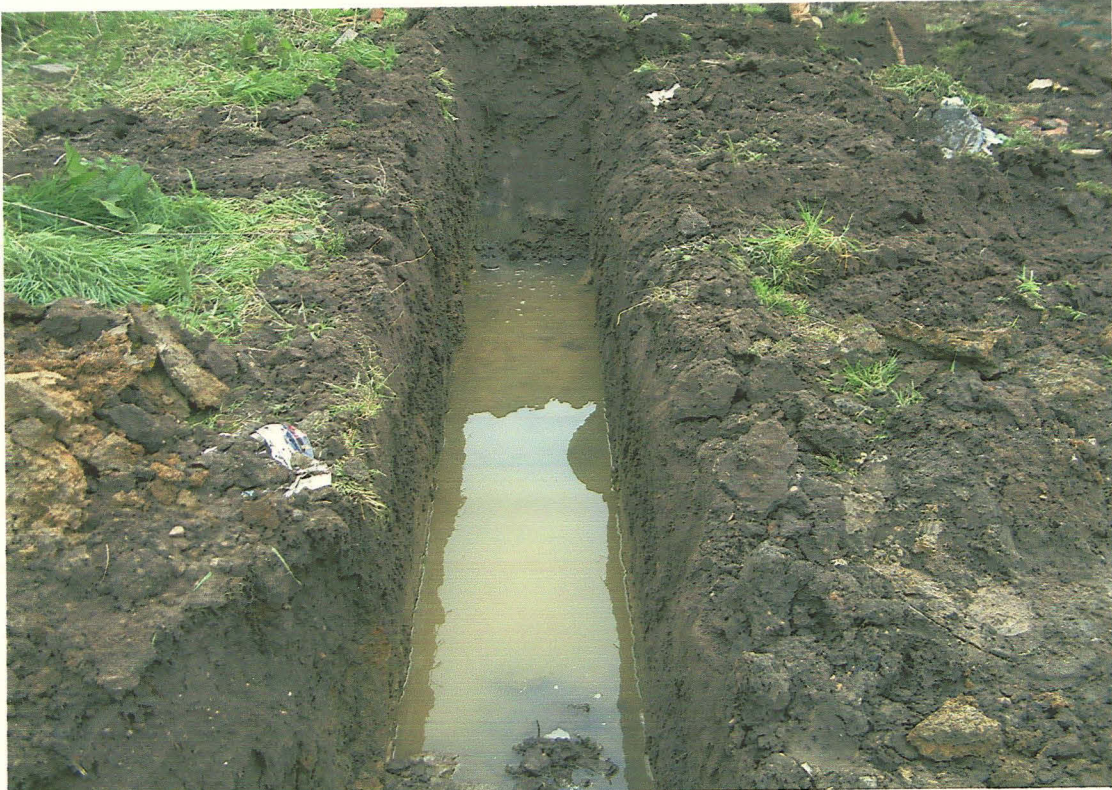
Plate 3. Shot of footings in Plot 1 showing water table.

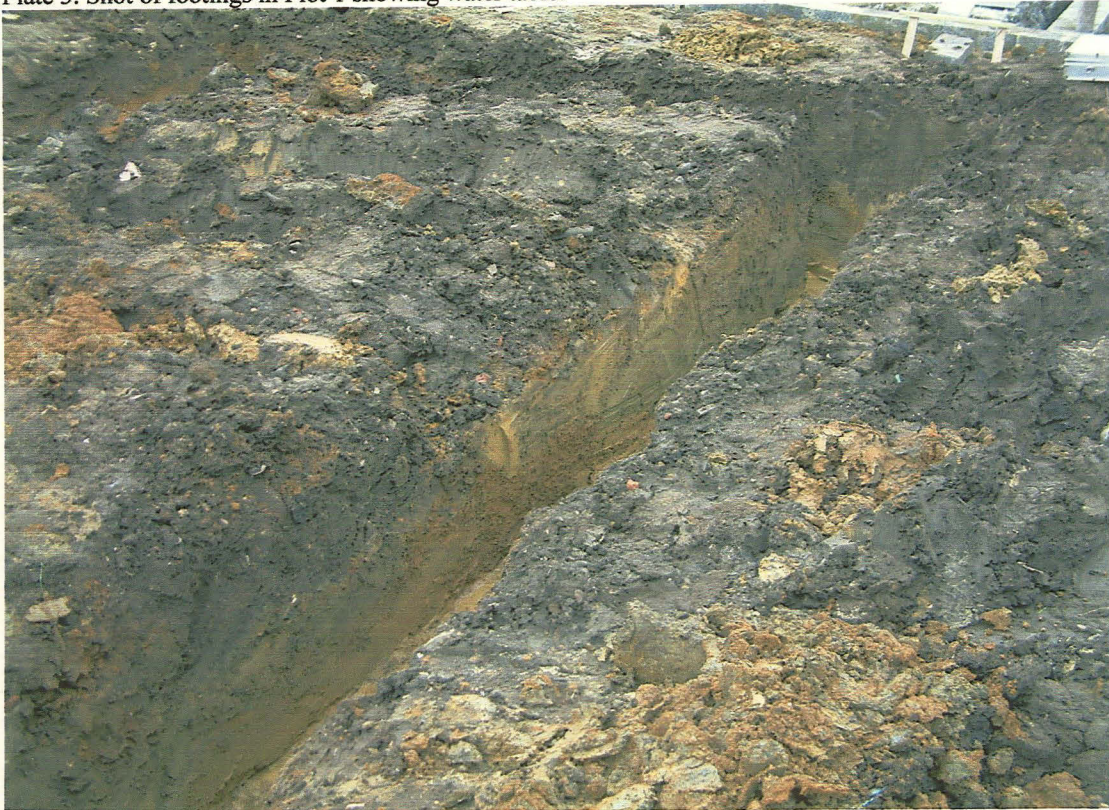
Plate 4. Showing general shot of footings in Plot 1 showing iron panning.

6.3 The footings in plot 1 revealed no physical signs of a previous building although there were occasional fragments of post-medieval brick in the top-soil. Examination of the footings did not reveal any evidence of previous building footings of any kind, but due to the deeply rutted ground surface caused by vehicles during development to the south of the site, it was impossible to interpret features with any degree of certainty.

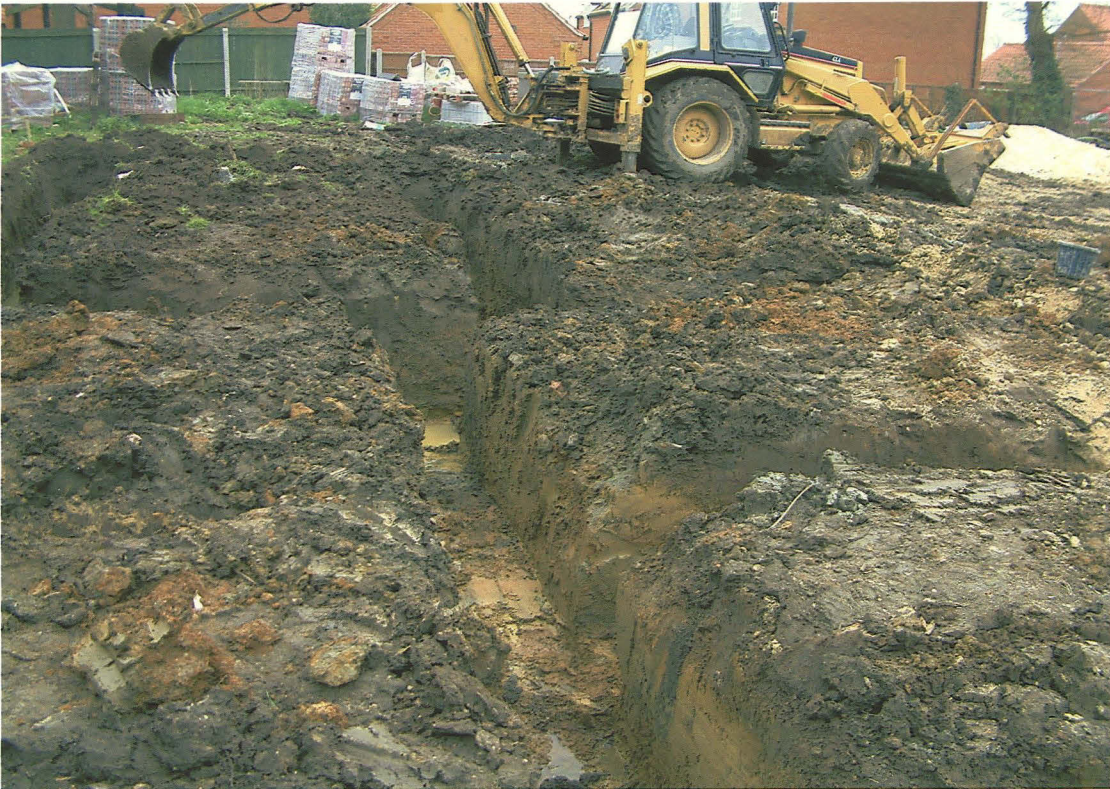
Plate 5. Shot of footings in Plot 2 looking east.

6.4 Plot 2 and 3 (See Plates 4-8) were similar in stratigraphy to plot 1 and both were excavated to a depth of around 1m. The stratigraphy of the plots suggest a probable continuation of the pond. Iron panning deposits were seen in all three plots but it was not a continuous layer. There were no indications of a building in either of the plots in the development. Modern tile and building material was seen in the top-soil covering most of the site but this is thought to have been introduced

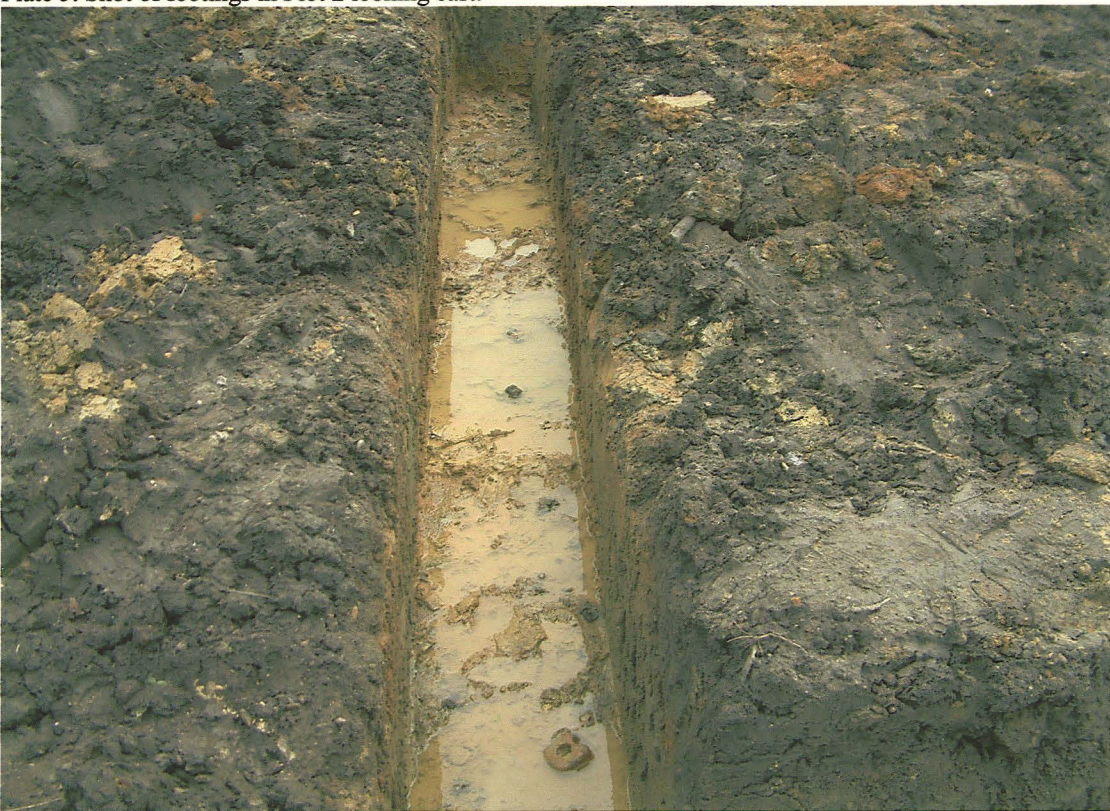
Plate 6. General shot of footings in Plot 2.

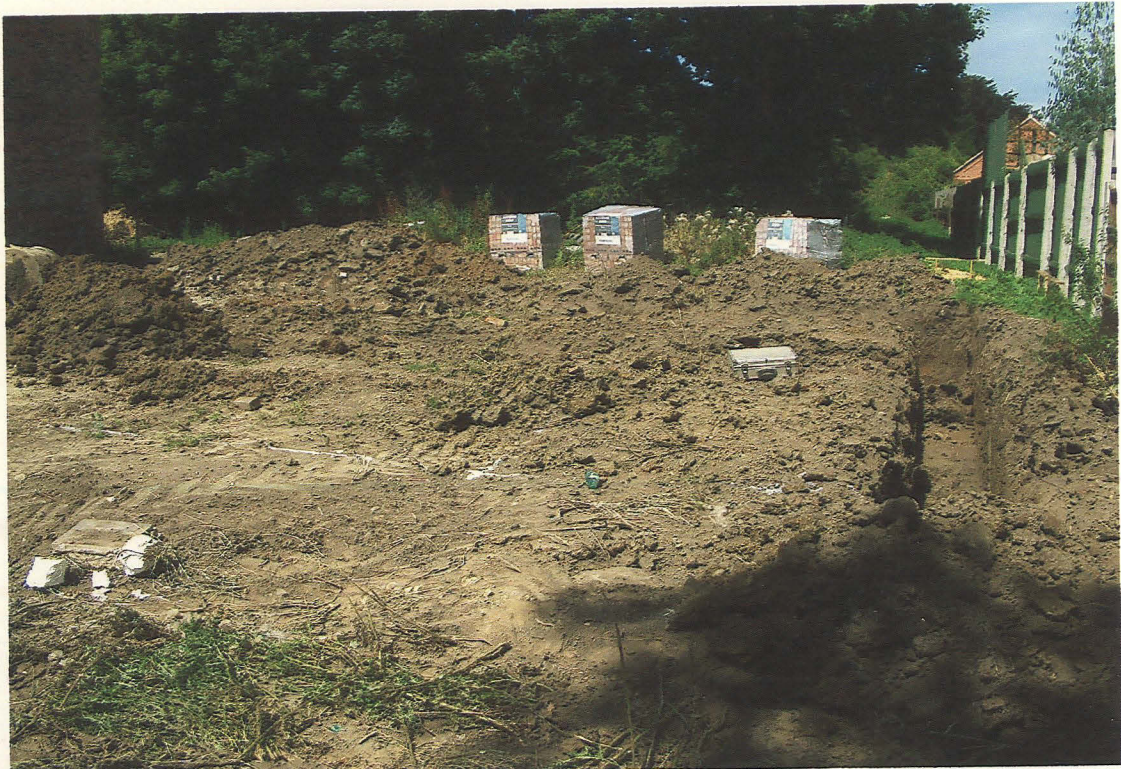
Plate 7. Shot of Plot 3 looking north.

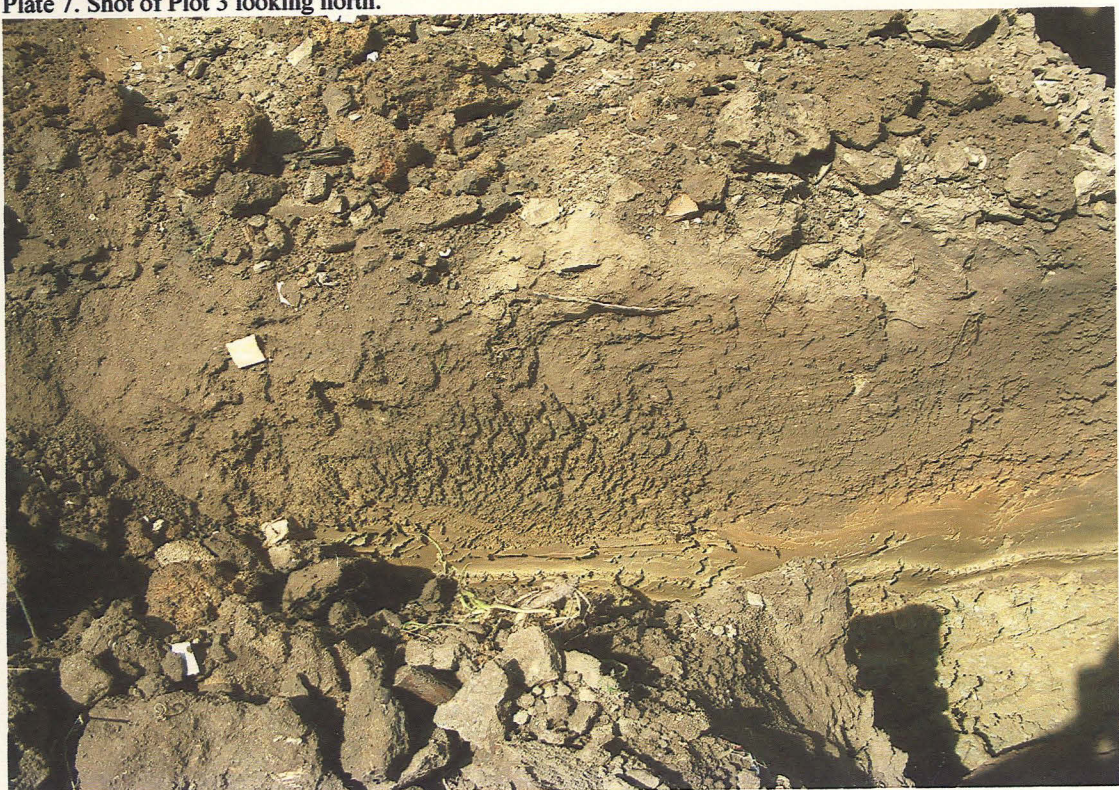
Plate 8. General shot of footings in Plot 3.
