**REINSTATEMENT OF PROTECTIVE
MOUNDS AT BARDNEY ABBEY,
BARDNEY,
LINCOLNSHIRE**

Work Undertaken for
The Jews' Court Trust

February 2008

APS Report No. **20/08**

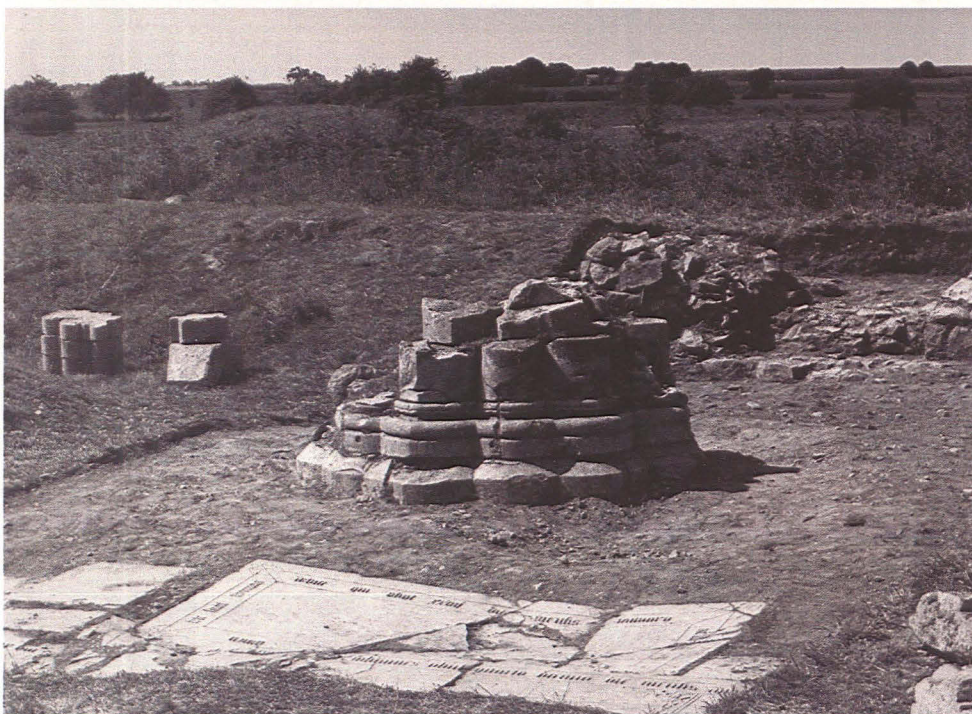
In 1974, a trench was excavated to assess the state of preservation (White 1978, 29). This trench was located over the nave pier (Plate 1), the subject of this report, and across the north wall of the church.

Plate 1 – View showing the exposed pier in the 1974 excavation trench with the graves of Thomas White and an unknown husband and wife in the foreground, looking north.

Brakspear does not include a photograph or plan of this pier, although the adjacent 4th pier is shown. The first record depicting this pier is from the 1974 excavation (Plate 1).

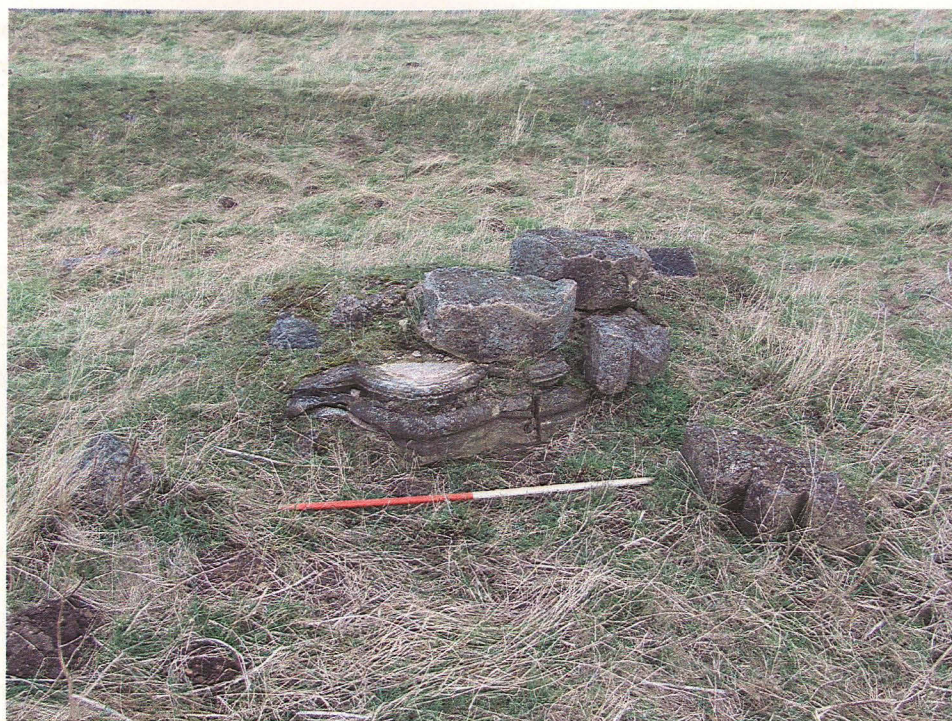
The pier had had suffered damage since 1974 (Plate 2) with nothing but the plinth surviving in its original position. Adjacent to the pier base was a moulded fragment from a doorway, although from where in the monastic complex could not be ascertained.

Plate 2 – View of the pier as found, looking north

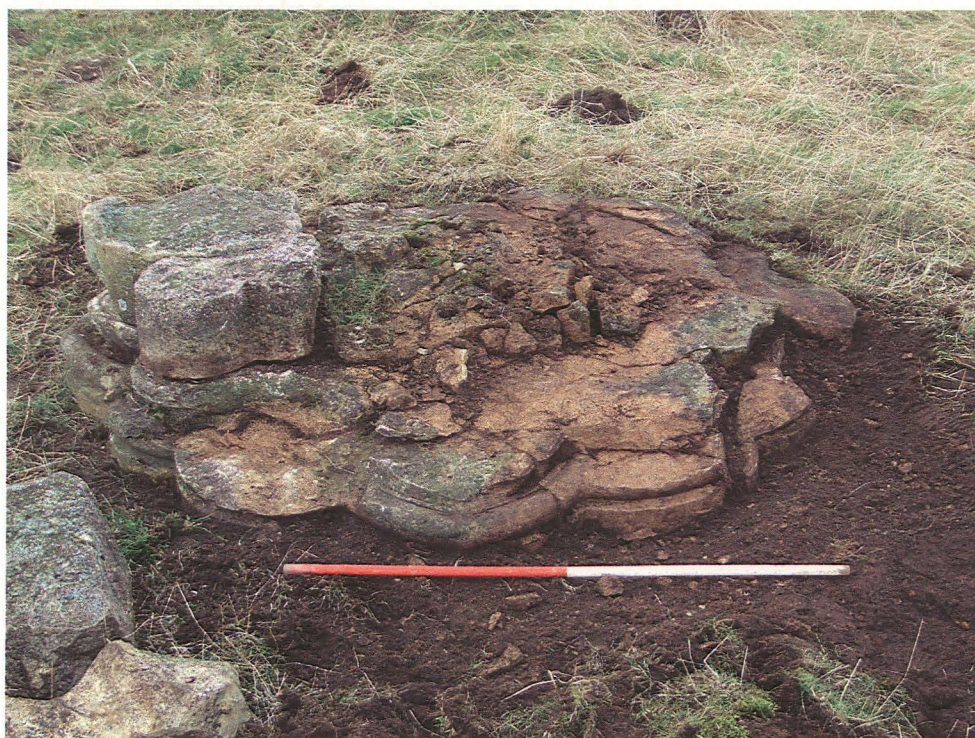
At this stage, all loose stonework was removed along with the soil and remaining vegetation of the protective mound (Plate 3). The stones were cleaned with the exception of the rubble core which was held together by a degraded mortar and quite loose. The damage recorded to the pier was quite significant with the upper mouldings of the plinth absent from the north side.

Plate 3 – The pier base after removal of covering material, looking south

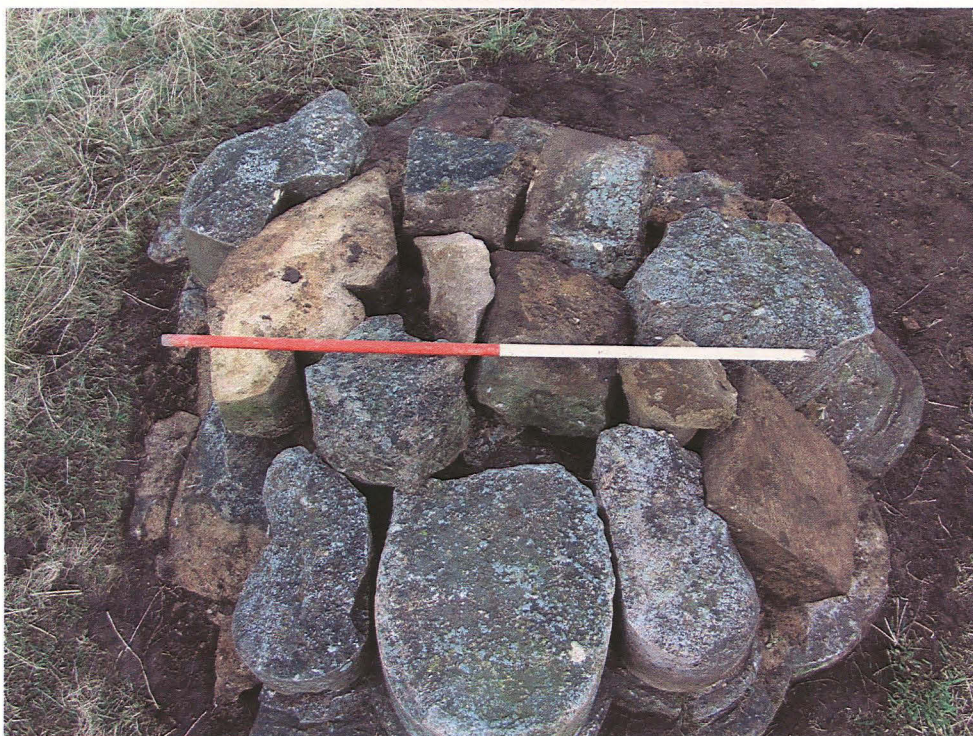
Of the worked stones, only the keeled shaft on the south side of the pier matched with that recorded in 1974 (Plate 1). A semi-circular pier was placed adjacent to this to the east, but was not in its original position as this stone was cracked in the 1974 photograph. An attempt was made to place the remaining stones in, or near, their original position, though with the damaged plinth this was not possible. The remaining worked stone from the vicinity was placed with care to be covered.

Plate 4 – View of the worked stone, showing a number of the semi-circular shafts, the keeled shaft (bottom) and the door moulding, a central roll flanked by arrises with double chamfer (left), looking north

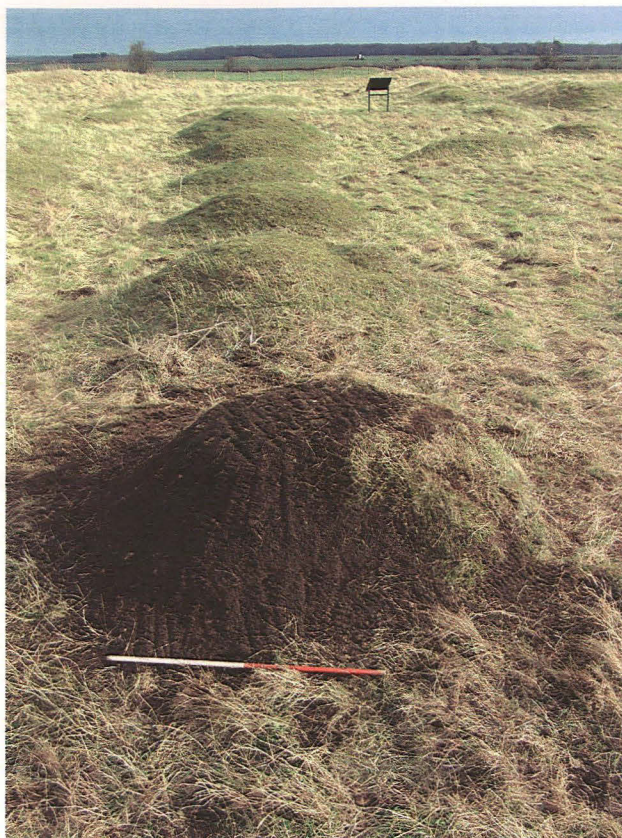
Plate 5 – The reinstated mound, looking east

After ensuring that the worked stones were stable and not liable to slip, the mound was covered with soil and compacted. Turf from the spoil mound was re-used to provide protection to the mouldings and the more exposed parts of the mound and the remainder planted with grass seed (Plate 5). Orange plastic barrier material was then placed around the mound to afford temporary protection.
