Boston, Nos. 11 and 11a Union Street

Archaeological Watching Brief

Site Code BUS 95

Report prepared for Meldrum, Lee and Gillatt

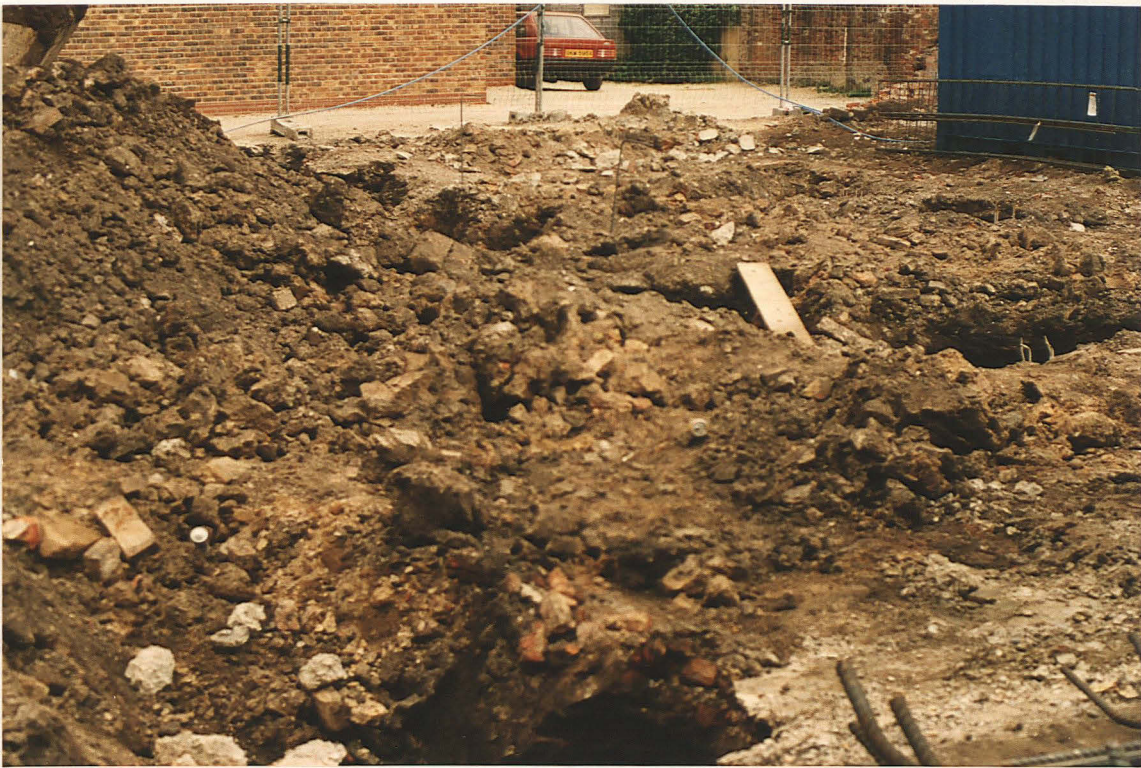
1. When the construction site was first visited on May 10th, much of the plot was found to be badly disturbed by irregular holes machined around the cap of each pile location in order that steel could be attached to the pile (Pls. 1 and 2). Various of these excavated holes had been backfilled to allow machine access to other parts of the site and the resulting surface was uneven and contaminated. The site had become dissected into numerous small islands of undisturbed stratigraphy and it proved impossible to link observations in the various holes and trenches reliably. Short lengths of brick wall footings and cellar walls were identified in several places and these have been marked on Fig. 5. It seemed probable that most, if not all, of these foundations were from the buildings most recently demolished on the site (Pl. 3). A collection was made of visible but unstratified pottery, all of which was post-medieval or modern (Appendix 1).

Pl. 1 Site conditions on 11 Union Street at the start of the watching brief (looking NW to rear of 13)

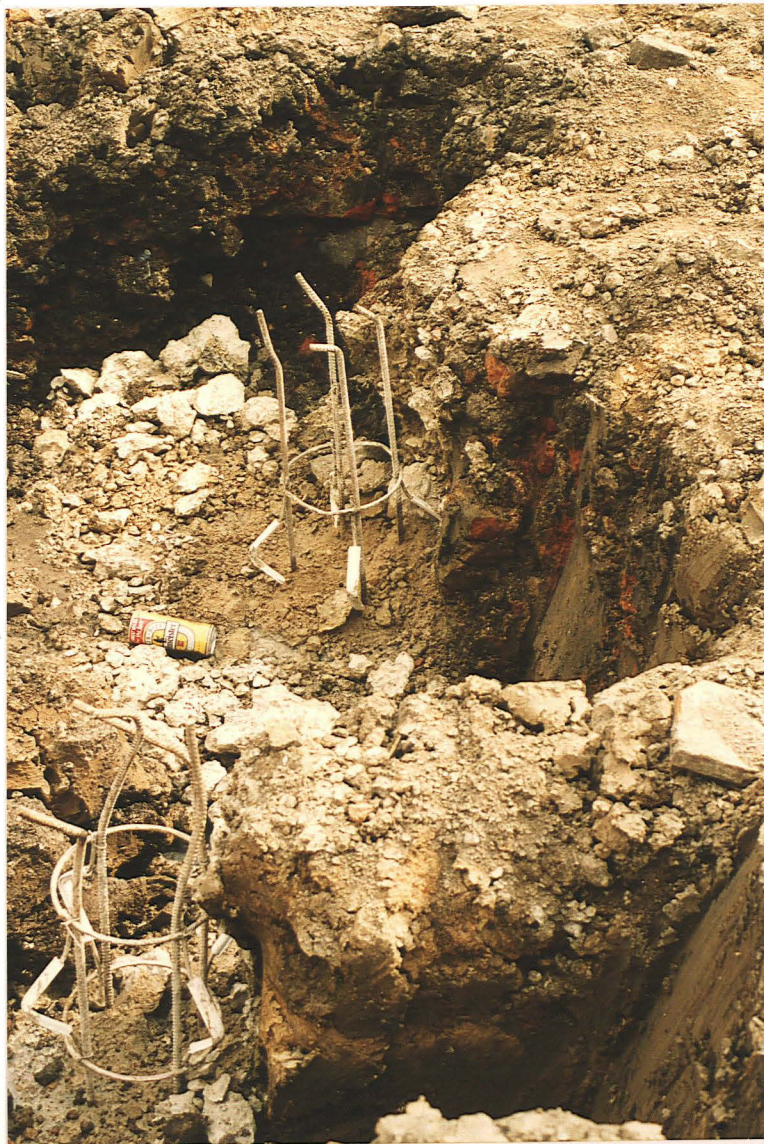
3. At the rear of the plot, close to Pile 3, a concentration of ash was noted apparently associated with two brick walls (Fig. 5). The brick dimensions were 230mm x 105mm x 65mm. The concentration was interpreted as a 19th century brick-lined cesspit.

Pl. 2 Holes dug around Piles 14 and 18, revealing brick walls of cess pit or cellar

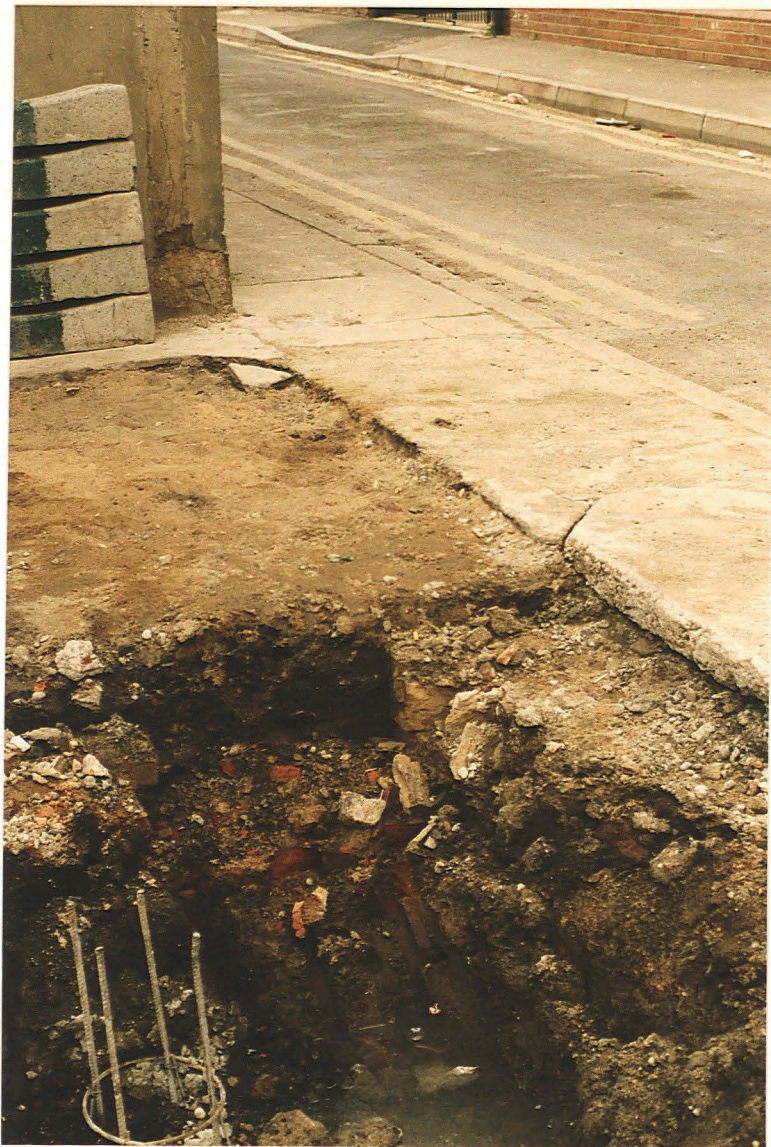
The mechanical excavation of the ground beam trenches was complicated by the open holes or by loose material where they had been backfilled. Ground conditions for archaeological recording over most of the area were poor, amidst minor collapses of trench faces and standing water.

Pl. 3 Hole beside Pile 12, showing brick wall foundation and level of standing water (looking east onto Union Street)

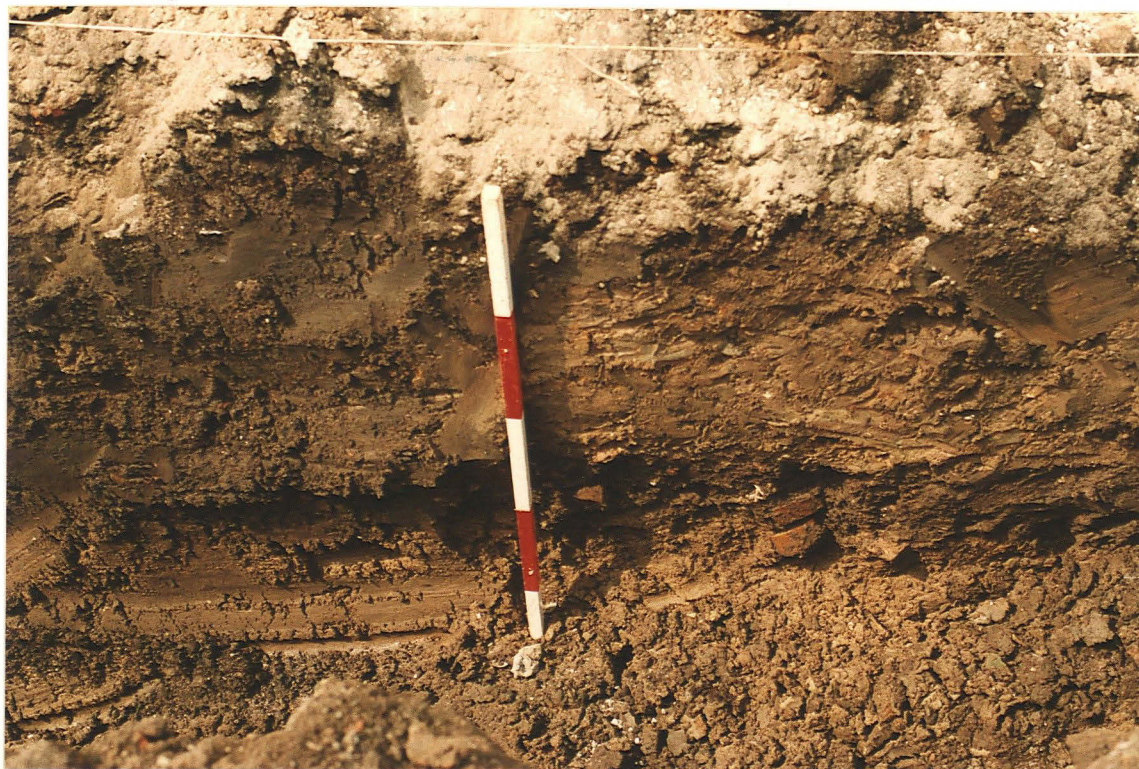
4. The recently demolished brick boundary wall at the western edge of the construction site had a foundation extending to 0.3m above the trench base (c. 0.95m below existing ground level). The 19th century foundation had cut into a deposit of dark brown clay loam containing medieval pottery together with mortar and brick fragments (Figs. 5 and 6; Pls. 4 and 5). The finds were made from a distinct layer which was traceable for at least 3m along the NW-SE trench; it was not from a rubbish pit and may represent a late-medieval ground surface. The pottery identification has suggested a date between the mid 12th and late 13th centuries (Appendix 1).

Pl. 4 Stratigraphy to south of Pile 1, with pottery sherds visible in a dark layer (Context 4) close to the trench base. The thick overlying layer may be post-medieval reclamation. (Looking west; scale divisions 0.2m)

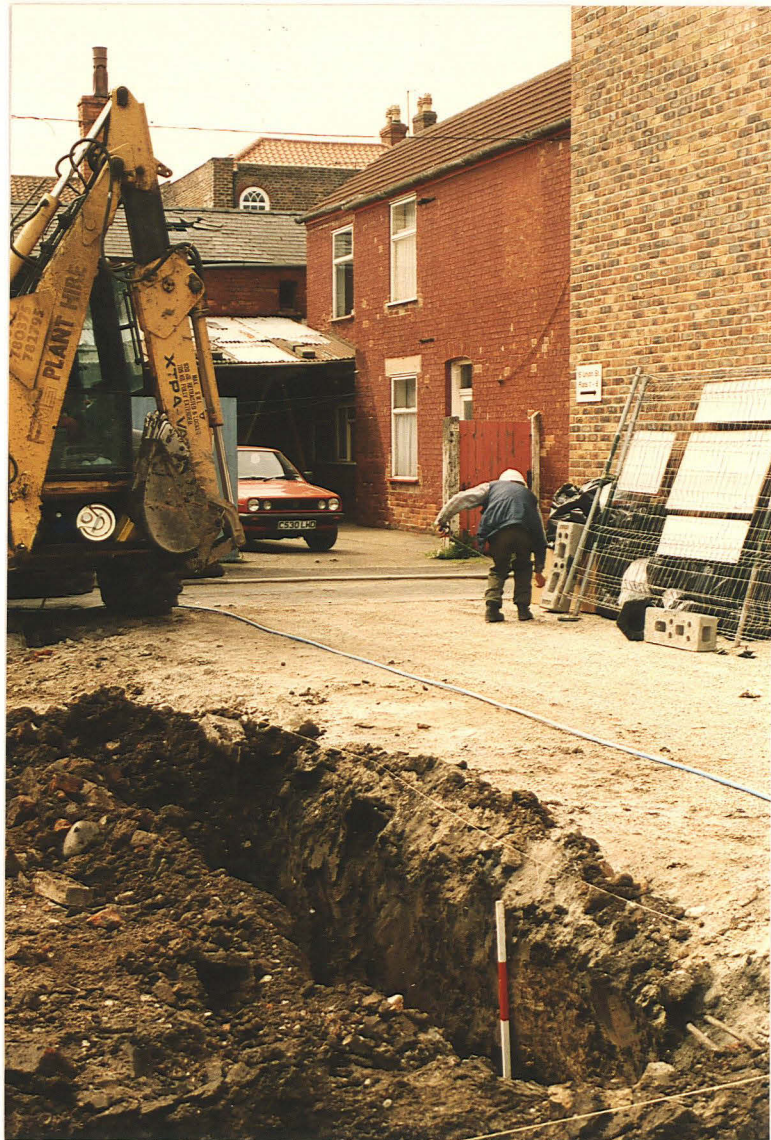
Pl. 5 Location of Context 4 on the western edge of the plot. (Looking SW to Union Street)
