**ARCHAEOLOGICAL WATCHING BRIEF
FOR A DEVELOPMENT AT
ST NICHOLAS CLOSE,
BOSTON,
LINCOLNSHIRE
(BNC94)**

Work Undertaken For
Chestnut Homes

September 1995

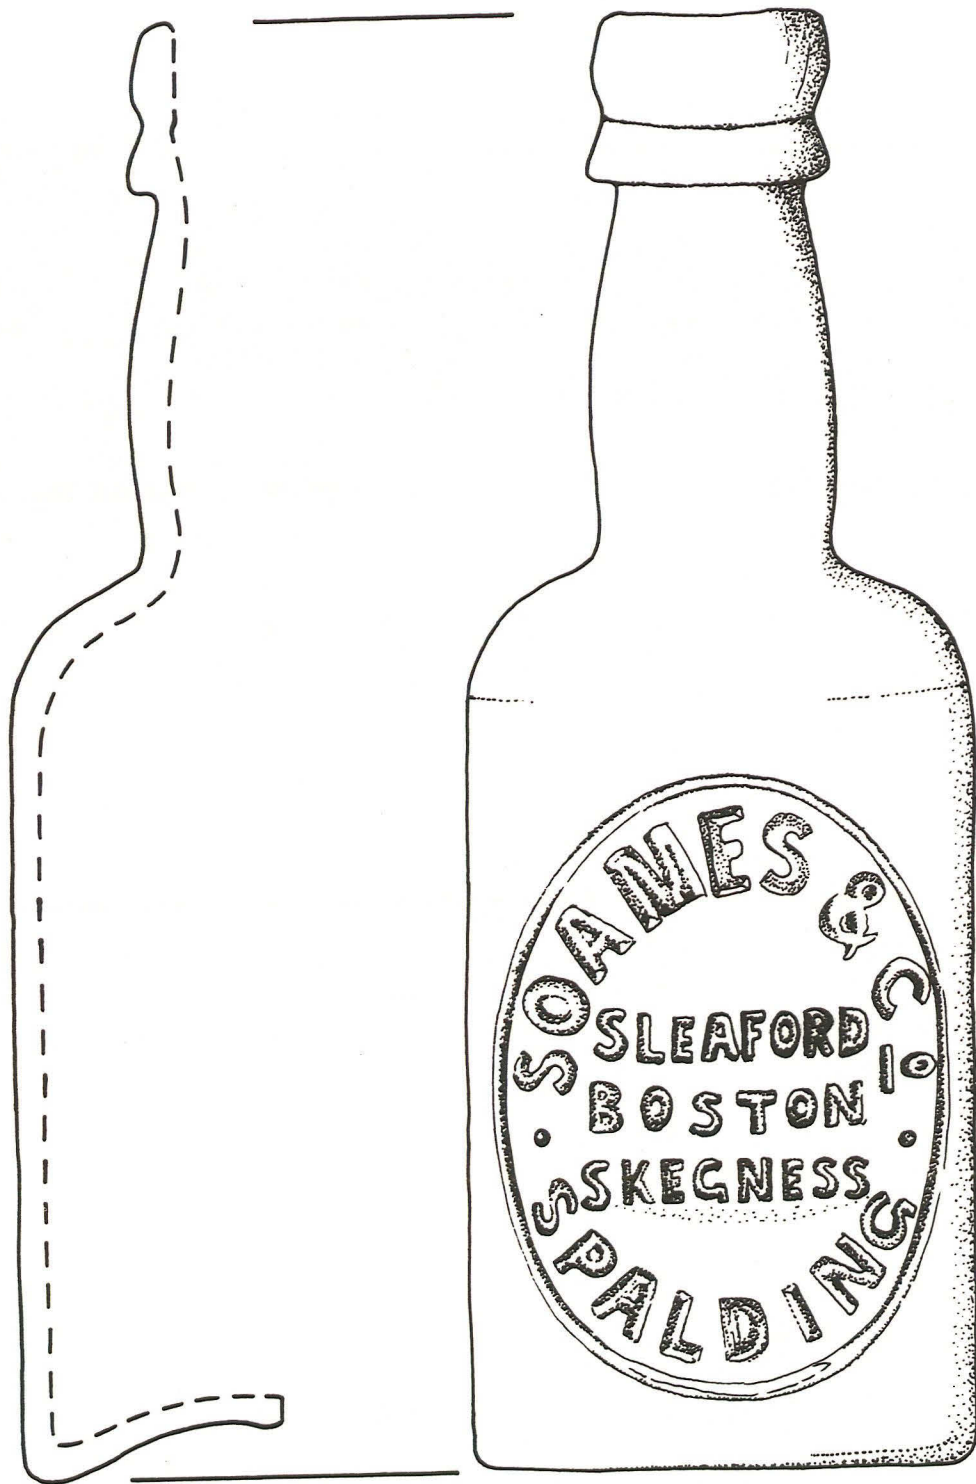
Fig. 10 Glass Bottle

Soames and Co were a brewery operating from Spalding in the late 19th century and early 20th century.

intermingled with dumped deposits, some of which are associated with rubbish dumping. Most finds including the bottle (Fig. 10) were retrieved from these layers. Above these are deposits associated with the use of the site as a timber storage warehouse. Services, in the form of drainage were readily apparent across the development area.

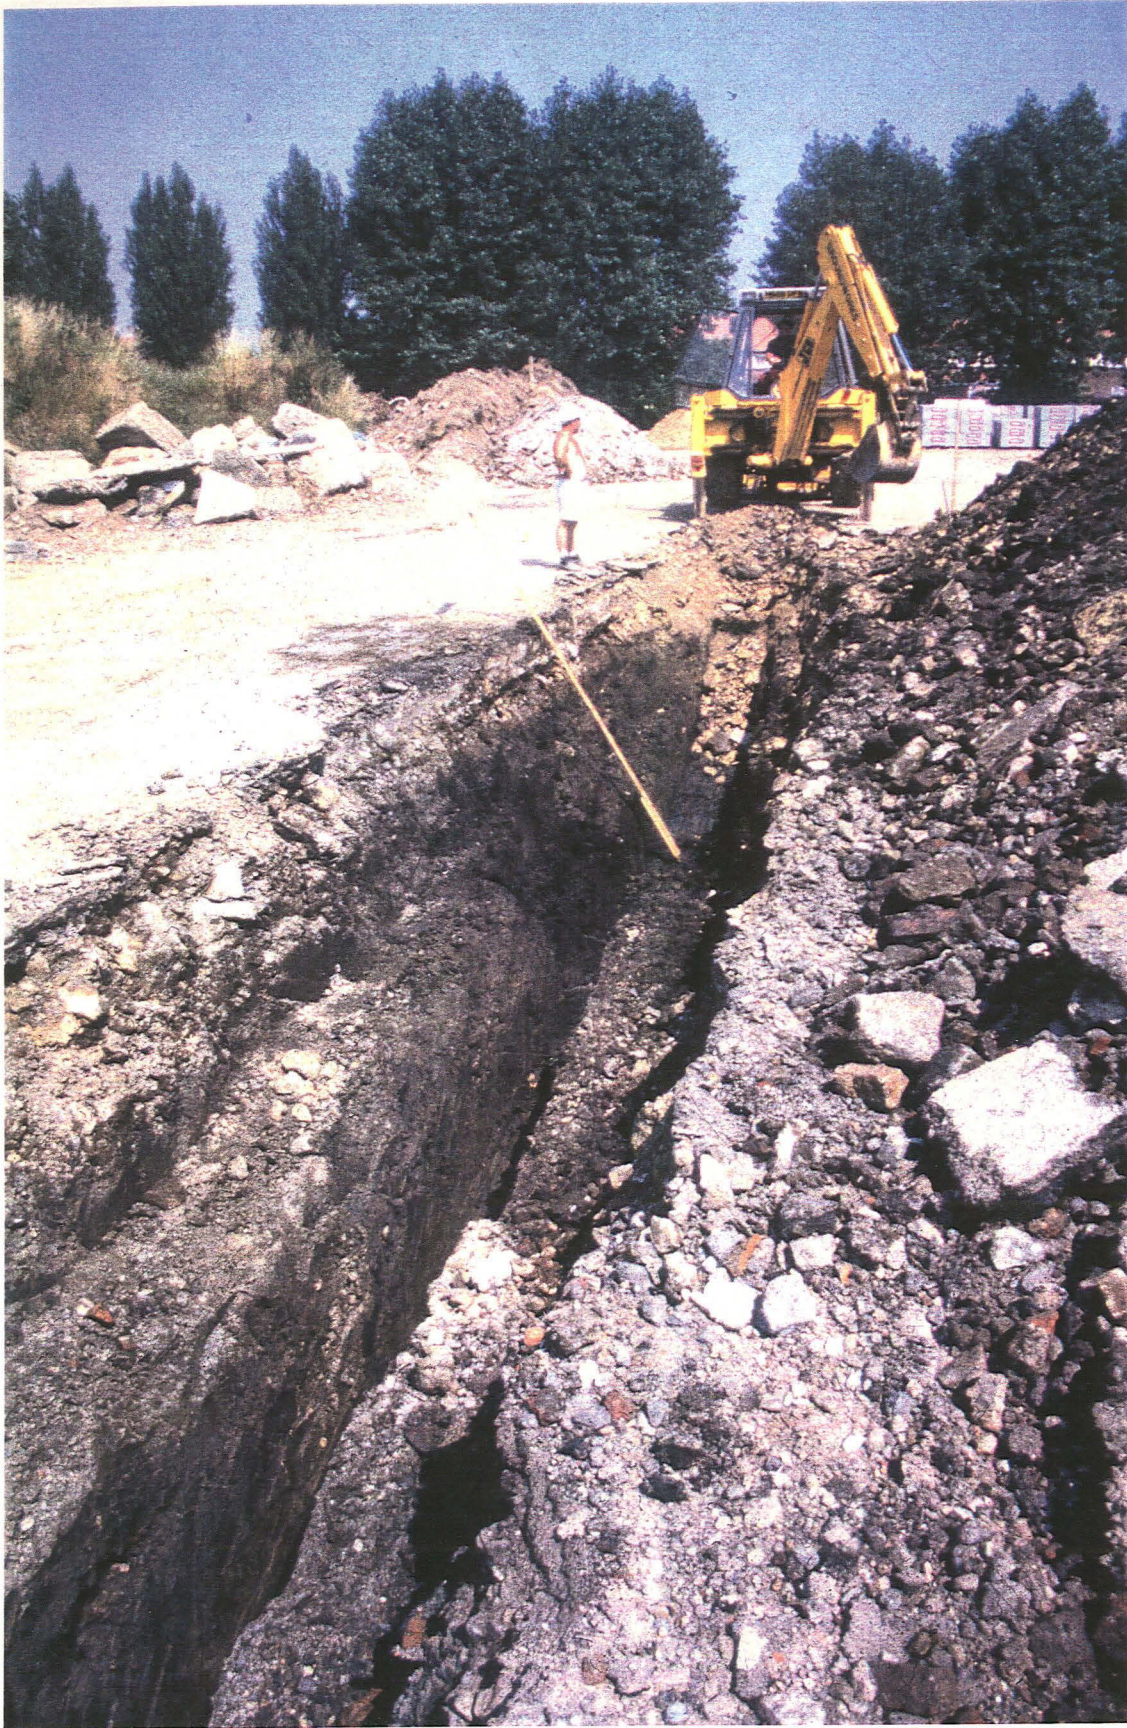
Plate 2. View along Drainage trench, looking North

Cutting group 1002, in plot B, were two linear features (Group 1001 and 1009). One (1001) measured 0.6m wide and 0.4m deep and aligned northeast to southwest, no length was ascertained. The other (1009) was orientated north to south and was 0.3m wide and 0.45m deep. They both contained a ceramic pipe and gravel fill and were identified as cuts for drainage pipes.
