**ARCHAEOLOGICAL WATCHING BRIEF
OF A DEVELOPMENT AT
9-17 BRIDGE STREET,
HORNCastle,
LINCOLNSHIRE
(HBS94)**

Work Undertaken For
Heritage Trust of Lincolnshire

September 1995

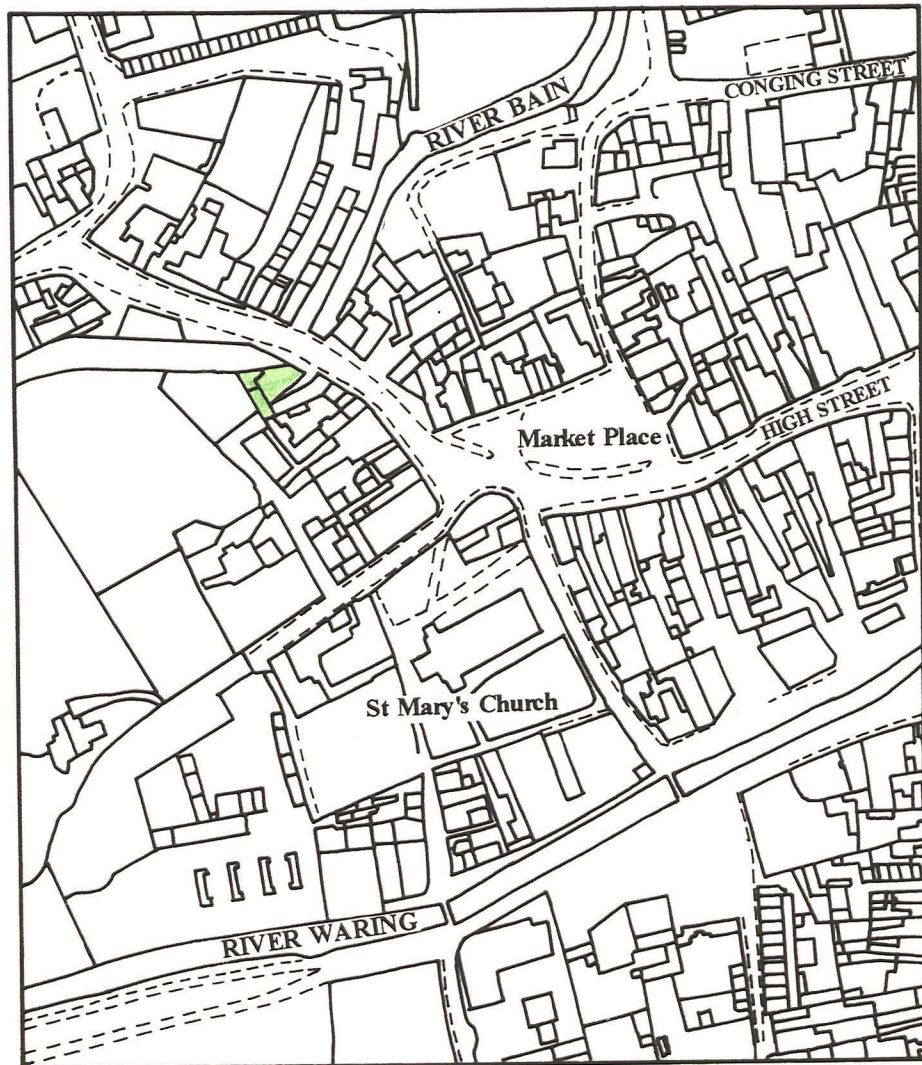
Fig. 3 Location of Trenches

Area of Development
