**Dunholme St Chad's Church
Archaeological Appraisal**

**LAS Report 1065
July 2008**

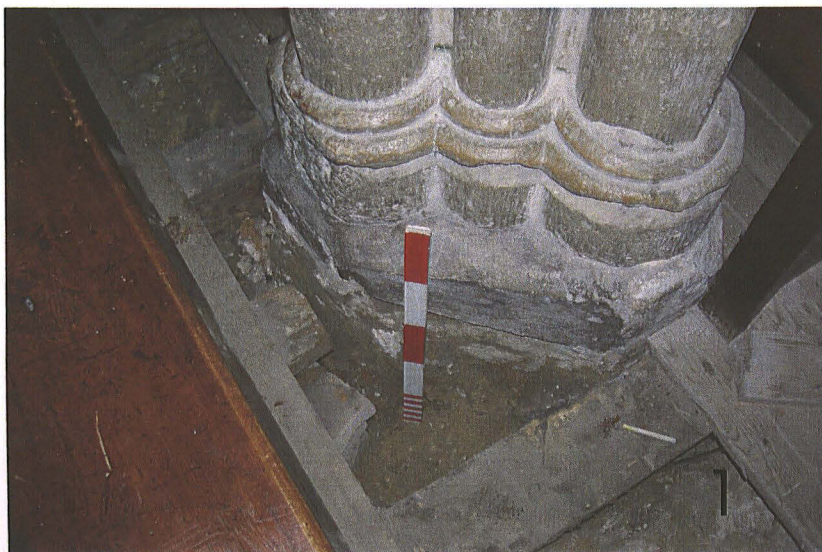
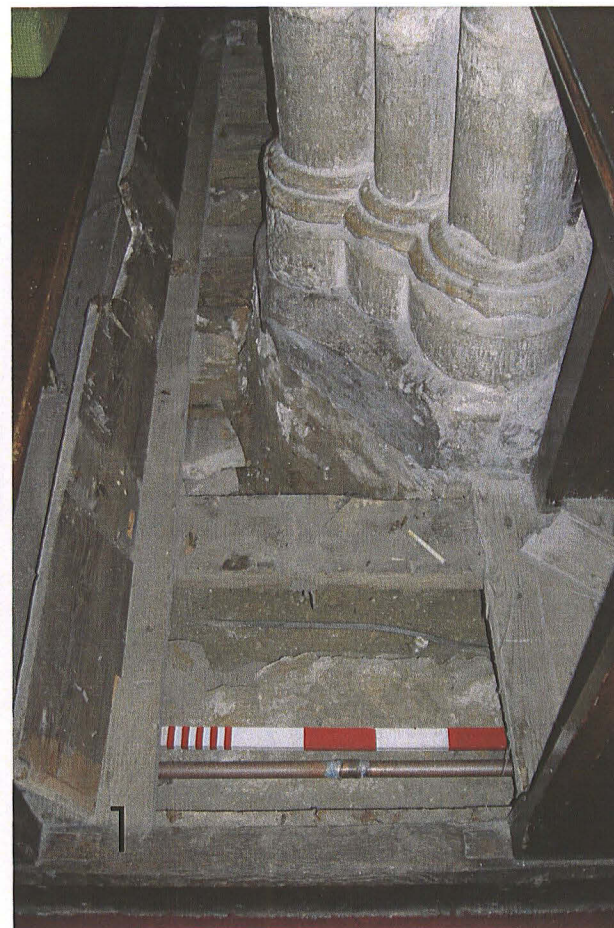
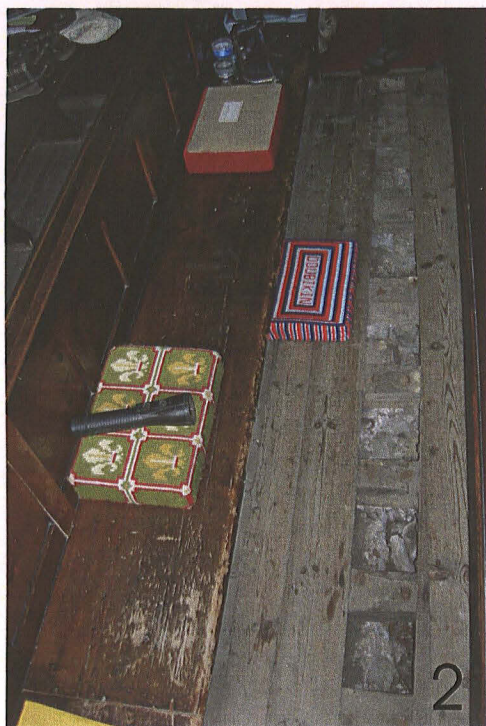
The void beneath the platform is 0.10m beneath the south aisle floor and 0.25m beneath the existing flagstones of the nave. Stone sleeper walls run along the north and south sides of the platform area and a brick cross wall which supports the pew platform joists that run W-E. (The joists appear to be reused timbers, possibly from the roof but they are not of any great age. Some beetle infestation was noted but the author is not qualified to state if this is current or old.)

The surface exposed beneath the pew platform is undoubtedly the remains of the old nave floor which consisted of a dry friable mortary material. This may have been the base for tiles or flagstones, long removed. Burials are likely to be present. Burial inside churches continued into the 19th century and there was no requirement for bodies to be buried 6' under. There are many excavated examples of shallow burials inside churches. Lincolnshire examples include Rand, Horncastle and Barton on Humber.

Dunholme St Chad's
Void beneath south west pew platform in two locations as shown on
Fig. 1 . Scale 0.50m

Option 1: Wooden floorboards over a concrete foundation to finish flush with the existing floor. The concrete base would have to sit on a layer of hardcore. Reduction of the floor levels encountered beneath the pew platform would be necessary, and would require archaeological excavation of the floor to the required level.

Option 2: Flagstone floor. This would also sit on a hardcore base but the total depth required would possibly be less than that for Option 1, and would result in less archaeological intervention.
