## **Swinhope Underground Electric Cable**

## **Archaeological Watching Brief**

**YORKSHIRE ELECTRICITY GROUP PLC**

**October 1995**

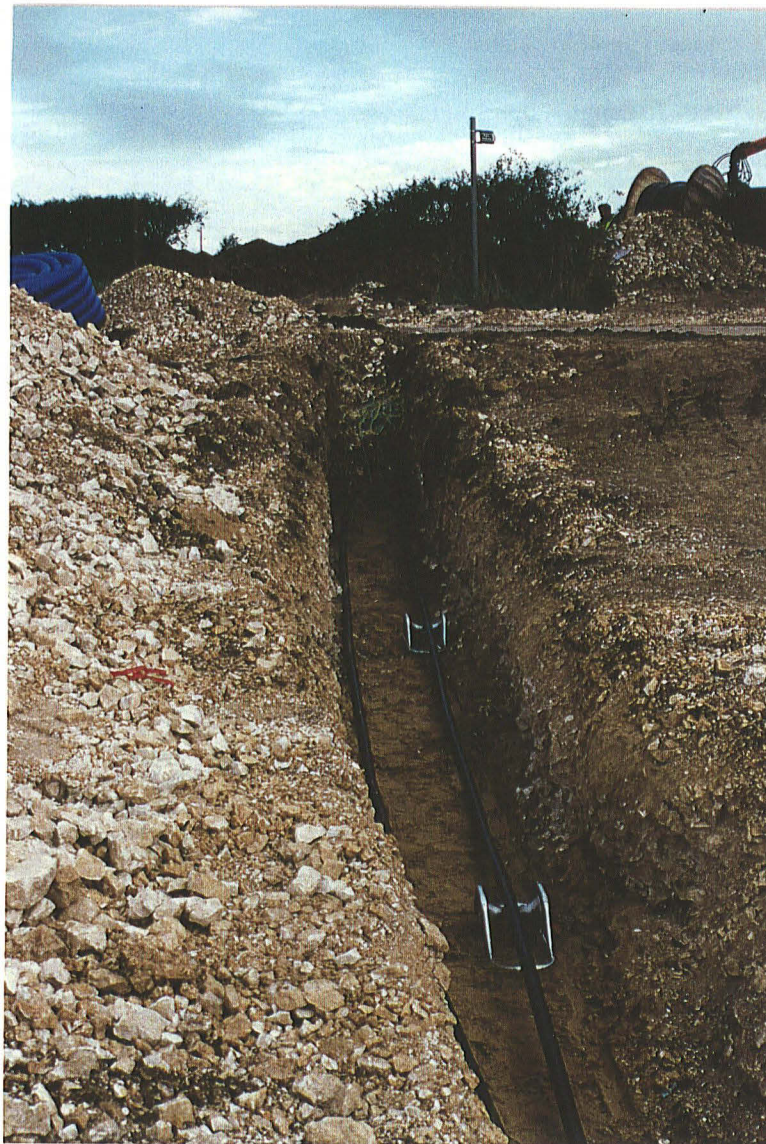
Pl. 1 North end of cable trench at junction with the road from Thorganby. Shows ducting under the road, the sand bedding and the two cables in position.

1. Chalk bedrock present beneath the topsoil and subsoil cover (Pls. 1, 2).
2. Chalky red-brown clay hillwash from the hill slope (Pl. 3, Pl. 5, background).

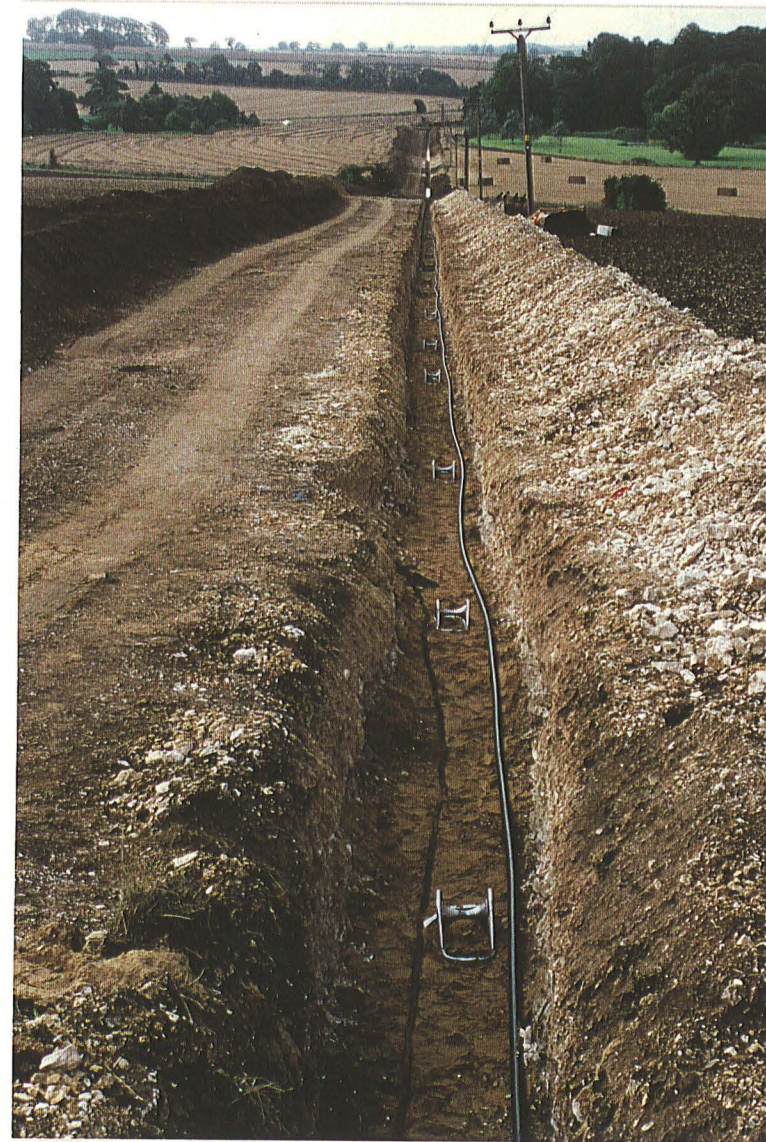
Pl. 2 General view of cable trench looking south across the valley from the Thorganby road. The chalk bedrock (1) lies immediately beneath the stripped topsoil.

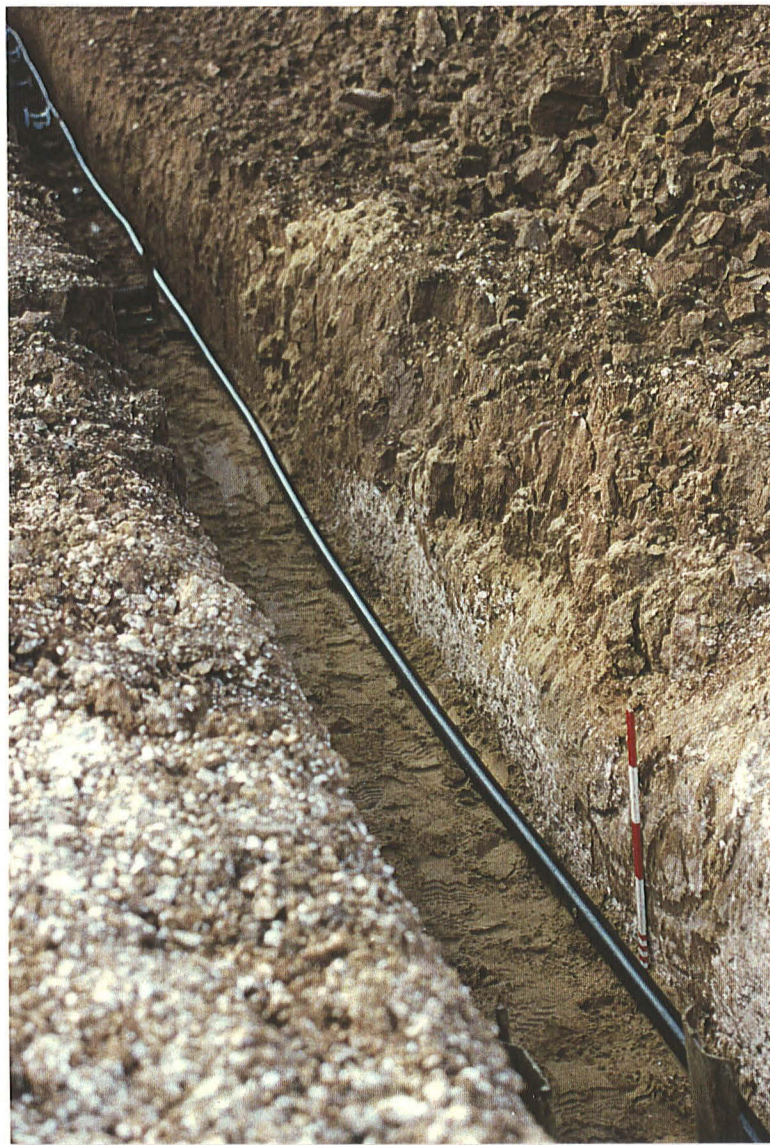
Pl. 3 Junction of hillwash (2) and bedrock, north of the stream, near valley bottom

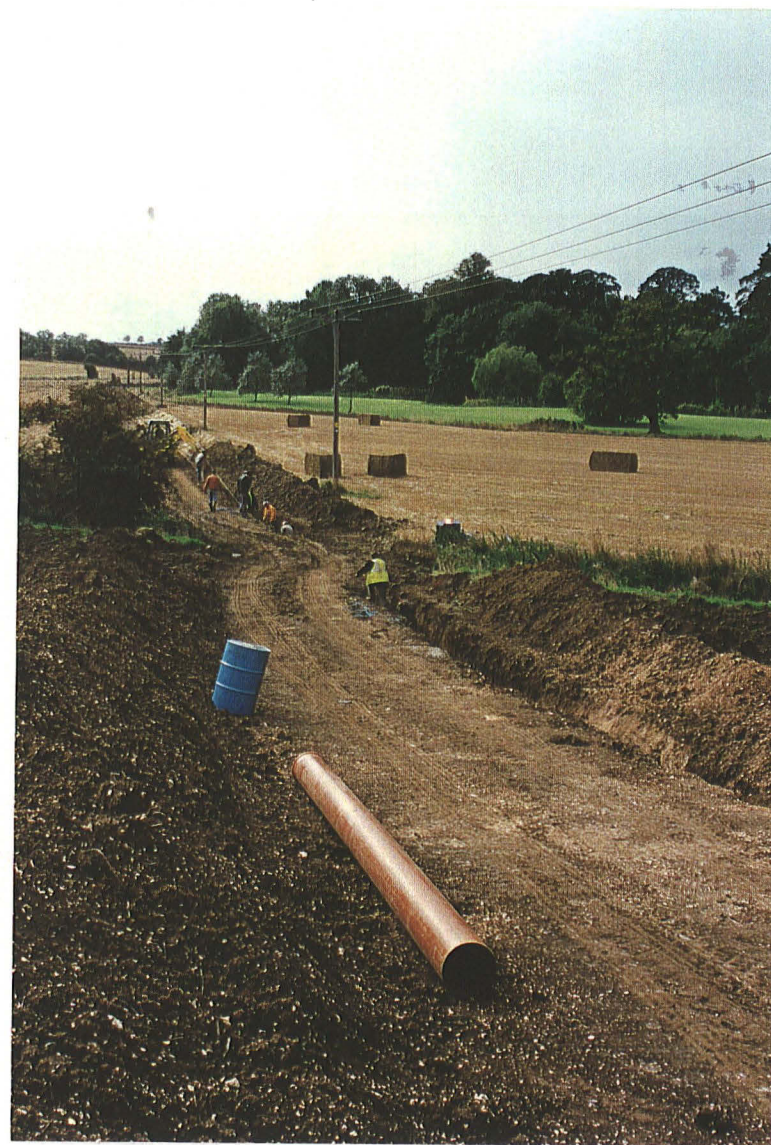
Pl. 4 Cable laying beneath the stream in valley bottom. Flood zone (3) marked by dark spoil to either side of the stream.

3. The glacial valley is cut through by a post-glacial stream. The flood silts are interleaved with the hillwash (Pls. 4, 5,6) .
4. South of the stream the flood silts deposits overlie banded layers of fine chalk pebbles (Pls. 5,6,7).

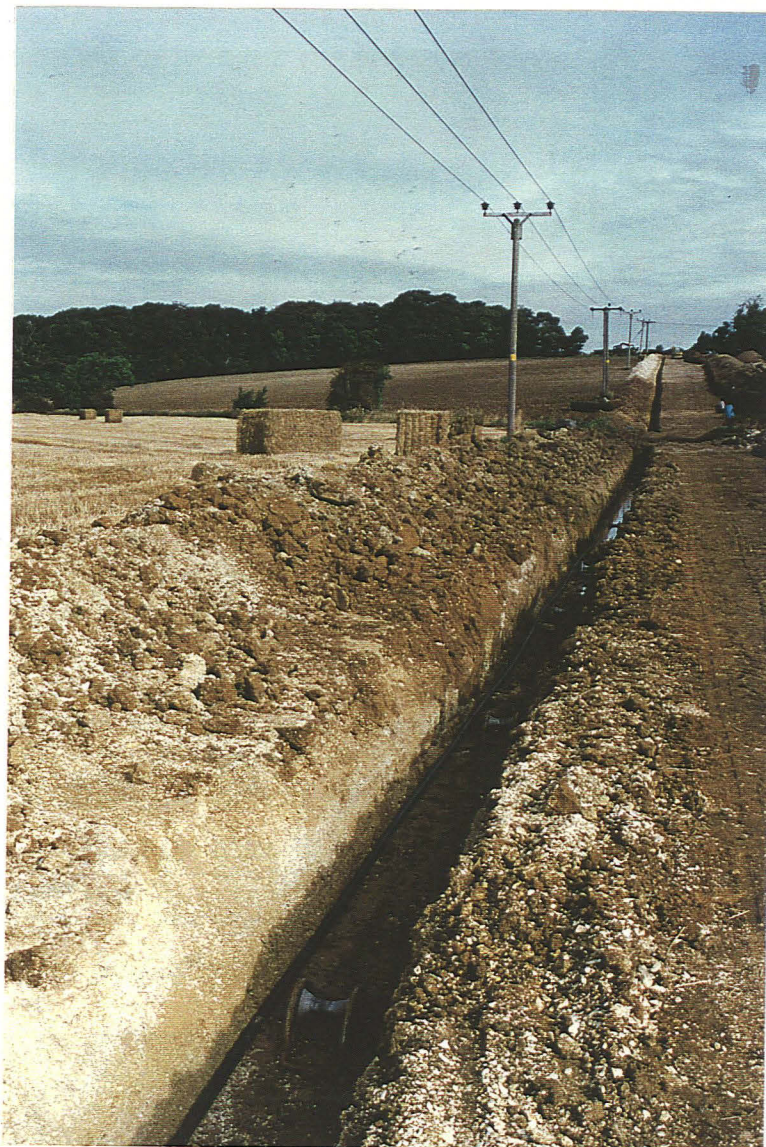
Pl. 5 General view from valley bottom looking northwards up the hill. Foreground shows junction of flood silts, 3, on south side of stream with chalk gravel

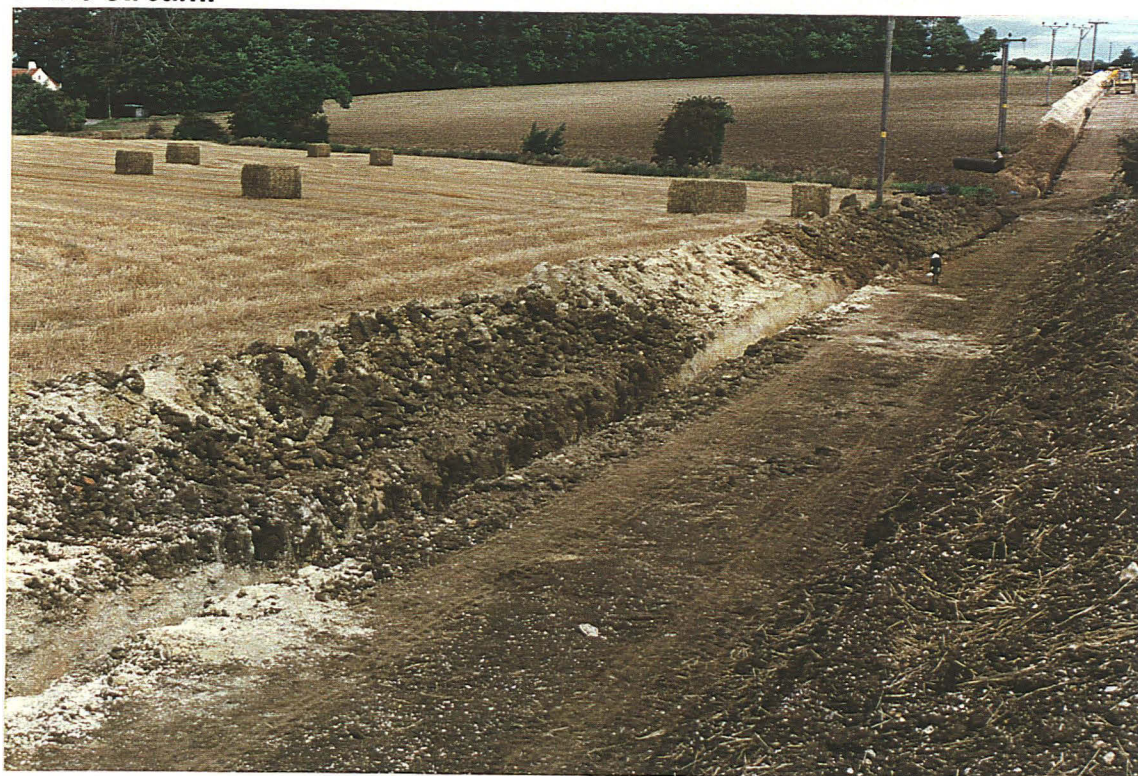
Pl. 6 Localised deposit of silty clay (5) overlying the chalk gravels(4) south of the stream.

5. Isolated patch of grey silty clay extends for 18m along the trench. Fills a low dip in the ground. Overlies 4 (Pl. 6)
6. As the trench passes parallel to an open drain further silts and clays are present, overlying the chalk gravels (4) with a thin black peaty layer at the bottom (7), which coincides with the trench base. The silts extend 10m south of the track leading to Swinhope Hall (Pl. 8).

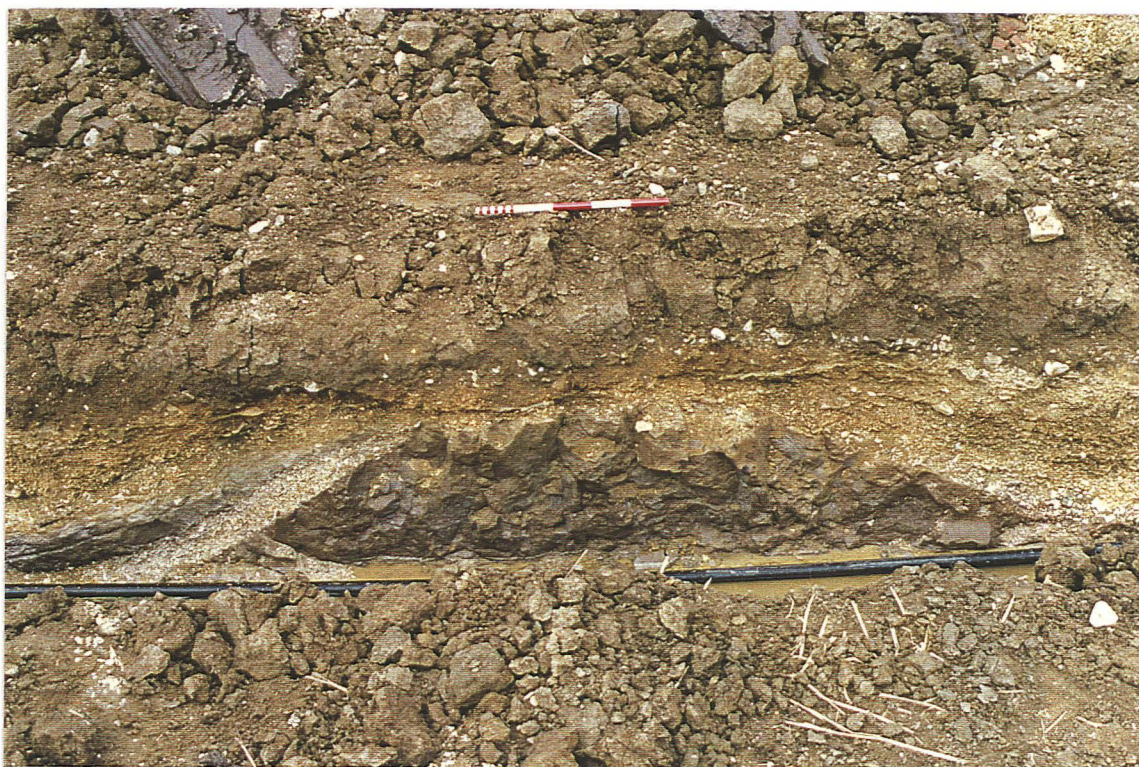
Pl. 7 Outcrop of boulder clay (8) beneath the chalk gravels (4), south of track to Swinhope Hall

8. Just south of the silt a peak of boulder clay was observed underlying the chalk pebbles (Pl. 7).
9. South of the boulder clay outcrop are bands of silt, some containing fine chalk pebbles, others smooth. These extend to the south limit of the trench where it meets the road. They vary in texture and colour from grey to orange-grey, where bands of iron panning are present. Occasionally the underlying chalk pebbles were visible in the base of the trench and in places black organic lenses were also visible. Water lay in the base of the trench along much of the stretch south of the track indicating the continuing long history of waterlogging in the valley base (Pls. 9, 10).

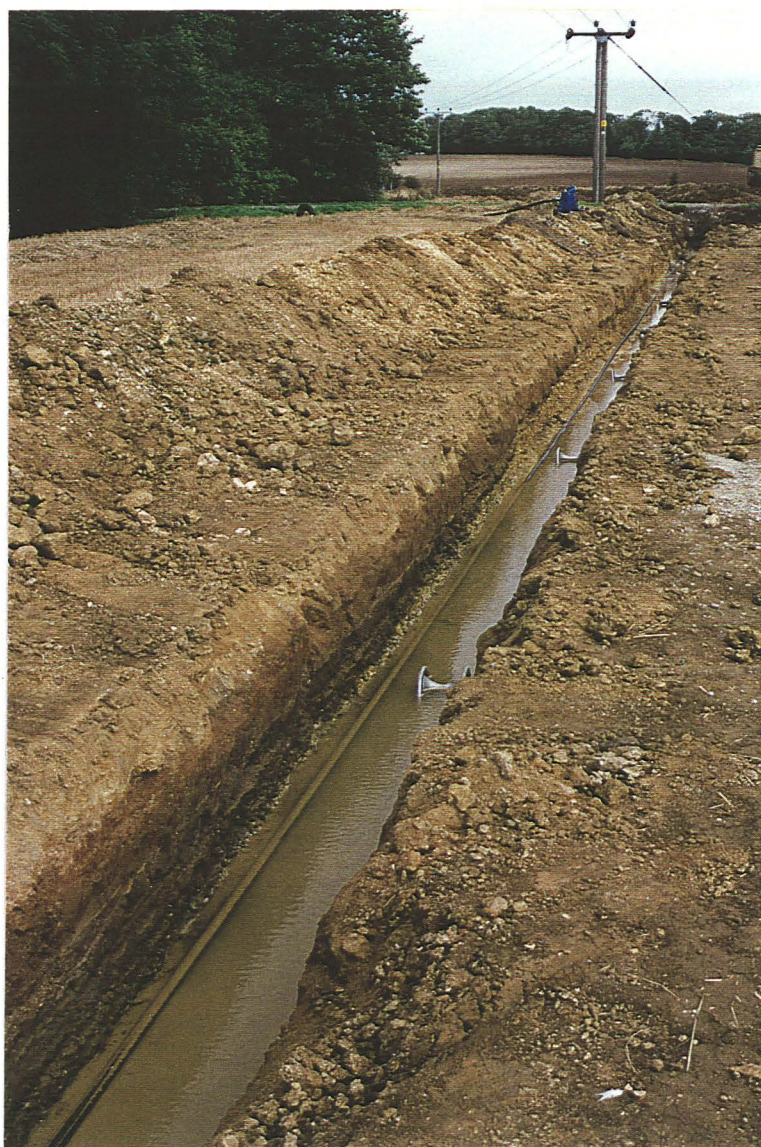
Pl. 8 Silt and peat deposits (6 and 7) in drain, cut through longitudinally by the cable trench

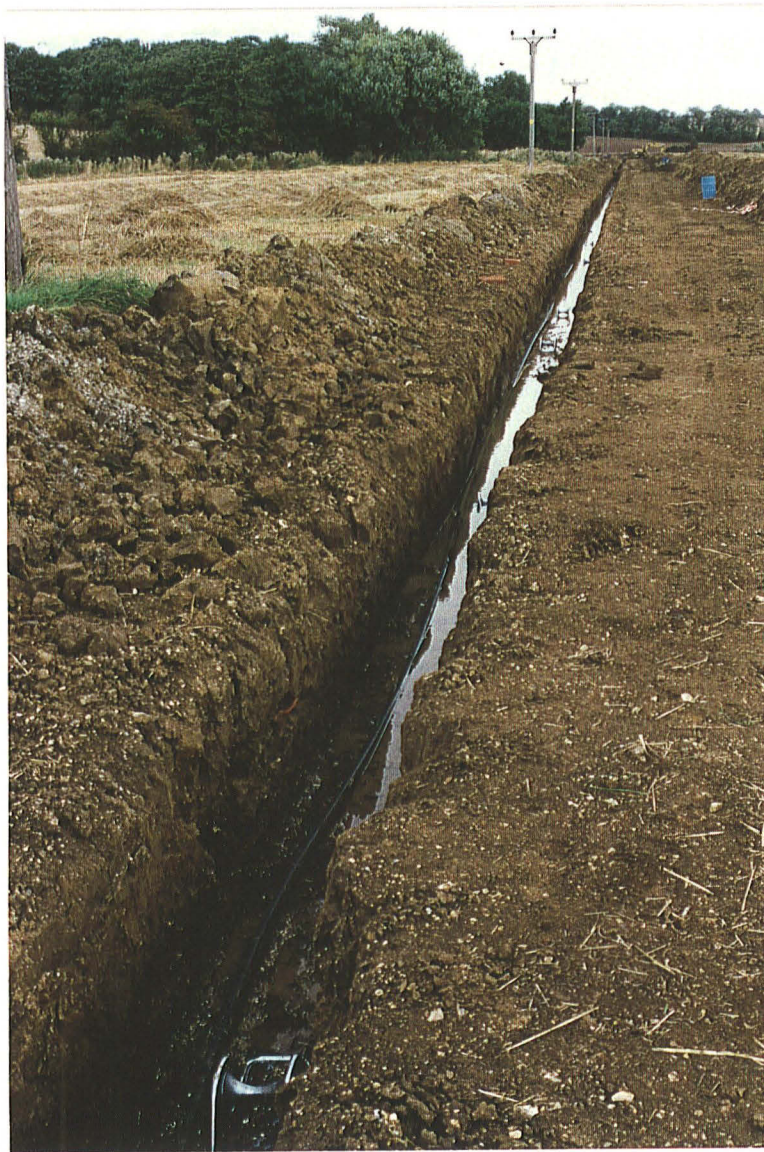
Pl. 9 General view looking north of the southern stretch of cable trench. Note standing water in the trench bottom.

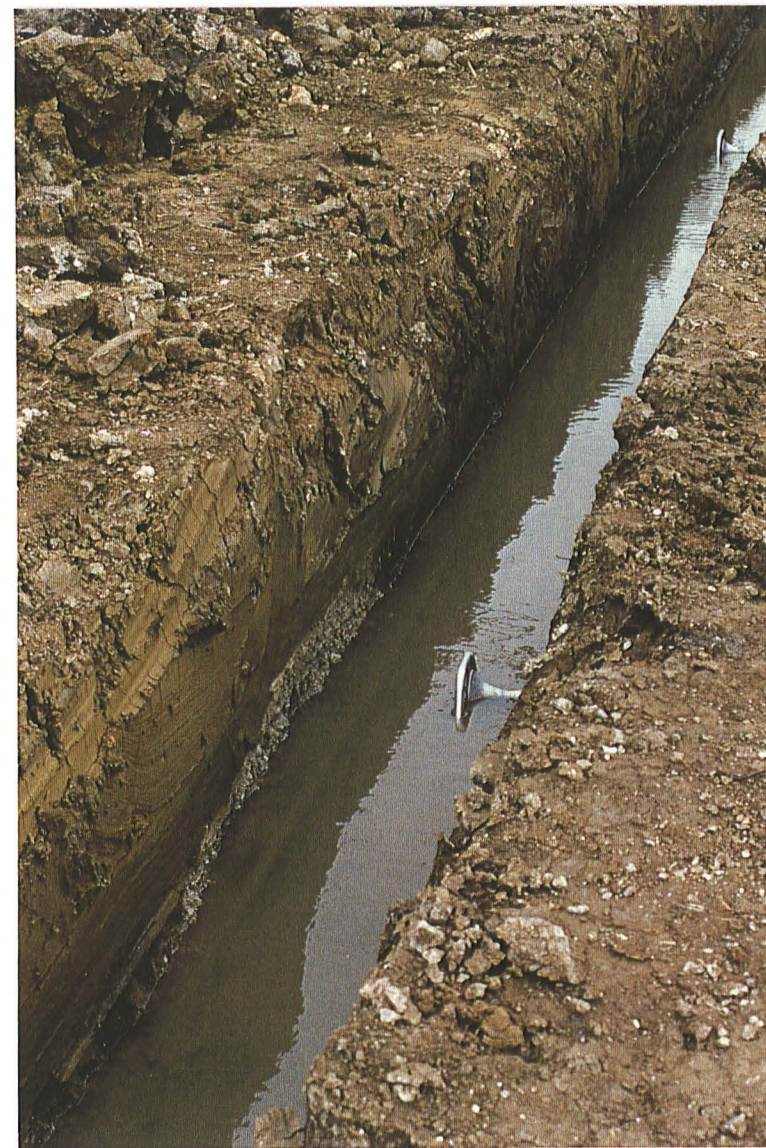
Pl. 10 Close up view of peat and silt deposits (9) at south end of cable trench. The chalk gravels undulate at, or just below, the water level.
