**AN ARCHAEOLOGICAL SCHEME OF MONITORING WORKS:  
PLOT 3, THE OLD VICARAGE,  
NORBECK LANE,  
WELTON,  
LINCOLNSHIRE**

**Site Code:** OVWL 08  
**NGR:** TF 010 795  
**LCNCC ACC. NO:** 2008.61  
**PCA 447 08 - 01 Rev A**

Report prepared for Daniel Kirk Ltd

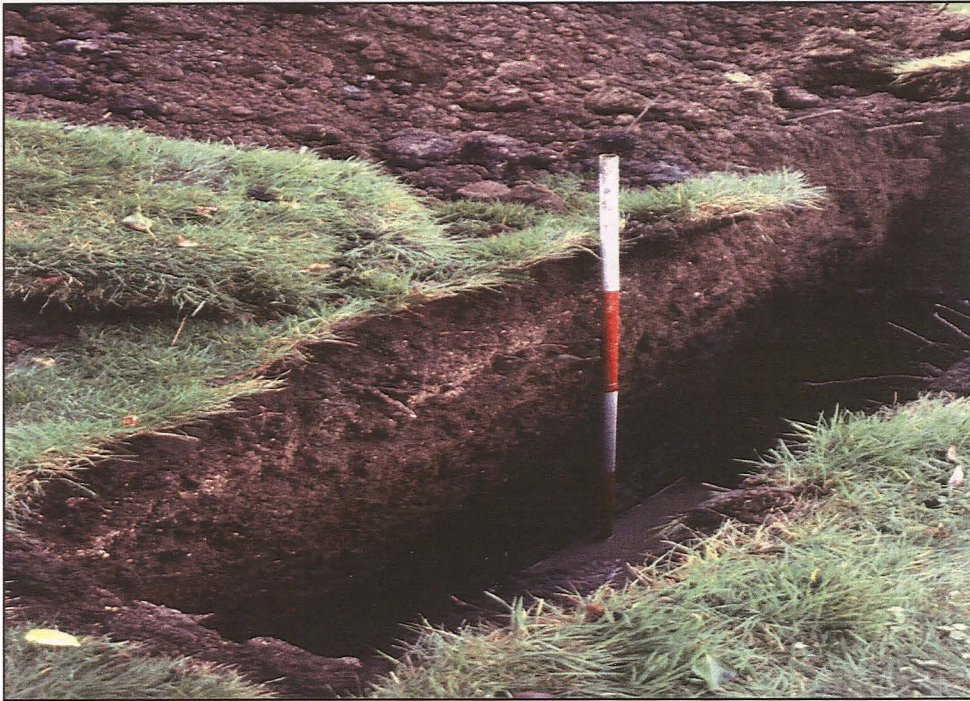
**Plate 3:** Sample section of test pit looking north

The exposed stratigraphy included two natural deposits. The earliest (006) occurred at a depth of 1.40m below the modern ground surface and comprised a layer of light grey course sand. Overlying (006) was layer (005). This was analogous to layer (007), evidenced in footing trenches.

Sealing (005) was a 0.10m layer of dark brown-black desiccated peat (004), suggesting that that at some point in time this area of the site had been subject to water-logging.

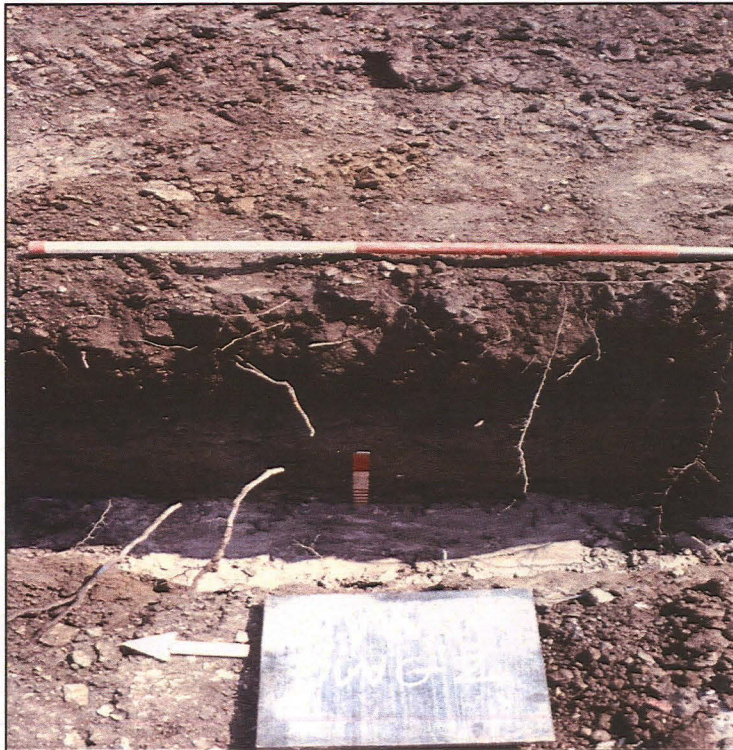
**Plate 4:** Sample section of footings trench looking east

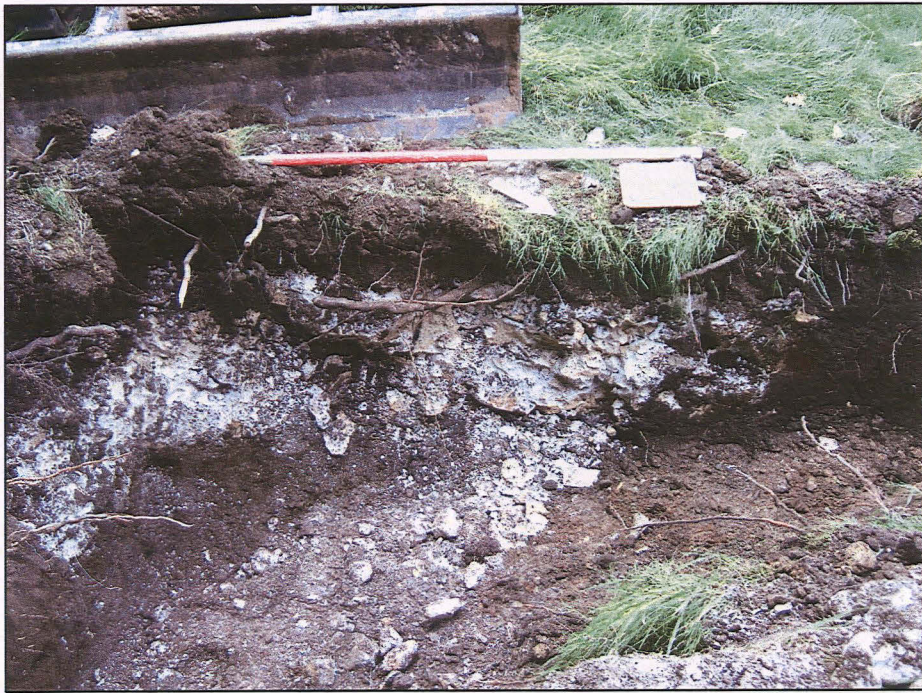
**Plate 5:** Drainage trench showing foundation (008) and foundation (110) at the left of the photograph, looking west.

The two drainage trenches were located at the southwest of the development (Fig 2). The earliest deposit exposed in both at a depth 0.70m below the modern ground surface was layer (003). Cutting this were the remains of two limestone foundations (008) and (010).

The location of foundation (008) suggested that it could have been a continuation of foundation (009) although this was only encountered at the far west of the drainage trench and there was no evidence that (009) extended into that area (Fig 2).

The second foundation (010) appeared to be a return of (008) and probably followed a north/south alignment.

Both (008) and (010) were broadly similar in size and fabric to (009), suggesting that they were possibly components of a foundation for a boundary wall or walls although it cannot be discounted that the foundation may have been part of a structure (possibly a barn) albeit a large one.

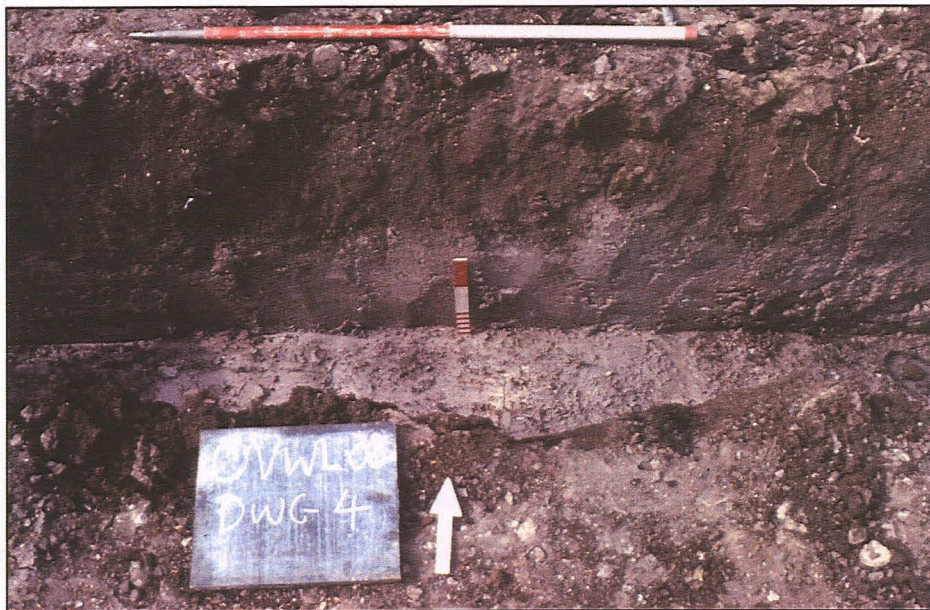
**Plate 6:** Sample section of footings trench looking north

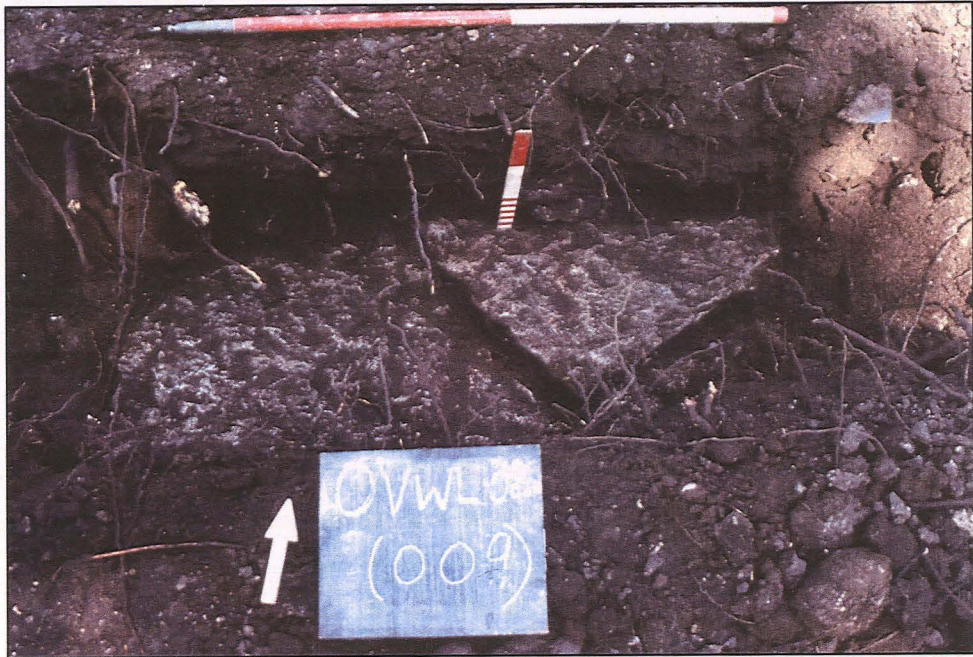
**Plate 7:** Foundation (009) in plan looking north

Overlying (007) was a 0.20m thick layer of mid orange-brown silty clay colluvium (003). Cutting this and evidenced in four sections was the remnant of a linear wall foundation (009). This was aligned north east - south west with a remnant wall fabric made up of flat limestones overlying a degraded limestone rubble foundation (plan/section I-J; Plates 7 & 8). The average foundation width was in excess of 0.50m.
