**ARCHAEOLOGICAL WATCHING BRIEF REPORT:
LAND TO THE REAR OF 90 HIGH STREET, LINCOLN**

SK Planning Reference: 2006/0736/F
NGR: 97225 70292
AAA Site Code: HSLI 09
LCCM Accession Number: 2009.058
OASIS Reference Number: allenarc1-59642

Report prepared for Quaybronze Limited

By
Allen Archaeological Associates
Report Number 2009/020

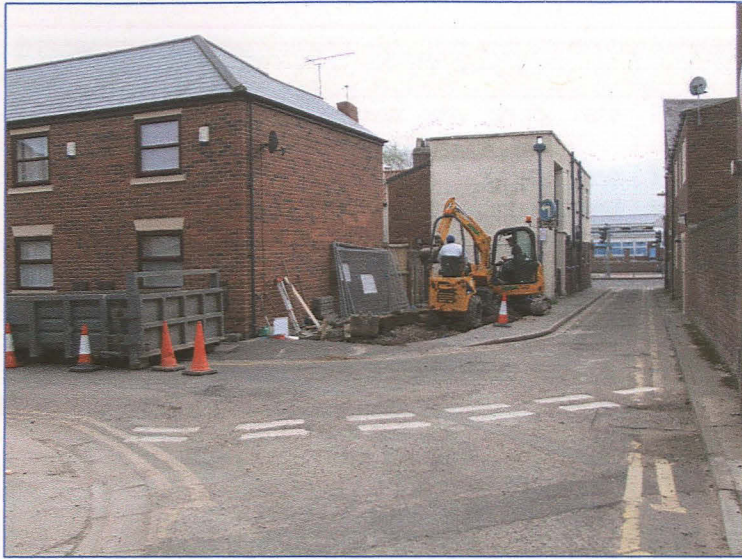
Plate 1: General view of the site during the groundworks, looking east from Mill Lane.

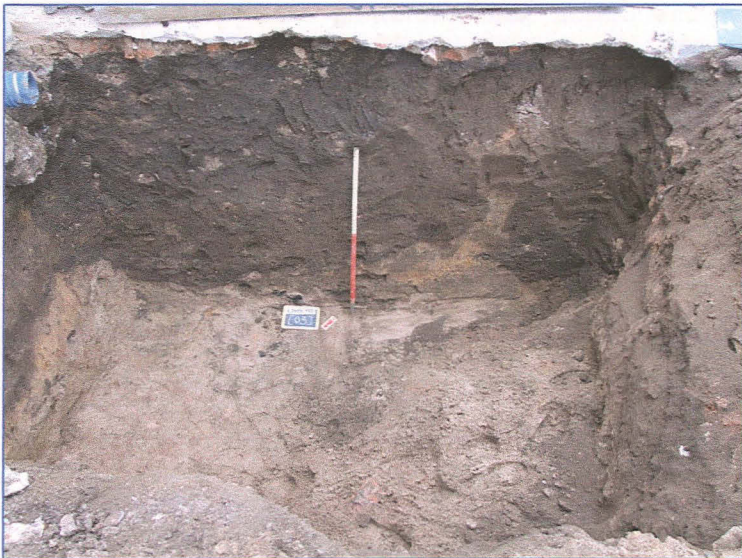
Plate 2: West facing section, showing probable robber cuts [06], [09] and [11]. Looking east-south-east

- 6.2 At the north-east corner of the plot, both layers were cut by a large steep-sided pit, [06], containing an undated backfill of very dark grey silty sand with frequent limestone fragments and small brick and tile fragments, 07. This feature was interpreted as evidencing the robbing out of a wall during the demolition of an earlier structure.

- 6.3 Towards the east side of the site, layer 08 sealed a loose greyish/yellow sand, 05, representing a probable naturally formed layer of windblown sand. This horizon was cut by a small shallow pit, [03], as well as a large steep-sided probable robber pit [09], and a further steep-sided possible robber cut, [11]. All the features were undated.

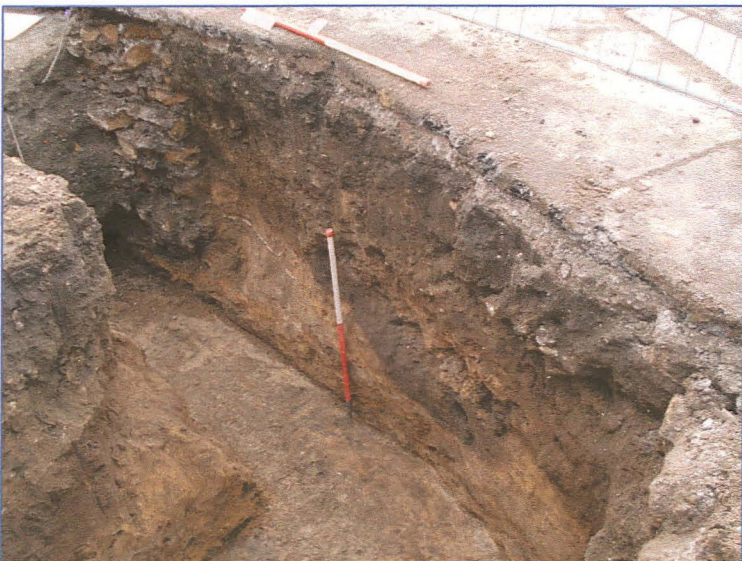
Plate 3: North-north-east facing section, showing pit [13] cutting possible soil horizon 16. The wall of the former cellar can be seen to the left of shot. Looking south-south-east

- 6.6 To the west of the cellar, there was significantly less disturbance to the stratigraphic sequence, which was slightly different to the sequence recorded to the east. Below layer 08 was a c.0.2 – 0.3m deep brown silty sand, 16, interpreted as a possible former soil horizon. This was cut by a single steep-sided pit, [13]. The feature contained two fills; a primary natural silting deposit of brownish grey silty sand, 14, sealed by a dumped deposit of redeposited natural sand, 15.
