**An archaeological watching brief at
Canwick Sewage Treatment Works,
Canwick, Lincolnshire
January – March 2009**

June 2009

Report 09/058

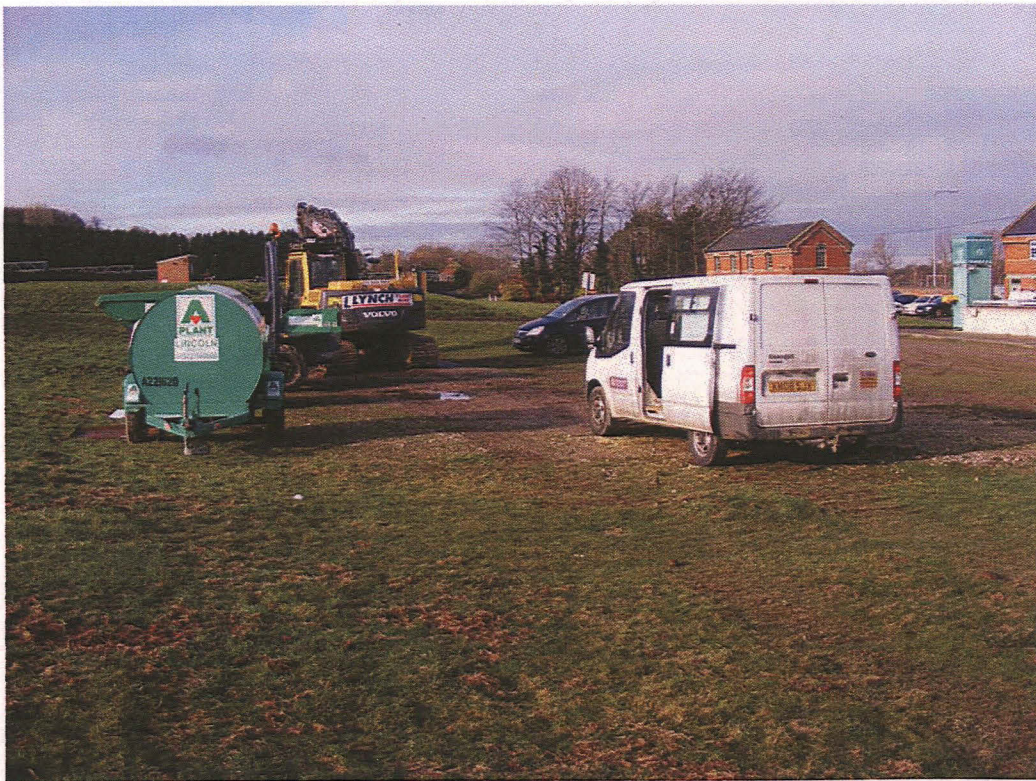
Plate 2: the area of temporary storage at the start of groundworks

Throughout the area of temporary storage and the access road hardcore had already been laid prior to the present development. Subsequently a low scrubby grass had re-colonised some of the area.

A disturbed stratigraphy was revealed across all of the new storage area and access road. This comprised pale grey/brown fragmented stone with pockets of crushed modern ceramic building material. This was partially overlain by up to 0.10m of grey/brown silt loam, containing occasional irregular stones and small fragments of modern ceramic building material. The upper surface of this was covered in a low scrubby grass.

No archaeological deposits or artefacts were present within the area of temporary storage and the access road.

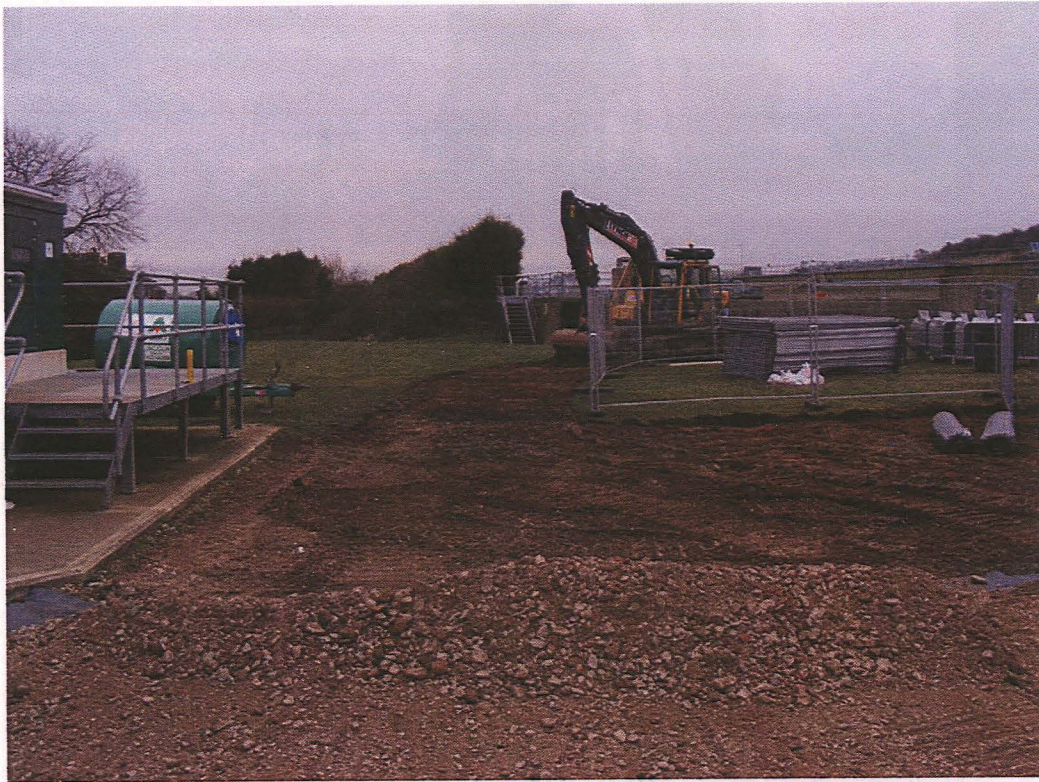
Plate 3: The temporary storage area during groundworks

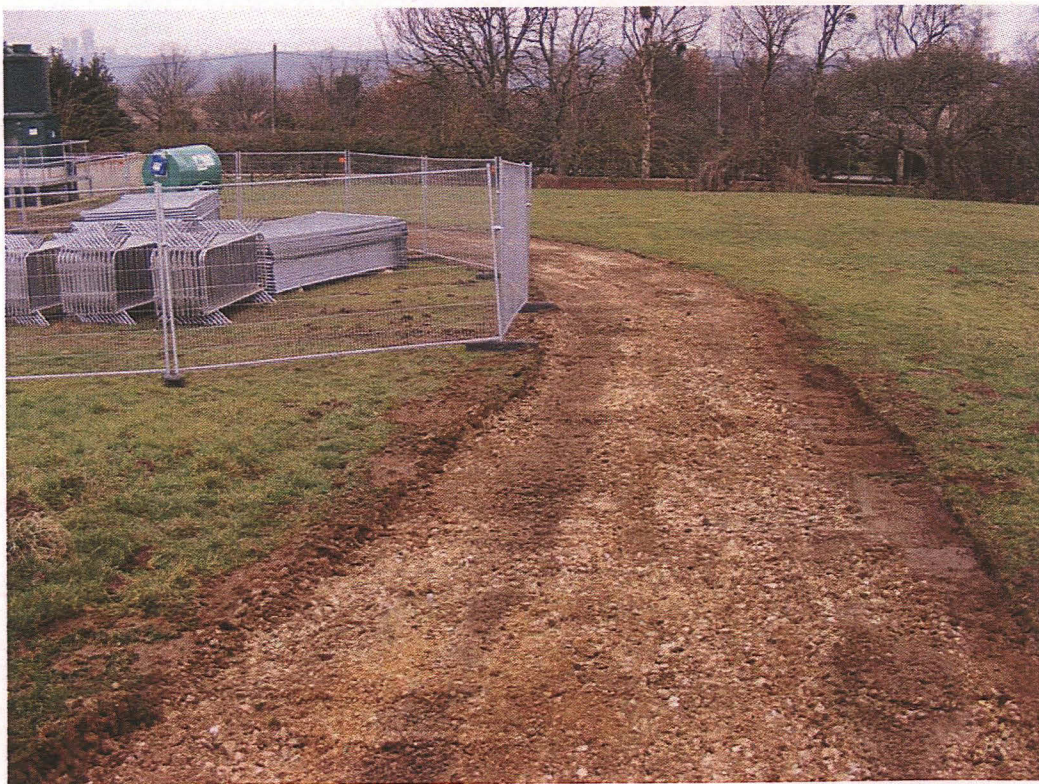
Plate 4: The temporary access road during groundworks

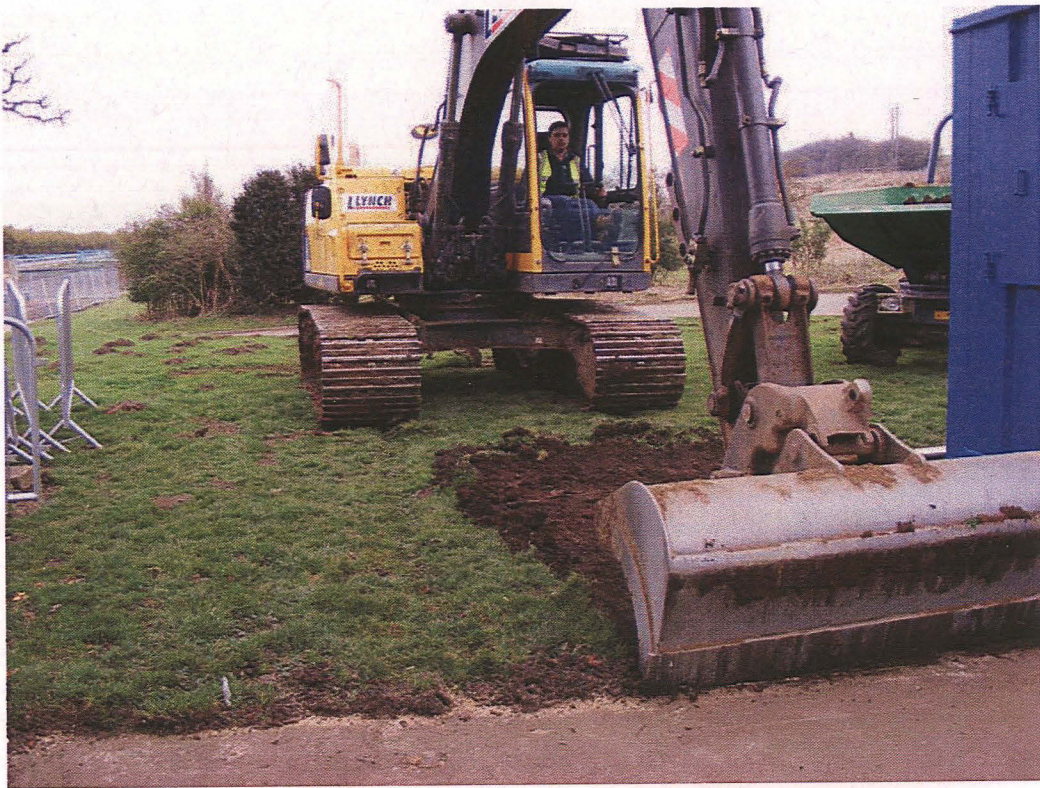
Plate 5: The temporary footpaths at the start of groundworks

The temporary footpaths were located on the southern boundary of a grassed island contained within the permanent access road in the sewage plant.

An examination of the stratigraphic sequence revealed grey/brown silt loam, up to 0.15m thick, containing numerous fragments of crushed modern ceramic building material and occasional small pockets of fragmented tarmac extending the full depth of the excavation. The natural substratum was not revealed.

No archaeological deposits or artefacts were present in the area of the temporary footpaths.

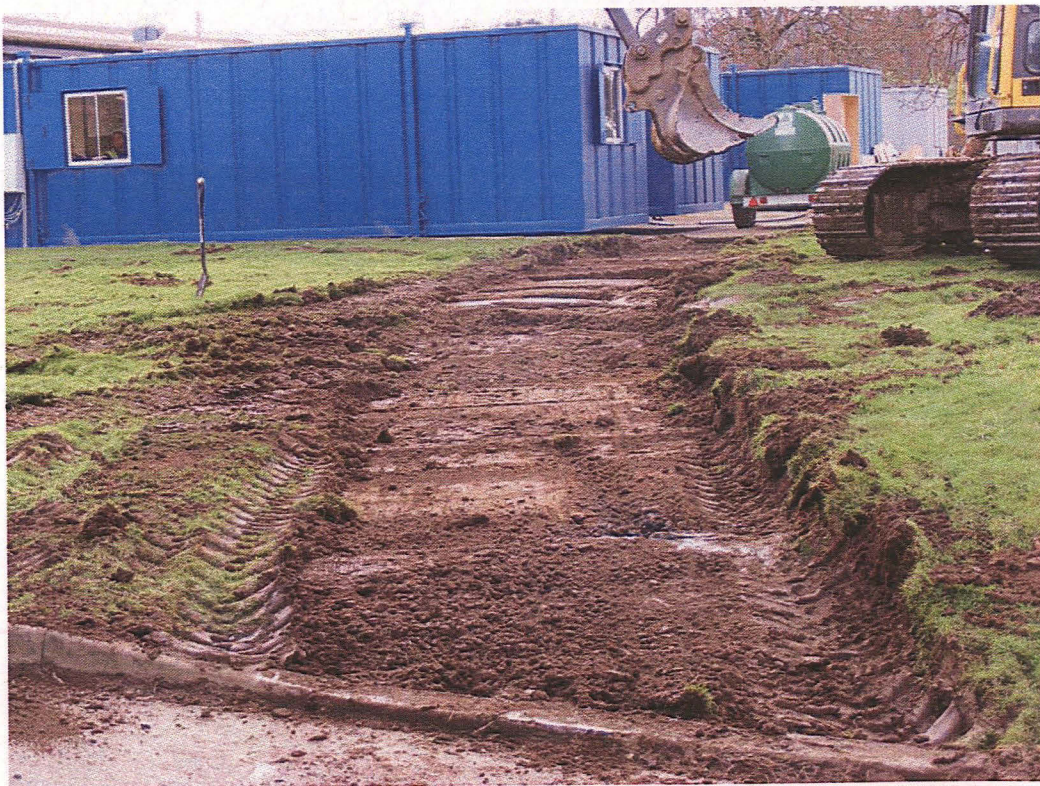
Plate 6: The temporary footpaths during groundworks

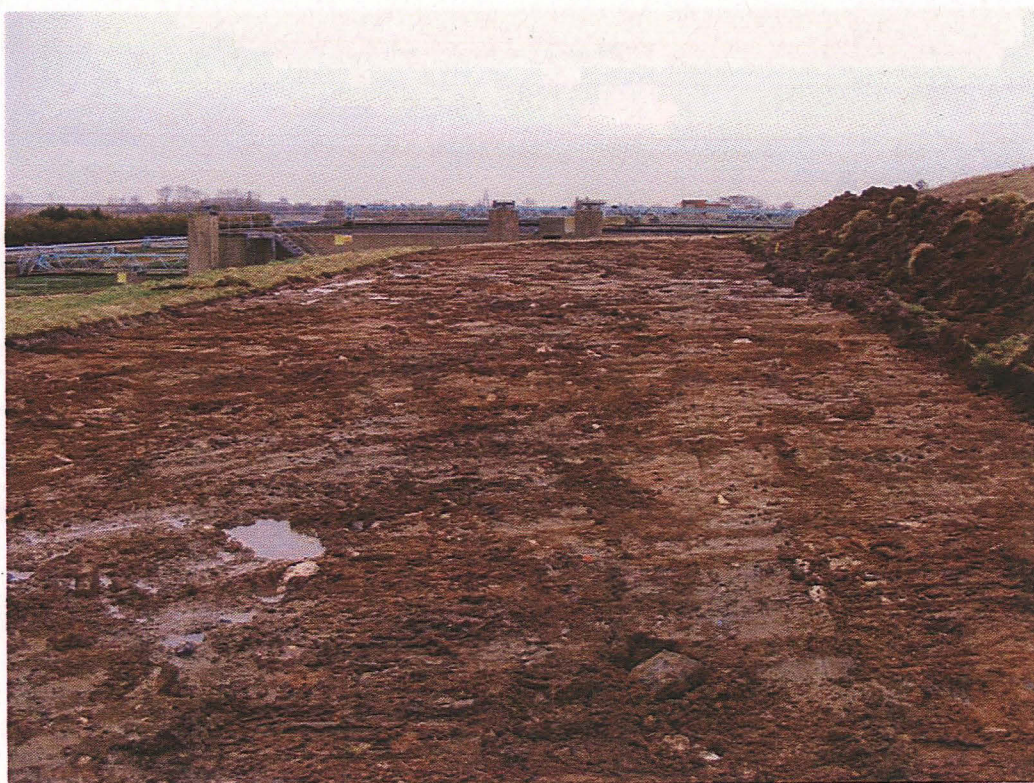
Plate 7: The eastern terminus of the pipeline route during groundworks

Archaeological observations were taken along the route of the new pipeline and were supplemented by a series of four auger holes in order to better inform regarding the stratigraphic sequence along the route of the pipeline. The route of the pipeline encompassed two areas covered by low grass. These extended westwards from the eastern terminus of the route.

An examination of the stripped area revealed mid grey/brown silt loam, containing numerous fragments of modern ceramic building material and fragments of corroded modern objects along with occasional pockets of red/brown sand. This was sealed by grey/brown silt loam, up to 0.15m thick, containing occasional rounded stones and numerous fragments of modern ceramic building material.

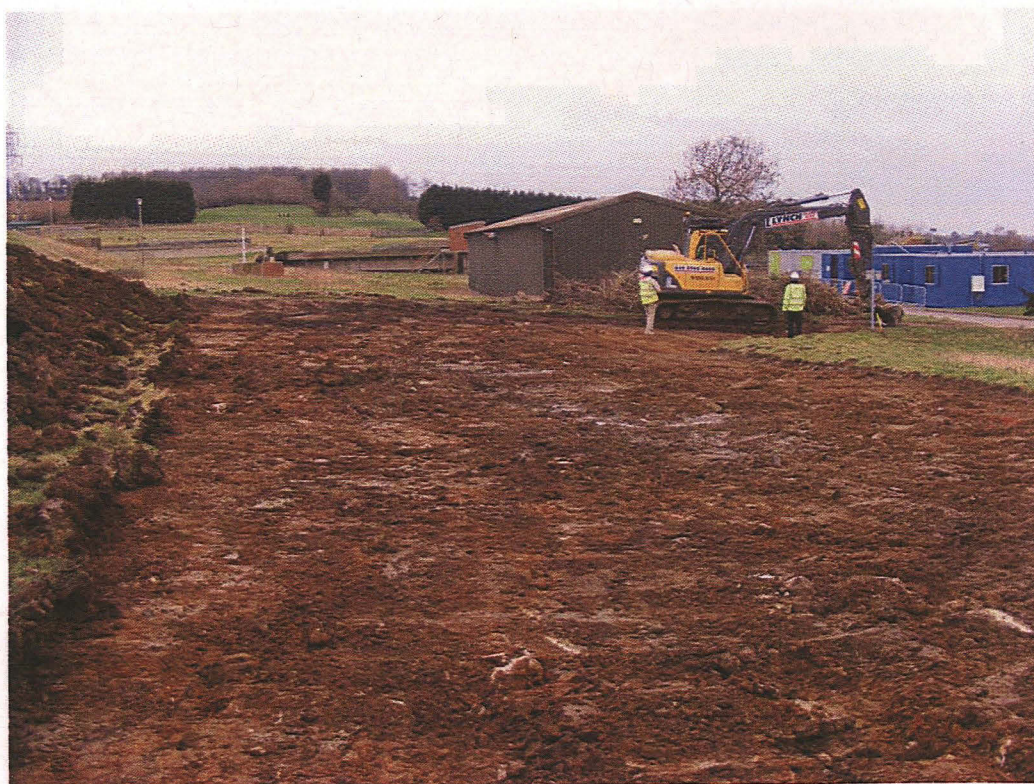
Plate 8: The pipeline route during groundworks

No archaeological deposits or artefacts were present within the examined areas of the pipeline route.

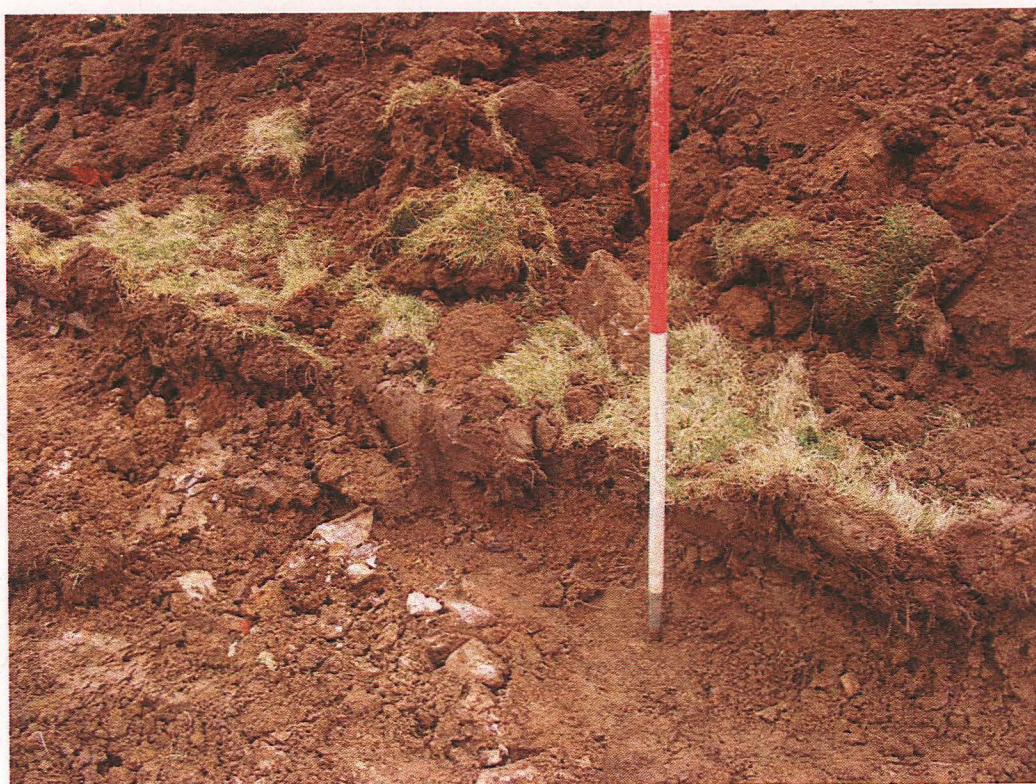
Plate 9: The stratigraphic sequence along the pipeline route

Auger holes were excavated along a section of the route in order to gain a better understanding of the stratigraphic sequence along the new pipeline route where it was thought that undisturbed soils may be present. Four holes were excavated to a maximum depth of 1.2m at which point the auger appeared to encounter a compact layer which could not be penetrated. This revealed crushed modern ceramic building material within a matrix of mid grey/brown silt loam extending for the full depth of the auger holes.

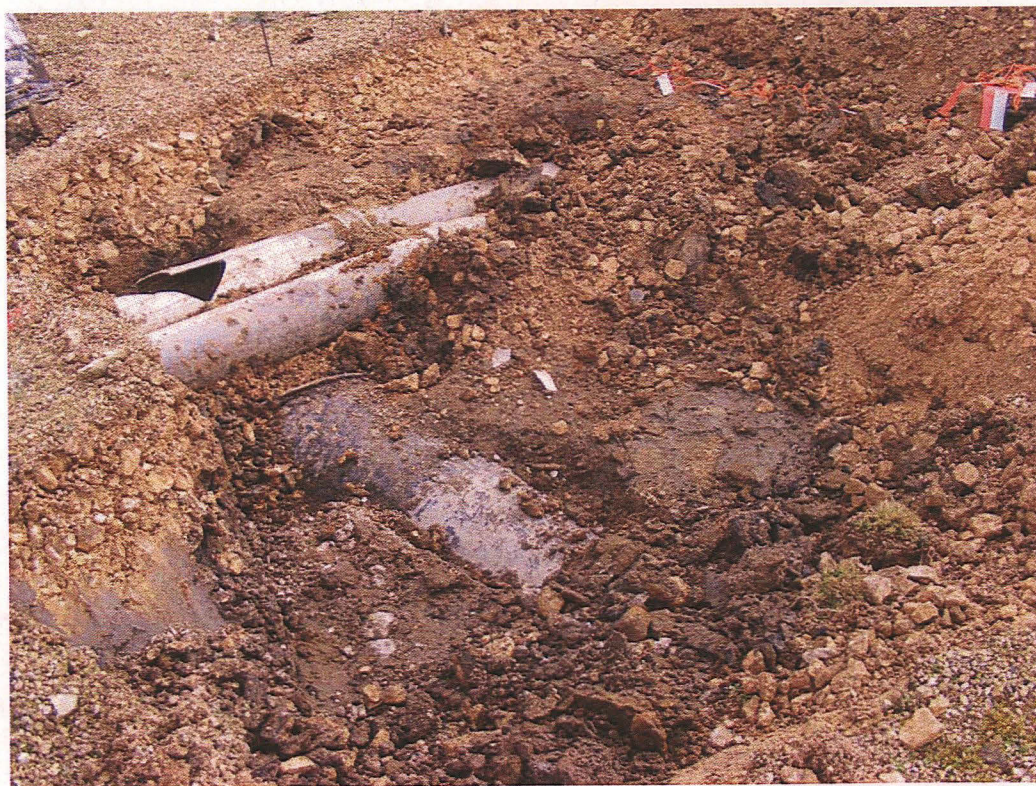
Plate 10: The test pit, western terminus of the pipeline route

In the western terminus of the route a test pit was excavated by the contractors in order to locate the line of the existing pipeline. This was excavated to a maximum depth of 0.30m and revealed grey/brown silt loam, containing numerous granite chippings and inclusions of soft grey/black peaty silt. This was overlain by pale yellow brown fragmented stone within a yellow/brown silt loam matrix, up to 0.30m thick.
