**BACK LANE  
SCOTHERN  
LINCOLNSHIRE**

**ARCHAEOLOGICAL  
WATCHING BRIEF**

Site Code: BLS09  
Museum Accession No.: 2009.57  
NGR: TF 0370 7738  
Planning Application No.: WLDC 123241 16 January 2009

**MJAS REPORT No.: 560**

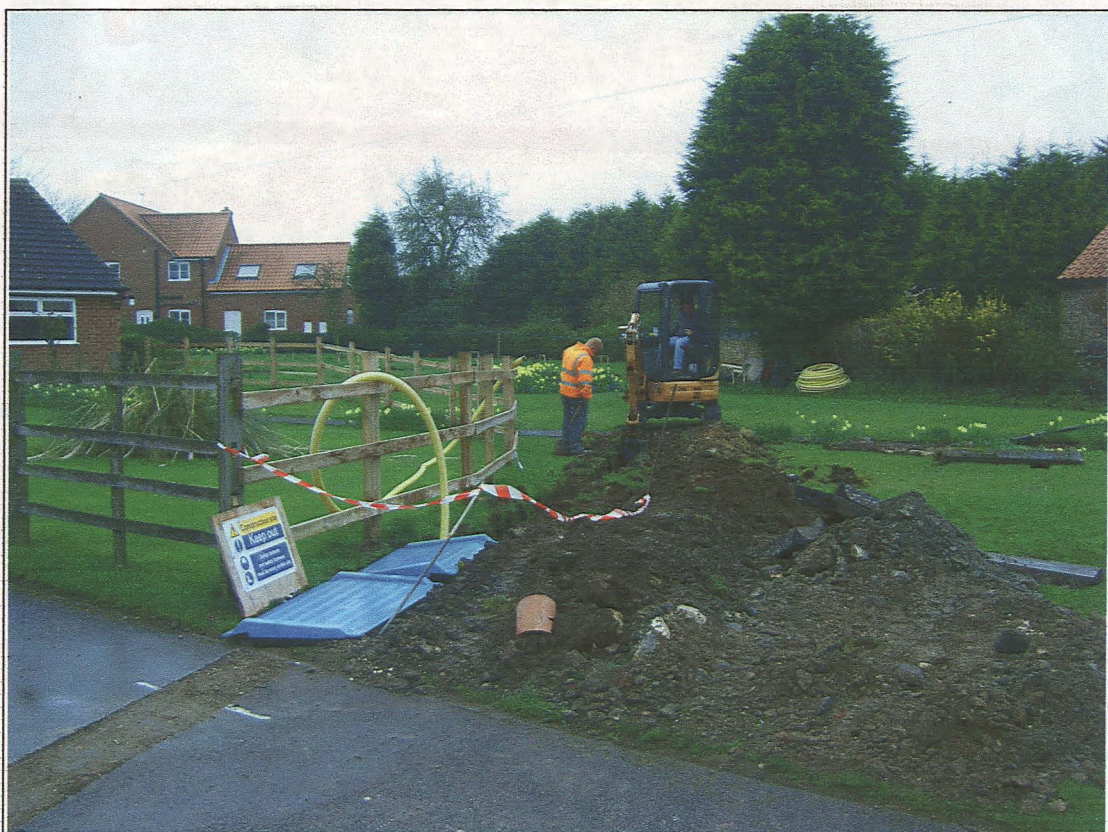
Plate I: General view of drainage trench looking south-west.

The drainage trench extended from the northwest corner of the new house plot, northeast to Back Lane, terminating just short of the lanes east side. It was 38m long and between 400mm and 900mm deep.

Natural mottled yellow sand ([005]) lay approximately 400mm below existing ground level (12.10m OD). Sealing natural was layer [010/008] (brown clayey silt soil with small angular limestone inclusions – c. 12.30m OD). A 2.70m wide U-shaped pit, [007], was cut into [008/010] and its fill [006]; dark brown sandy silt was undated (top – c. 12.37m OD).

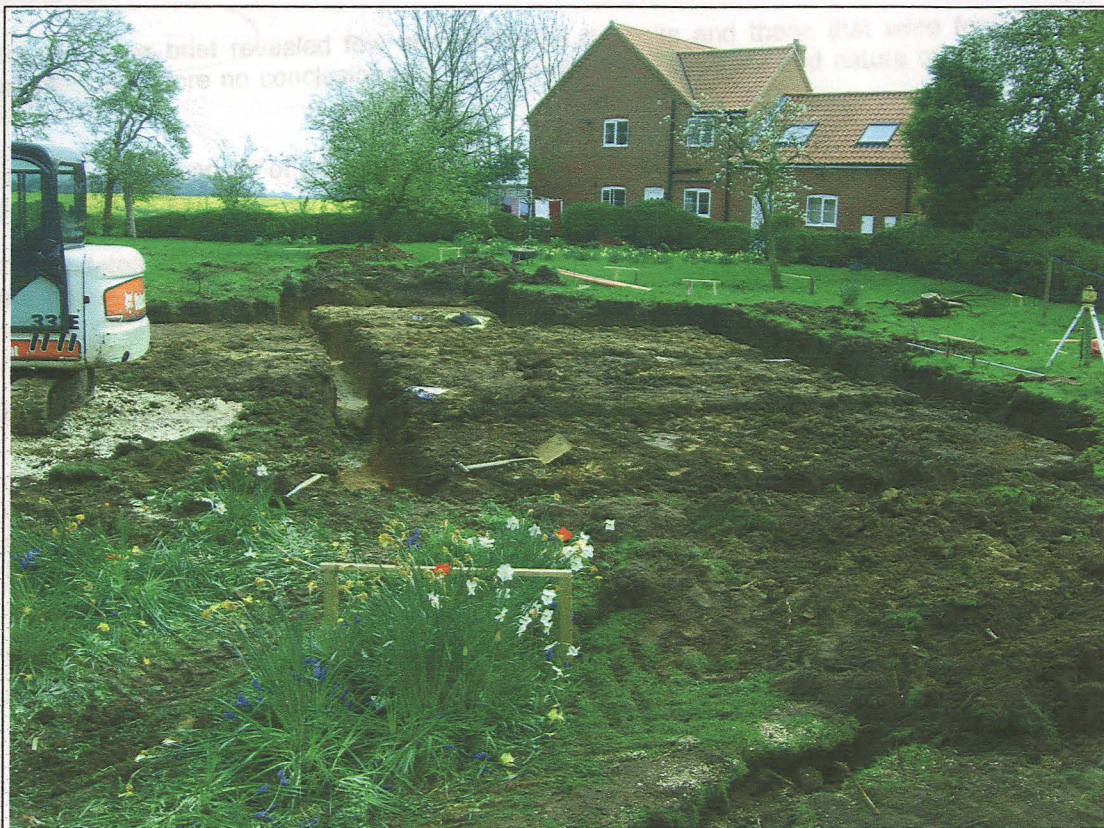
Plate II: General view of foundation trenches looking south.

The house plot lay in the approximate centre of the site on a north-west to south-east alignment. External foundation trenches were 600mm wide and internal foundations 450mm wide respectively. Trench depth varied between 800mm to 1.15m deep. Prior to the machine excavation of the foundations, tree stumps and topsoil was removed over the footprint of the plot.

Natural [005] lay approximately 650mm below ground level (c. 12.20m OD). A probably linear cut ([019]) of indeterminate form or function was recorded cut into the natural in the northeast corner of the plot. The cut measured approximately 2m wide and was at least 5.5m long and 400mm deep with a U-shaped profile (base of cut 11.87m OD). Filling the cut was layer [015], which also extended across the entire footprint of the house plot (top c. 12.64m OD).
