ARCHAEOLOGICAL WATCHING BRIEF REPORT

LAND OFF HALTON ROAD, ASHBY BY
PARTNEY

LINCOLNSHIRE

PRE-CONSTRUCT ARCHAEOLOGY (Lincoln)

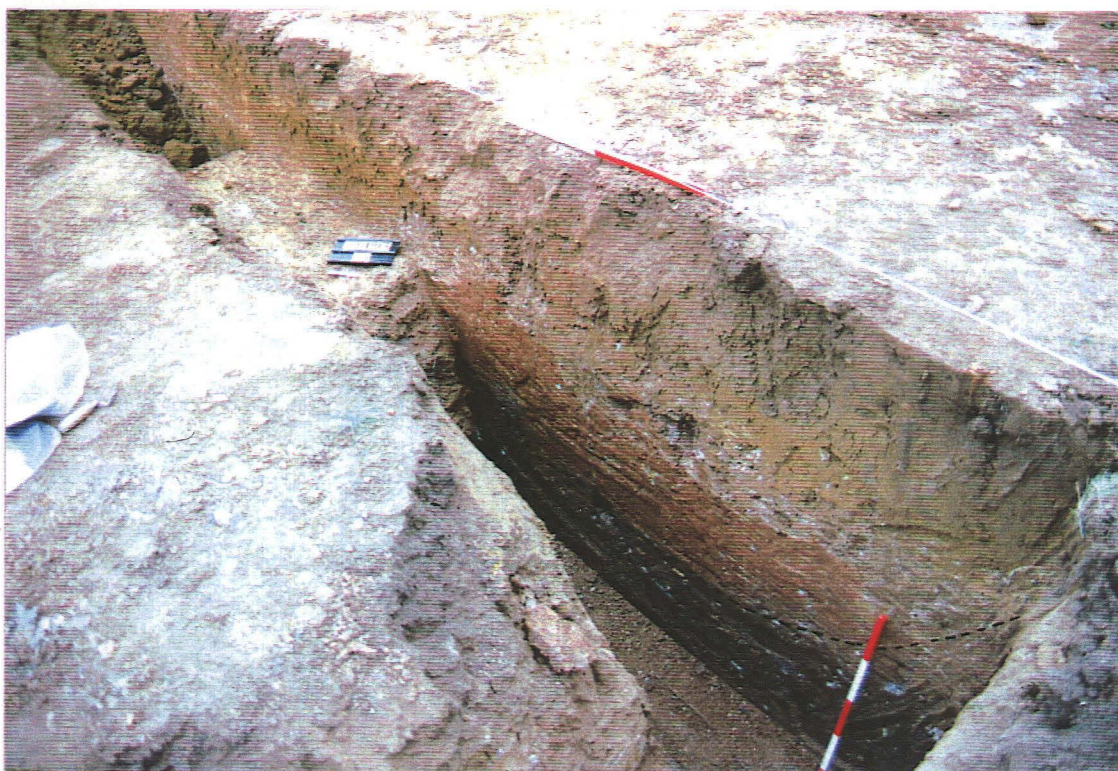
P2. North-west garage foundation trench showing ditch [17] (red fill) cut by ditch [13] (yellow fill, left side of frame), looking west

An east-west ditch, [17], was truncated on the north side of the plot by ditch [13]: the direct relationship is indicated in Fig. 4 and can be seen in photographs 2 and 4

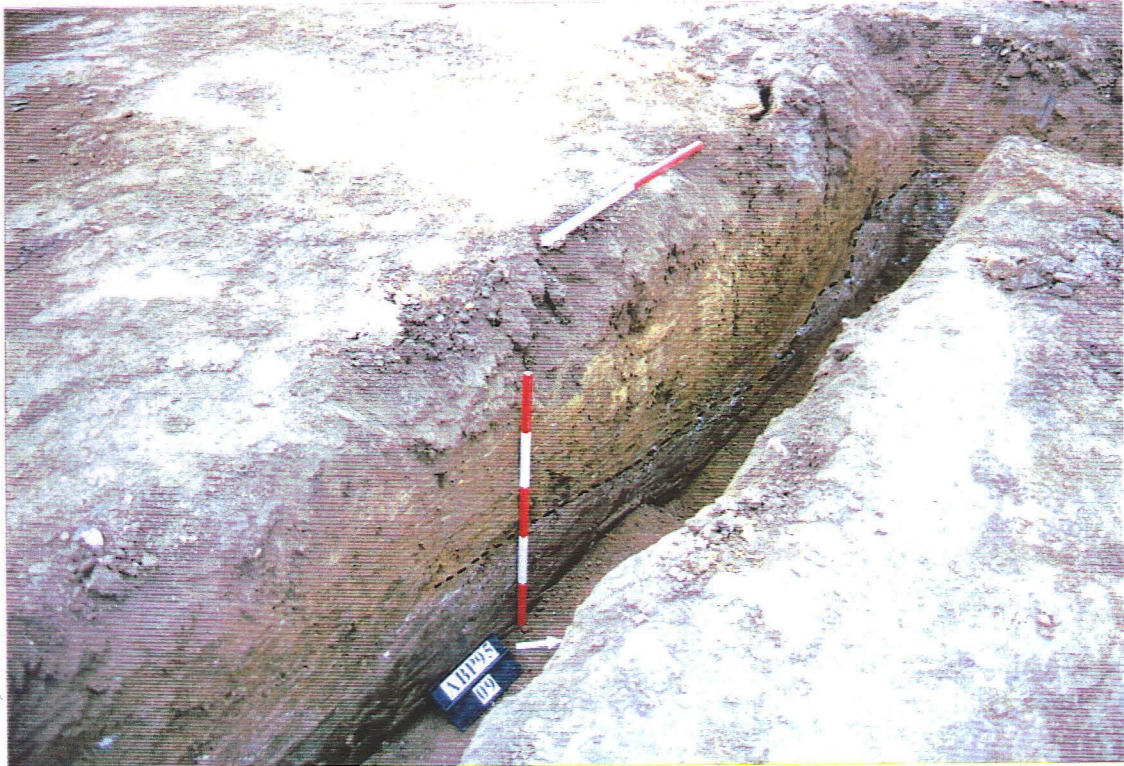
P3. Longitudinal section through ditch [13], as exposed in south-west garage foundation, looking west
