**7 St CATHERINES
LINCOLN**

**ARCHAEOLOGICAL
WATCHING BRIEF**

**PREPARED BY
MIKE JARVIS ARCHAEOLOGICAL SERVICES**

MJAS REPORT No.: 553

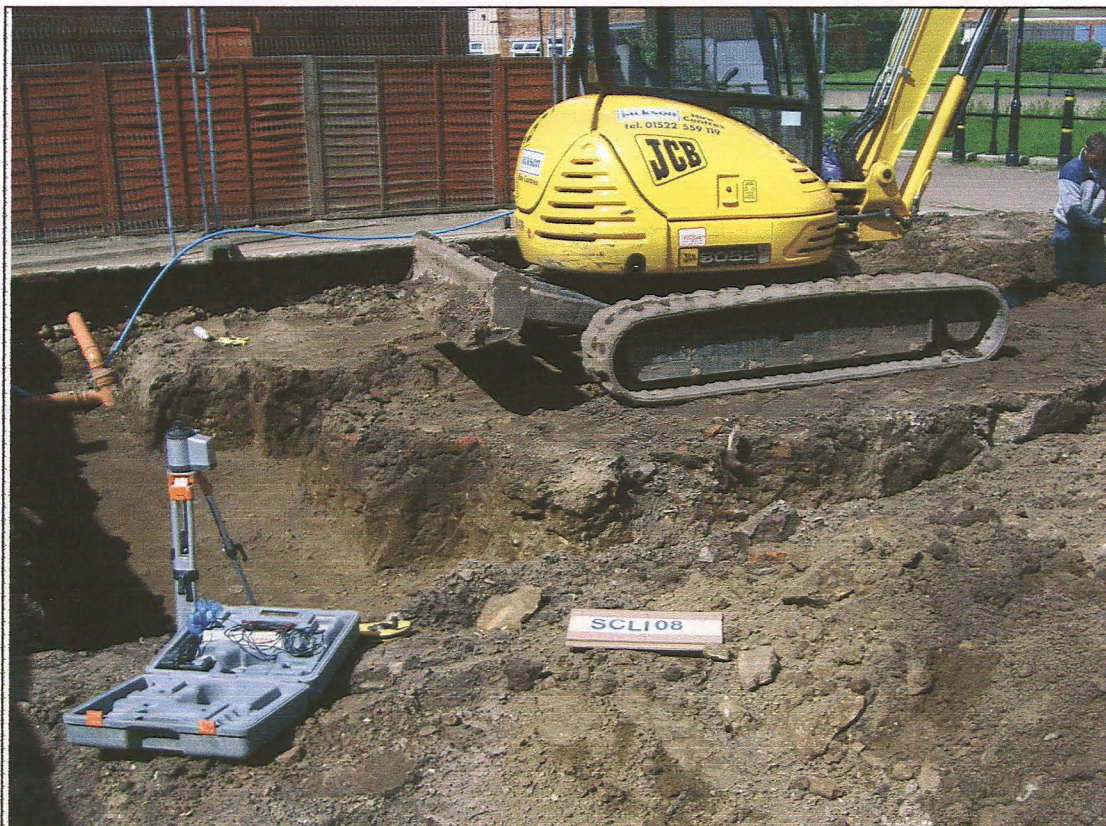
Plate I: general view of the site during the excavation of the foundation trenches (looking north-west).

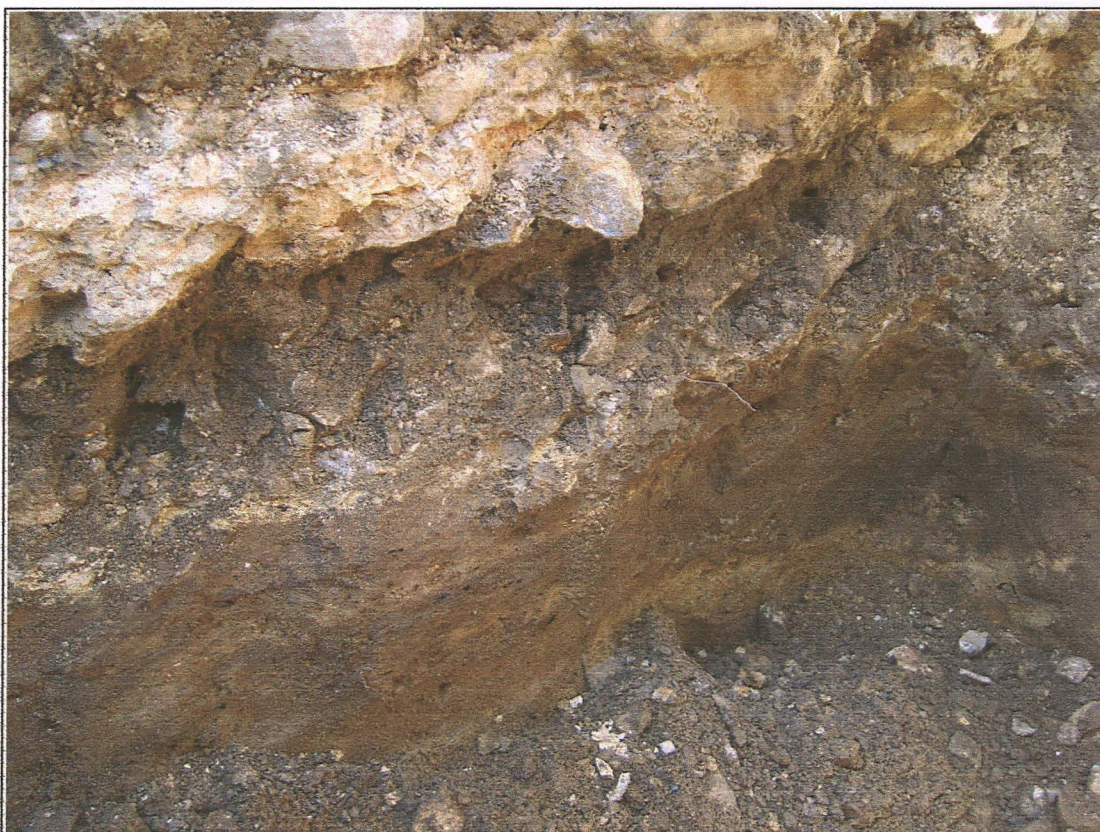
Plate II: close-up of section 2 showing metalling [004] (top of picture) with make-up deposit [005] beneath and banded fine sand/silt deposits [006-008] below.

The earliest deposit encountered was [008], an undated deposit of slightly laminated/banded light-mid brown coarse sand soil with infrequent charcoal and small rounded pebble inclusions (5.29m OD). Sealing [008] was two similar sand deposits ([006] & [007] – top 5.43m OD), both of which were undated

Lying above [006] was layer [005], a friable, mid-brown sand soil containing frequent small angular limestone fragments and occasional tile (mid-12th to mid-13th), animal bone & infrequent burnt clay flecks (5.76m OD). Sealing [005] was [004] a compact 120mm thick layer of small angular limestone fragments bonded with a pale brown sandy mortar and occasional tile fragments (late 12th – 14th century - top of surface 5.85m OD). It was noted that a thin layer of pea-gravel was present on the upper surface of this layer and may indicate that the surface was external. Above surface [004] was ([003]) a friable pale-mid brown sand/silt containing infrequent animal bone fragments (6.00m OD). Overlying [003] was [002] a layer of

The metallated surface ([005]) exposed during the watching brief almost is almost certainly associated with the medieval priory of St Catherines although its position & function within the confines of the priory remains unclear. Similarly, a number of worked limestone fragments present within the backfill of a modern sewer trench were also believed medieval in date although the lack of evidence for structures on the site suggests that they may have been imported from elsewhere in the vicinity.
