## Swineshead Rising Main and STW Extension: Archaeological Watching Brief

*NGR: TF 2281 4196 - 2310 4130*

Site Code **SRM 95**  
LCNCC Museum Accn. No. **125.95**

Report prepared for Anglian Water Services Ltd  
**December 1995**

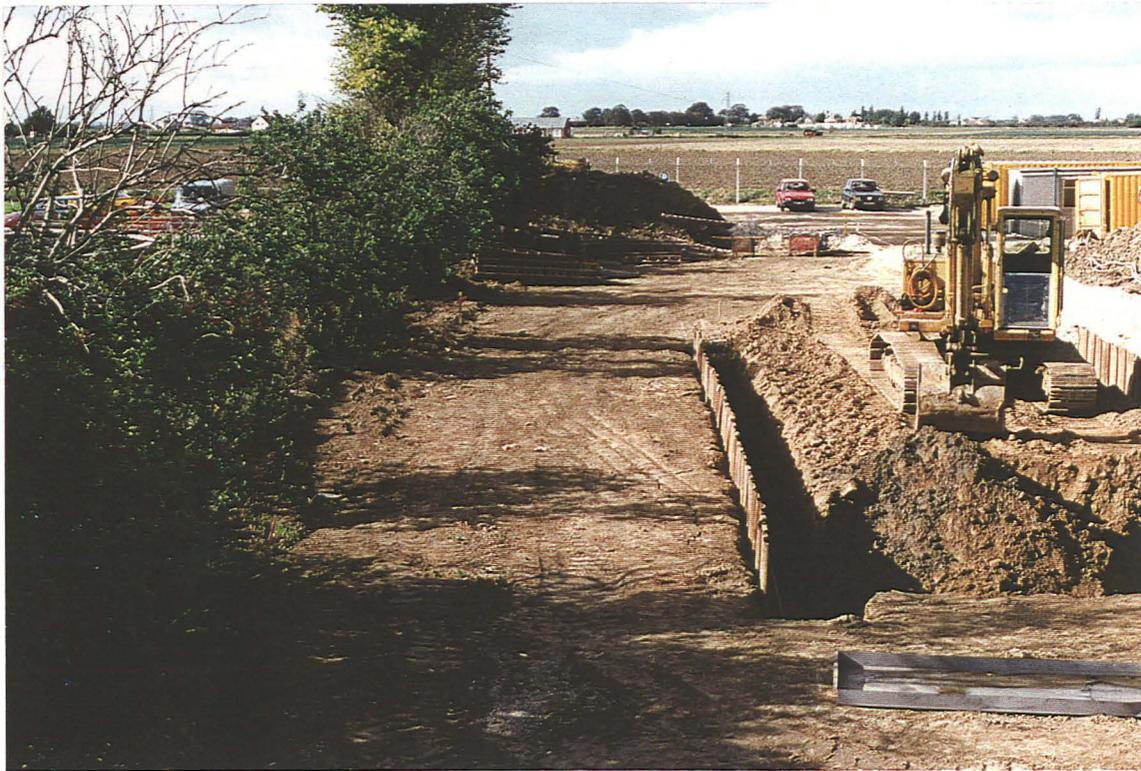
Pl. 1 Excavations for the Aeration Tank; the existing STW is beyond the trees. (Looking NW across the extension area to Swineshead Bridge hamlet. Hammond Beck lies beyond the compound fence).

After the pipeline had been laid, a 2.7m deep trench was excavated in the extension area (previously stripped of topsoil) for the foundations of a new Aeration Tank (Pls. 1 and 2). The stratigraphic sequence was:

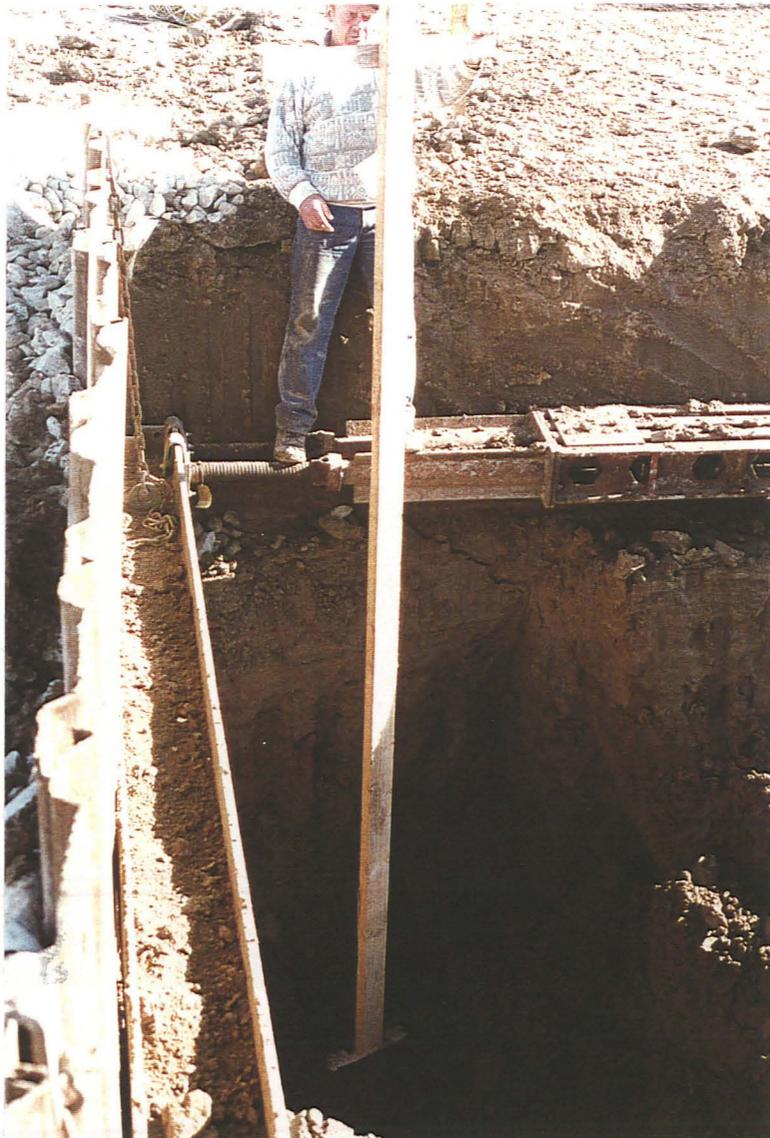
Pl. 2 Stratigraphy in the Aeration Tank trench. The 2.7m deep trench did not cut below the flood silt deposit.

0.00 - 0.30m topsoil (removed)  
0.30 - 1.50m brown silty clay, becoming lighter with depth  
1.50 - 3.00m grey sandy silt  
3.00m trench base ( -0.5m OD)

The sandy silt was saturated and the trench face slumped during excavation so there was no opportunity to clean or examine the trench side. The soil was clearly composed of flat sediment lenses which extended deeper than the trench base and were apparently the product of marine deposition or freshwater deposition close to marine influence (the material was not submitted for analysis). It was not possible to establish the actual depth of the flood silts here or to determine the number of flooding episodes; no peat deposits were present.

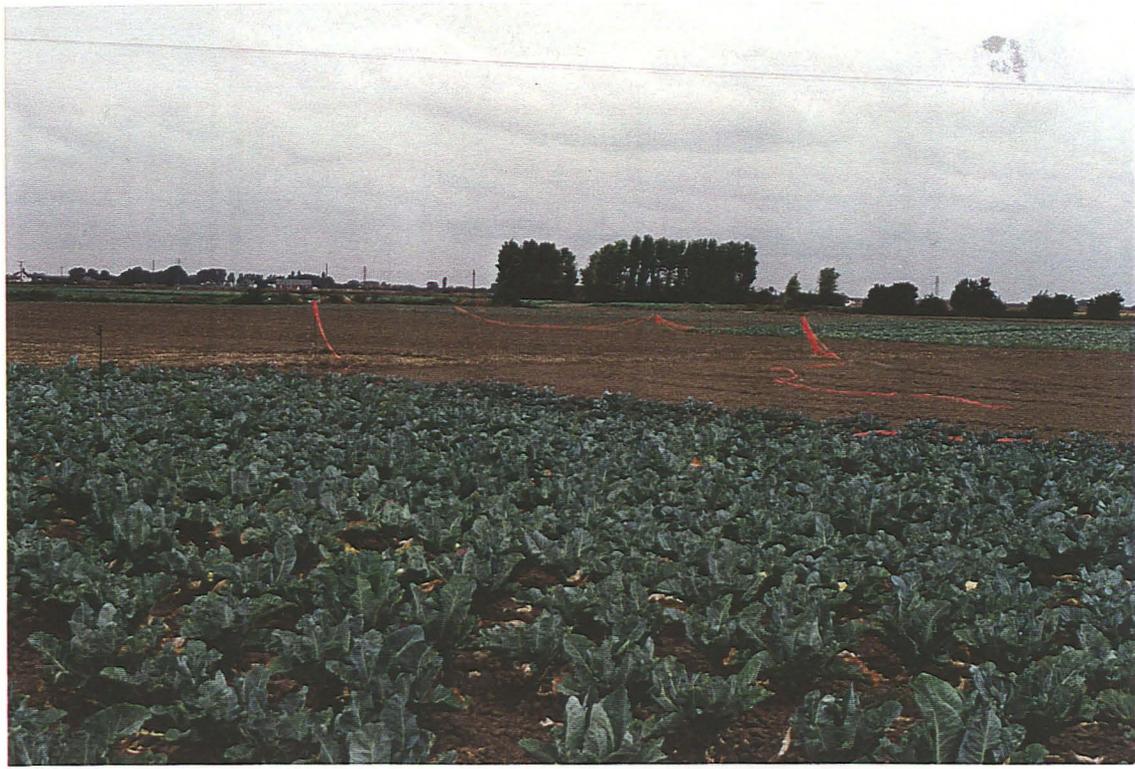
PI. 3 Looking NW along the centre of the pipeline easement (marked by fencing pins) towards the Swineshead STW (beyond the poplars) before topsoil stripping. The cauliflowers were at the eastern edge of Field 2, with seedlings to the west. Field 1 is beyond the low hedge.

The fields comprising most of the pipeline route were planted with young brassica crops at different stages of growth, but much of the field surface was visible (Pls. 3 and 4). An intensive fieldwalking exercise in advance of topsoil stripping recovered 32 sherds of medieval pottery from Field 2 but almost no trace of early activity in Field 1.

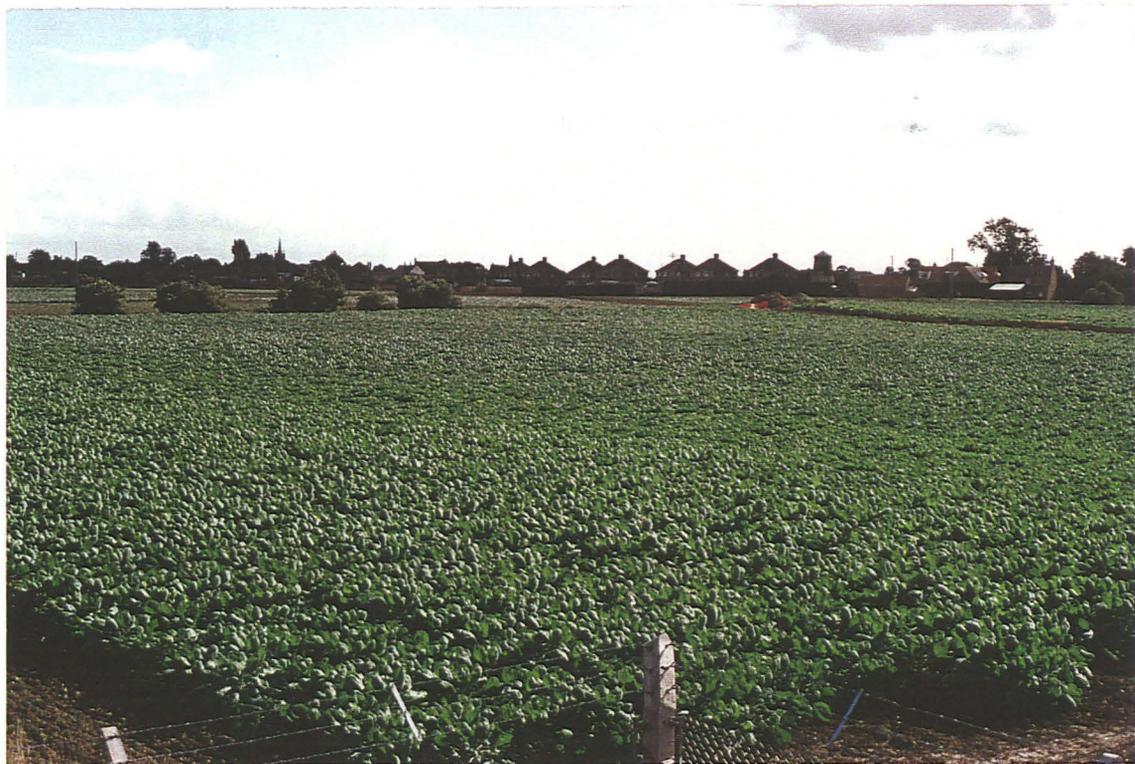
PI. 4 Looking SE from the STW extension to the line of the backfilled pipeline approaching Golden Cross public house. The plastic fencing marks the Field 1/ Field 2 ditch-line; the excavator is in Field 3.

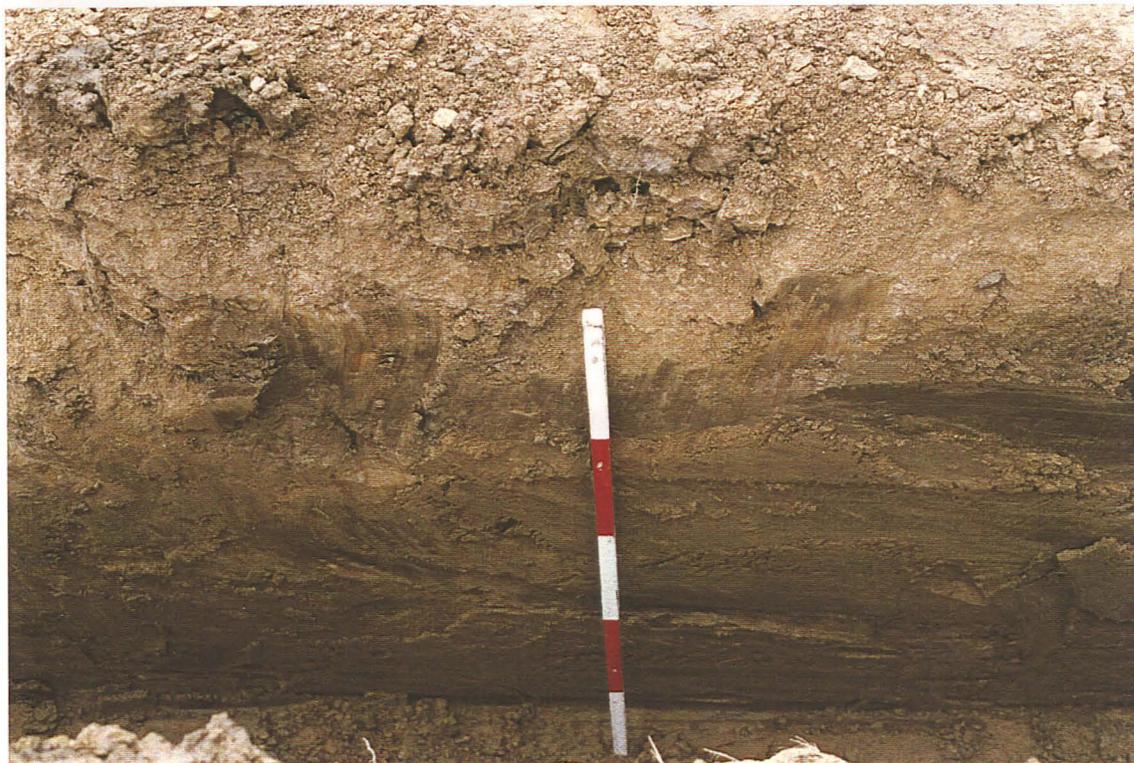
Pl. 5 Trench stratigraphy in Field 1 (ch. 580) showing layers of different coloured silts. Scale divisions 0.2m.

The stratigraphy revealed in the pipe trench close to its northern end was recorded; no archaeological features were noted in this field and the sequence represents natural deposits (Pl. 5)

0.00 - 0.25m topsoil  
0.25 - 0.40m brown silt  
0.40 - 0.55m light brown silt  
0.55 - 0.75m grey brown silt  
0.75m+ light brown silt

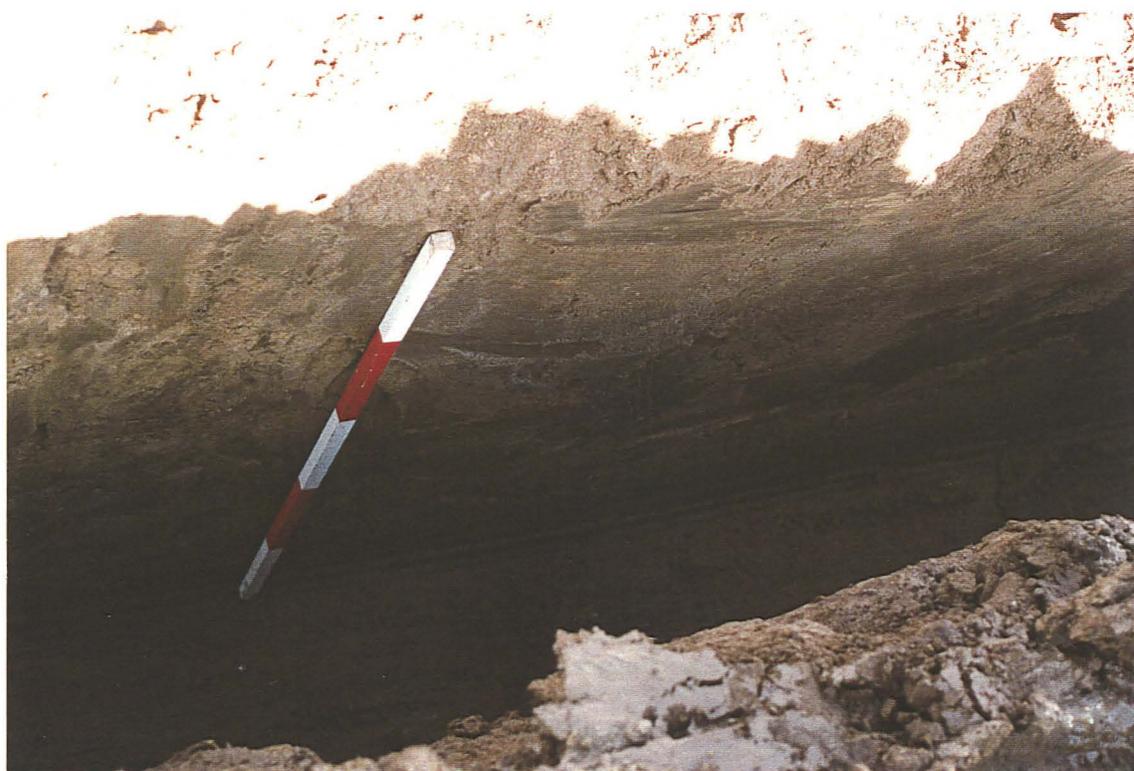
Pl. 6 Shallow ditch showing in the trench side at 2G; the darker fill contrasts with the light coloured flood silt layer. Scale divisions 0.2m.

A broad ditch, 5m wide and with a 1m thick fill of dark brown silt loam was seen (Pl. 6).

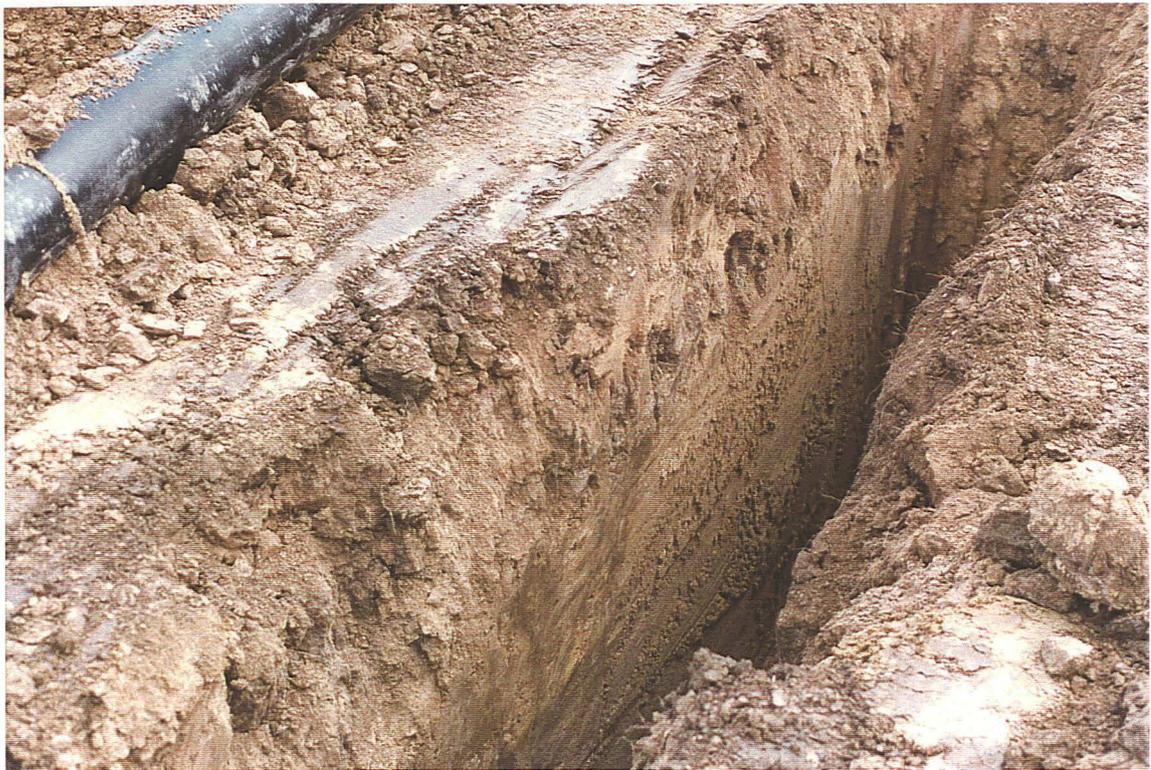
Pl. 7 Darker fill in the eastern side of a ditch at 2H (foreground), contrasting with the flood silt beyond. This is thought to be one of two post-medieval ditches flanking the position of a former farm track.

Two ditches with similar characteristics and fills were recorded. Each was 6m wide with its base 1.5m below the stripped easement. The latest surviving fill was dark brown silty clay above an earlier grey/brown silt with infrequent shell fragments. A small number of post-medieval and modern pottery sherds

were seen but not collected. These ditches probably define a NE-SW aligned post-medieval trackway between fields (Pl. 7).

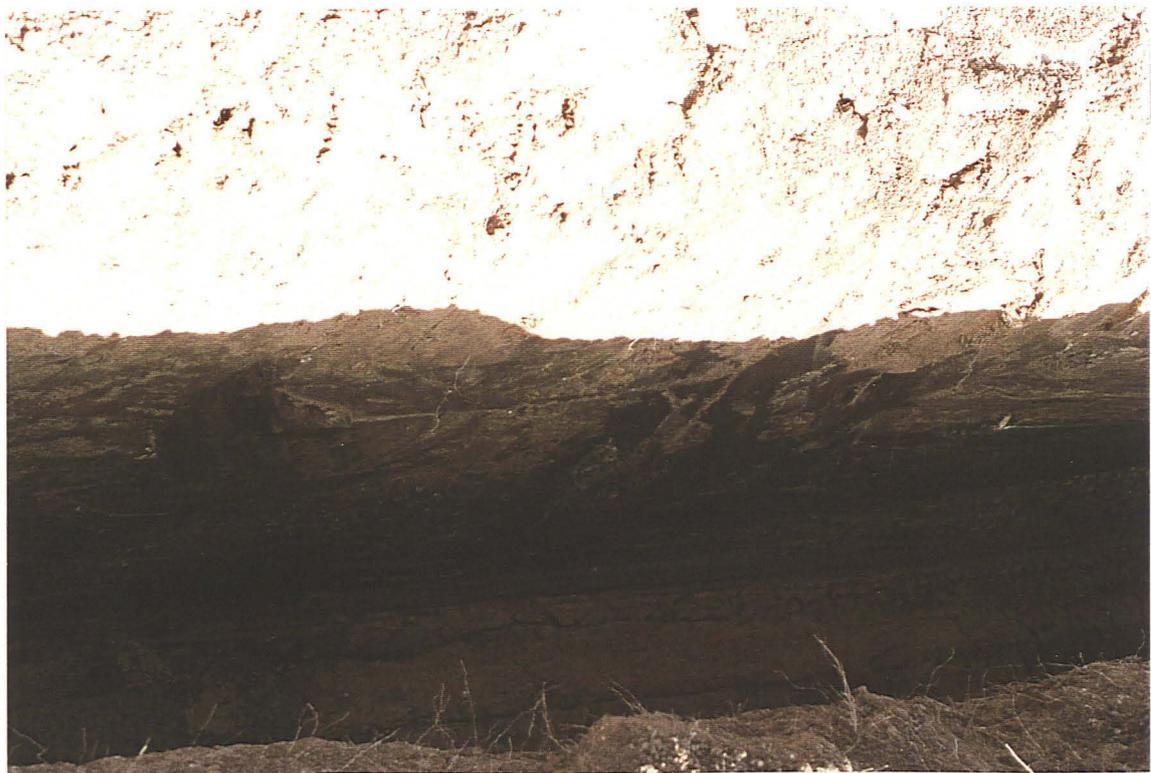
Pl. 8 Black primary fill of a deep ditch at 3C (at trench base) containing charcoal, fired clay fragments and other signs of a nearby fire.

A ditch, about 2m wide and 1.45m deep, was cut through light brown silt (Pl. 8). The top 1.15m of its fill was dark brown clay and a whetstone was found from it; the primary fill was black, with an animal bone fragment, fired clay and burnt material. The whetstone could not be dated on typological grounds more precisely than after the 9th century AD.

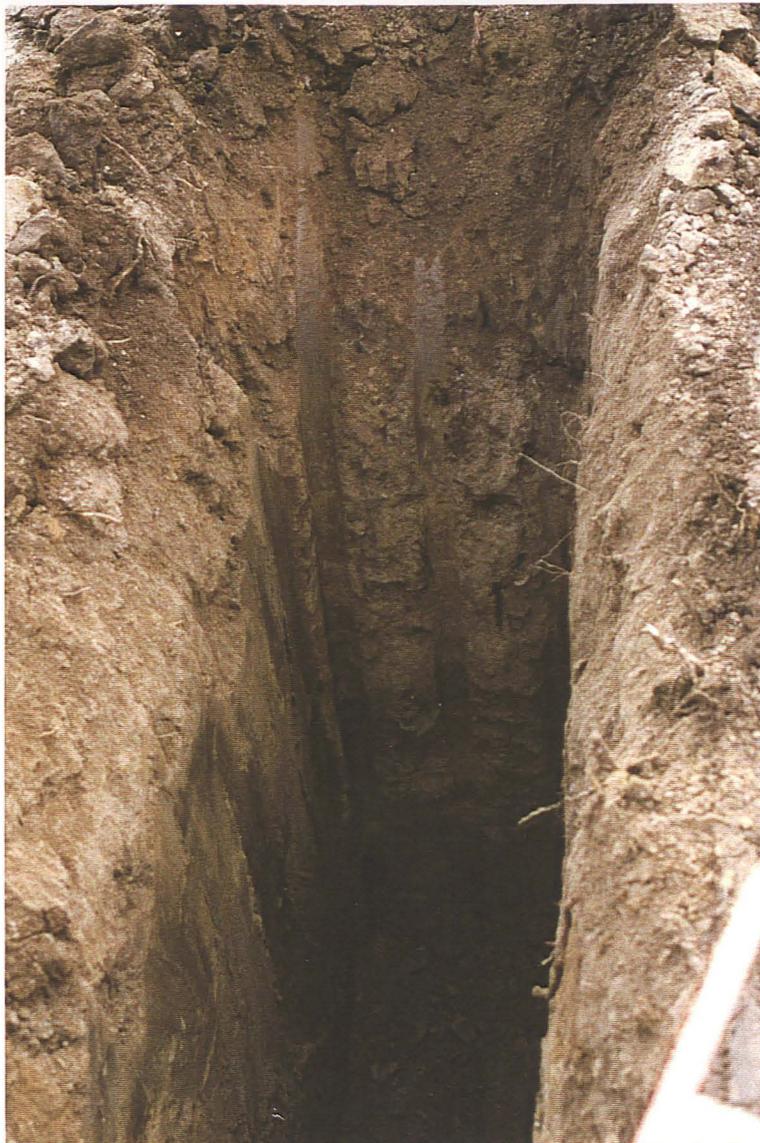
Pl. 9 Grey silt with shell inclusions seen near the top of the trench at 4E, thought to be a fill of a post-medieval ditch.

A ditch 1.5m wide, and greater than 1.6m deep was observed. The latest fill was light brown silt, sealing earlier dark brown fills (Pl. 9).

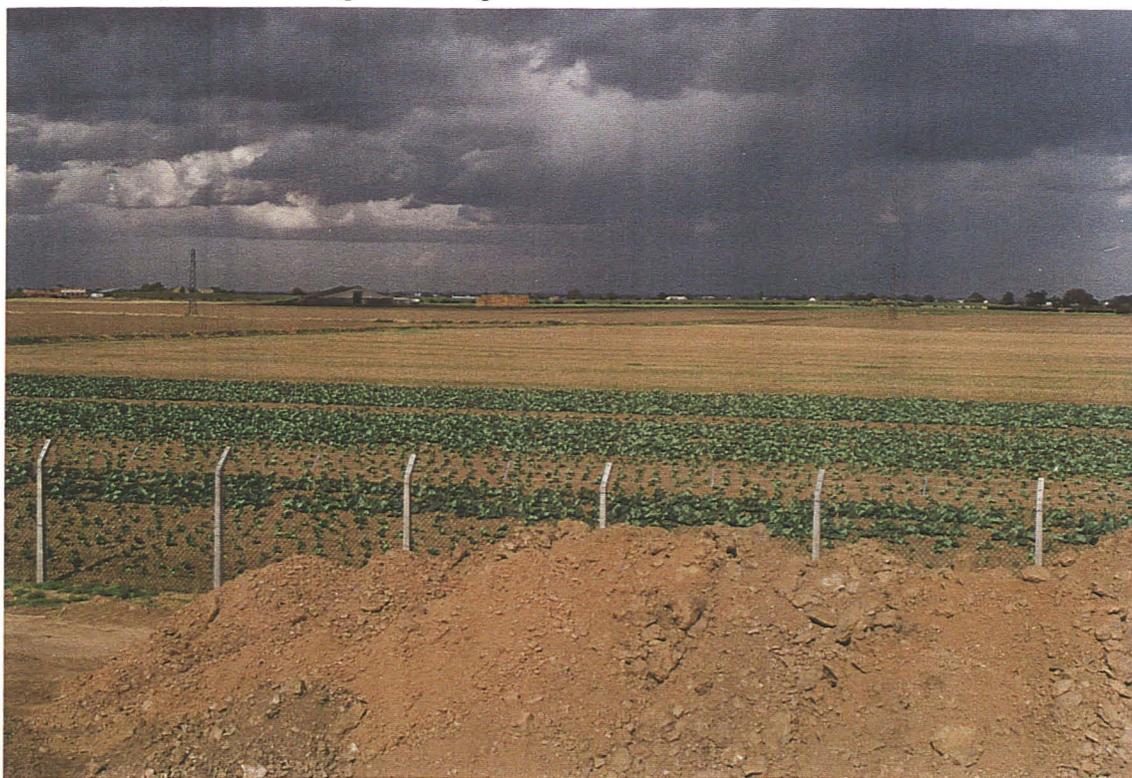
Pl. 10 View to north from STW extension area. Romano-British pottery has been reported from this area, probably disturbed from deep deposits during cleaning of Hammond Beck (centre left).
