BRANSTON CHURCH HALL, BRANSTON

Site Code: BCH 95 CCM Accession Number 208.95 Lincolnshire County Council
Archaeology Section
12 Friars Lane
LINCOLN LN2 5AL
TEL. 0522 575292 FAX: 0522 530724

BRANSTON CHURCH HALL

AN ARCHAEOLOGICAL WATCHING BRIEF REPORT

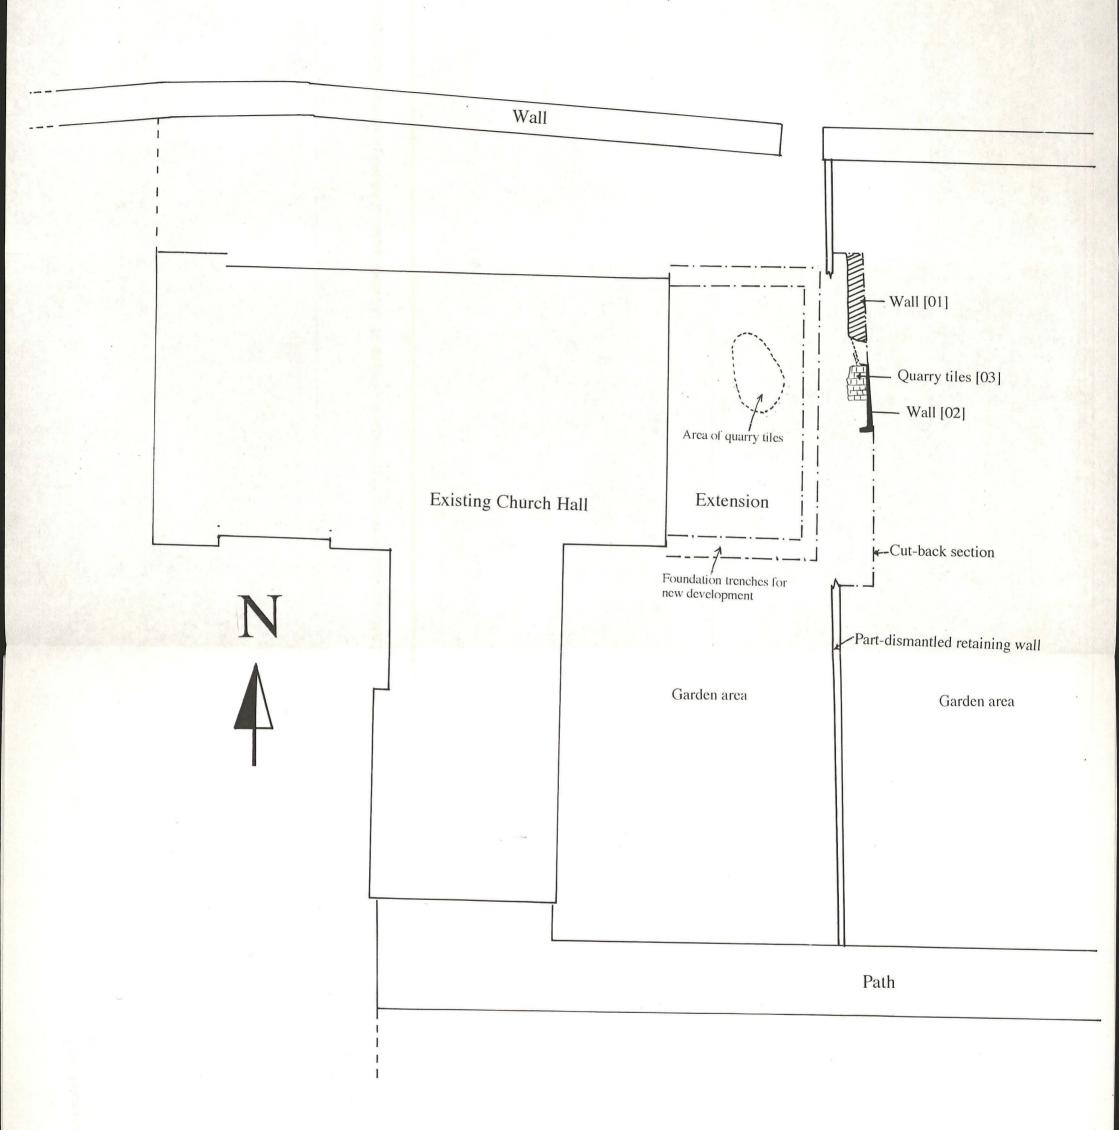
Fig. 2 1:100 site plan incorporating location of archaeological features exposed by cut-back east section

Groundwork involved the partial removal of a north-south retaining wall which marked the east boundary to the hall garden (the wall, which measured c. 1.0m in height, was apparently built in the mid-1980's as part of a Community Project). The exposed section face was cut-back by approximately 1.0m: this largely involved the removal of loose soil and limestone rubble which had been used to fill a void on the east side of the wall (ie its construction trench). On the north side of this section, two post-medieval walls were exposed: one made from stone, the other of brick.

The stone wall, [01], lay at the extreme north end of the section, and it continued northwards beyond the area investigated. A length approximately 2.3m was exposed within the cutting, which survived to four courses and measured c. 0.5m in height. It was made from crudely-dressed limestone blocks, bonded with soft lime mortar. Only its west face was exposed and this was partially concealed behind a veneer of wall plaster. The plaster was in fact secondary to the wall - it was part-destroyed and incorporated within a later brick-built structure. Embedded in the lower face of the stone wall was a single sherd of later post-medieval white china.

The later structure was represented by a well-preserved, short stretch (1.8m) of brick work, [02]; a westerly return of which lay on its south side. The brickwork survived to a height of 0.8m, and was bonded with lime-based mortar. The exposed west face was part-covered behind a veneer of plaster identical to that on wall [01]. Cleaning at basal level (between the two walls) revealed a line of plaster which connected the walls; thereby suggesting that the stone wall had been part-demolished and incorporated as part of the later build.

The brick wall section was butted by a small, discreet area of red quarry tiles, [03] (each tile 18cm x 18cm x 4cm) and, in places, the basal line of plaster described above was also butted by fragments of tiles. The tiles themselves were bedded on a thin deposit of lime mortar. Further patches of tile flooring were observed within the actual new building plot, though the movement of machinery precluded detailed inspection in this area.

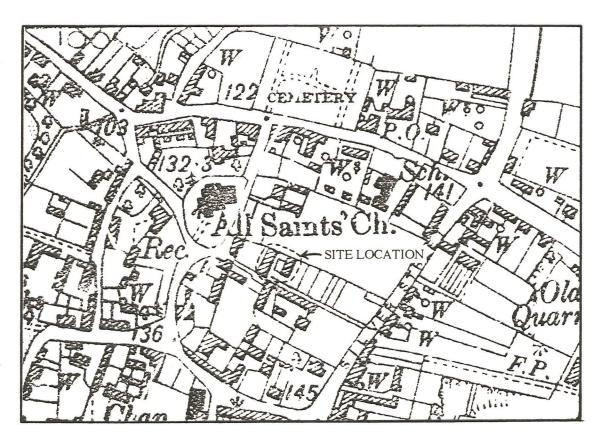
Extract, 2nd Edition Ordnance Survey

The Ordnance Survey 2nd edition (surveyed 1886, revised 1904) shows that the site of the present church hall/garden was occupied by buildings, and it is suggested that features exposed during the present watching brief belonged to these structures. Unfortunately, the latest edition of the Ordnance Survey 1:10,000 does not include the present church hall, rendering further identification difficult.

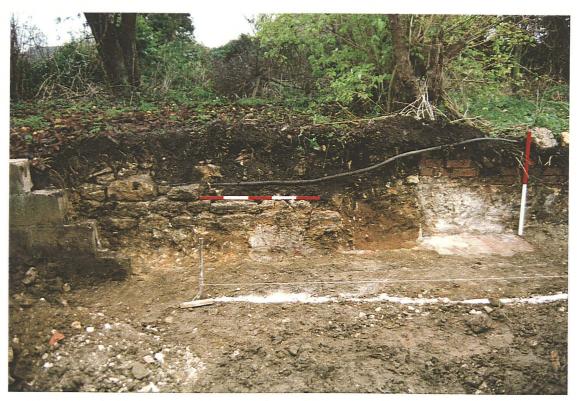
Photo. 1 General view of features exposed in cut-back east section, looking east

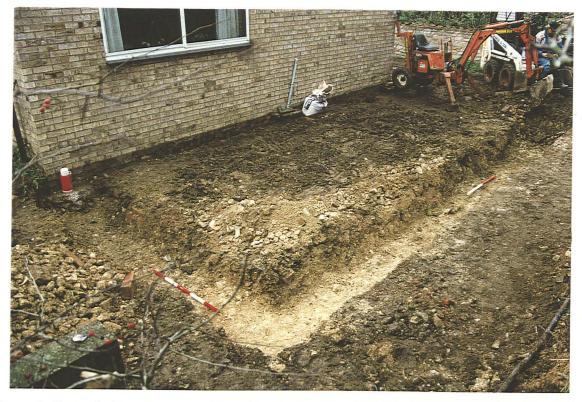
Photo. 2 General view of construction trenches for Church Hall extension, looking north-west

Construction trenching commenced on the south side of the plot and progressed northwards. The density of the parent bedrock meant that progress was slow. No archaeological features had been cut through the bedrock.

Construction trenches measured approximately 60cm in width and were excavated to a depth c. 35 - 40cm beneath the top of the limestone. The watching brief was terminated upon the completion of construction trenching.
