## **Old Bolingbroke Electricity Rebuild:**

### **Archaeological Monitoring of New Transmission Pole Holes near Southfield Farm, Mavis Enderby**

Report prepared for East Midlands Electricity

**February 1996**

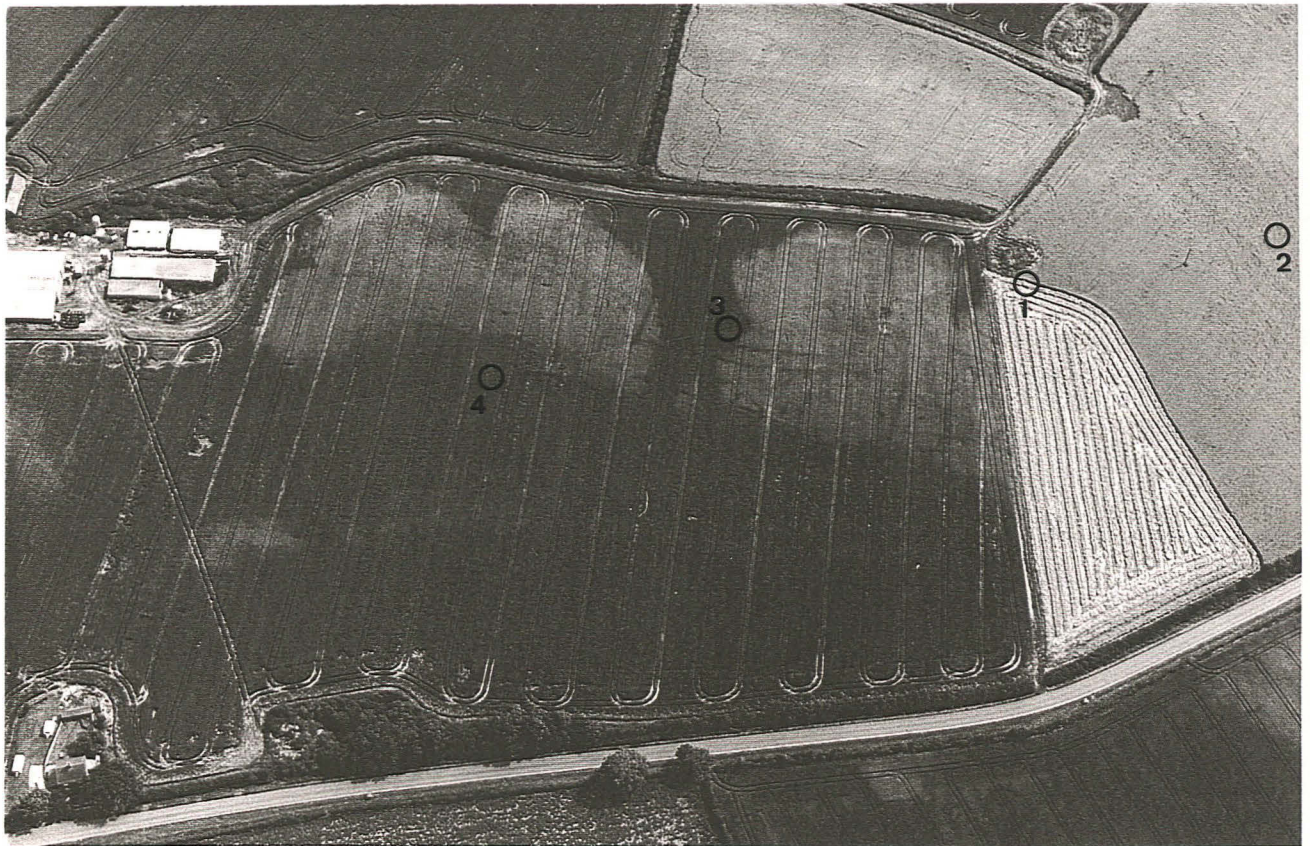
Pl. 1 Cropmarks of archaeological features to the west of Southfield Farm, Mavis Enderby. The existing transmission lines cross the centre of the photograph; The approximate locations of the new poles are marked. (Photograph CDC SF 3213/3 [26.7.86]; Copyright reserved).

A cropmark complex in the fields between Southfield Farm, Mavis Enderby and Highfield Farm, Old Bolingbroke was photographed from the air by Chris Cox in 1986 and has recently been plotted by the RCHME Lincolnshire Mapping Project (Pl. 1; Fig. 3). From the shape of the visible features (ditched trackways and rectangular small fields) the site had been thought to be a Romano-British rural settlement site but no finds had been recorded from the site.

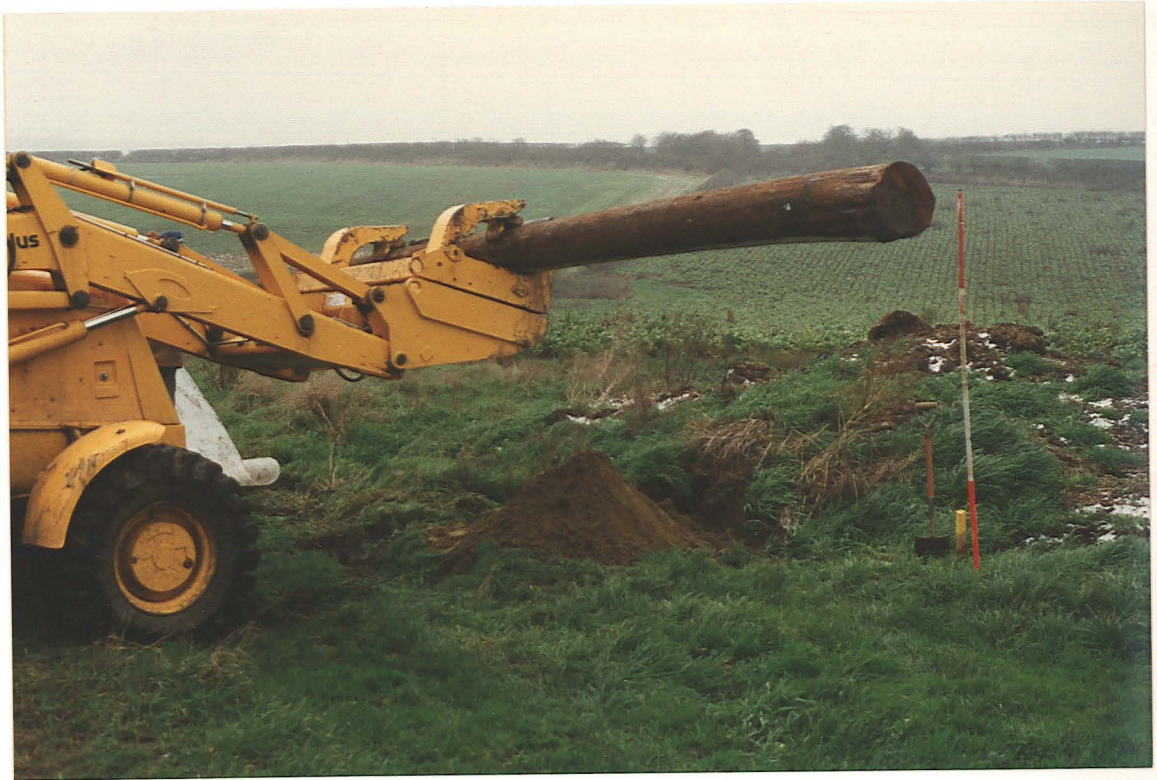
Pl. 2 Location of Pole 1 (looking SE)

This pole location was on a ridge beside a farm track and a muck heap (Pls. 2 and 3). The subsoil was dark red-brown sandy loam which overlay a thick green sand deposit containing pieces of orange sandstone. No archaeological remains were found during the augering of the hole.

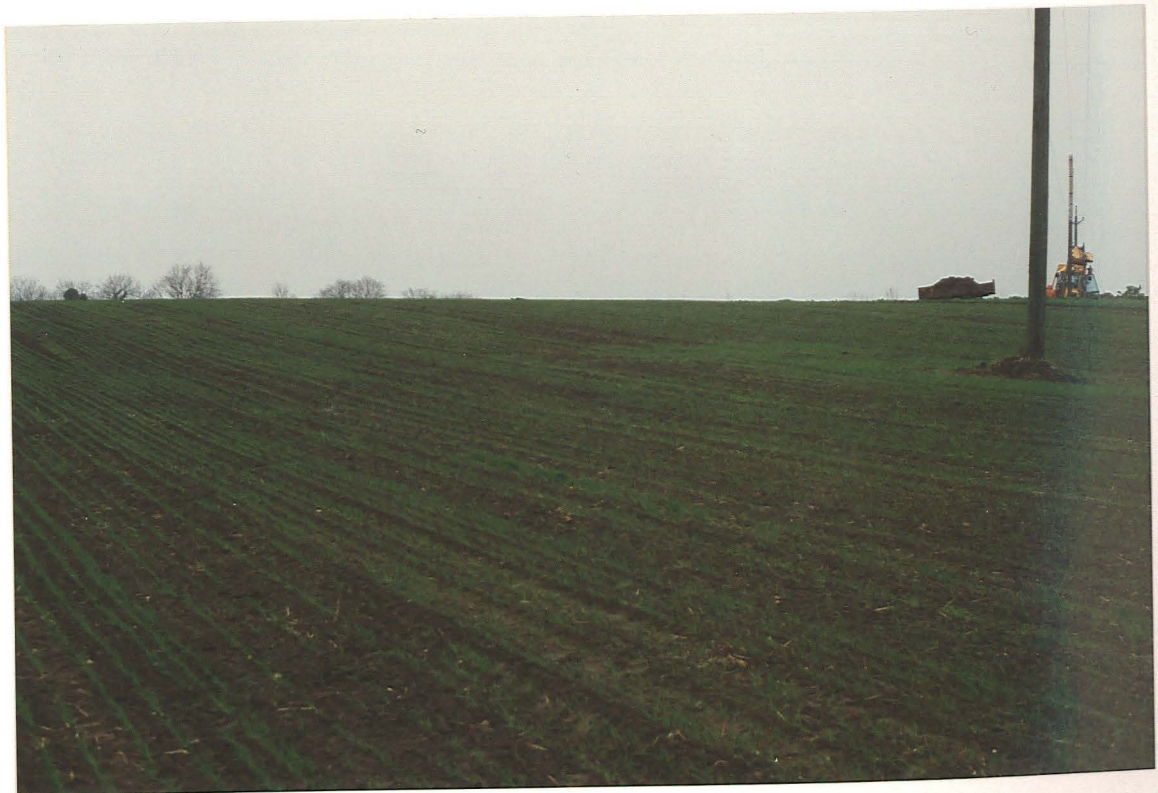
Pl. 3 Pole 1 (beside JCB) looking NE up slope from site of Pole 2

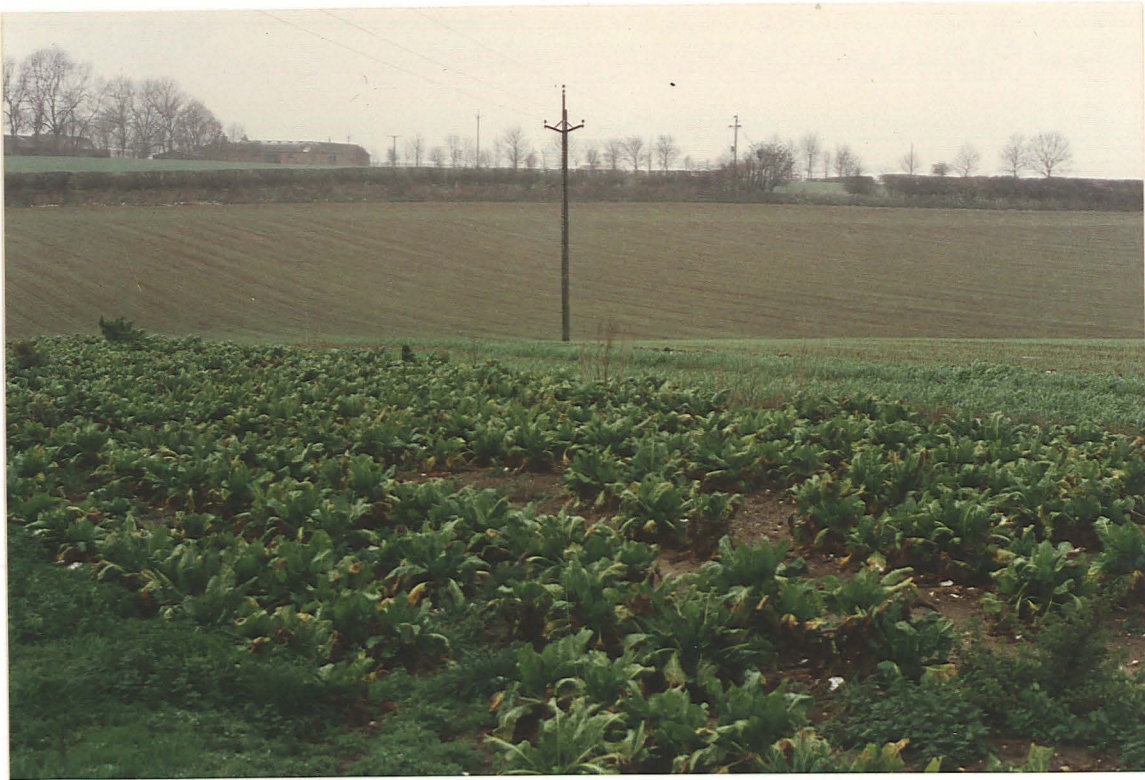
PI. 4 Pole 2 was sited in the base of the west-east depression between the existing poles (looking NE from Pole 1)

The second monitored hole lay to the SW of 1, at the base of a pronounced NW-SE depression thought to be of natural origin (Pl. 4). The sequence of deposits visible in the spoil was:

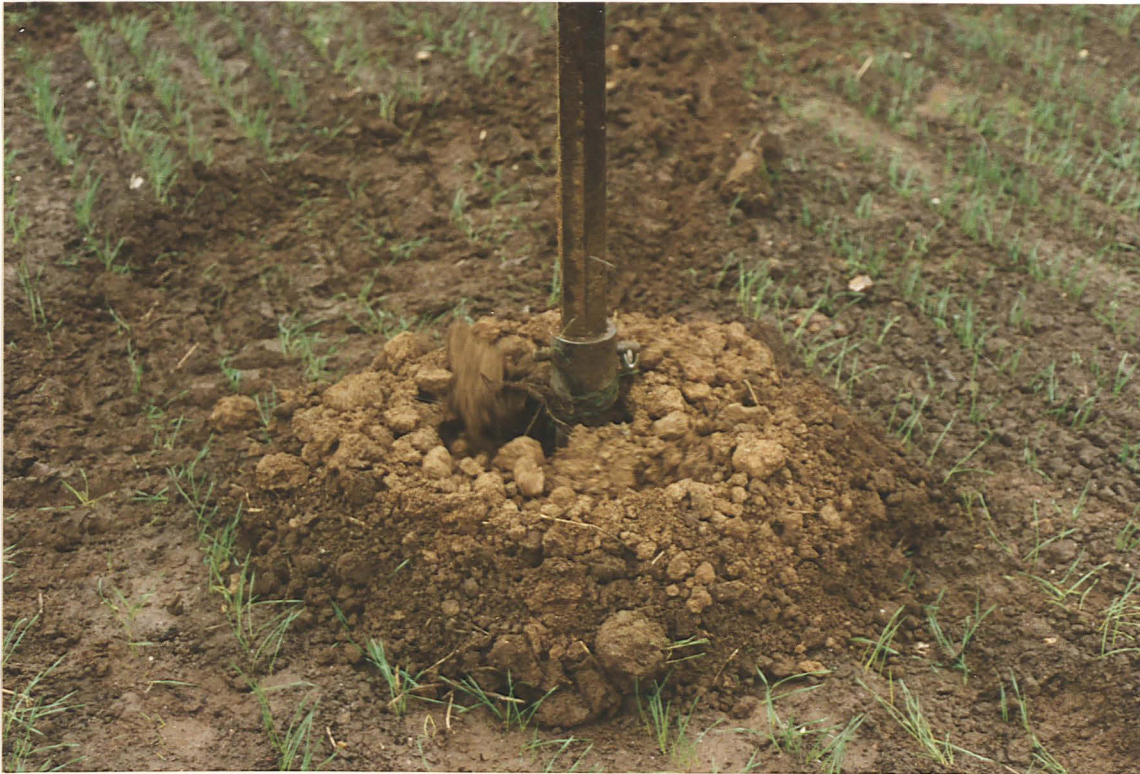
PI. 5 Subsoil disturbed during augering for Pole 2

grey clay (from about 1m below the ground surface to the hole base at 2.1m deep) (Pls. 5 and 6).

The grey clay was interpreted as a formerly waterlogged deposit of glacial or post glacial date. No archaeological remains were found at this pole location.

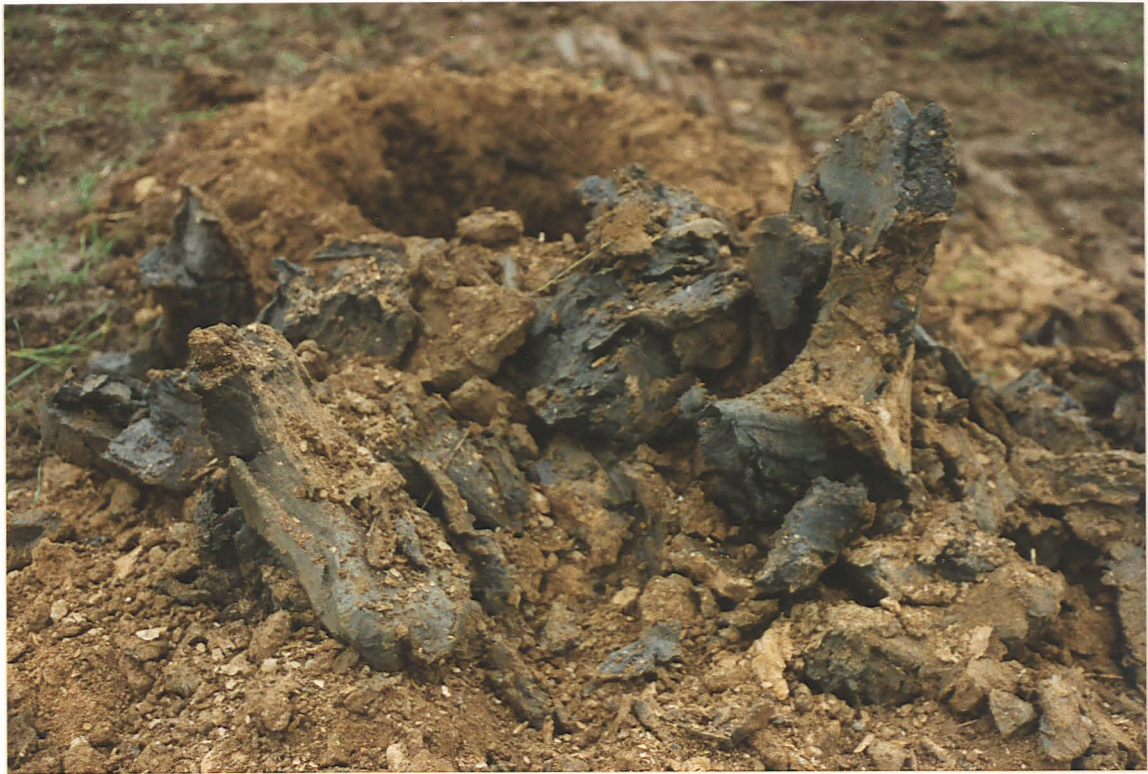
PI. 6 Grey clay beneath the sandy subsoil at Pole 2

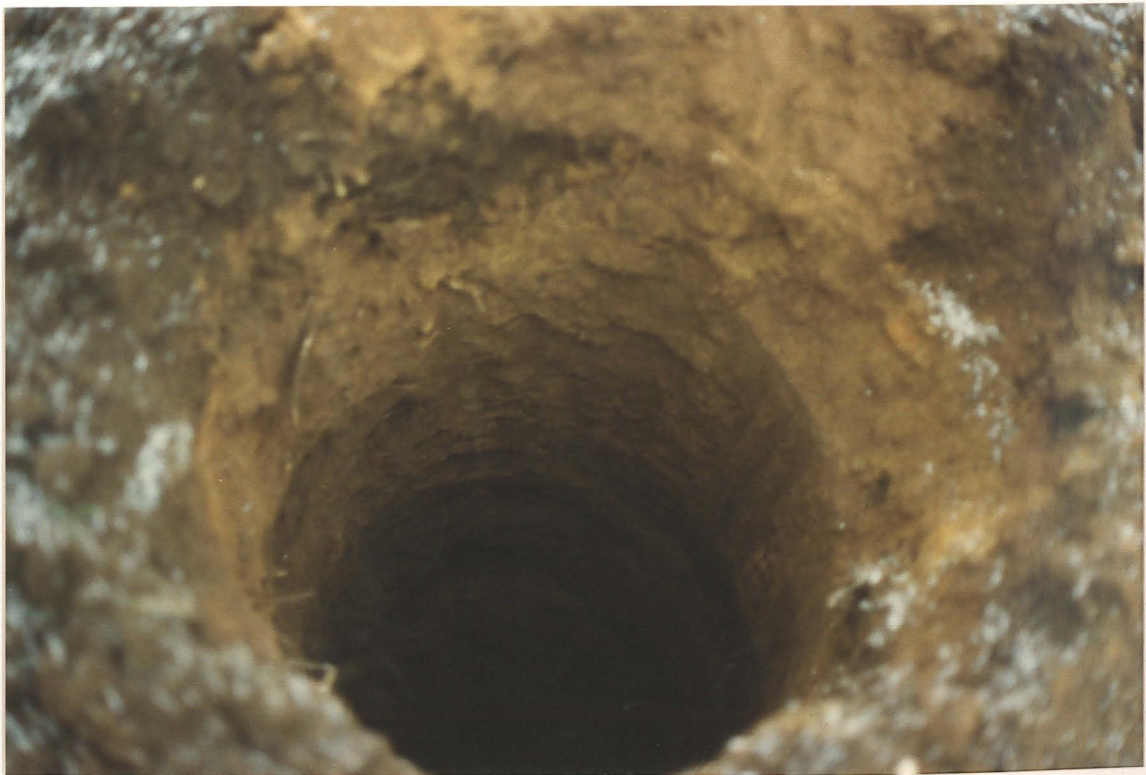
PI. 7 No archaeological features could be seen in the smeared sides of the augered hole at Pole 3

During the augering of this hole, 9 Romano-British pottery sherds were disturbed including one unabraded larger sherd (Appendix 1). The sequence of deposits here was:

The ironstone pieces on the field surface were irregular and not dressed but may have come from a demolished structure. The stratified pot sherd indicated that this hole had either cut through a buried archaeological feature or that the ground level had become raised since the Romano-British period.

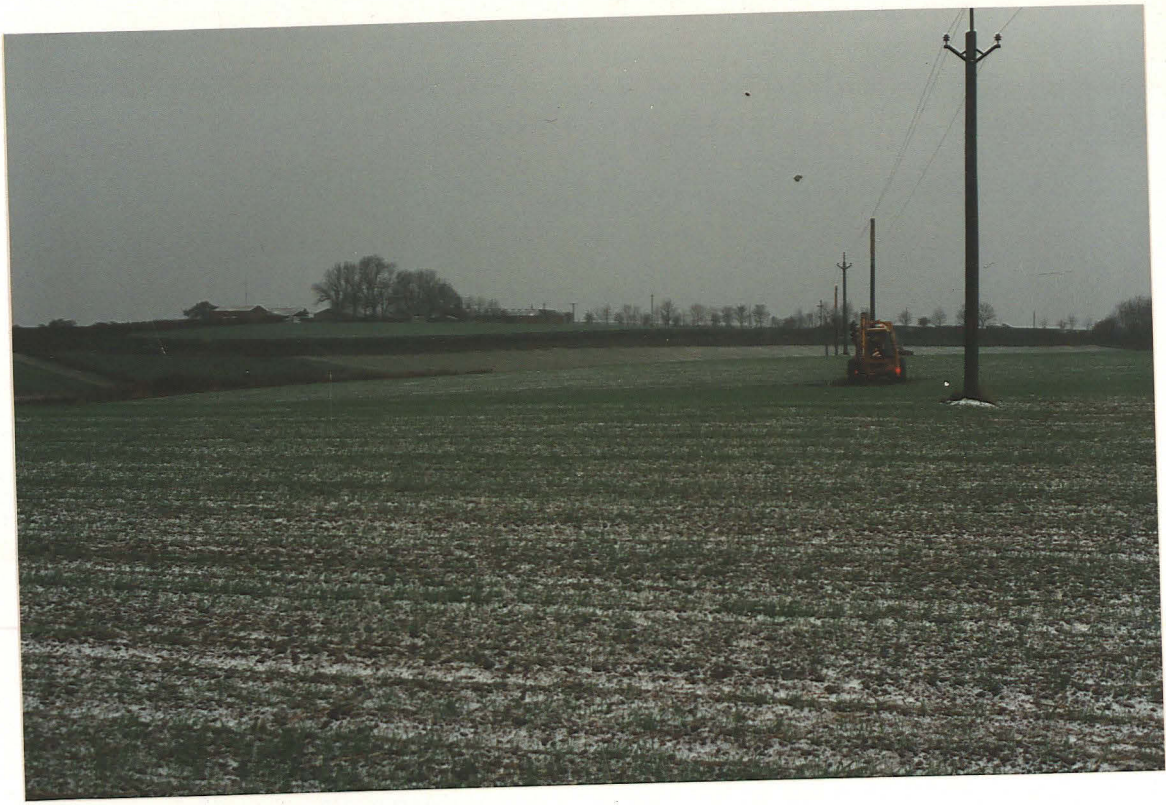
PI. 8 Location of Pole 3 (looking NE)

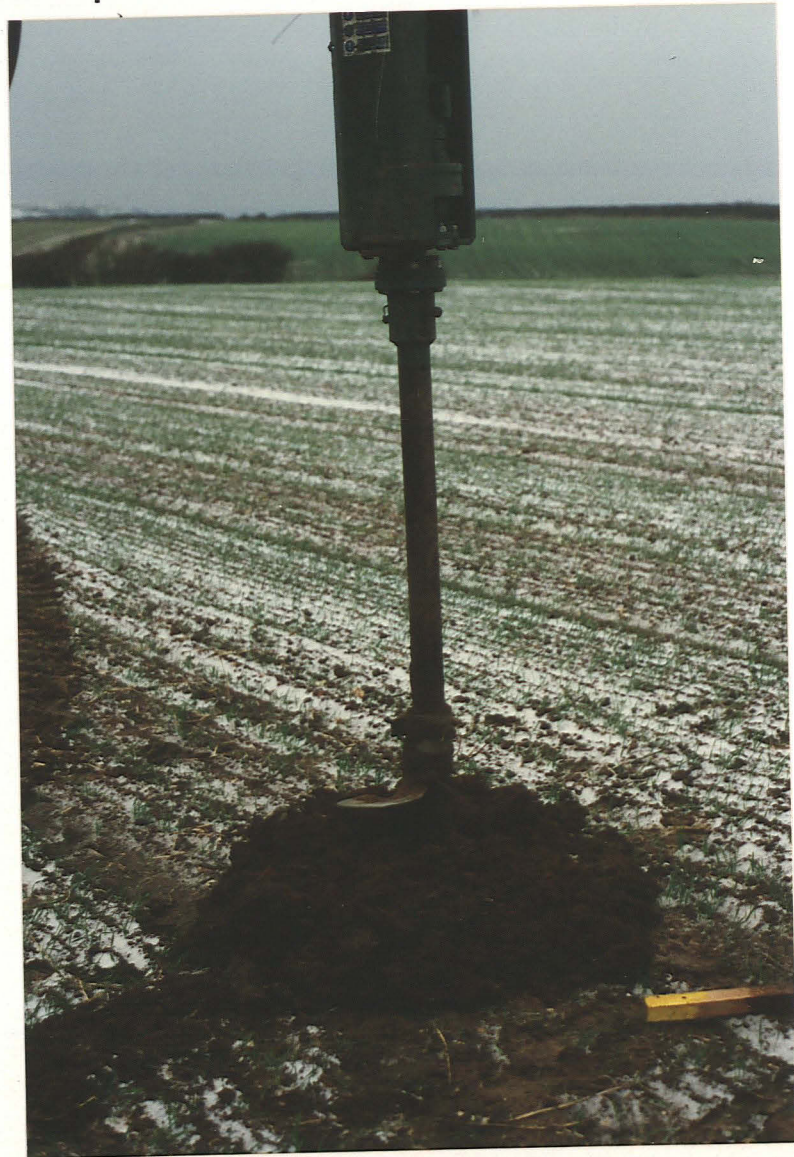
PI. 9 Dark brown topsoil and subsoil at Pole 4

No archaeological remains were found at this pole location, the last to be monitored and the most easterly of the group .

The sequence of deposits within the hole was:

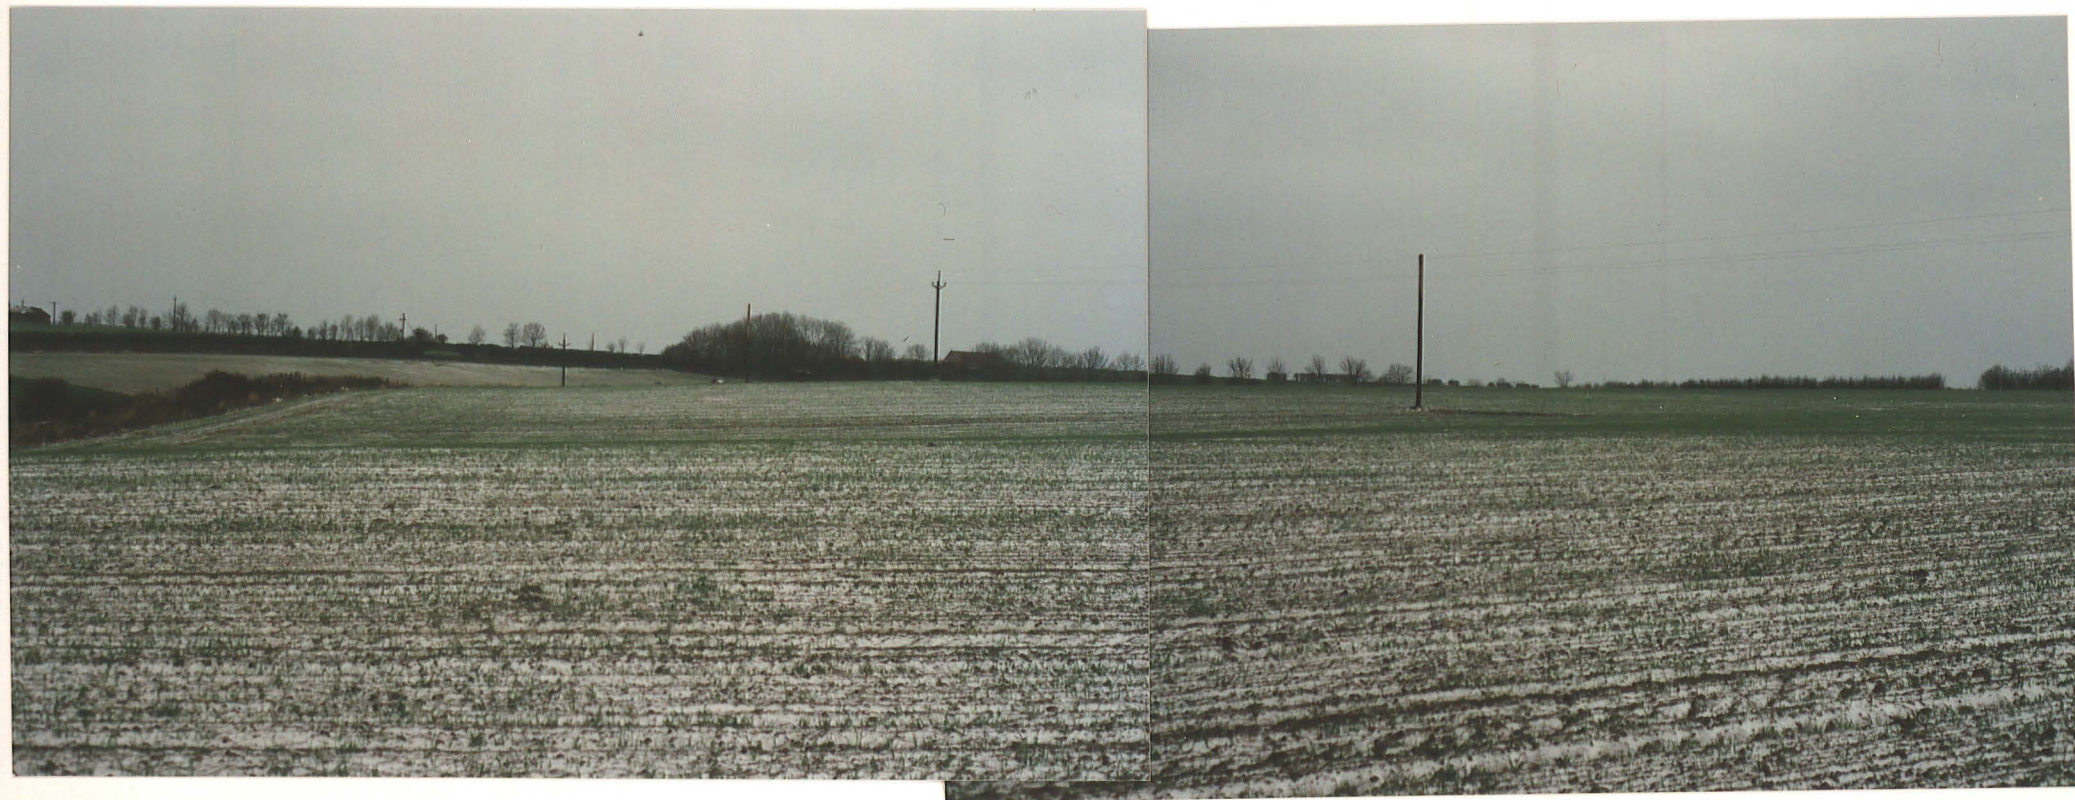
PI. 10 Panoramic view of the field surface near Pole 3 (looking west;  
Highfield Farm on left edge)

The Romano-British pottery confirmed the interpretation of the air photographs that a settlement site of that date is located in the vicinity of Pole 3. It is likely that features survive beneath the ploughsoil (as shown on the photograph) and are associated with dateable material including pottery. Structural remains may still be present, as indicated by the sandstone pieces on the field surface. There may even be vestigial physical traces of archaeological features such as ditches and banks showing as low ridges on the field surface at ground level (Pls. 10, 11 and 12).

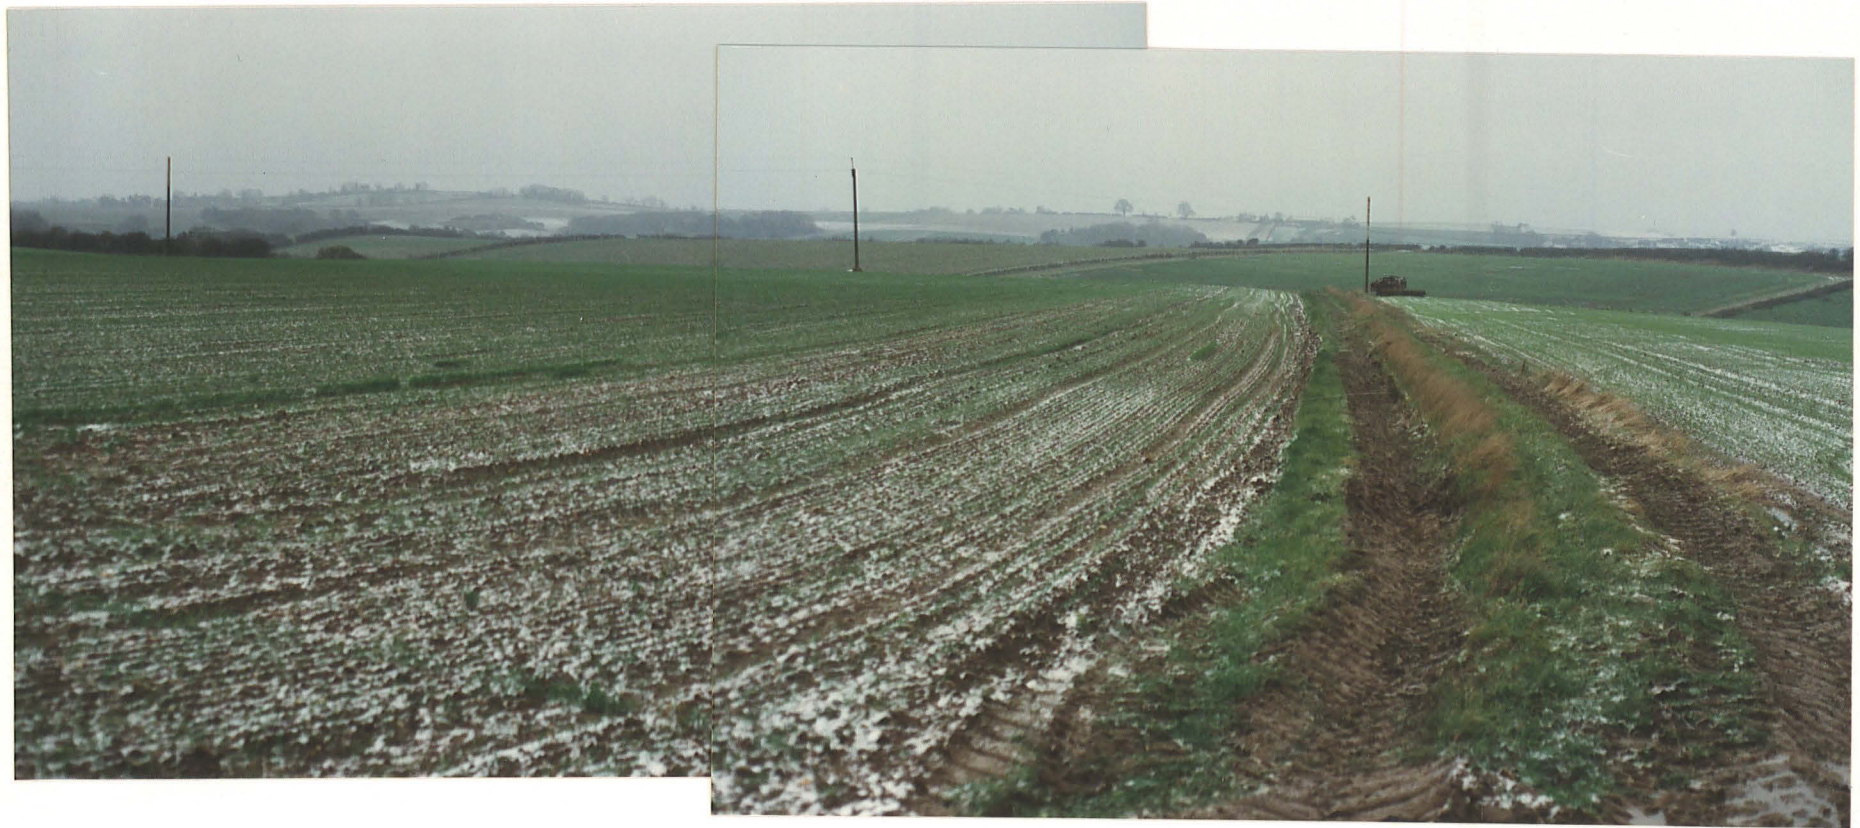
Pl. 11 Panoramic view, looking south; Pole 1 is beside the track, Pole 3 on the left. A slight ridge can be seen in front of the poles.

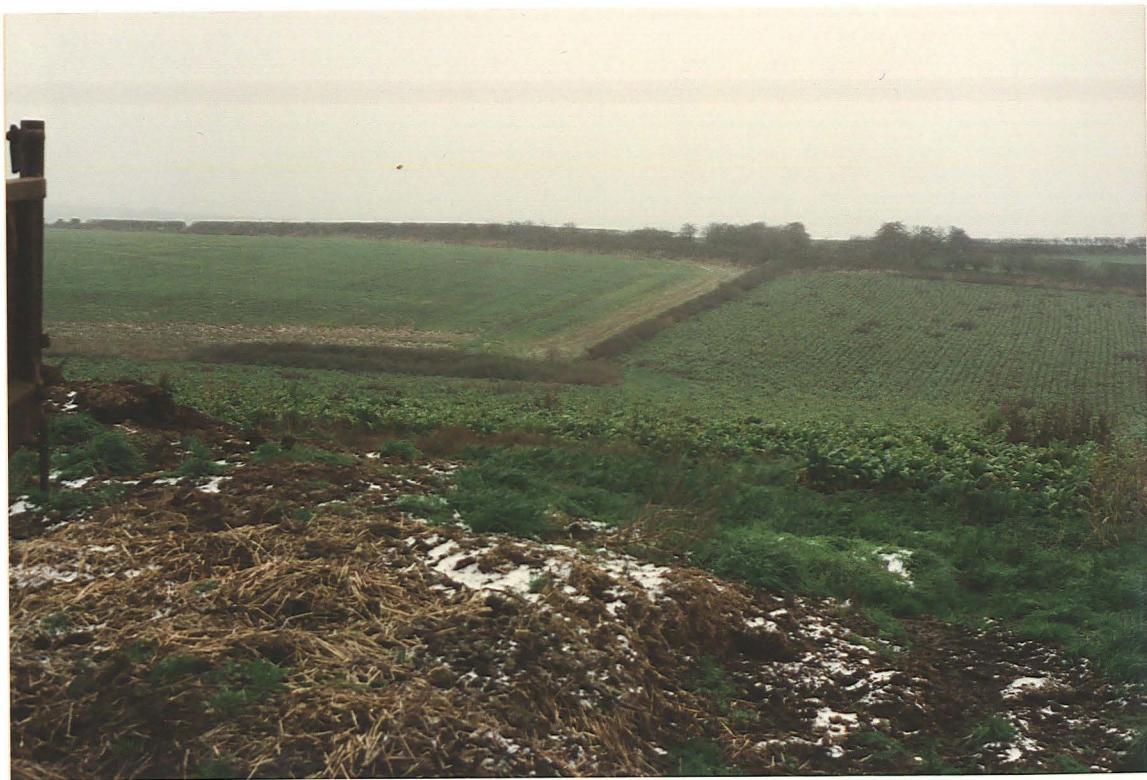
Pl. 12 Undulations in the fields to the SE (looking south from Pole 1)
