PROPOSED RESIDENTIAL DEVELOPMENT SITE OF NAAFI DISTRIBUTION CENTRE LINCOLN ROAD, NORTH HYKEHAM

ARCHAEOLOGICAL WATCHING BRIEF (INTERIM REPORT)

Proposed Residential Development Lincoln Road, North Hykeham Archaeological Watching Brief

Planning Application No: 43/1182/94 NGR : SK 948665 Site Code : HLR 95 LCNCC Accession No. : 113.95

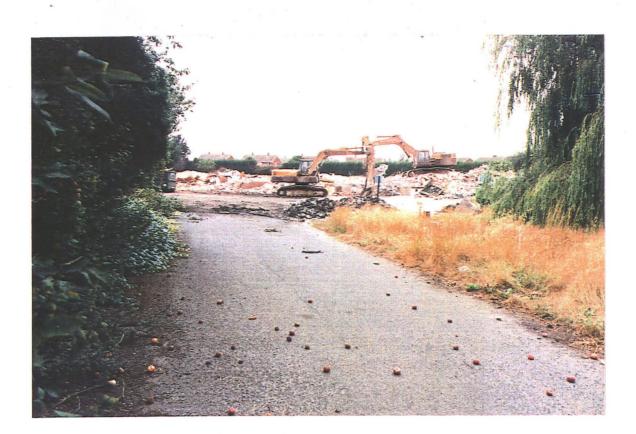
- PI. 1 General view from one of existing access roads; looking north-west towards depot during demolition.
- PI. 2 Detail of demolition in progress; looking north-west.

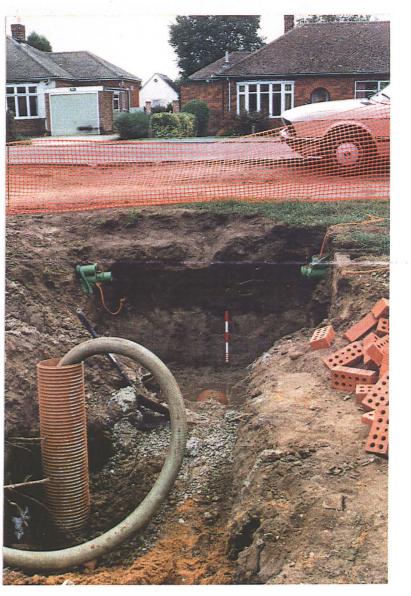
- PI. 3 North-west facing section at Observation Point 1; looking south-east. Scale 0.50m.
- PI. 4 As PI. 3; detail.

This was located at the south-east end of the sewer trench running along the proposed main access road (Fig 2B). The exposed section was cleaned by hand, and revealed four layers (PIs.3-4):

turf (0.30m thick) topsoil (grey-brown sandy loam; 0.22m thick) alluvium (grey-brown sandy silt with orange mottling; 0.24m thick); natural sand (pale grey sand with some orange-brown iron mottling, greyer with depth; at least 0.50m thick).

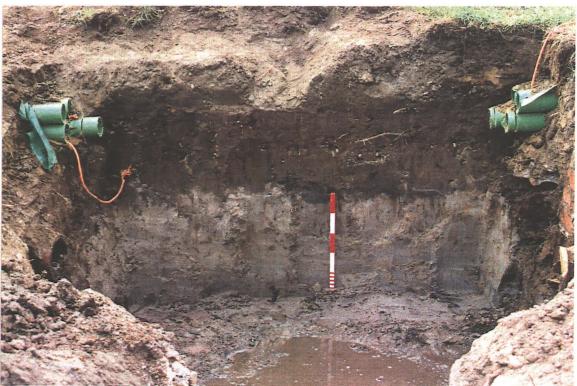
- PI. 5 North-east facing section at Observation Point 2; looking south-west. Scale 0.50m.
- PI. 6 General view of service trench with Observation Point 3 in left foreground. Note previously disturbed ground in trench section just beyond Observation Point 3. Looking north. Scale 0.50m.

This was located further north along the main access road on the west side of the same sewer trench (Fig 2B; PI.5). Here, the exposed section, though less clear due to machine smearing, appeared to display the same sequence of deposits as at Point 1.

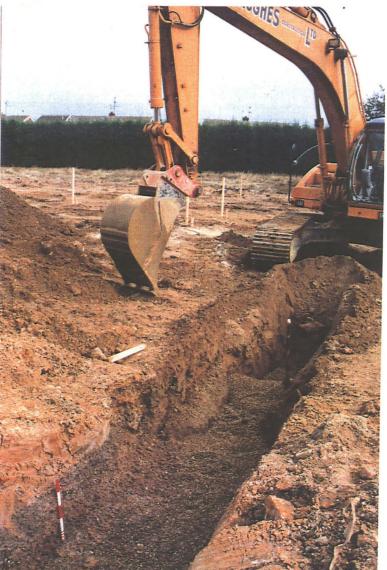
PI. 7 South-east facing section at Observation Point 3. Looking north-west. Scale 0.50m.

The sewer trench containing Point 3 ran south-west to north-east along the line of the side road (Fig 2B; PI.6). The sequence of deposits revealed here was unlike that at Observation Points 1 and 2. The NAAFI building had overlain this area and all trace of turf or topsoil had been removed. The surviving uppermost layer was 0.30m-0.50m of orange-grey sandy clay (PI.7). Beneath this was a series of fairly compact brownish-grey or orange-brown gravels containing lenses of sand and silty clay and occasional organic remains (twigs, roots *etc.*). The gravel measured at least 0.50m thick, and appeared to continue below the base of the sewer trench.
