**ARCHAEOLOGICAL WATCHING BRIEF
OF A WATER PIPELINE TRENCH
HACCONBY DROVE,
HACONBY
LINCOLNSHIRE
(HAC96)**

Work Undertaken For
Anglian Water Services Ltd

April 1996

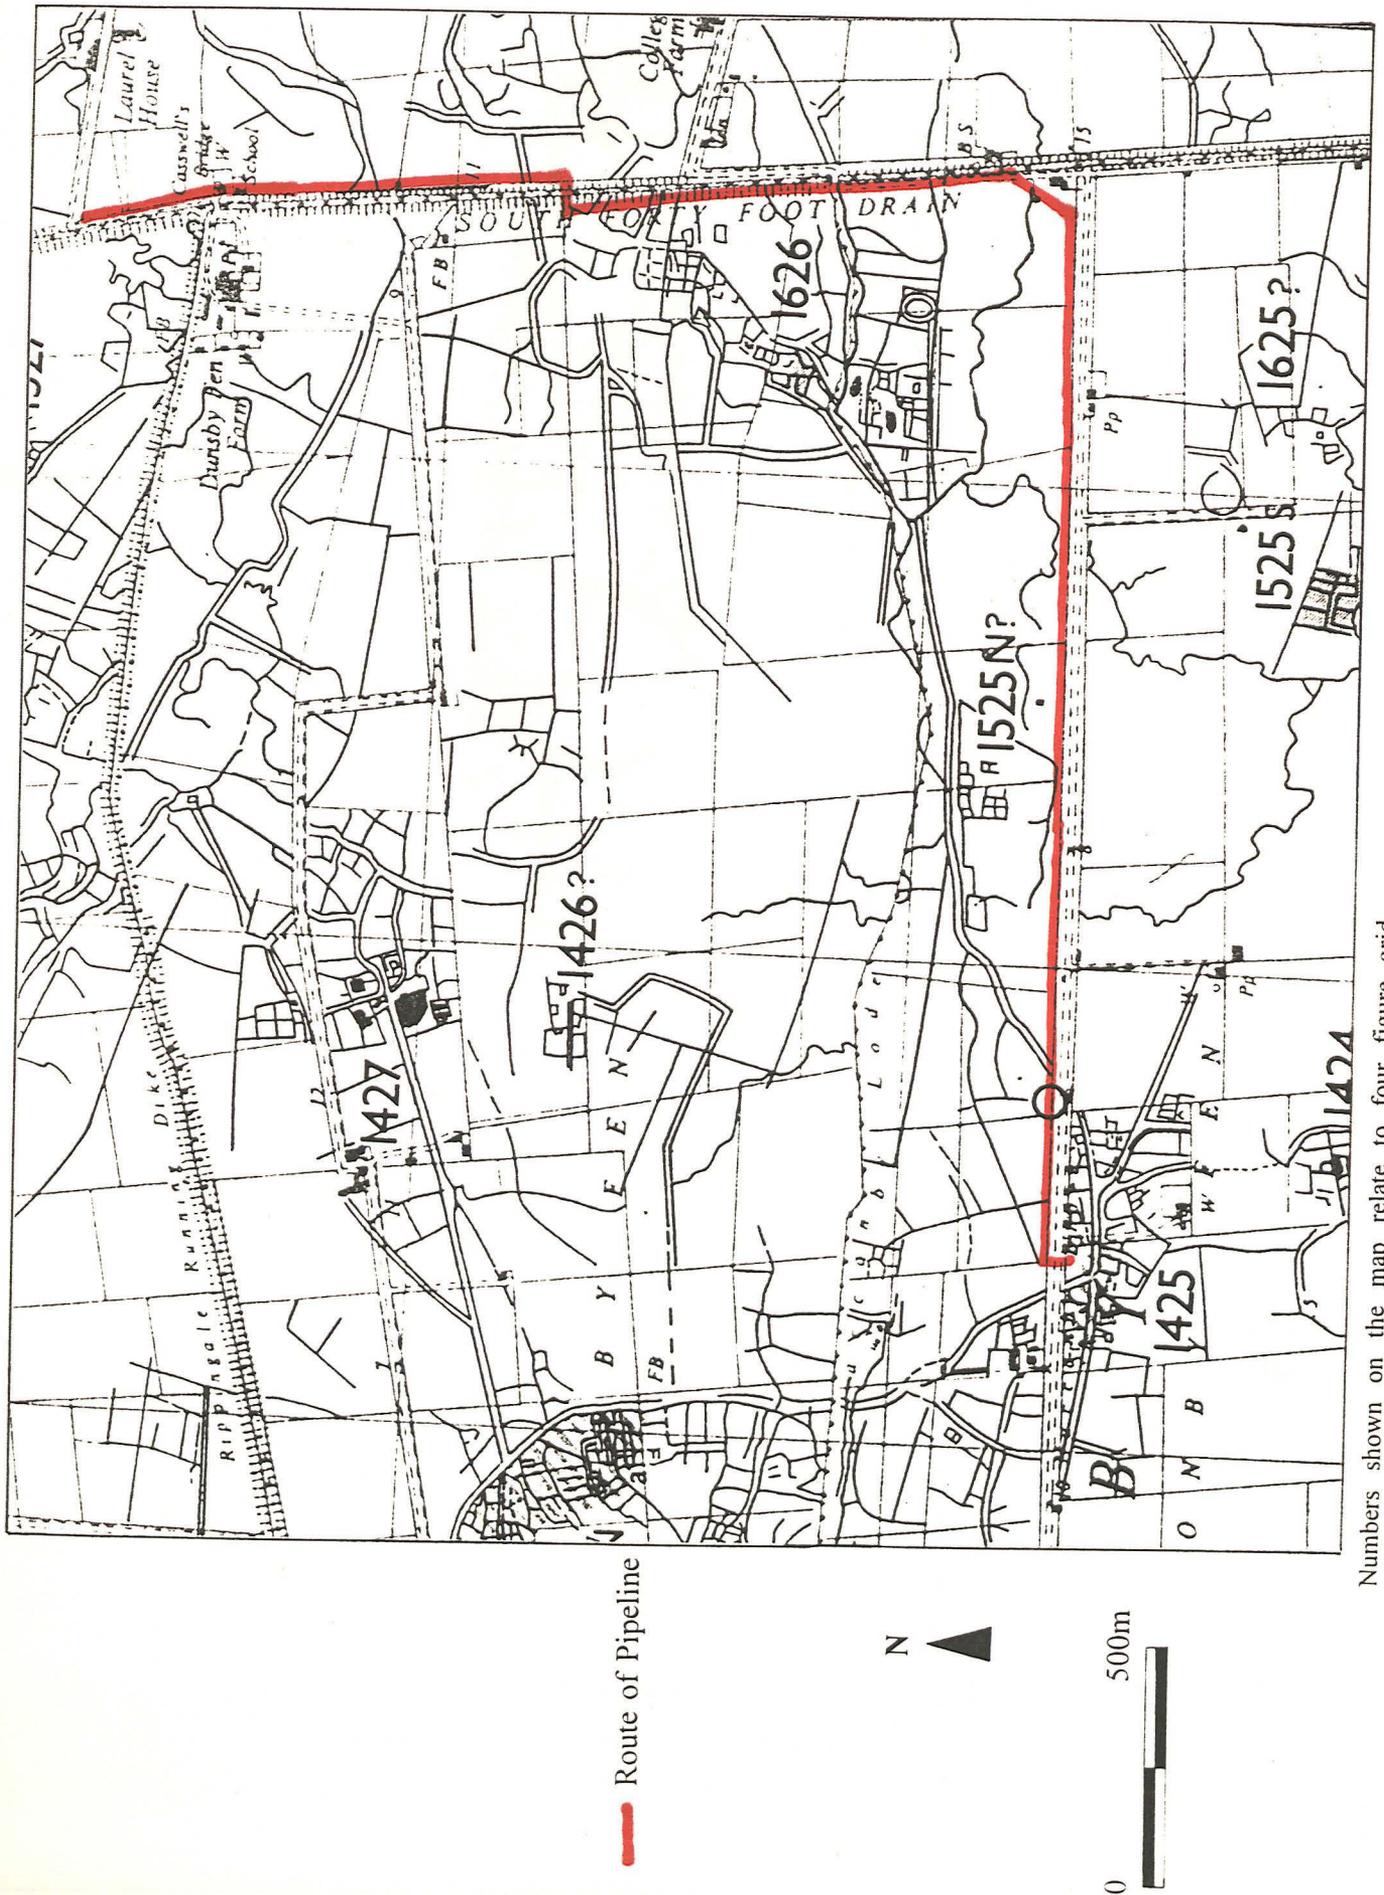
Fig. 10 Landscape Interpretation of the Romano-British Period.
After Hayes and Lane 1992

Numbers shown on the map relate to site codes used by the Fenland Project Survey, A summary of these sites appears in Appendix 3.

Field walking in Haconby Fen confirmed the evidence of settlement as identified by the aerial photographs (Hayes and Lane 1992, 98-109). Furthermore, artefacts revealed during the survey indicated that some of the sites were salterns associated with extinct tidal water channels. Subsequent to the Roman period, the area returned to freshwater wetland.

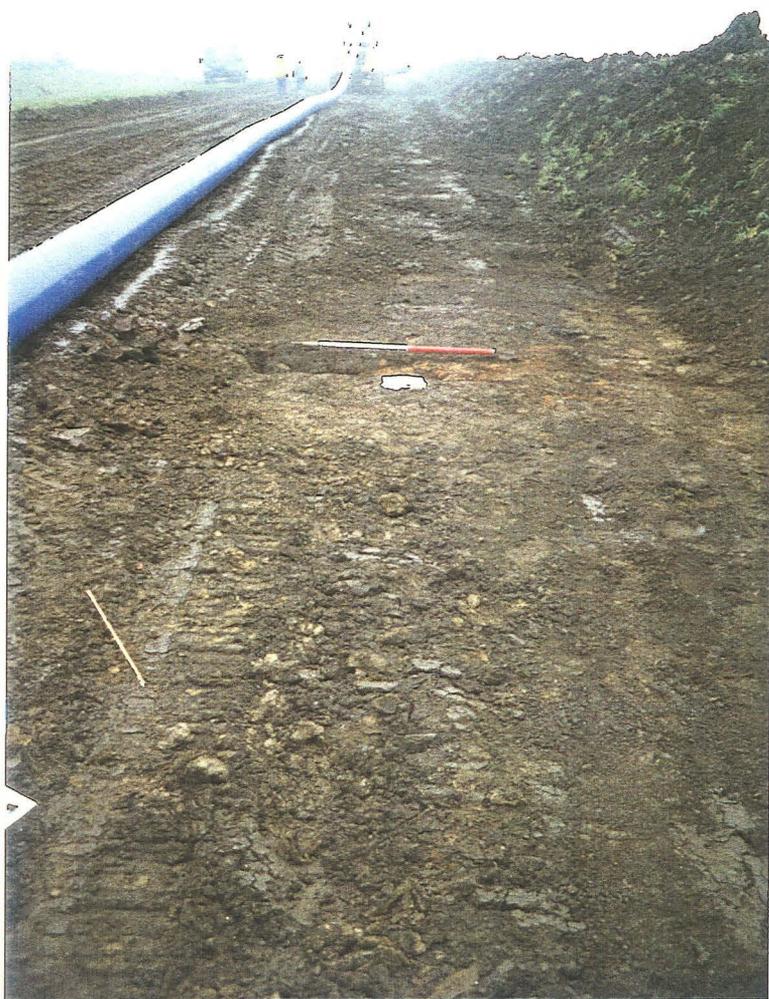
Plate 1. General View along the pipe line easement. Section 1 lies in the foreground.

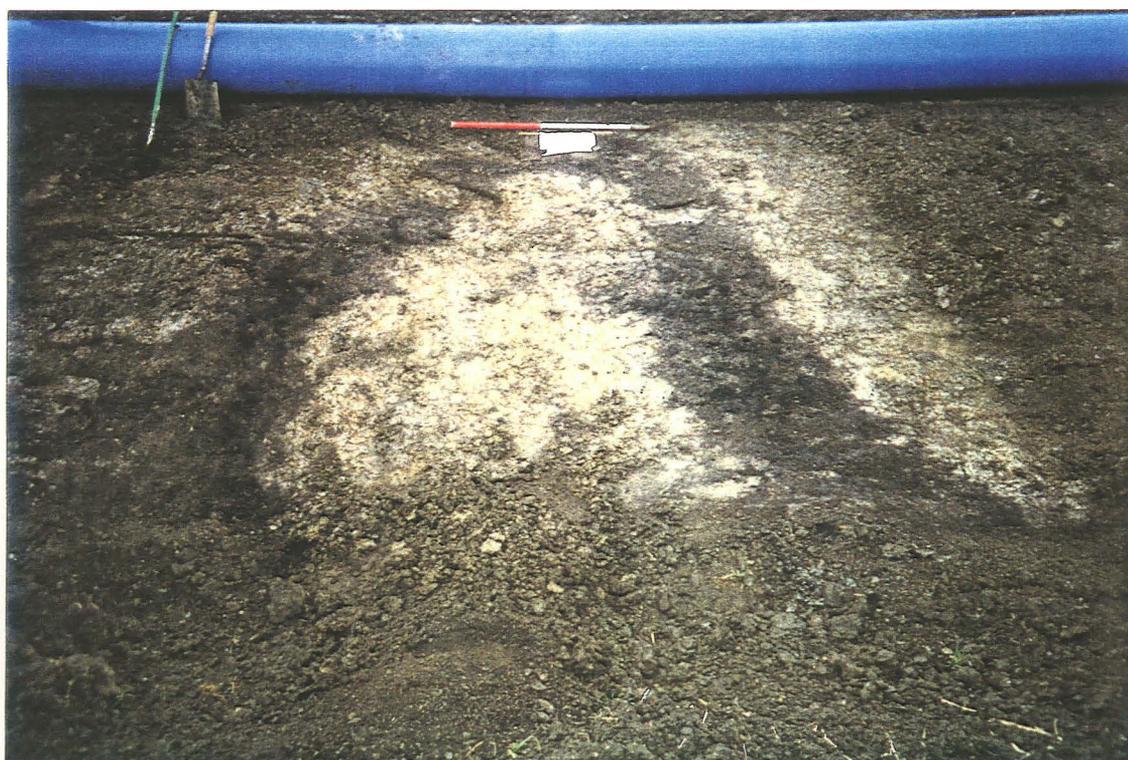
Plate 2. Area B, showing the curvilinear feature.

Area B (Fig. 6) comprised a single meandering linear feature (10). Entering the easement from the west, it extended south for *c.* 3m before heading north and leaves the easement 3m east of where it entered. This was 0.6m wide and 90mm deep with a vertical slope on one side. Identified as a gully, this was filled with a dark brown clayey silt (11).
