ARCHAEOLOGICAL WATCHING BRIEF REPORT
THURLBY WETLAND CREATION SITE

THURLBY WETLAND CREATION SITE

AN ARCHAEOLOGICAL WATCHING BRIEF REPORT

APRIL 1996

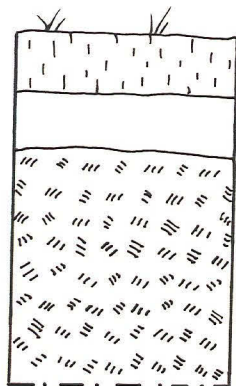
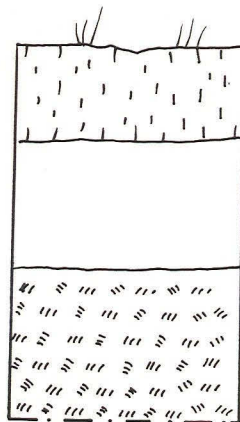
Fig. 3 Test Pit Schematic Sections

The pits were excavated (using a back acting machine with a 1.9m wide bucket) to depths averaging 700mm and were on average c. 3.5m long. Schematic sections through natural strata were drawn to indicate depths of deposits (Figure 3).

The test pits which were excavated in advance of the main development revealed no evidence of *in situ* archaeological deposits or artefacts, aside from a single worn sherd of Roman Nene Valley ware which came from the topsoil in Test Pit 1 and dates within the third/fourth centuries AD (B Davies, pers. comm.). The borrow pit sites were also demonstrably sterile, and the schematic sections derived from the test pit sites demonstrates the common stratigraphic sequences which prevail over the site and the relative depths of deposits (Figure 3).

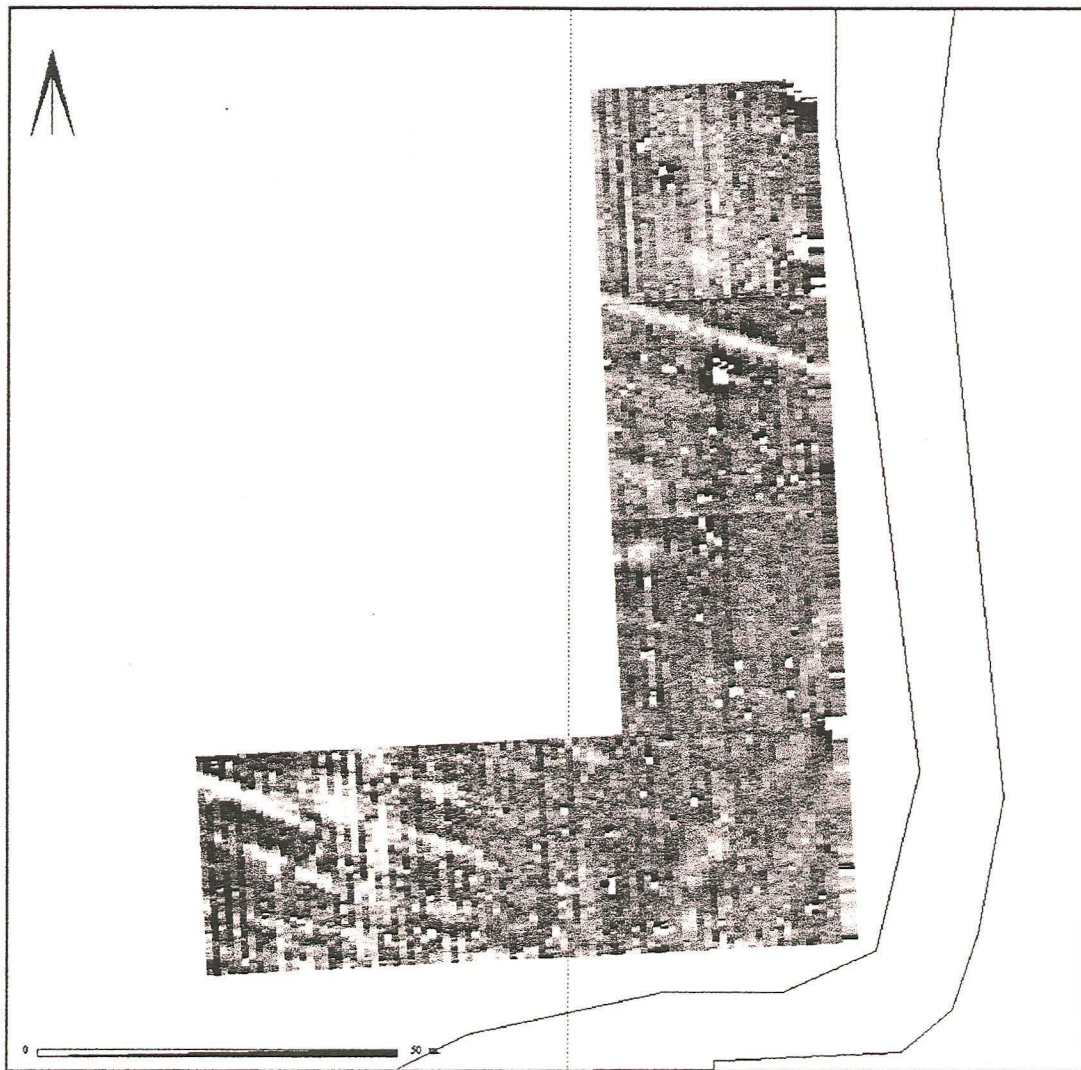
Figure Two

This plan shows the results of the gradiometer survey of Area C displayed as a greyscale image. The survey area consists of 6 30m grids, thus 0.45 hectares.

Sixteen anomalies were noted in area C.

C1 and C8-16 are all linear anomalies with the same ESE-WNW alignment. It is quite possible that these anomalies relate to the position of field drains, although the different magnetic response of some of the anomalies may relate to the date of the drains.

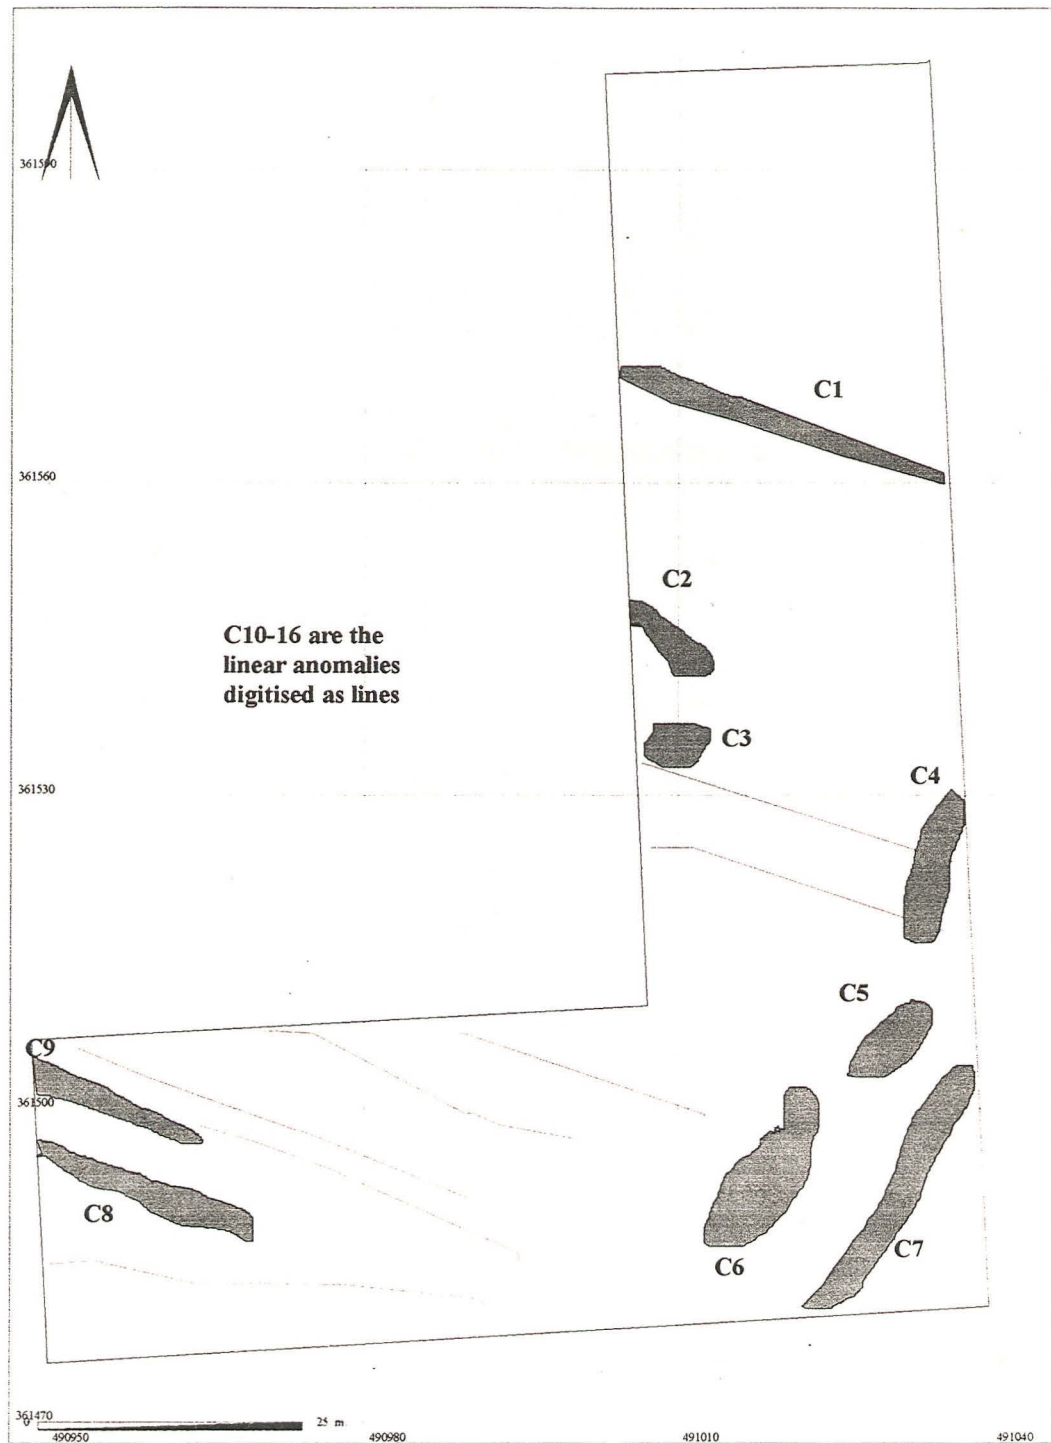
Figure Three

This plan shows the positions of the digitised interpretation of the magnetic anomalies in Area C with the letters and used in the text below. Note that these are the digitised outlines of magnetic signals and need not necessarily equate with the true size of the feature, which might be either larger or smaller than the extent of the magnetic signal.

Anomalies C4-C7 all have the same NE-SW alignment. It is possible that these anomalies may relate to a different course of the river, and thus may be geomorphological in origin.

Anomalies C2 and C3 are the only anomalies in this area which may be archaeological in origin. It is difficult to categorise archaeological features when only a 30 metre wide strip has been surveyed, although anomaly C2 appears to be a linear anomaly, and C3 appears to be localised.

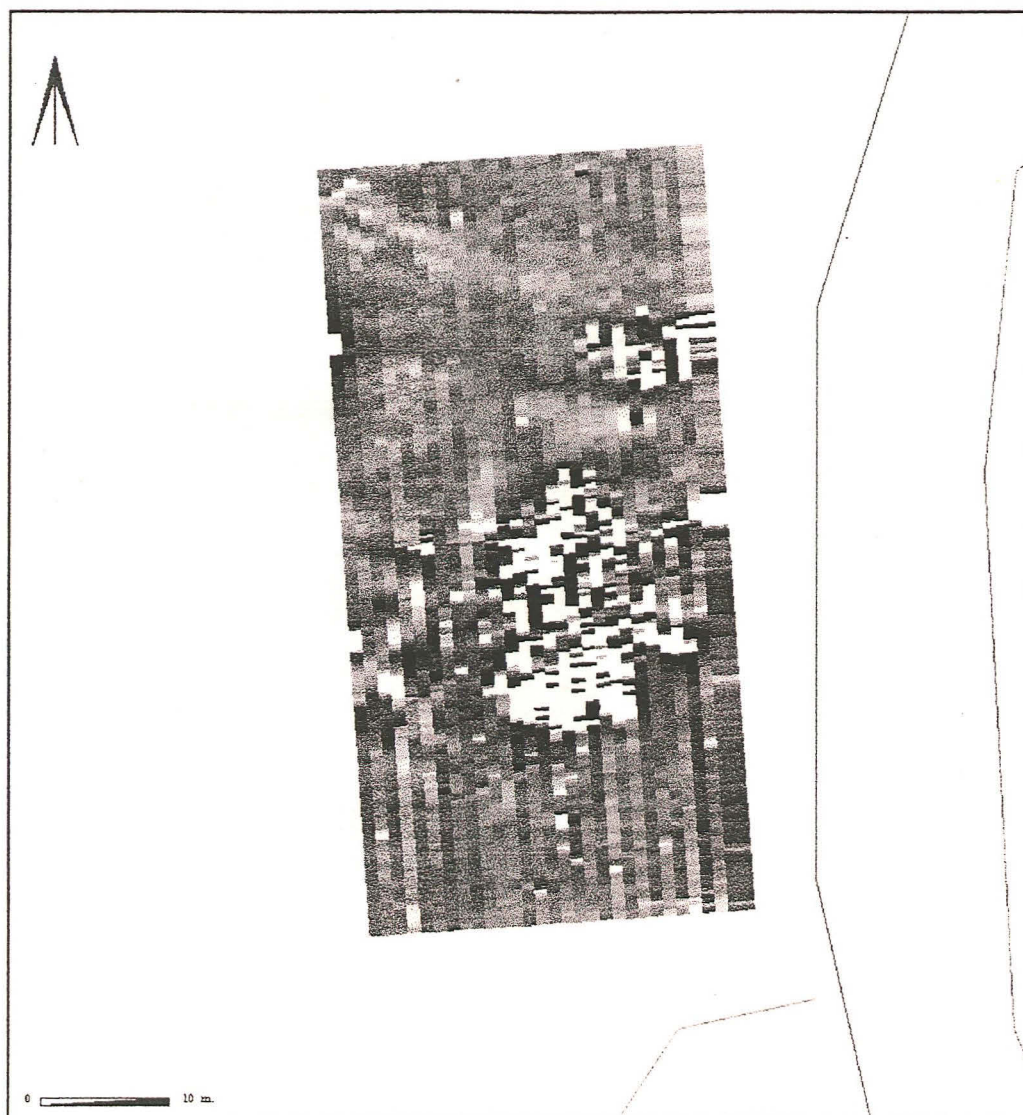
Figure Four

This plan shows the results of the gradiometer survey of Area B1 displayed as a greyscale image. North is to the top of the page. The area covered consists of 2 30m grids, thus 0.18 hectares.

Anomalies B24 and B25 are strong magnetic anomalies almost certainly caused by modern action. A number of bricks were noted in this part of the survey area, and these almost certainly caused the strong magnetic signals.

Anomalies B27 and B28 relate to a raised area running across this part of the site.

Anomaly B26 may be archaeological in origin, although the proximity of the electricity pole and the areas of modern disturbance make this difficult to ascertain.

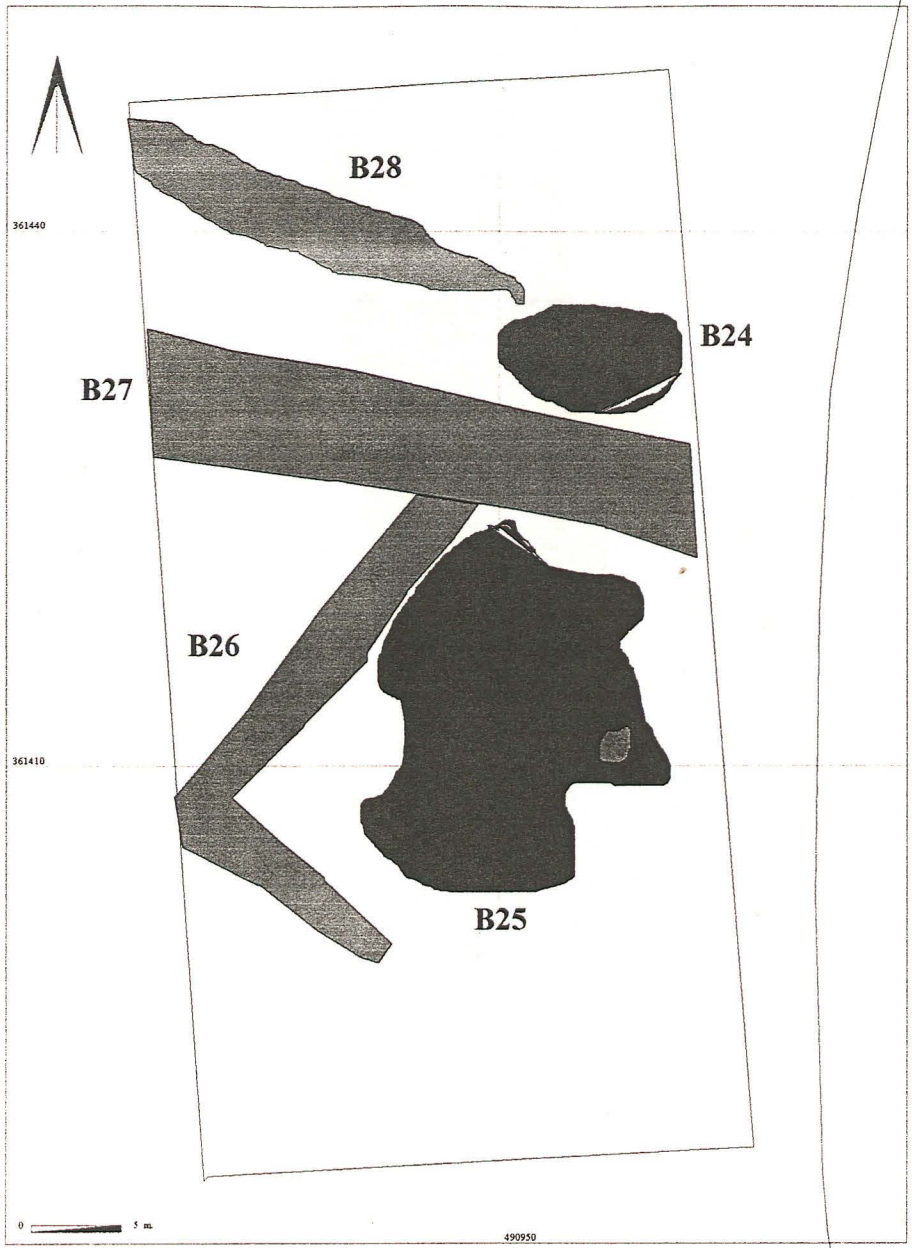
Figure Five
This plan shows the positions of the digitised interpretation of the magnetic anomalies in Area B1 with the letters and used in the text. The green area marks the position of an electricity pole.

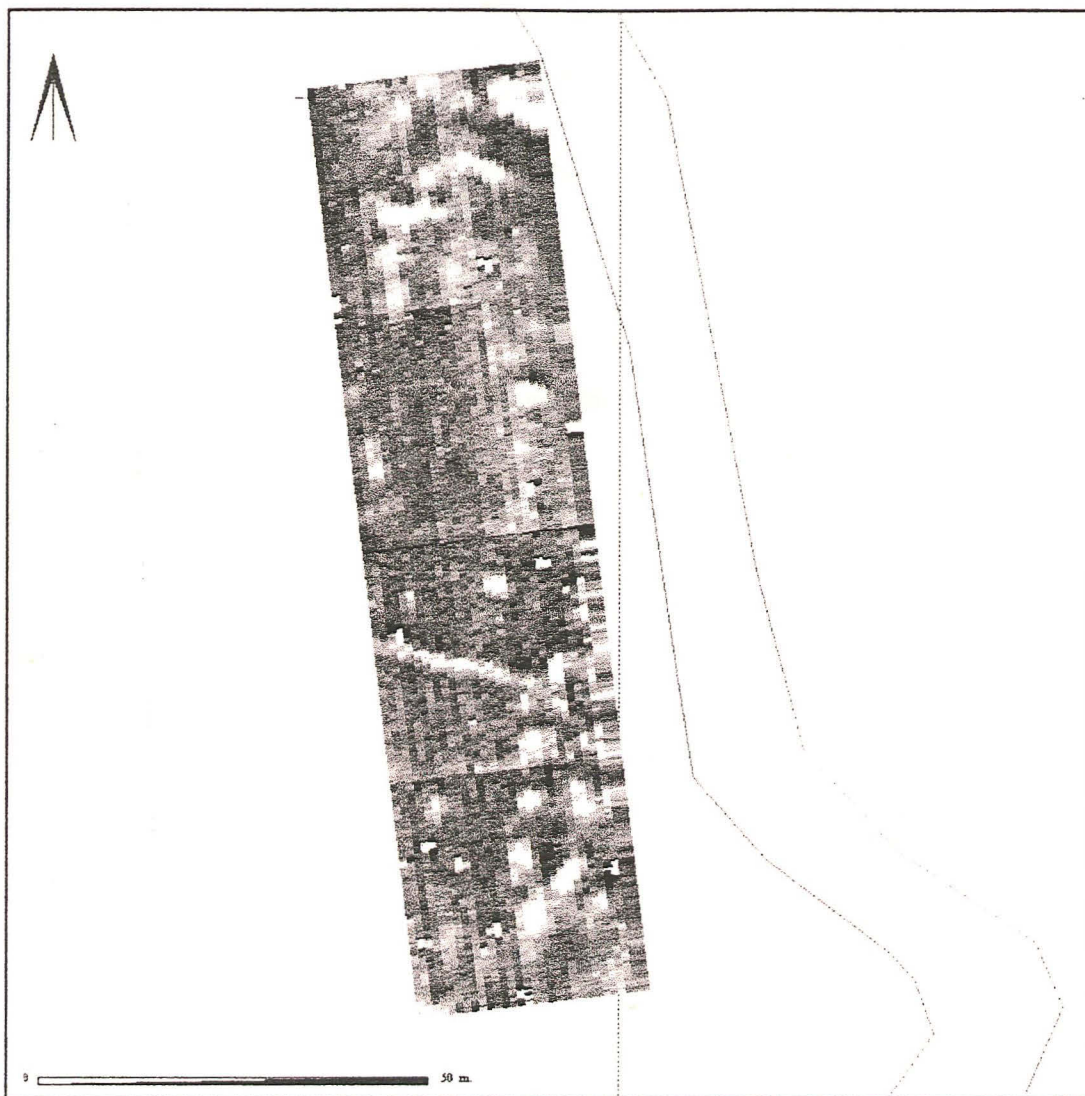
Figure Six

This plan shows the results of the gradiometer survey of Area B2 displayed as a greyscale image. North is to the top of the page. The area covered consists of 4 30m grids, thus 0.36 hectares.

This area proved to be the most productive in terms of anomalies found. Anomaly B23 is the area where a test pit was located. Anomaly B1 may well be another field drain.

Anomalies B2-B5 are all localised linear anomalies in the north-east of survey area B2. It is possible that these anomalies consist of more than one localised anomaly close together, and that they are of a similar nature to the other anomalies in this survey area.

Anomalies B6-B22 are all localised anomalies. It is possible that they may be a number of pits. The position of a number of these anomalies is of note, in particular in the south-east of the survey area. The anomalies appear to form a roughly north-south alignment. It is not possible to say whether this alignment has some structural significance, because the survey area is only 30 metres wide, although it would seem likely that more of these anomalies would occur to the east.

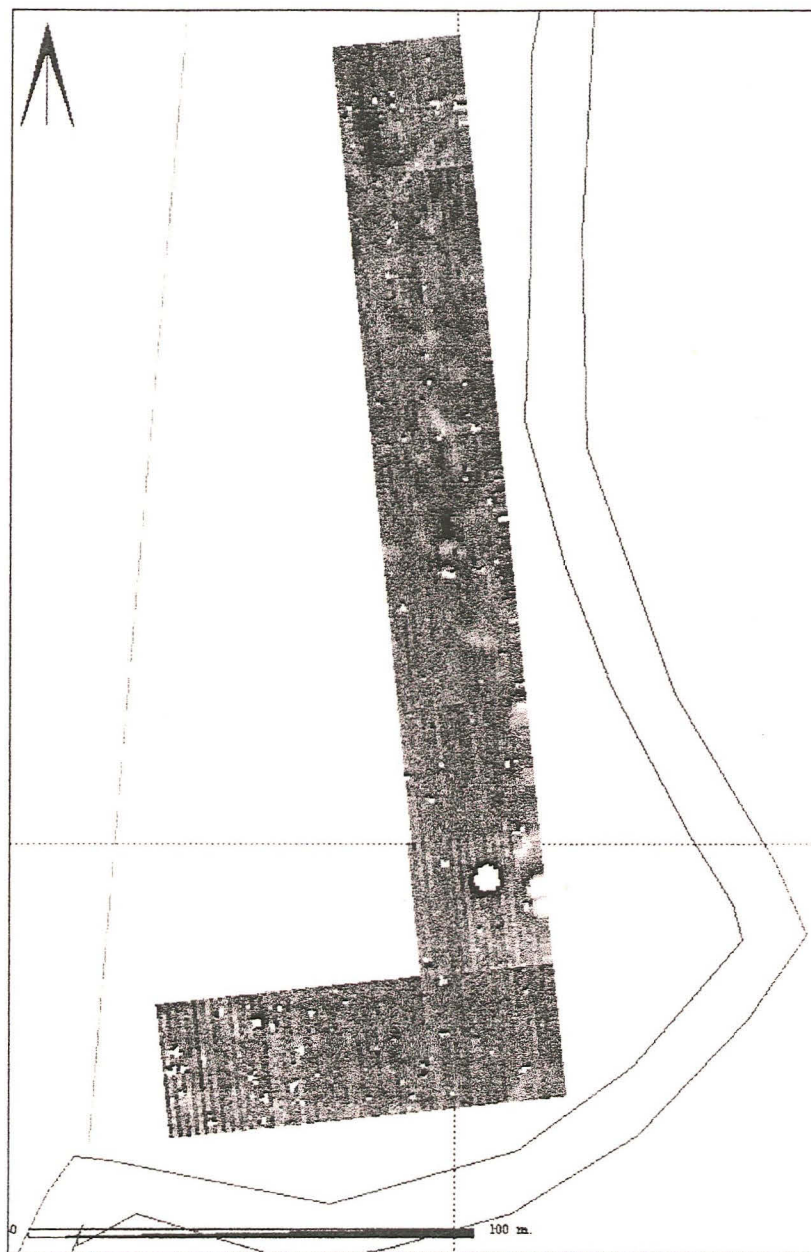
Figure Eight

This plan shows the results of the gradiometer survey of Area A displayed as a greyscale image. North is to the top of the page. The area covered consists of 10 30m grids, thus 0.9 hectares.

Anomaly A3 is an exceptionally strong magnetic anomaly, almost certainly caused by the presence of a large lump of metal or pipe in the area. Anomalies A4 and A5 are located just to the south-east of A3, and are localised anomalies of a similar nature to the anomalies noted in area B2.

The area in between anomalies A2 and A3 has a number of weak, amorphously shaped anomalies (See greyscale image Figure 8). While it is possible that some of these anomalies are pits, it is likely that these anomalies are geological in origin, caused by periodic flooding of the area.

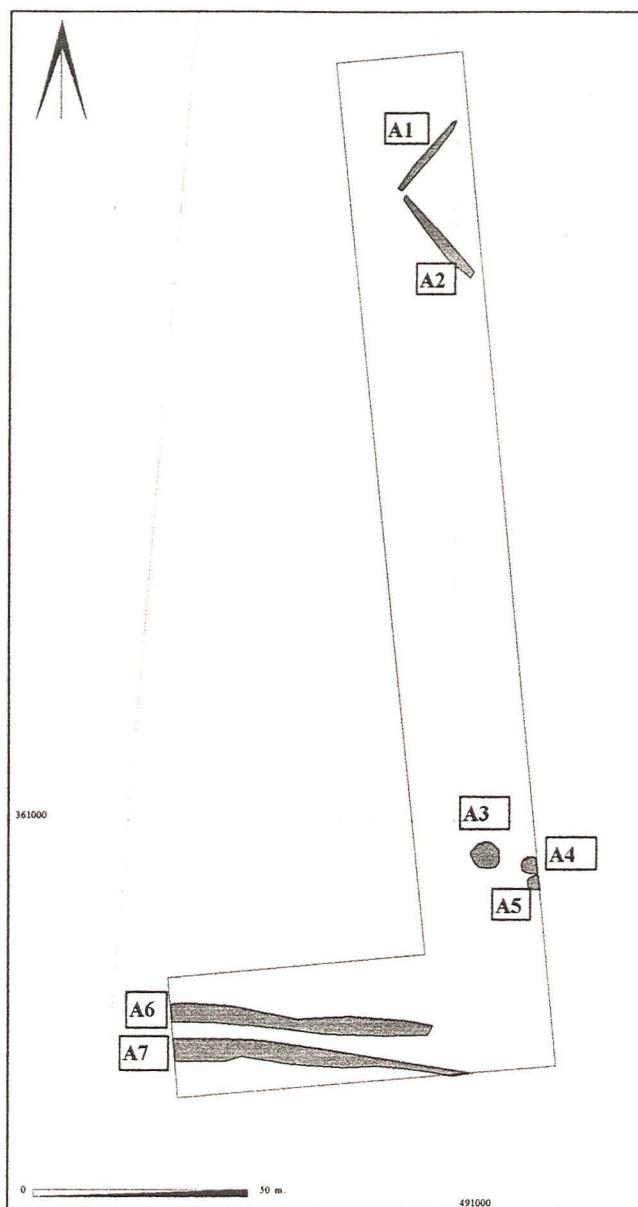
Figure Nine

This plan shows the positions of the digitised interpretation of the magnetic anomalies in Area A with the letters and used in the text below.

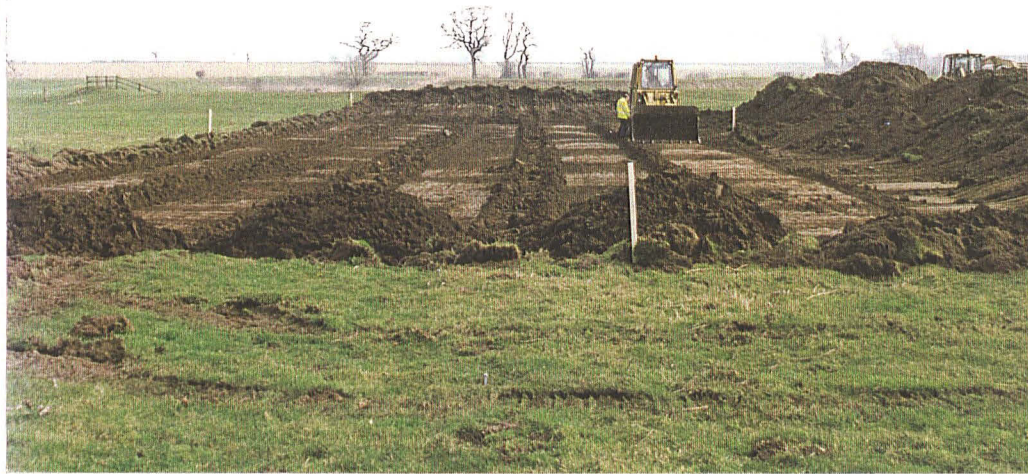
P1- Bulldozer scraping subsoil in Flood Bank 3, looking east

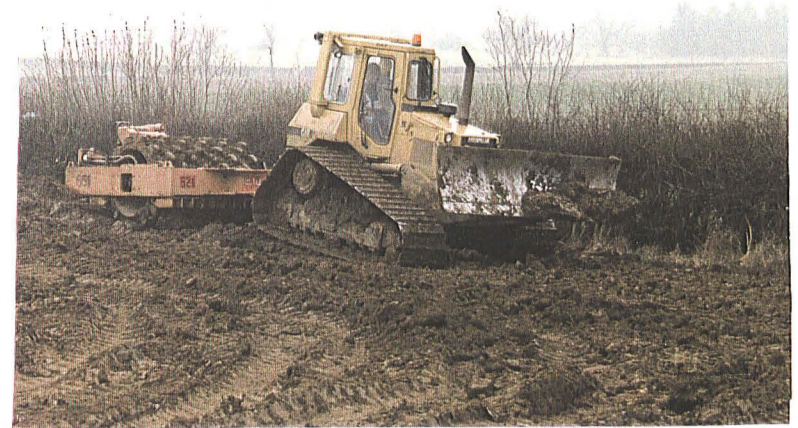
P2- Bulldozer battering down lias clay core of Flood Bank 1, looking south

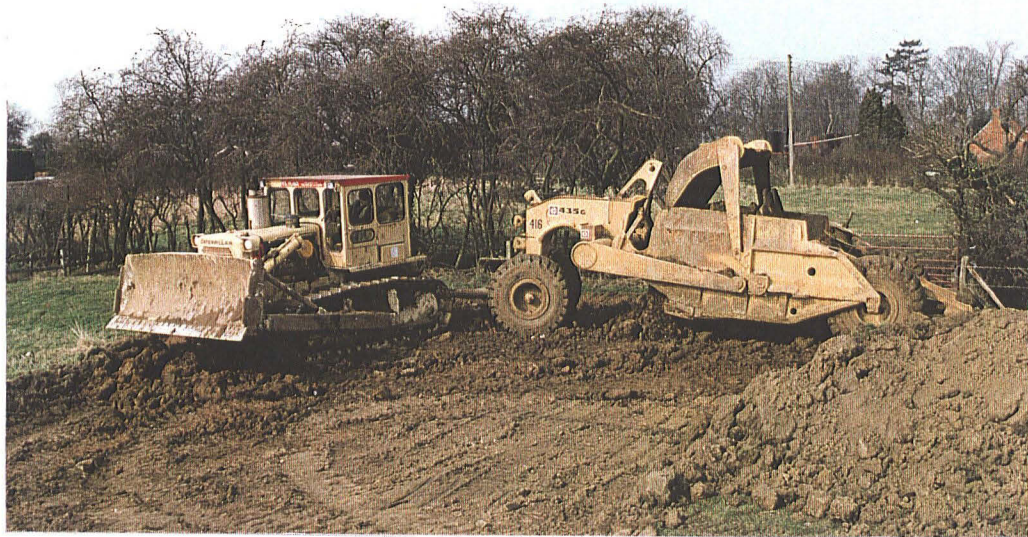
P3- Box-scraper dropping clay core in Flood Bank 2, looking north

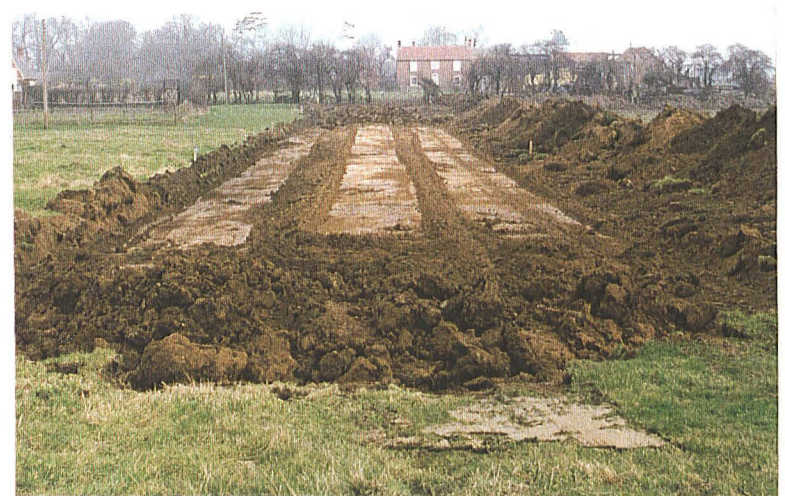
P4- Area stripped for Flood Bank 2, looking north

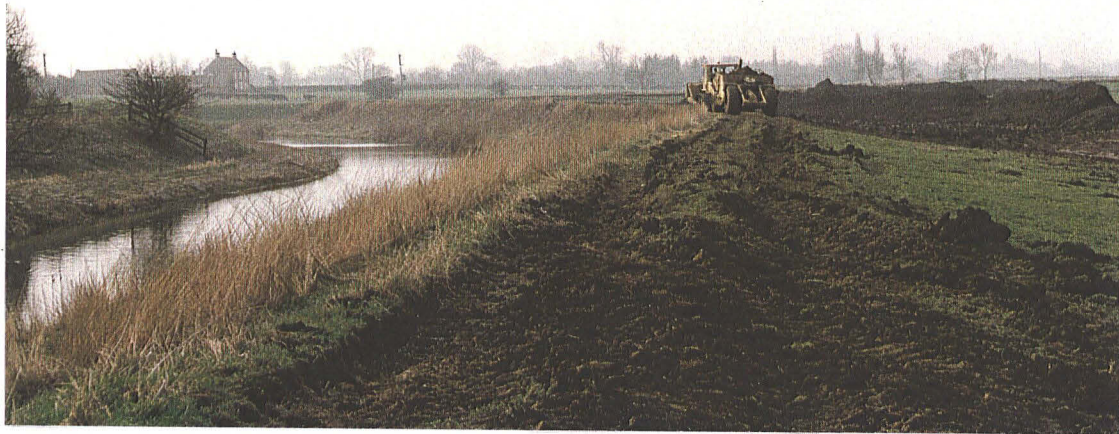
P5- General shot of River Witham and Borrow Pit A, looking south

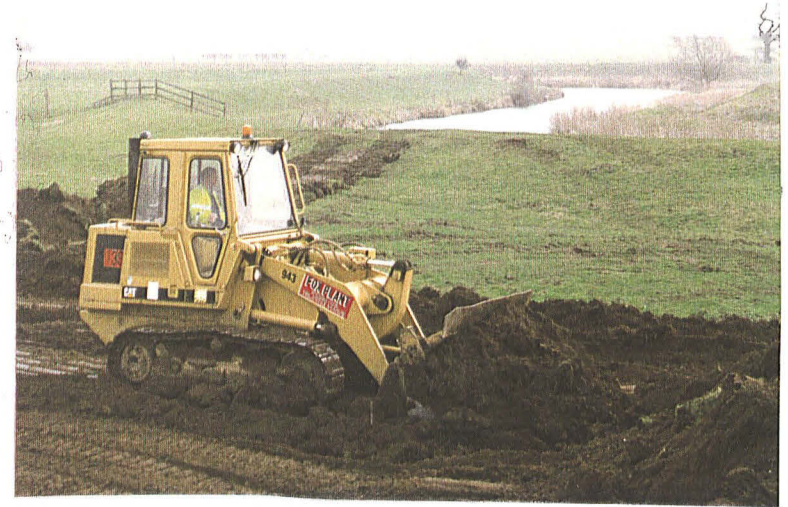
P6- Bulldozer stripping topsoil in Flood Bank 3, looking east

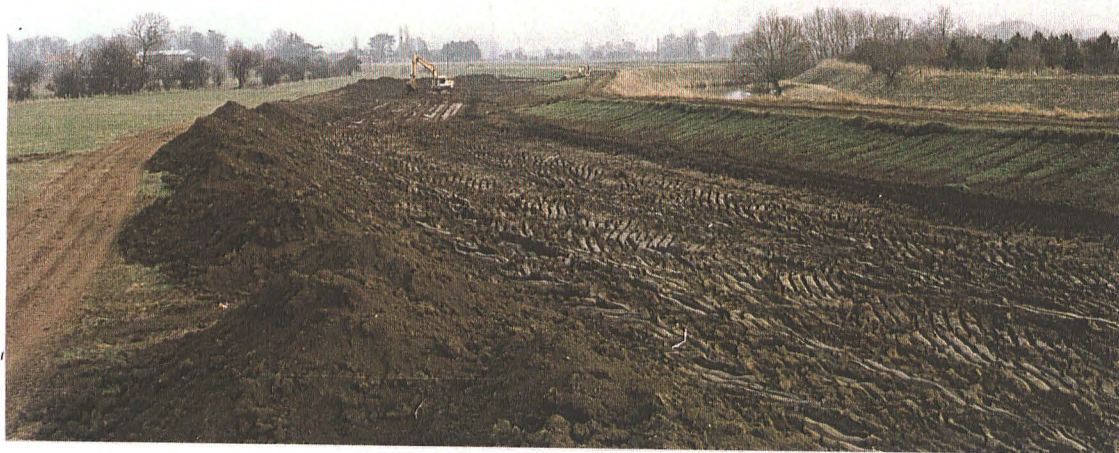
P7- General shot showing full extent of Borrow Pits A and B, looking north

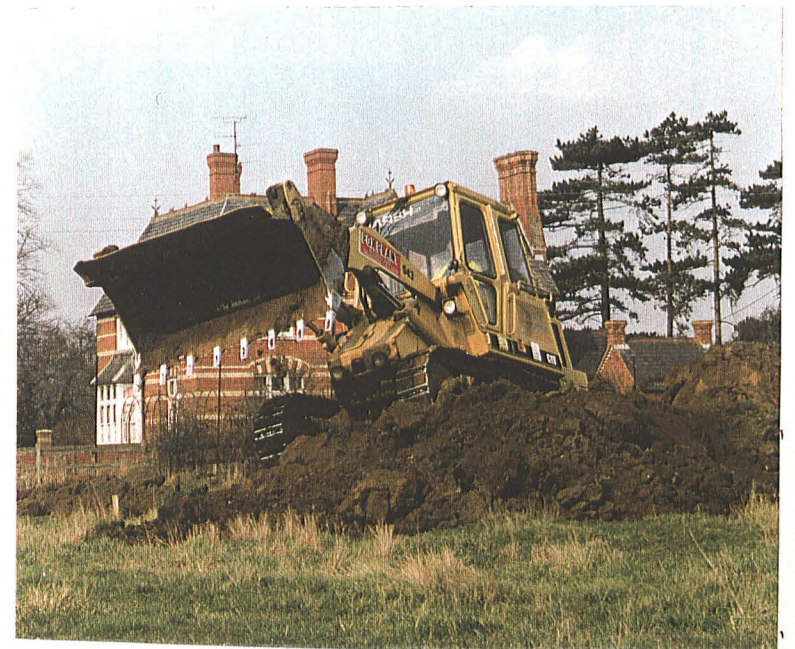
P8- Bulldozer working in Flood Bank 2, looking west

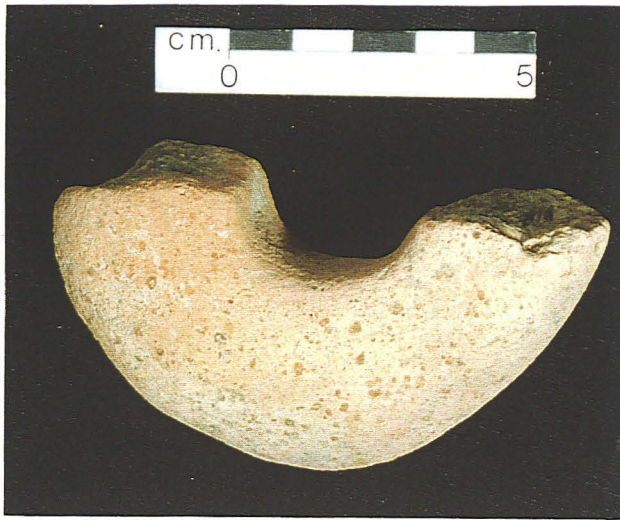
P9- Loomweight recovered from Flood bank 1

Flood Bank 1 There were no *in situ* archaeological deposits. Several ceramic finds were recovered from the subsoil but none lay within archaeological features such as pits or ditches. Most of the finds were post-medieval (Appendix 4), excluding a large bun-shaped clay loomweight of late Saxon/medieval date (Appendix 3).

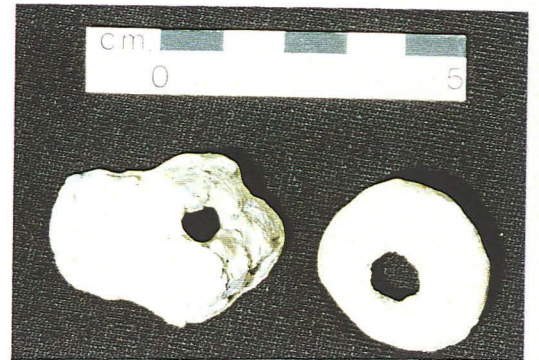
P10- Lead ?net-sinkers (in possession of site owners)

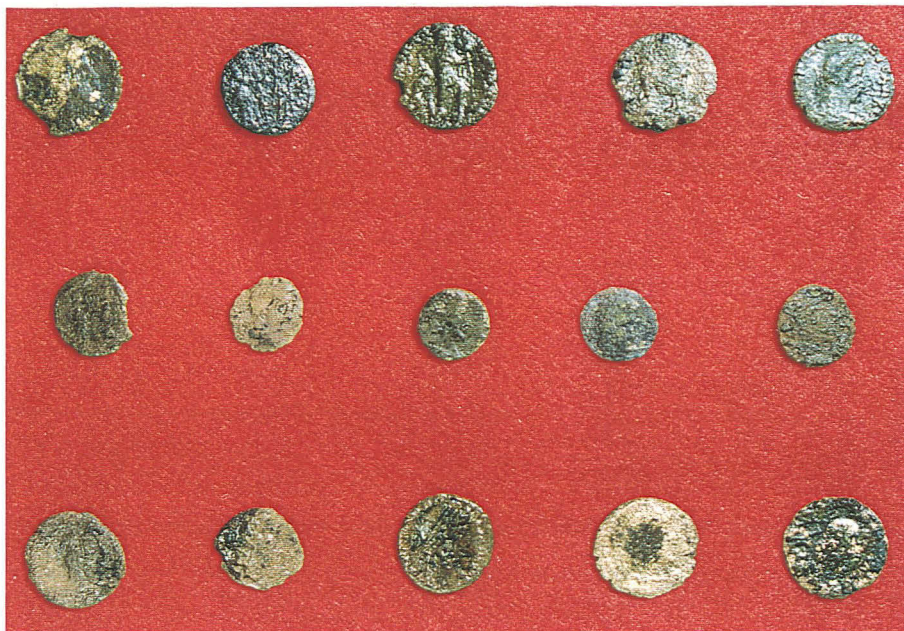
P11- Roman coins (in possession of site owners)

The coins were removed from their backing (to which they had been attached with Blu-tack) in order to examine them, and then replaced.
