## **Nettleham Village Mains Replacement Scheme:**

**Archaeological Monitoring at  
Washdyke Hill and High Street**

Site Code: **NMR 95**  
LCNCC Museum Accn. No. **88.95**

Report prepared for Anglian Water

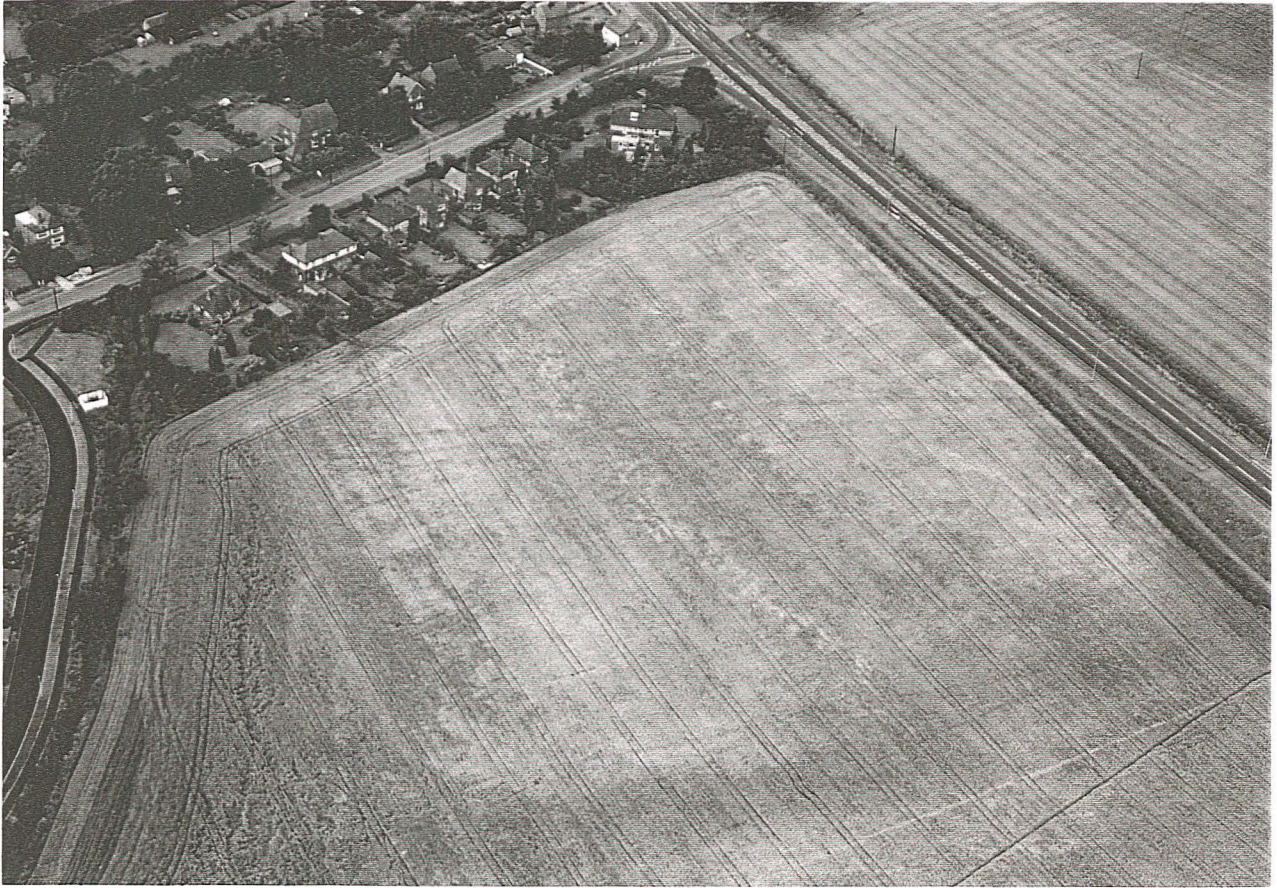
**Pl. 1** Aerial photograph showing course of the prehistoric triple linear ditch, running from Riseholme Lane (upper right) to the Kingsway /Washdyke Hill junction (centre left), looking SW. LAS Photograph ref. 2972/30 [5.8.79 PE]. Copyright reserved.

Cropmarks of a linear ditch complex have been identified on aerial photographs to the NW and SE of Nettleham (Everson 1979, 1980 and 1982; Fig. 2; Pls. 1 and 2). The feature appears as a series of up to three almost parallel and closely positioned dark lines where the growing crop reflects different growing conditions over a backfilled ditch cut into the limestone bedrock. Parts of the same or similar triple linear ditch complexes are known at other sites in Lincolnshire and elsewhere. LAS staff have investigated the ditches and associated features on several occasions; the Nettleham feature was examined within the Lincoln city boundary at Nettleham Glebe in 1979, and also off Riseholme Lane in 1993 when an Anglian Water replacement rising main pipeline crossed it in an arable field. The section at Riseholme Lane found three ditches within a 19m total width, with evidence for a bank between two of the ditches (Palmer-Brown and Field 1993). The ditches varied from 3.5m wide to about 4.5m wide, and from 1.2m to over 1.4m deep.

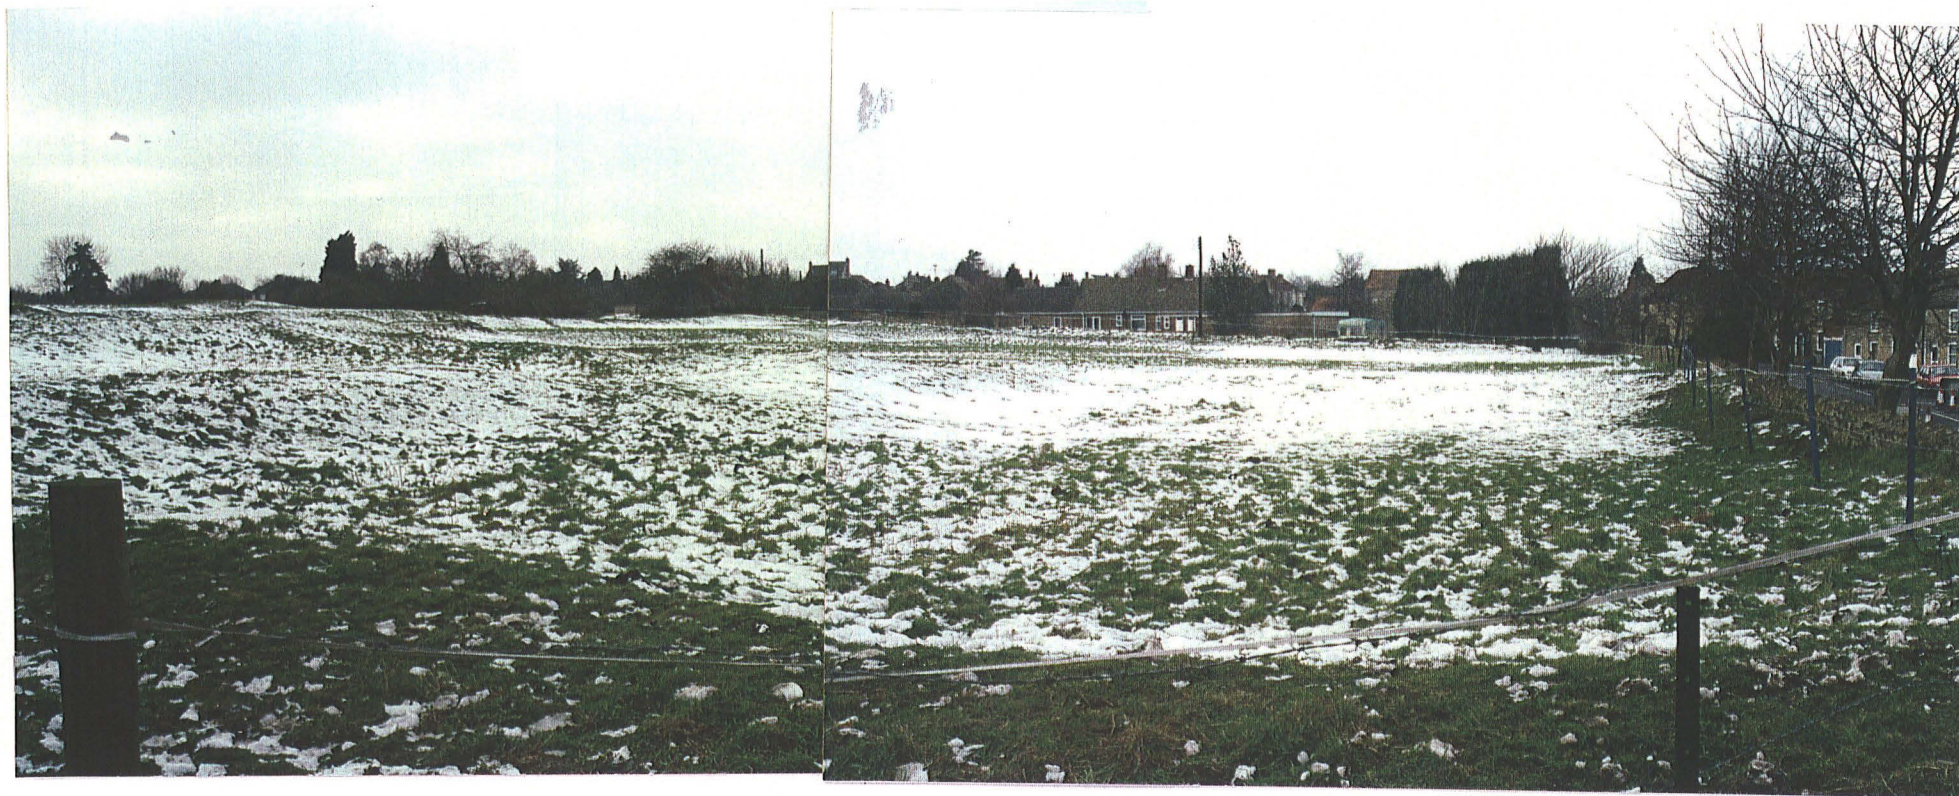
PI. 2 Aerial photograph showing the prehistoric triple linear ditch between the A46 (right) and Kingsway, Nettleham (left) [looking SW]. The cropmarks are lost on the left, obscured by alluvium from Nettleham Beck. LAS Photograph ref. 2990/9 [31.7.77 PE]. Copyright reserved.

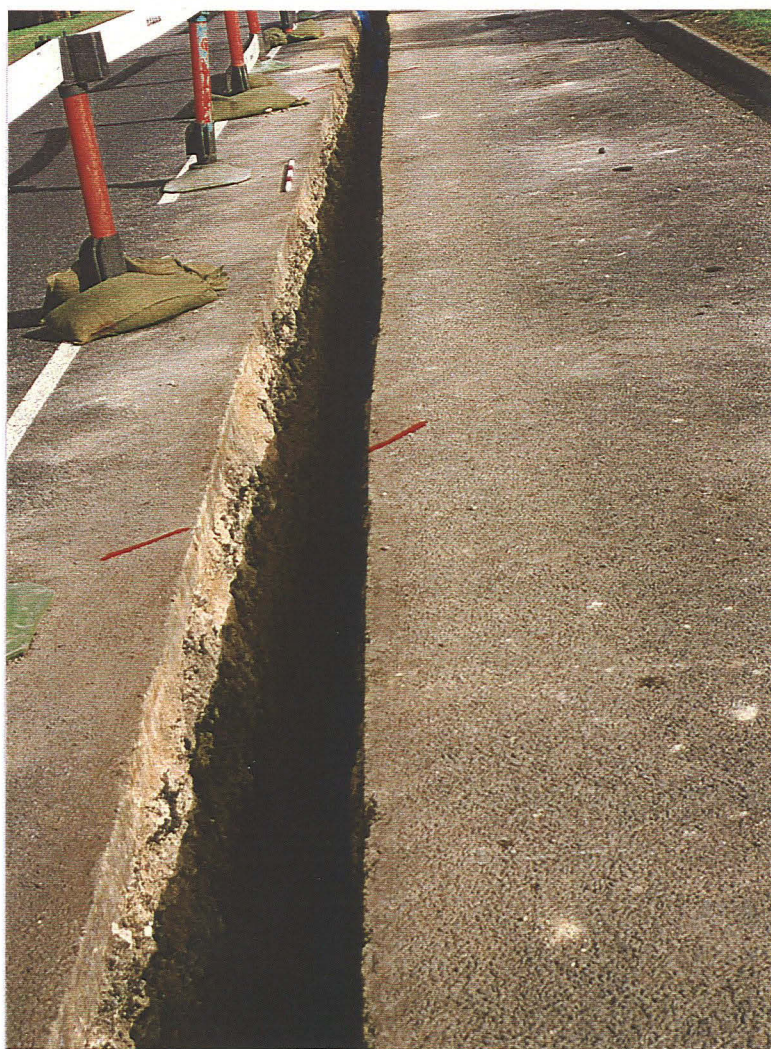
Pl. 4 The pipe trench on Washdyke Hill. The 1m photographic scale marks the centre of backfilled feature 1, probably a limestone quarry pit. The eastern edge is marked by red paint in the foreground (looking west).

1 The trench cut through undisturbed bedrock between Greetwell Lane and the brow of Washdyke Hill. Opposite No. 32 Washdyke Hill, a disturbed area was observed, where the stone was mixed with loam (Pls. 4-7). The feature, about 10m west-east and over 1m deep, was thought to be a backfilled quarry pit.

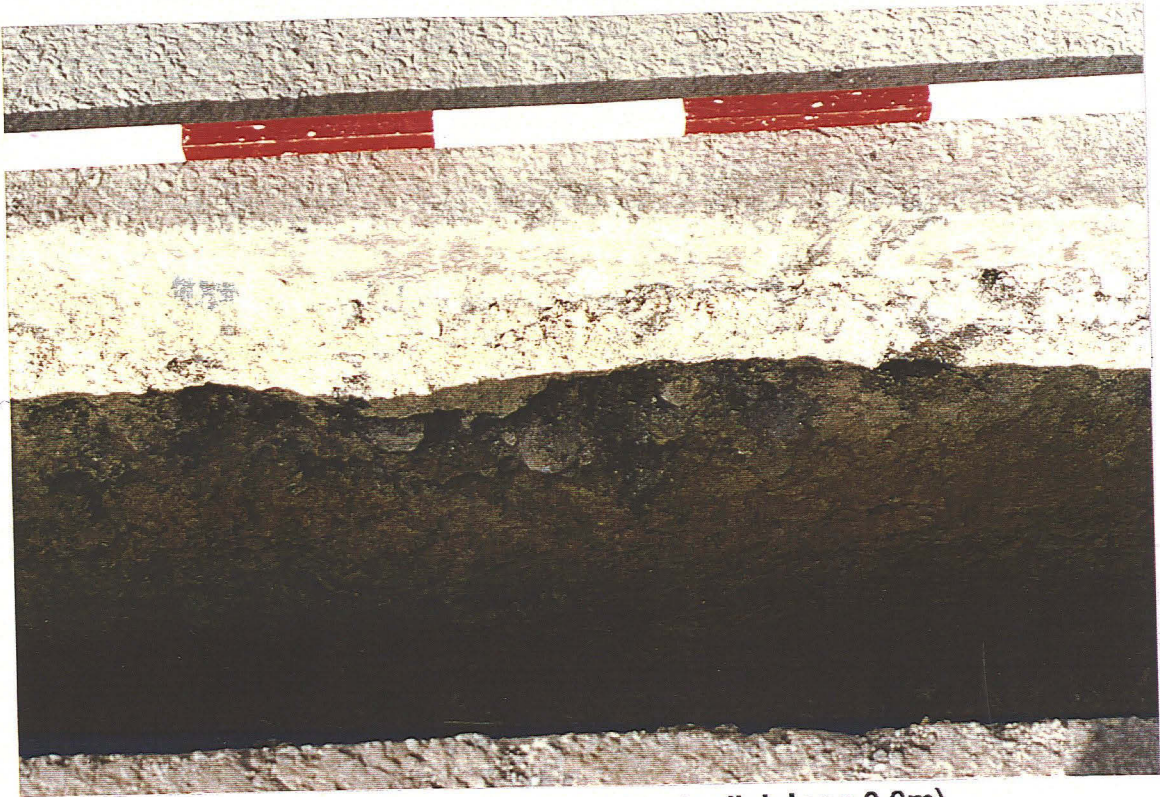
Pl. 5 Detail of pit 1, marked by red paint and the 1m photographic scale. Dense rock is visible in the trench face in the foreground, with light brown soil within the feature. Looking east.

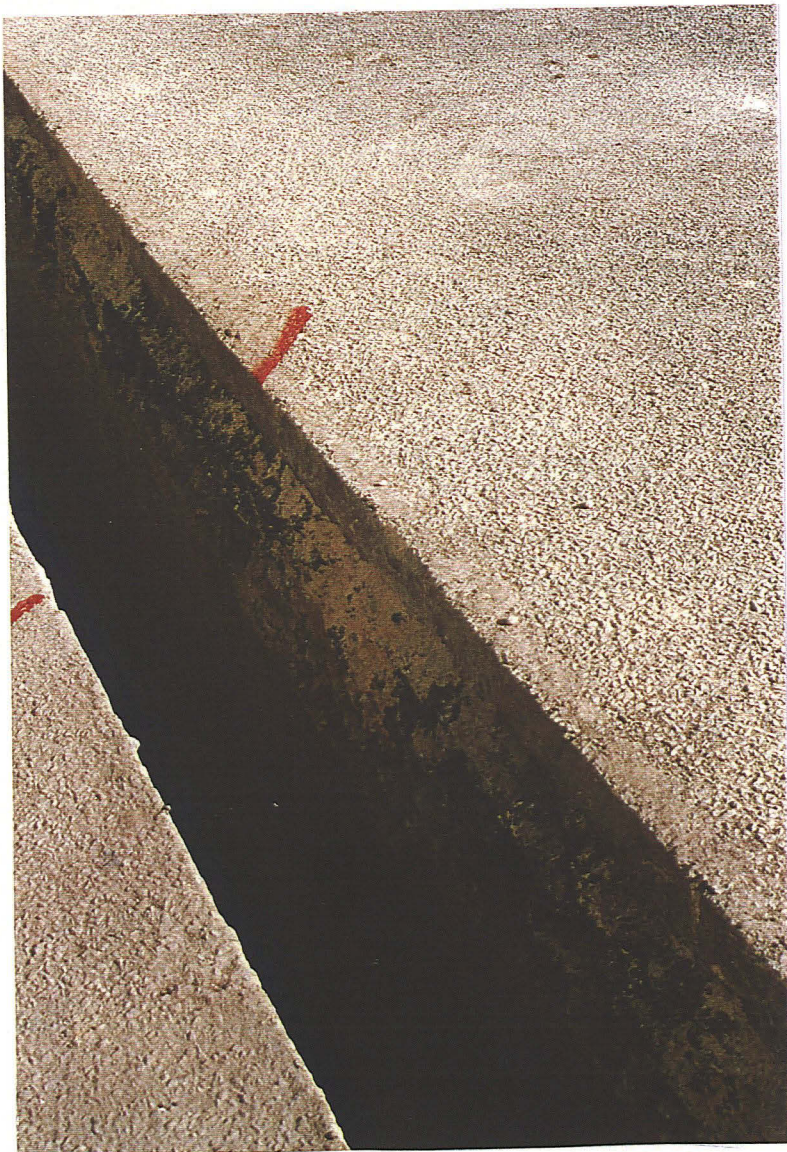
Pl. 6 Brown soil fill in the centre of 1 (scale divisions 0.2m).

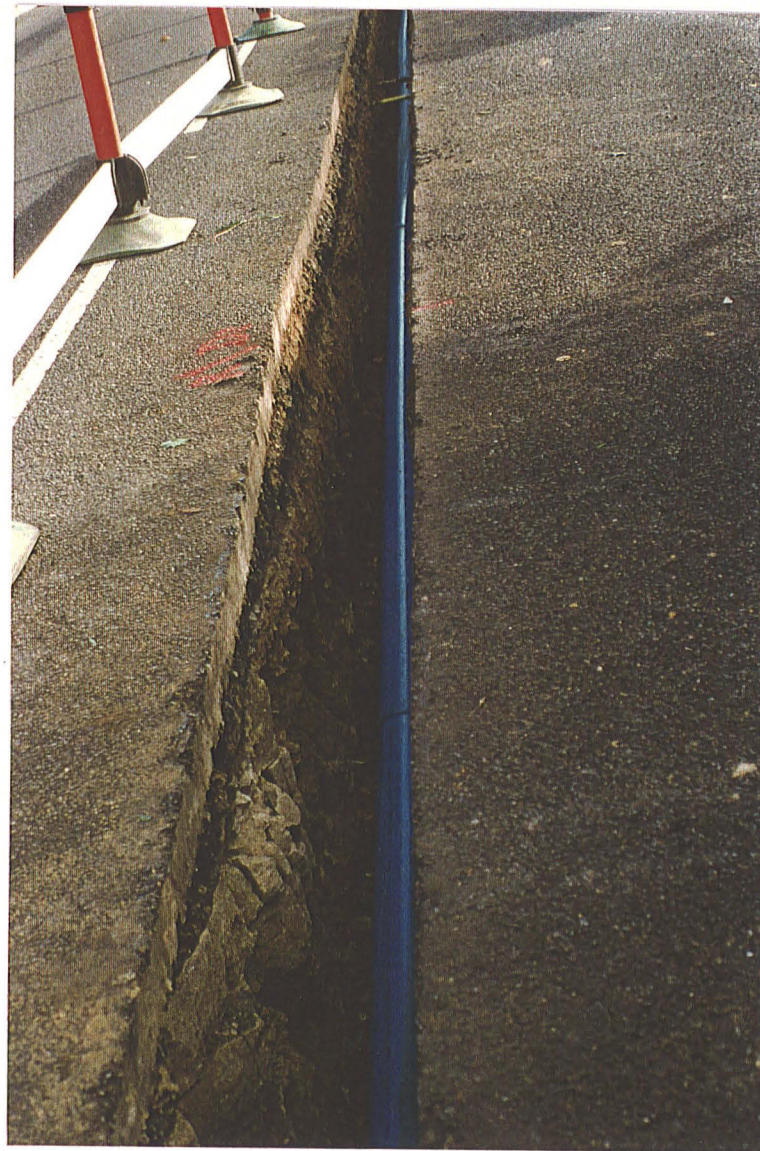
Pl. 8 Location of 2, immediately north of The Old Quarry (behind field gate). Dense limestone to the west of the gateway replaced mixed soil and stone to the east, probably backfilling another quarry pit. Looking east along Washdyke Hill.

2. South of 'Hillside', No. 38 Washdyke Hill, another large area of apparently disturbed limestone with soil (extending for more than 25m west-east) was observed, ending to the west in a slope against solid limestone bedrock (Pls. 8 and 9). This disturbed ground lay adjacent to a plot named 'The Old Quarry' and it was interpreted as a backfilled stone quarry, probably of medieval or post-medieval date. It was not possible to tell whether it represented part of the same quarry, over which the road has since been widened, or part of an earlier feature pre-dating the road.

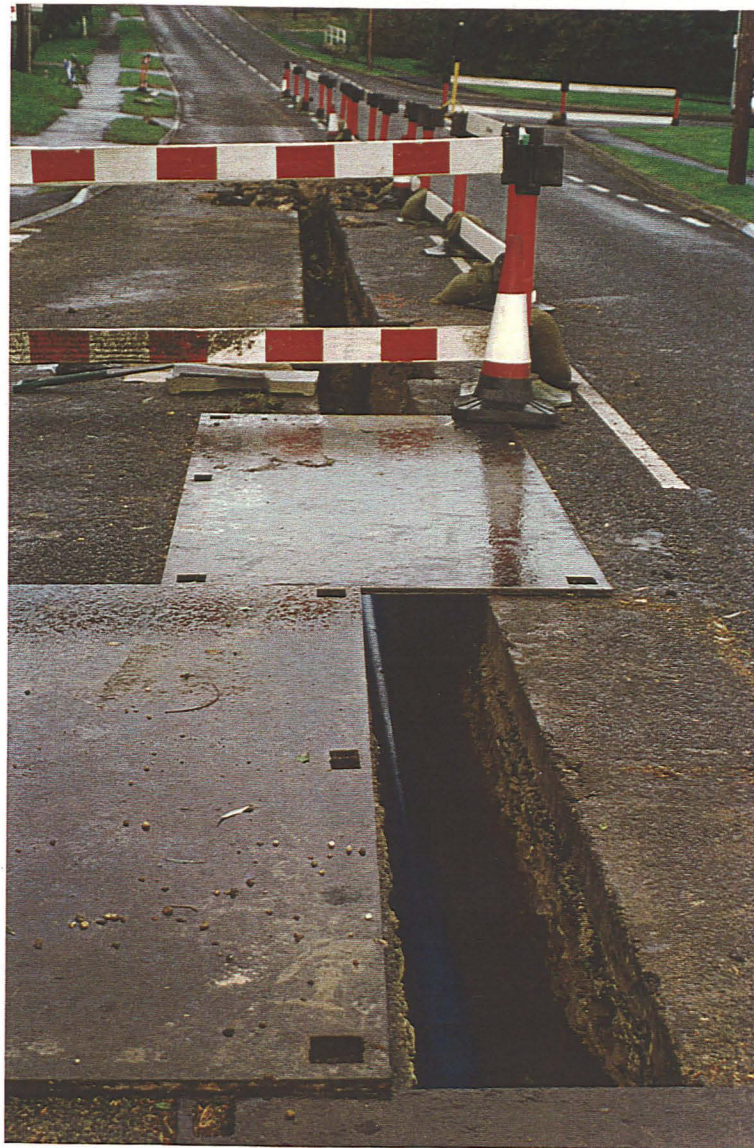
Pl. 9 The western edge of Quarry 2. Dense bedrock extending close to the road surface has been cut to the east (marked by paint) and backfilled with mixed material. Looking east.

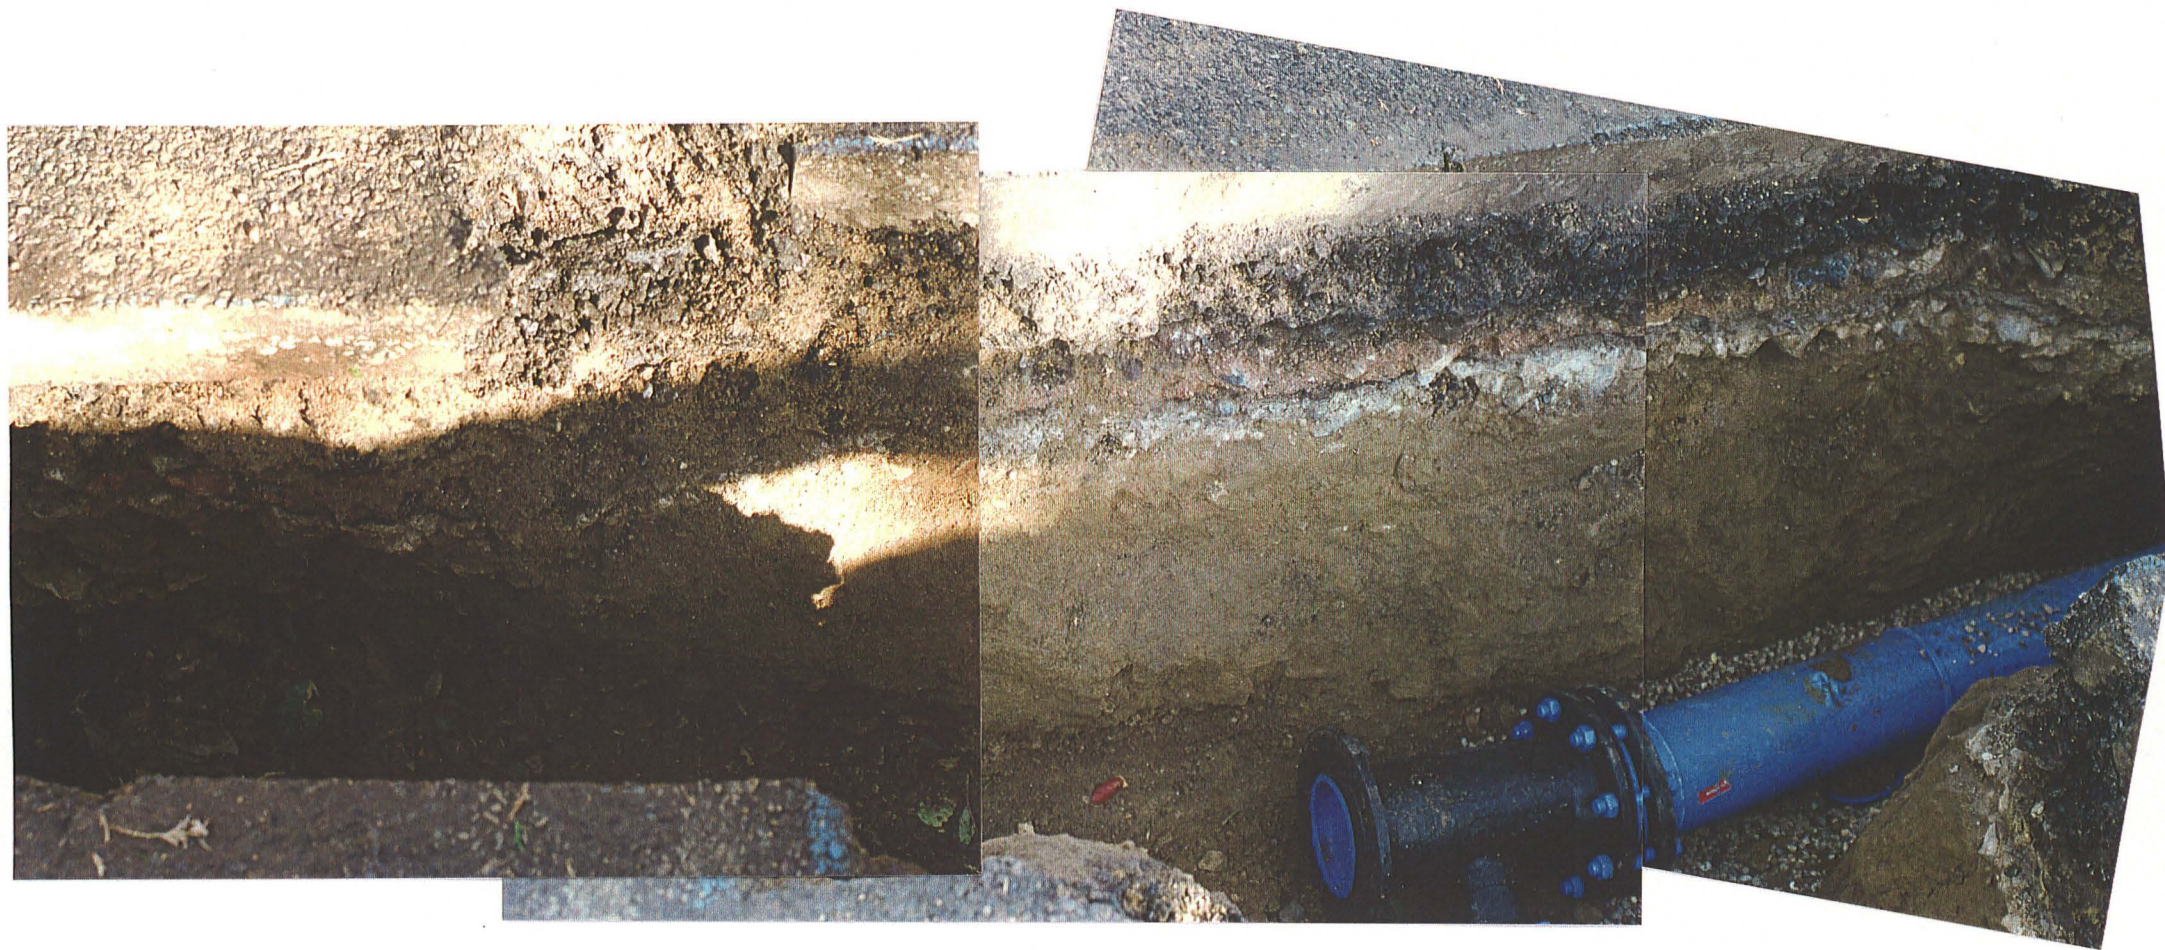
Pl. 10 Position of 3, possibly a prehistoric ditch, at the junction of Cliff Avenue and Washdyke Hill. (Looking west, Kingsway and Nettleham Beck on right).

3. At the Cliff Avenue junction, the bedrock was interrupted again for about 7m. Here the trench faces showed mid-brown loam to beneath the trench base (Pls. 10 - 13). A trench cut to the south into Cliff Avenue revealed that the loam extended only a short distance beyond the main trench, but it was thought that the feature continued obliquely. This feature was tentatively identified as one of the expected prehistoric ditches, aligned NW-SE, exposed at an unfortunate angle where its width and profile could not be ascertained. No dating material of any form was seen.

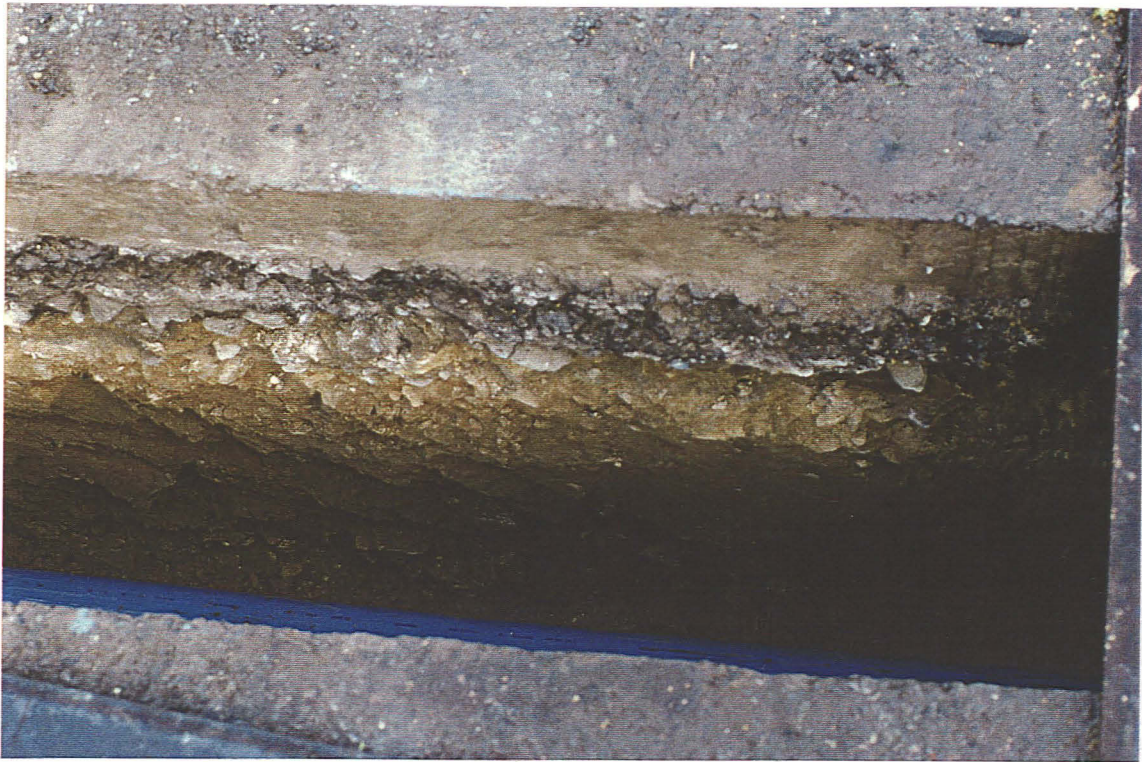
Pl. 11 Composite photograph of soil backfilling 3. The western edge of the feature (left) clearly cuts dense limestone, but the material to the east is almost stone-free. Looking north at the Cliff Avenue junction.

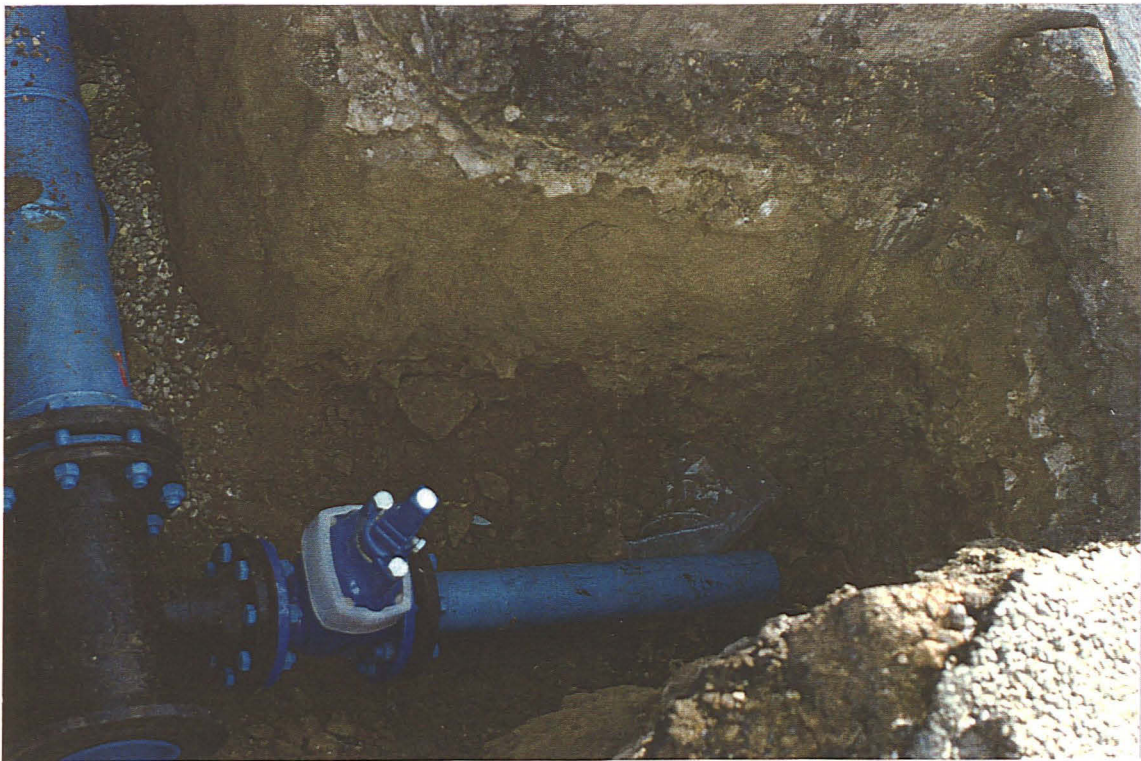
PI. 12 Eastern limit of 3 marked by dense limestone rising from the trench base to near the road foundation (extreme right). Recording was difficult here as access had to be maintained at the junction. Looking north.

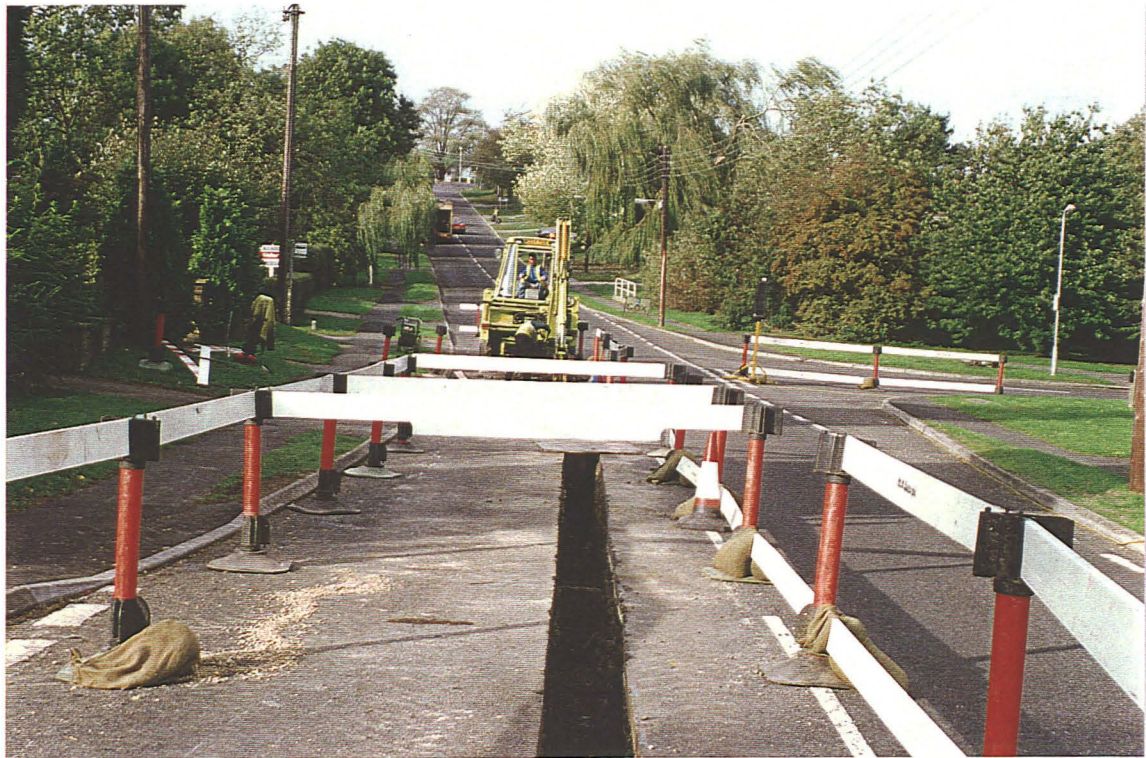
PI. 13 Stratigraphy in the Cliff Avenue spur trench suggested that 3 was becoming shallower to the south, possibly aligned NW-SE. Looking east.

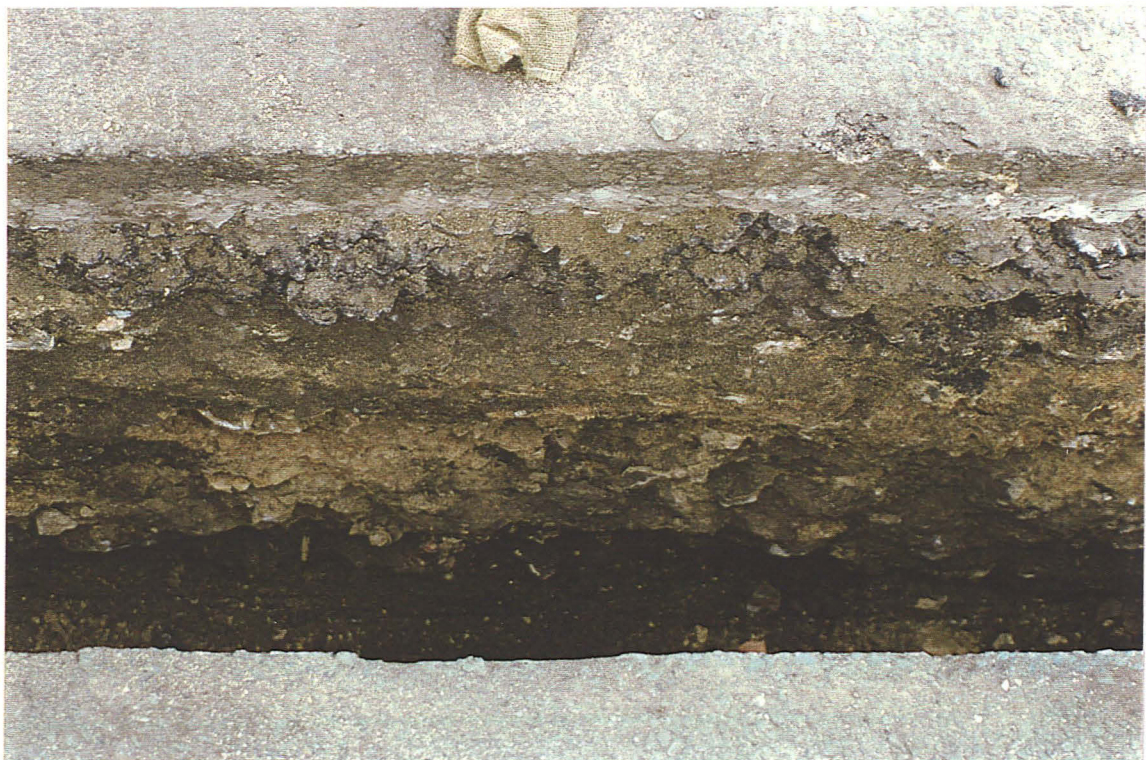
Pl. 14 Location of 4, marked by the excavator close to Kingsway (looking west towards the A46).

4. The limestone continued another 20m to the west before it was again replaced by disturbed material close to the boundary west of No. 37 Washdyke Hill (Pl. 14). At this location, the nature of the ground was very different; the tarmac and asphalt forming the modern road covered a 0.4m thick layer of redeposited limestone. Beneath this was a layer of dark brown soil at least 0.2m thick which continued below the trench base (Pl. 15). These conditions continued westwards past the junction with Kingsway but the western limit was not observed.

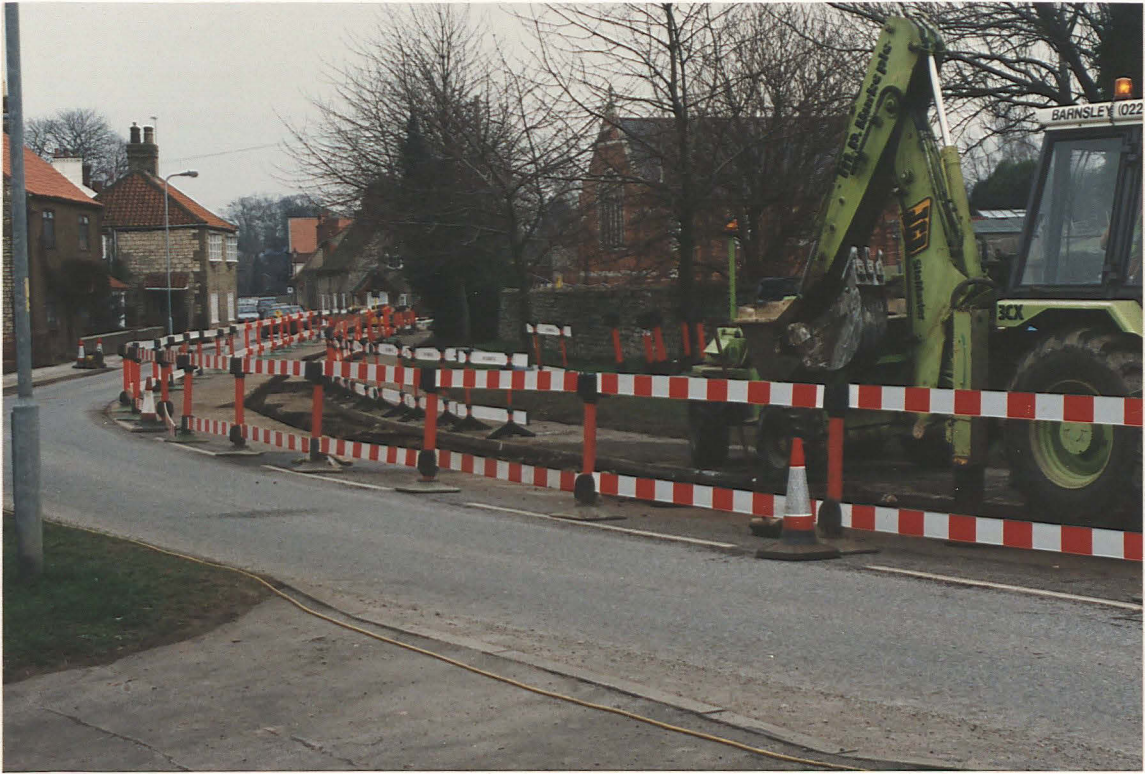
Pl. 15 Thick deposits of tarmac and redeposited limestone at 4, apparently above buried topsoil. This was interpreted as comparatively recent raising of the road in the Nettleham Beck valley. Any archaeological features would have been below the depth of the trench here.

It seemed probable that the natural valley crossed by Nettleham Beck had formerly been considerably deeper and steeper than now, and that comparatively recent raising of the road level had occurred. The former ground surface may survive below the trench base, at least 1.2m lower than the modern road surface.

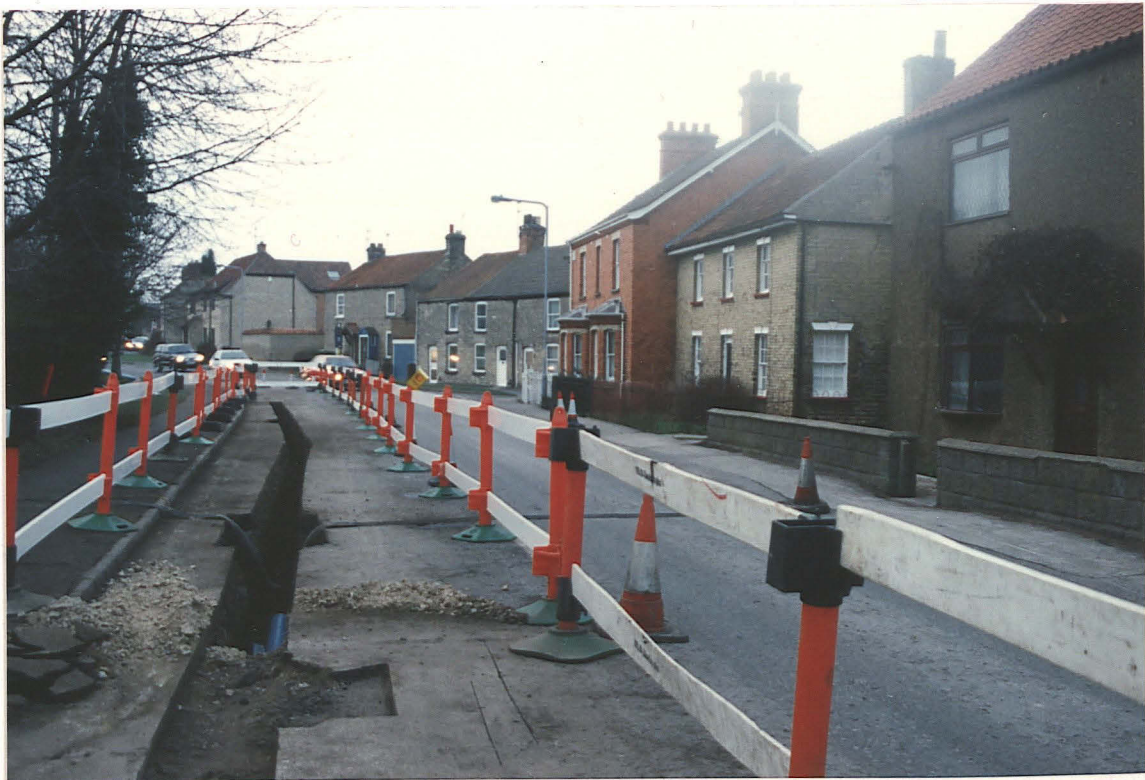
Pl. 18 High Street lies lower than the adjacent earthworks; it may be aligned over an early ditch or on ground sloping towards the beck. (Looking SW).

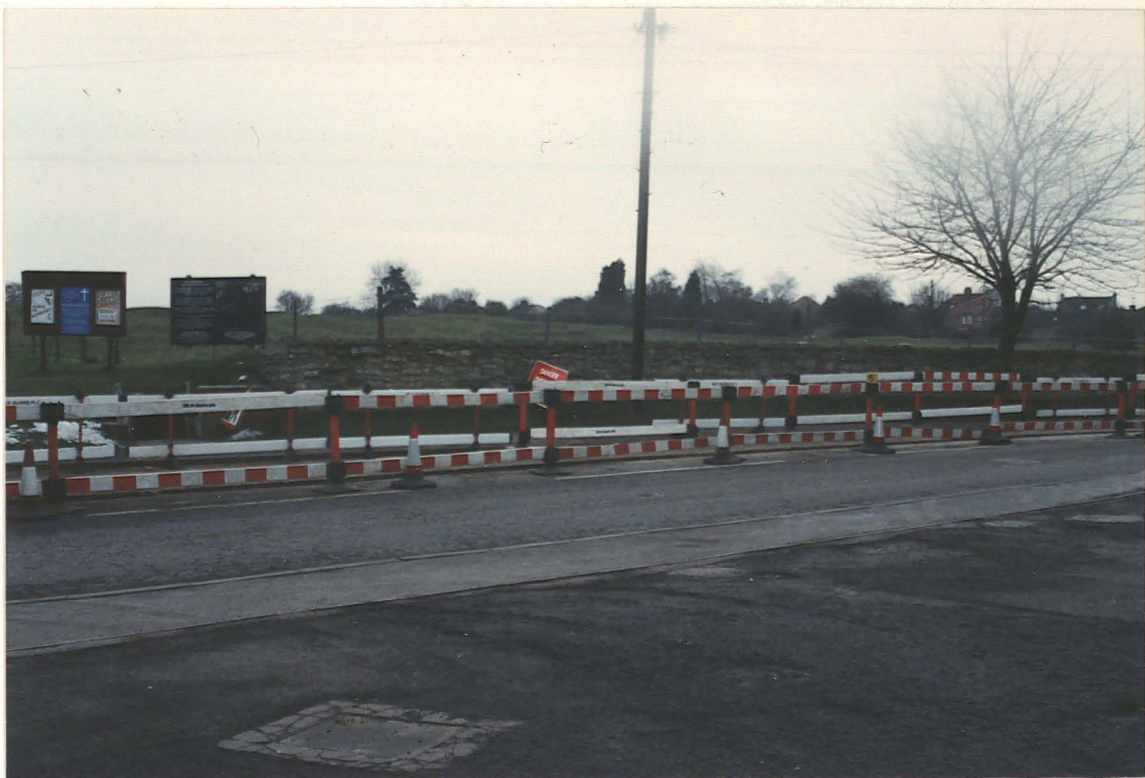
Pl. 19 Clay visible at the trench base at 5, beneath the road foundation of large stone lumps and redeposited limestone brash.

5. To the west of the Bishop's Palace site, the tarmac layer sealed limestone lumps (road foundation material) to a depth of 0.5m. Beneath this was a layer of redeposited limestone brash, covering a deposit of yellow/grey clay extending beneath the trench base (Pl. 19). The clay was visible beyond the junction with Watermill Lane.

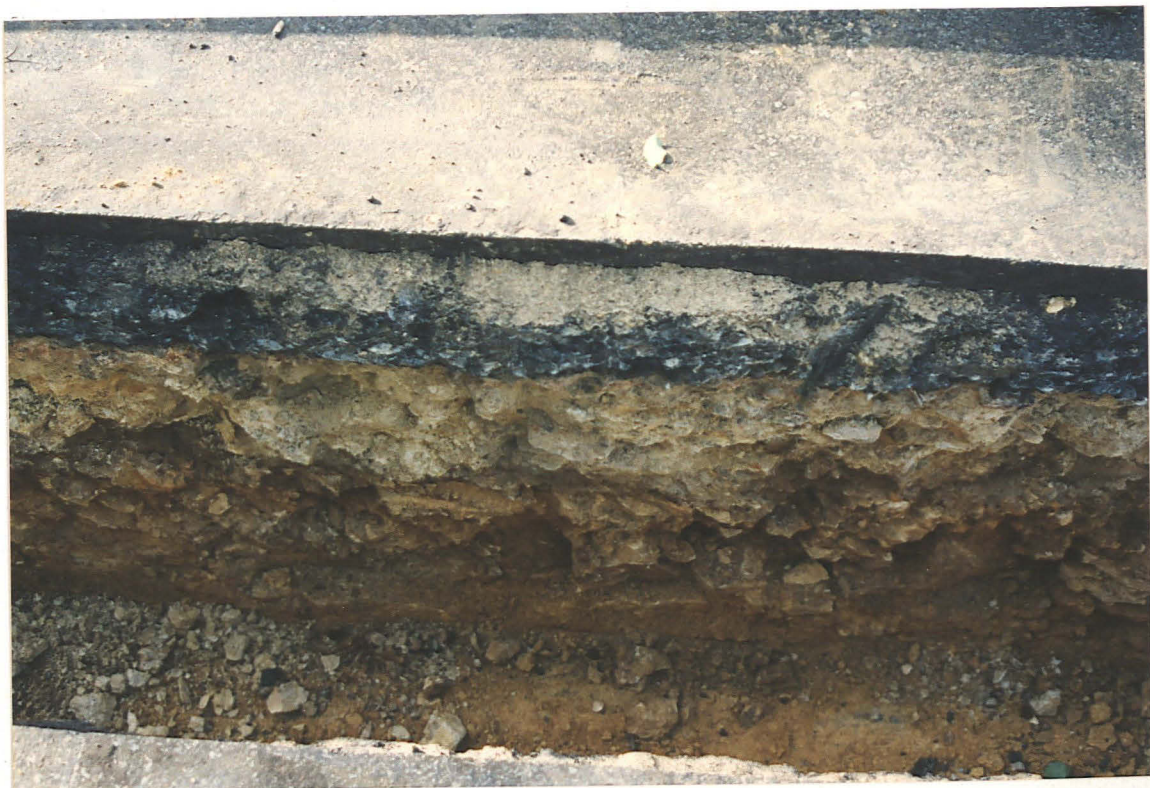
Pl. 20 A marked depression, probably of a former tributary of Nettleham Beck, crosses Kingsway close to 5; this may explain the observed clay. (Looking NW).

The ground dips at the junction of Kingsway, apparently in a natural SW-NE valley leading towards Nettleham Beck (Pl. 20). The clay was interpreted as a natural deposit associated with the stream course. Overlying material had been deliberately laid to raise the road level and to provide a firmer surface.
