Caistor Mains Relay: Archaeological Monitoring at Cabourne (A46), Caistor (Rawlinson Avenue) and Nettleton (Cook's Lane)

Site Code: **CMR 96**

Report prepared for Anglian Water

May 1996

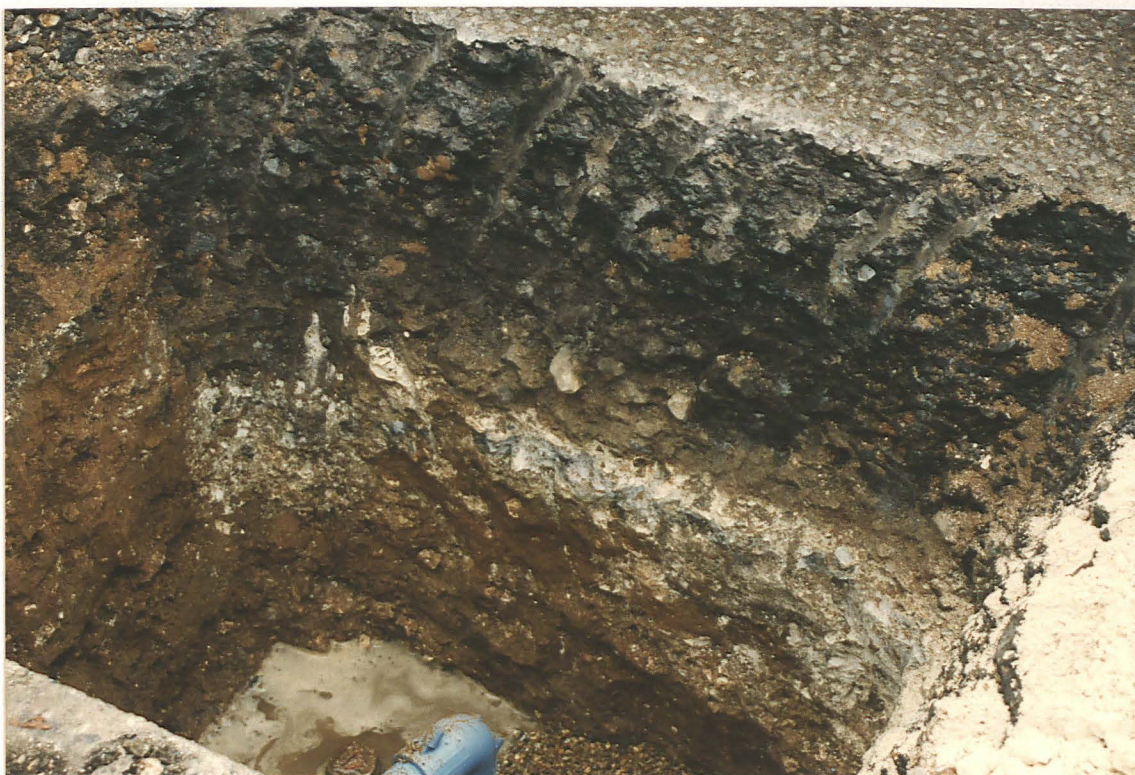
A single hole was excavated by hand in the road in front of the Telephone Exchange, at the western limit of the present village. The 0.55m thick tarmac layer was bedded onto 0.22m of redeposited stone and a thin layer of chalk; all this deposit may represent quite recent road construction. Beneath the stone were two sand layers; the upper was light brown and 0.22m thick, and the lower was much darker and 0.25m thick (Pl. 1).

Pl. 1 Section cut close to the northern edge of the A46 Grimsby Road at the Telephone Exchange, Cabourne.

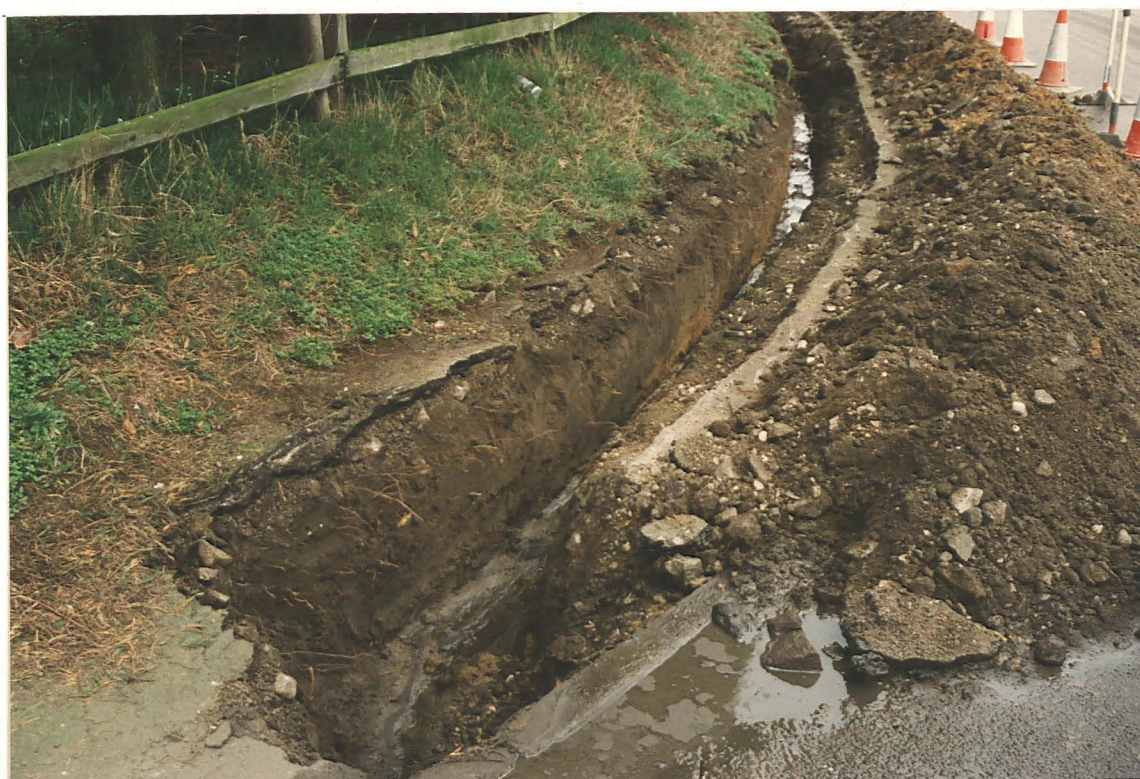
Land to the east of Wood Farm was particularly disturbed, with early 20th century refuse visible in the trench face beside an uneven paddock. The uneven depth of the uppermost dark grey, fine sandy loam layer hinted at levelling of low or uneven ground, although a backfilled ditch slightly skew to the new trench could have produced similar stratigraphy (Pl. 2).

Pl. 2 Uneven dark grey soil in the trench face in front of Wood Farm, Nettleton (looking west).

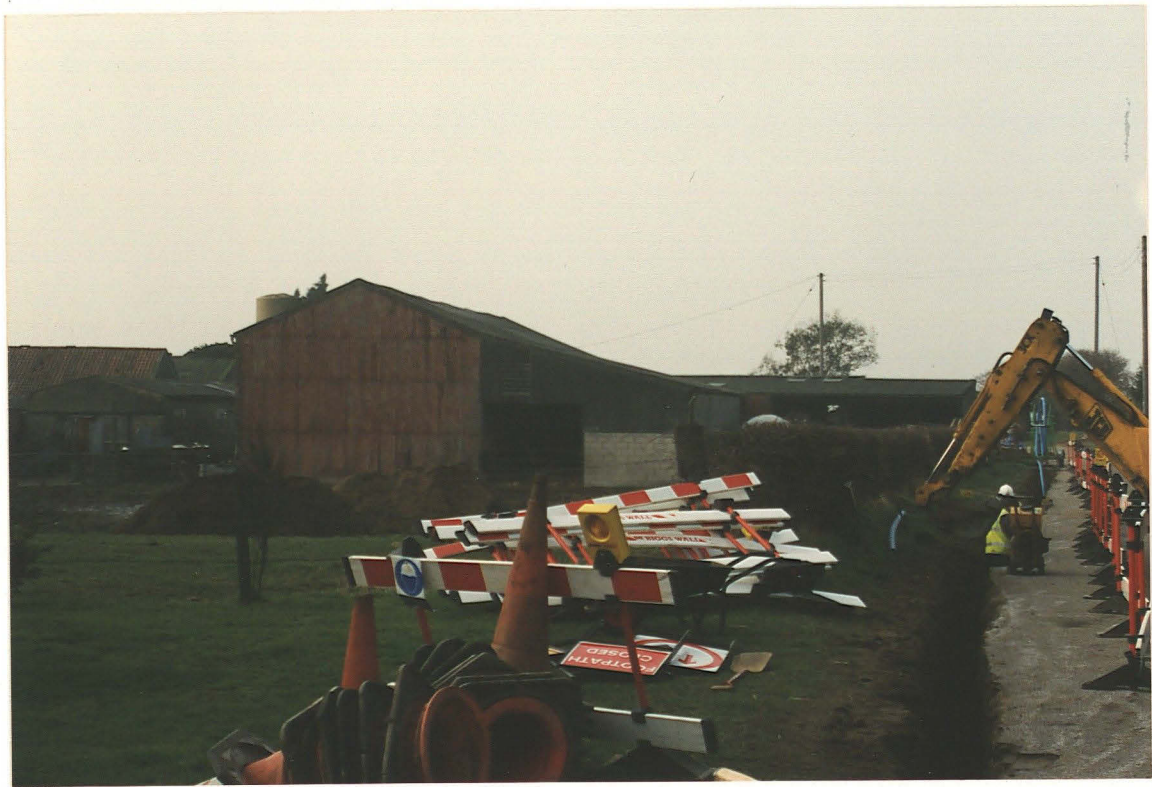
At Nettleton the trench sections suggested that Cook's Lane crosses land once used for refuse disposal, probably around the beginning of the 20th century. The processes of backfilling low-lying and wet ground continue in the field to the south of the road past Wood Farm, where the farmer is gradually levelling previous pond-like hollows (partly with spoil from the present trench) (Pl. 3).

PI. 3 Uneven ground in the roadside paddock beside Wood Farm (looking west).
