**ARCHAEOLOGICAL WATCHING BRIEF
AT 14 BEDEHOUSE BANK,
BOURNE,
LINCOLNSHIRE
(BBH96)**

Work Undertaken For
Mr C. LONG

Report Compiled
by
Fiona Walker

May 1996

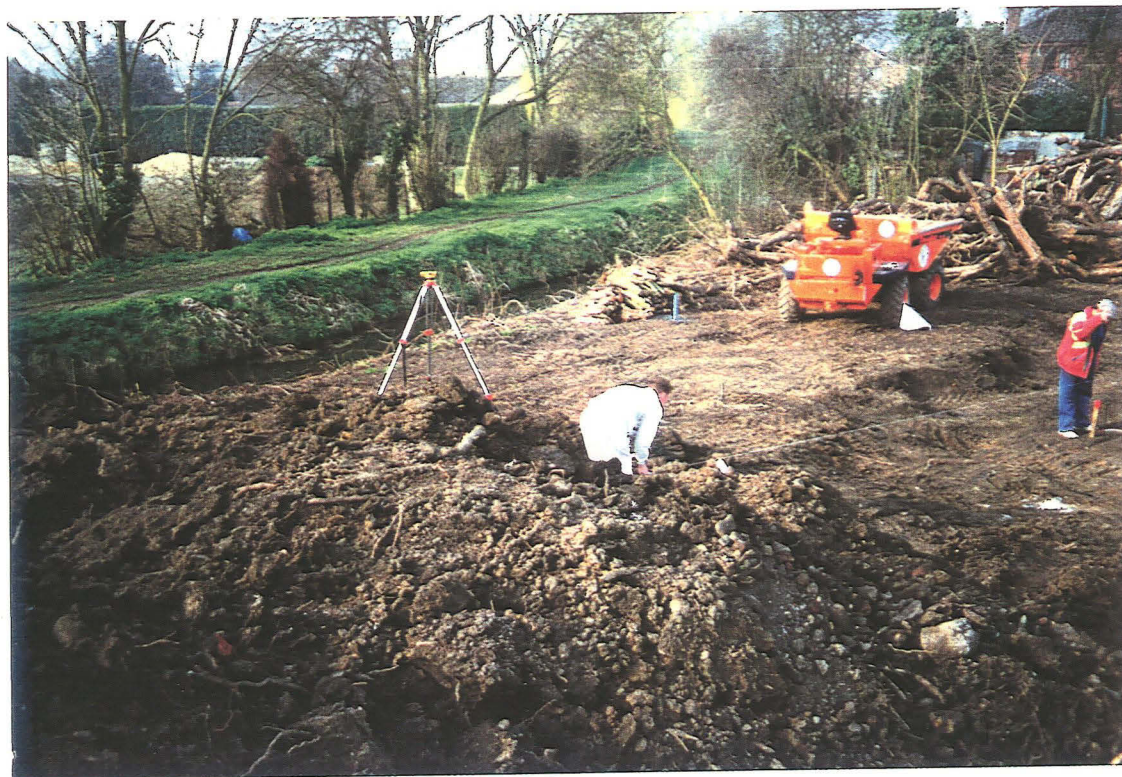
Plate 1. General view across the development site. The Car Dyke is visible in the background.
