**Burton, Middle Street and Lincoln, Burton Road
Mains Replacement Scheme:**

Archaeological Monitoring

Site Code: **BVM 95**

Report prepared for Anglian Water

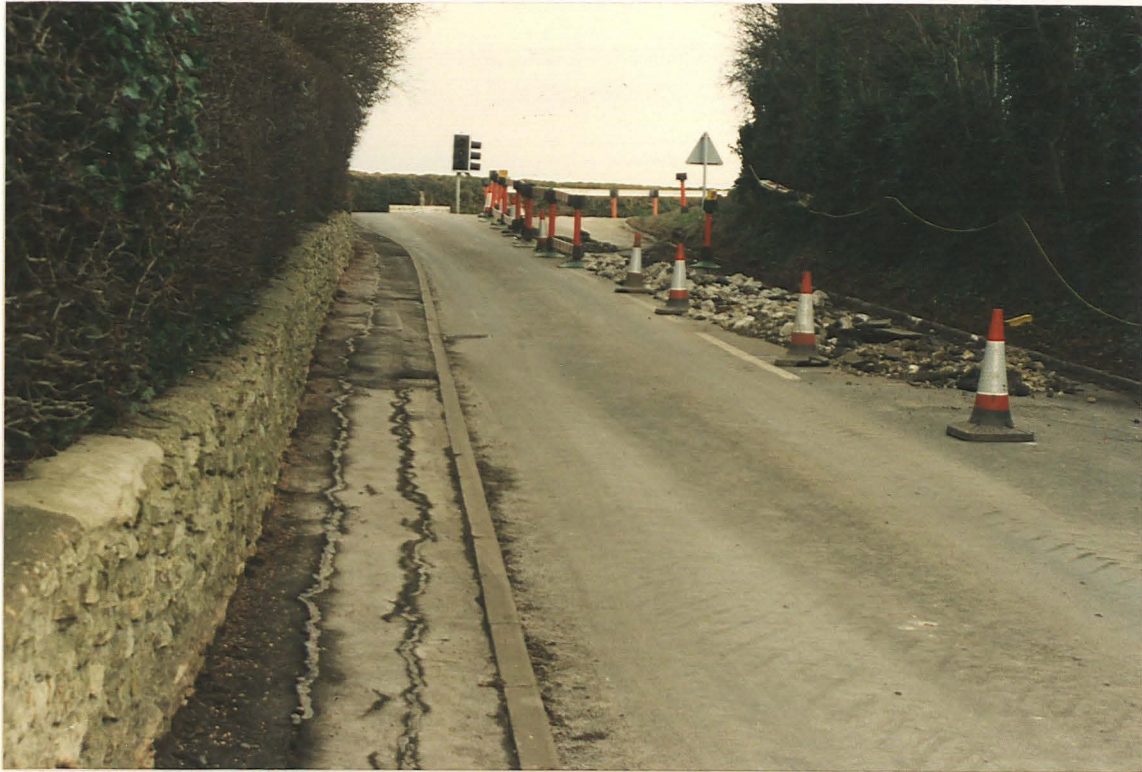
1. A spur was laid to the west into Main Street, Burton to connect with a future scheme in the village. The present road junction is at the top of a steep slope leading down from Middle Street into the village (Pl. 1). The trench revealed that much of the upper slope has been constructed relatively recently, using up to 0.95m depth of tarmac. Thinner tarmac overlay concrete of unknown thickness, perhaps over an existing culvert (Pl. 2). The machine operator recounted a local tradition that a hump-backed bridge lay beneath the present road here but no evidence was found to support the suggestion.

Pl. 1 The road into Burton village drops abruptly from the junction with Middle Street (looking east towards Middle Street).

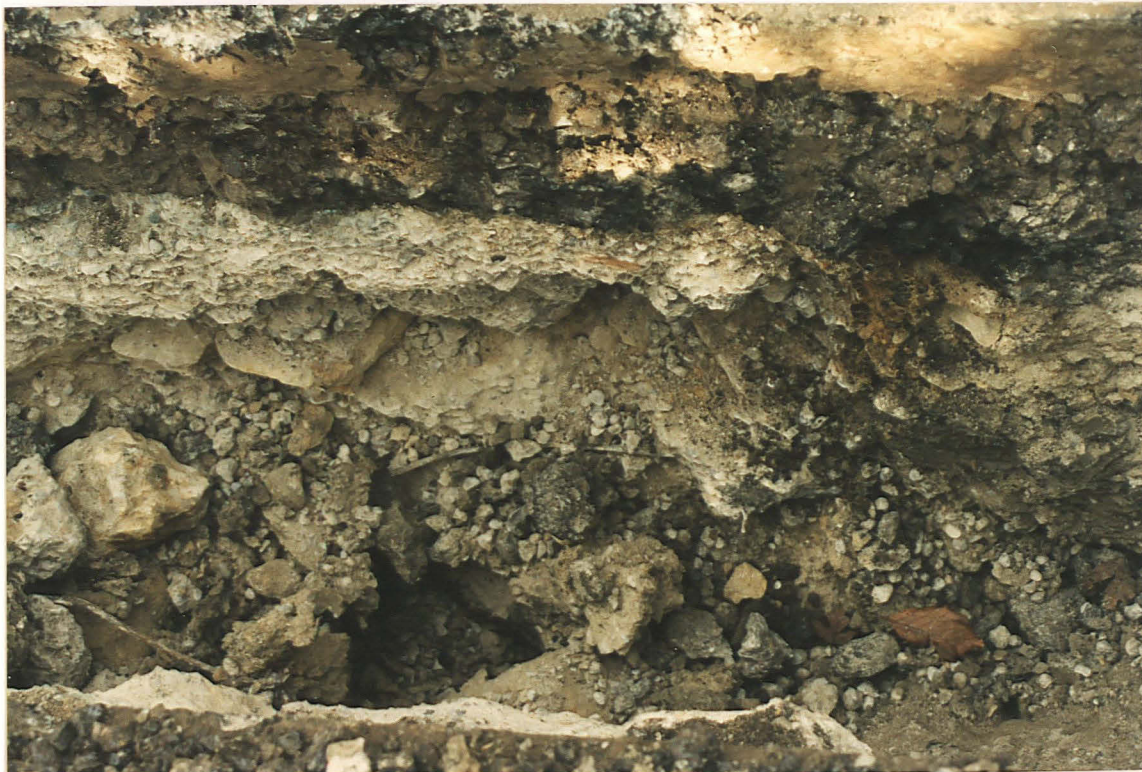
Pl. 2 Thick tarmac overlay concrete and stone to the west of the Middle Street/Burton Main Street junction, probably serving to raise the road level.

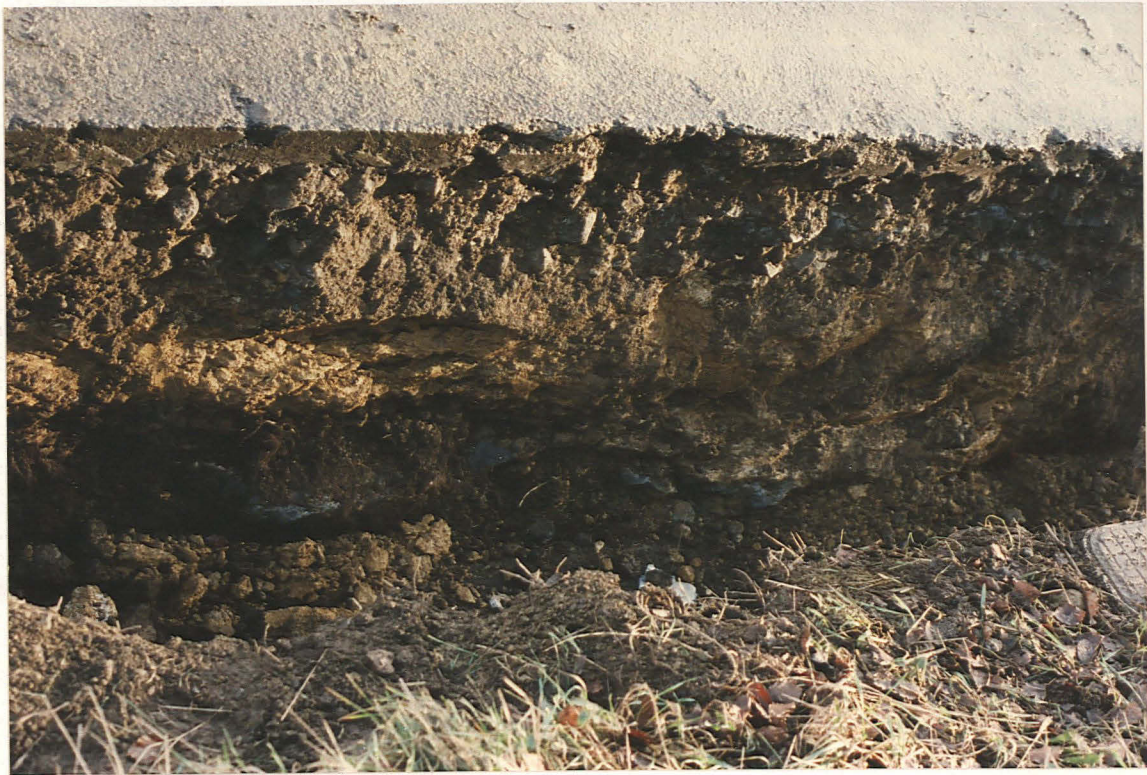
2. For 100m to the south of the road junction, limestone bedrock was found 0.3m beneath the modern road surface, suggesting that higher deposits had been removed (Pl. 3).

PI. 3 South of the Burton junction, the modern road had been built onto bedrock.

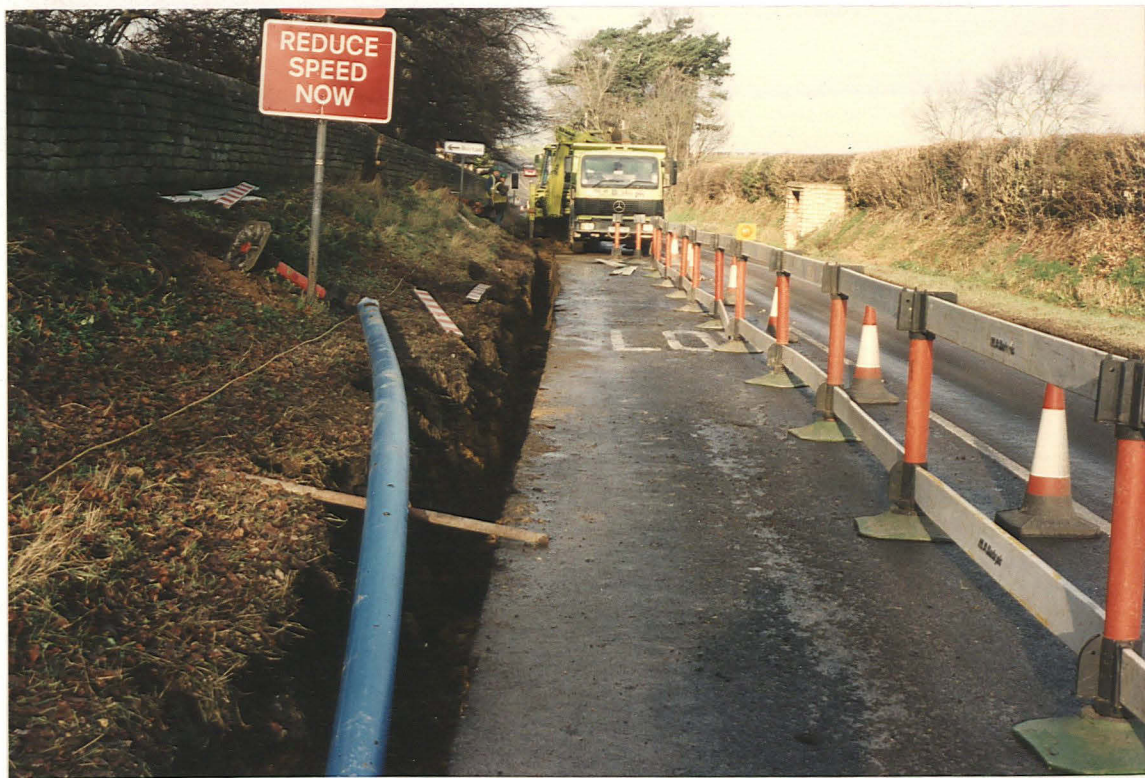
3. Beyond this, the bedrock was overlain by a series of deposits which could not all be satisfactorily explained (Pl. 4). Beneath the tarmac and asphalt road base was 0.25m of yellow limestone which may have been a late post-medieval road foundation (Pl. 5). A layer of buff-coloured sandy clay 0.2m thick separated this from a rocky layer incorporating large blocks and flaky fragments of limestone; this layer may have been a weathered bedrock. These conditions extended to near St. Vincent's House.

PI. 4 About 100m south of the junction, the bedrock dipped lower and was covered by mixed deposits. (Looking north).

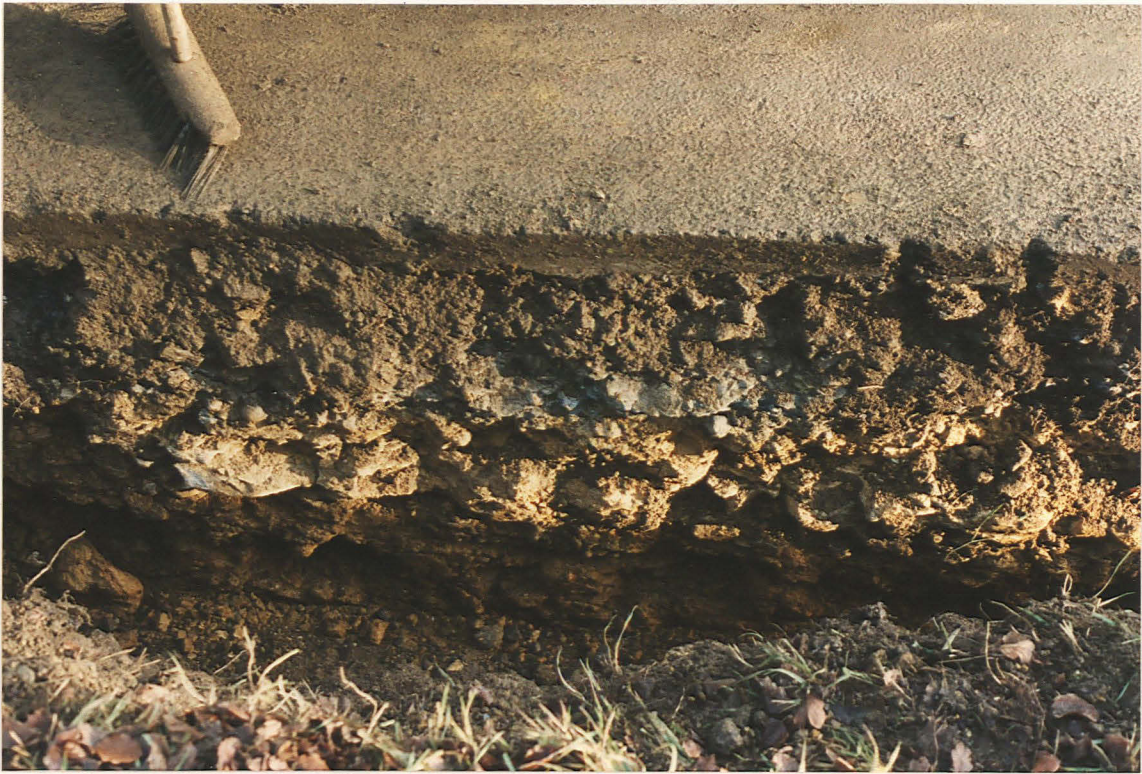
PI. 5 Mixed layers of road construction material; at 3 the lowest visible layer may have been weathered bedrock, suggesting that little or no truncation of deposits had occurred.

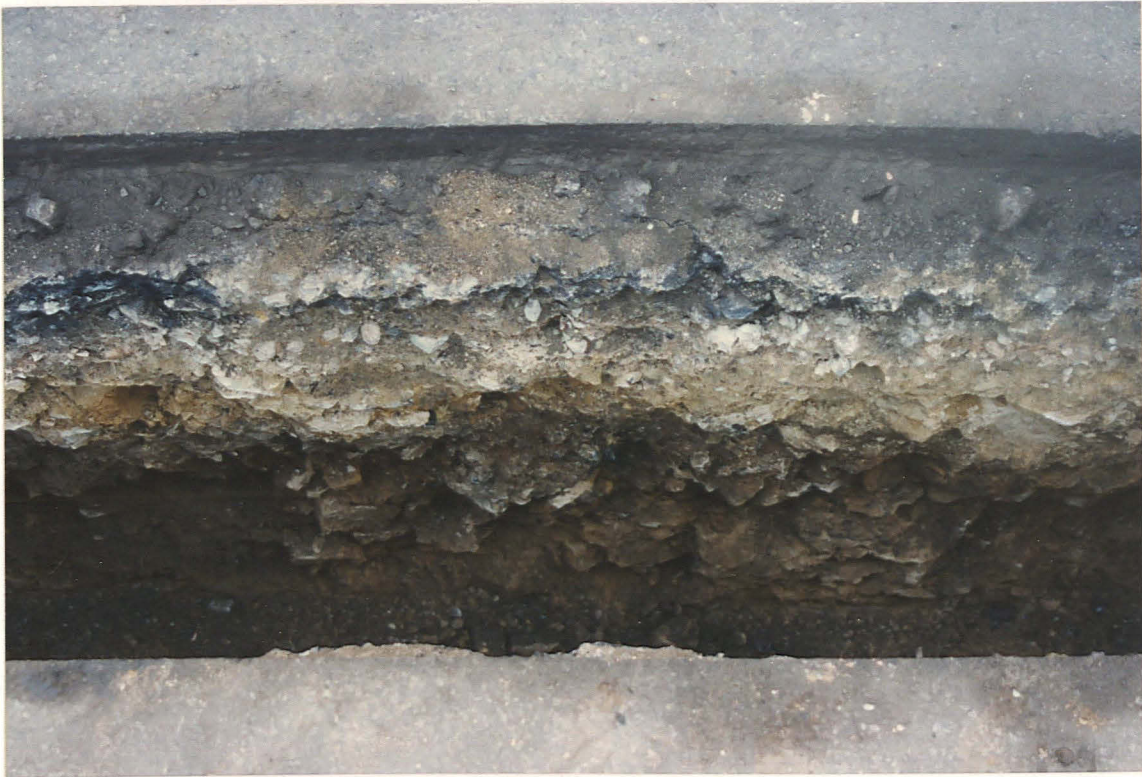
8. At the junction of Queen Elizabeth Way the tarmac road lay on clean limestone to a depth of 0.55m (Pl. 6). The mixed stone and soil layer beneath this was possibly an earlier road surface founded on the bedrock 0.8m beneath the surface.

PI. 6 Road construction layers at the junction with Queen Elizabeth Way (8).

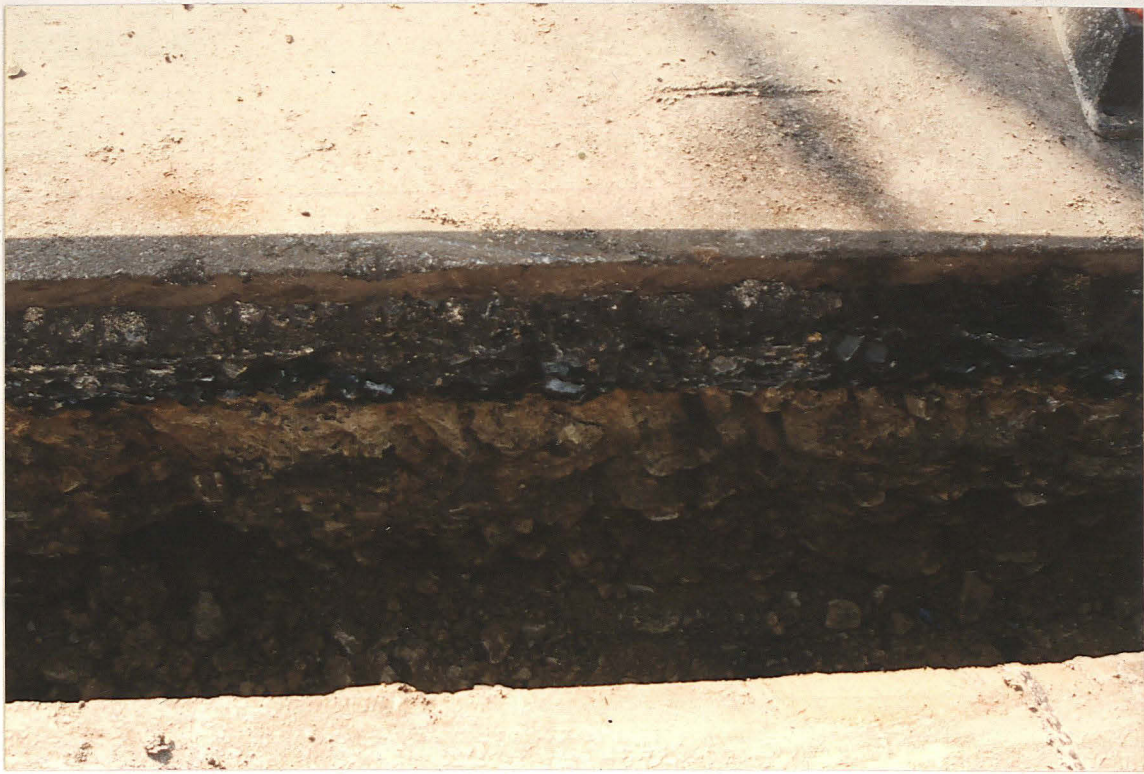
9. Opposite Lincoln Lodge the tarmac sealed a layer of pitched limestone pieces, 0.2m thick (Pl. 7). This was identified at intervals along the trench to the SE and interpreted as a post-medieval road construction technique recorded elsewhere along Burton Road by the City of Lincoln Archaeology Unit. Pieces of pitched stone thought to be reused flagstones were seen opposite Burton Cliff House, perhaps confirming the suggested date. The stone lay on a dark yellow-brown clay deposit 0.15m thick and beneath that was the mixed layer of soil and rock greater than 0.3m thick. From the greater sequence of deposits here and the better construction of the later stone road, this may have been a wetter patch of land which required consolidation.

Pl. 7 Pitched limestone pieces close to Lincoln Lodge (9), thought to be the post-medieval road foundation.

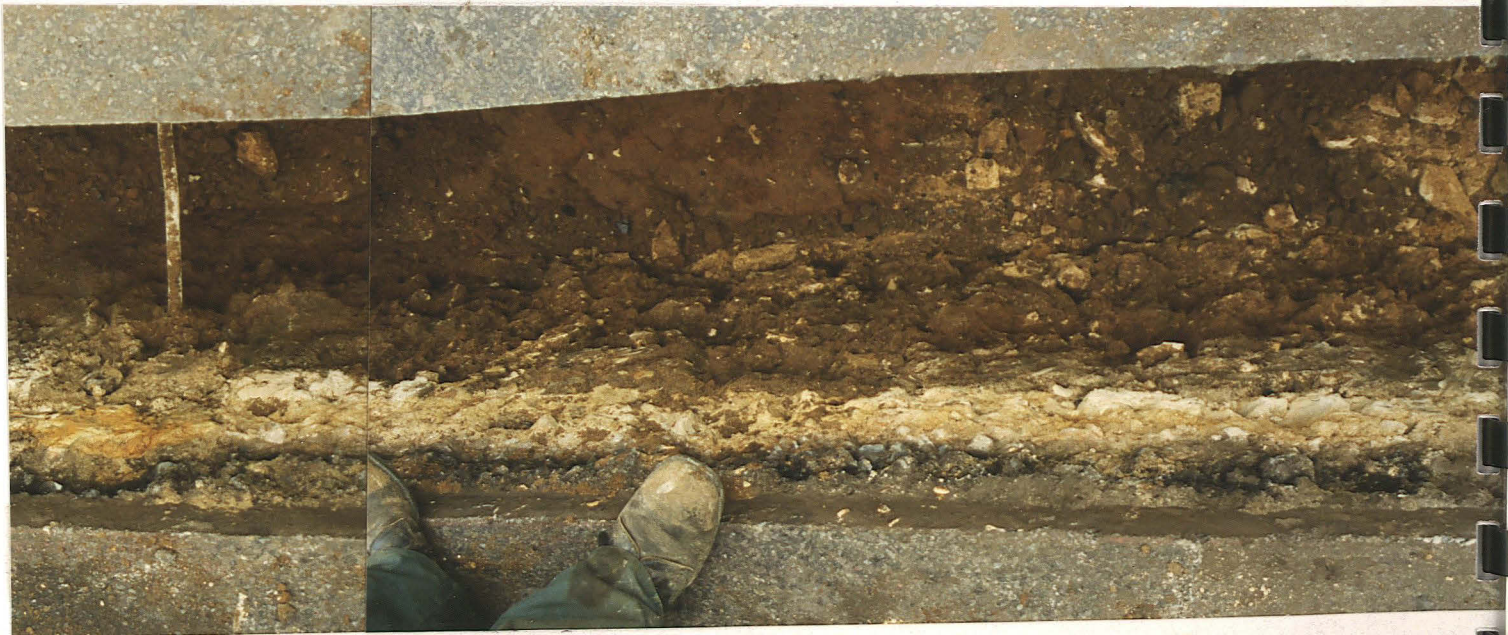
14. A feature about 1.2m wide was observed to have cut this soft material and was interpreted as a small pit (Pl. 8). It had been filled with mixed stone and dark brown soil but no datable finds were recovered. A pipe trench had cut the pit fill at a later date.

Pl. 8 Dense bedrock near Sobraon Barracks (far left) was cut by a pit or similar feature 14, backfilled with mixed soil and rock. The pit was at the interface between the rock and a sandy, almost stone free deposit (right) which may have been fill of a small stream channel. (Looking east).
