**ARCHAEOLOGICAL WATCHING BRIEF
OF A WATER MAINS RELAY AT
WITHAM ON THE HILL,
LINCOLNSHIRE
(WOH96)**

Work Undertaken For
Anglian Water Services Ltd

June 1996

A.P.S. Report No. 20/96

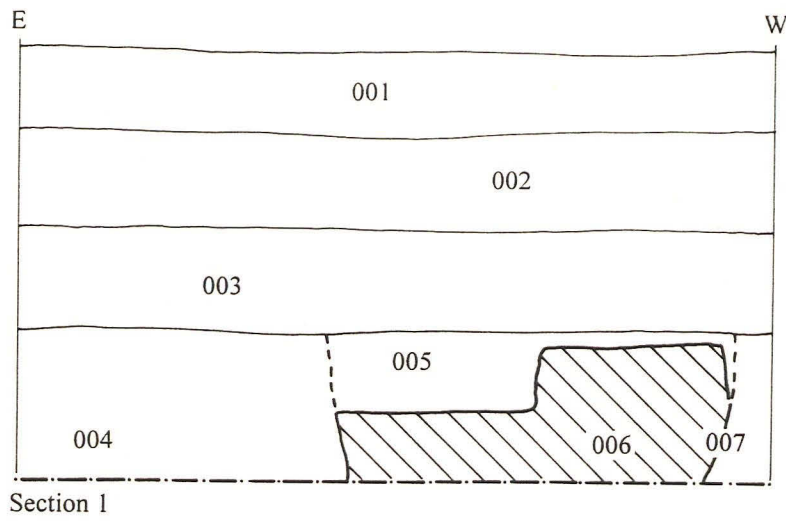
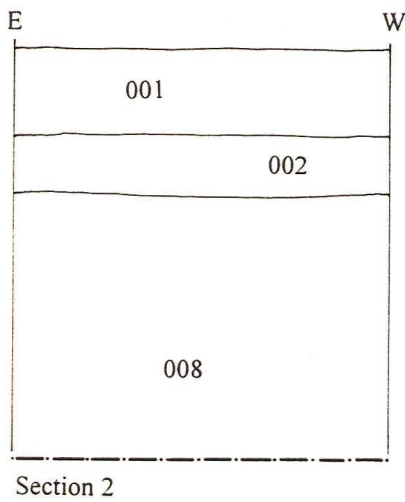
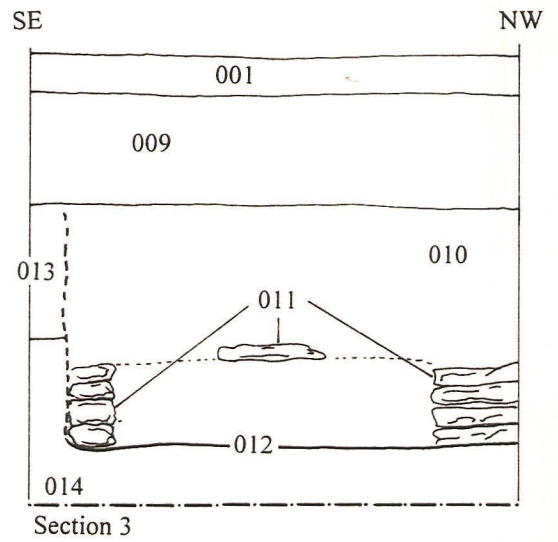
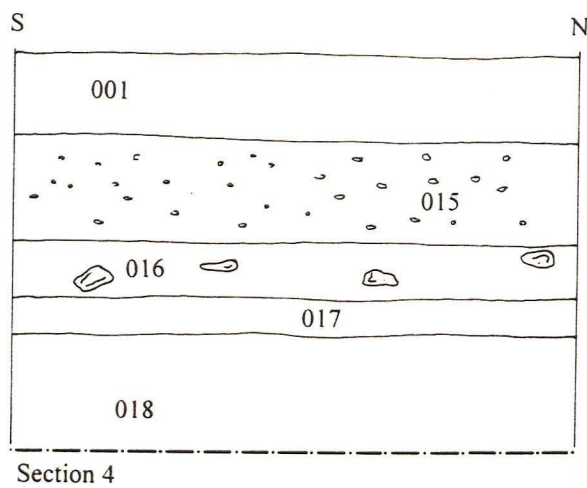
Fig. 3 Sections 1, 2, 3 and 4

Feature (007). Observed in Section 1 (Fig. 3). Linear cut aligned southwest to northeast. 1m wide. Contains wall (006). Limestone blocks with no mortar present. Backfilled by (005), brown clay. Foundation trench, wall and subsequent demolition or partial robbing.

Feature (012). Observed in Section 3 (Fig. 1). Linear cut aligned east to west. 0.75m wide by 0.7m deep. Contains drain (011). Consisting of two side walls of shelly

limestone, covered with a single slab. Drain fill (010) of brown and dark grey silty clay. Former drain channel.

Deposit (017). Observed in Section 4 (Fig. 1). Dark grey clayey silt with occasional charcoal flecks. 100mm thick. Possible former topsoil.

No dating evidence was obtained in the form of artefactual material from phase 2 deposits. Three walls were located during the investigation (Sections 1, 10 and 11). Wall (006) crossed the road at an oblique angle and dates to before the highway was constructed. The remaining two walls, by virtue of their proximity and alignment, may have been separate parts of the same wall. Its removal was probably due to highway improvements to allow easier access through the village. A stone drain was recorded in Section 3 aligned east to west. Stone drains have been a recognised feature from the Romano-British period to the 19th century.

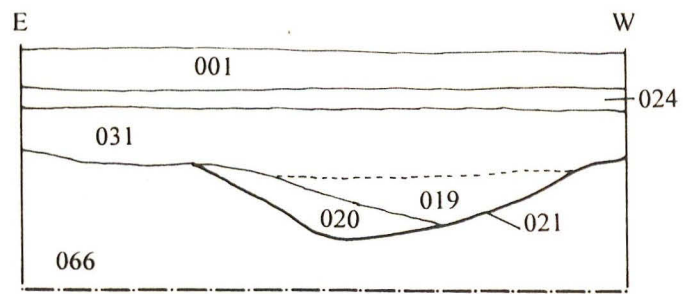
Feature (021). Observed in Section 5 (Fig. 4). Linear cut aligned north to south. 2.1m wide by 0.4m deep. Contains two fills, lower (020) of dark grey sandy silt, 0.2m thick, and upper (019) of greyish brown clayey silt. Boundary ditch.

Deposit (031). Seals ditch (021). Dark greyish brown clayey silt 0.36m thick. Indeterminate deposit.

Pits and ditches were also encountered during the investigation, all of which were located to the west of the village. A former boundary ditch was recorded in Section 5 and probably relates to agricultural land division. Two features interpreted as pits were situated in Section 6. There is no indication as to the use of these pits, but refuse disposal appears unlikely. A broad shallow feature (030) was also identified as a pit or hollow though its function was not ascertained.

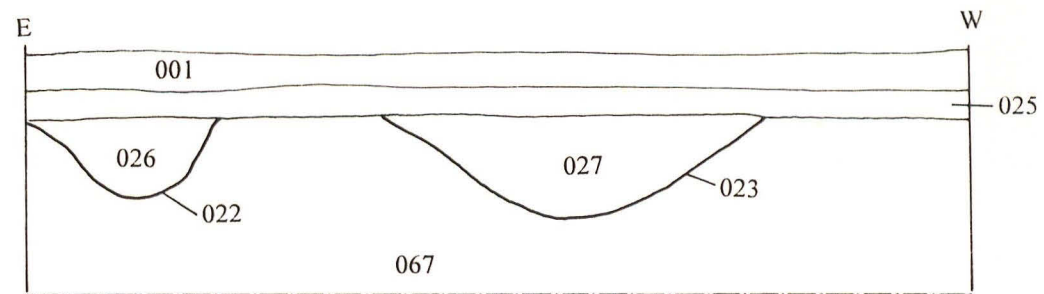
Feature (022). Observed in Section 6 (Fig. 4). Appearing in section. 1m wide by 0.44m deep. Contains a single fill (026) of dark grey sandy clay. Pit.

Feature (023). Observed in Section 6 (Fig. 4). Appearing in section only. Located 1m west of Pit (022). 2m wide by 0.54m deep. Contains a single fill (027). Pit.

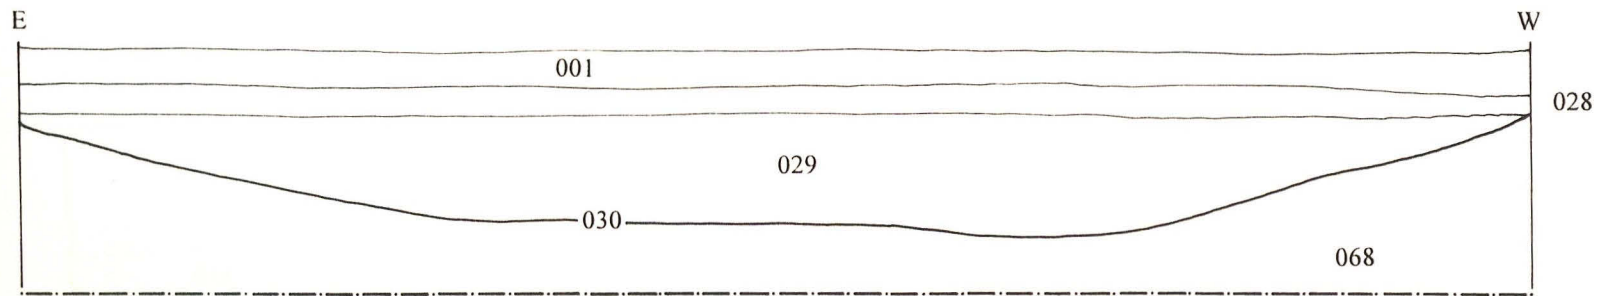
Feature (030). Observed in Section 7 (Fig. 4). Linear cut aligned north to south. 8m wide by 0.66m exposed depth. Contains a single fill (029) of dark brown clayey silt. Shallow pit/hollow.

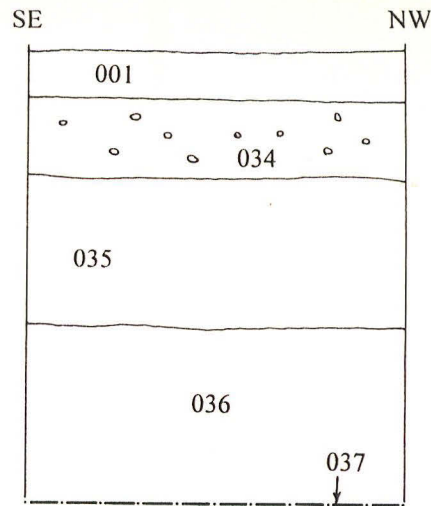
Deposit (037). Observed in Section 9 (Fig 5). Yellow limestone fragments in yellow clay matrix. Weathered surface of bedrock.

Deposit (014, 036, 049 and 067). Observed in Sections 3, 6, 9 and 12. (036) overlies (037). Predominantly dark grey clay, though brown clay was also recorded (049). 0.46m thick. Natural layer.

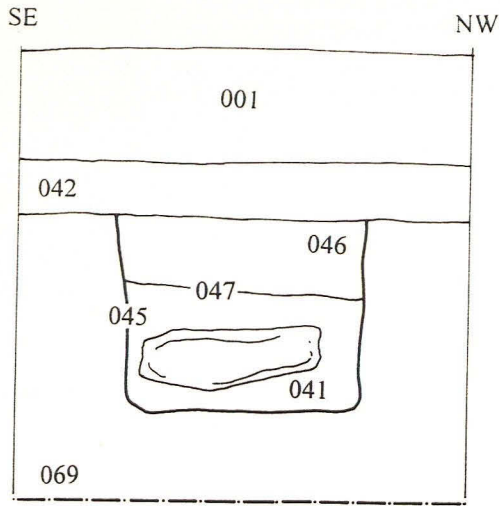
Feature (045). Observed in Section 11 (Fig. 6, Plate. 2). Linear cut aligned east to west (90° to wall (038)). 0.6m wide by 0.5m deep. Contains wall (041) of roughly shaped unmortared limestone blocks. Foundation cut and wall for former land boundary.

Feature (047). Robbing of wall (041). Backfill (046) of brown sandy silt 0.2m thick.

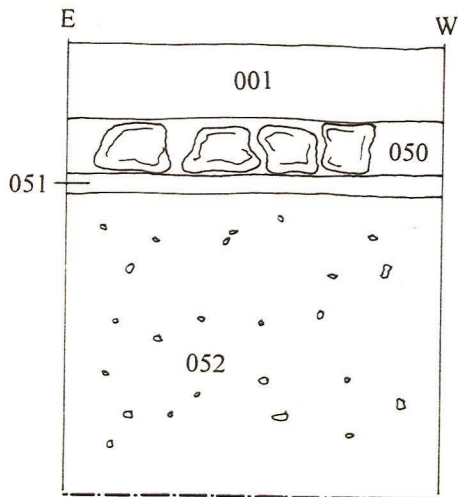
Deposit (052). Observed in Section 13 (Fig. 6). Brown pebbles and stone mixed with sandy clay. Minimum 0.8m thick. Dumped layer to improve natural gradient.

Surface (051). Sealing layer (052). Tarmac 50mm thick. Former road surface.

Modern deposits (phase 3) comprise the make-up and tarmac of the modern thoroughfare. Section 13 indicates road improvements with a previous tarmac surface identified 0.36m below the present road. Additionally, the make-up layer for this former road was of substantial thickness and may indicate an attempt to improve the gradient of the road.

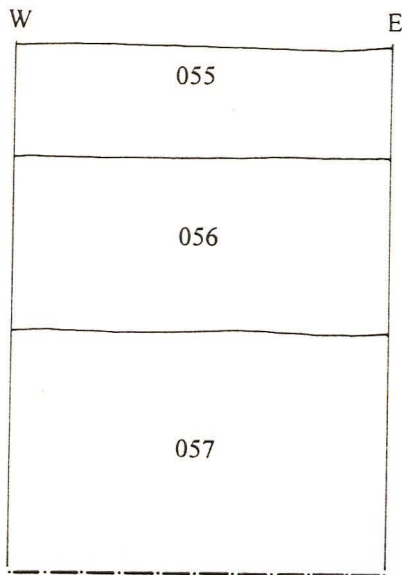
Deposit (056). Observed in Section 15 (Fig 6). Sealing natural (057). Light brown sandy clay 0.16m thick. Natural layer.

Deposit (055). Observed in Section 15 (Fig. 6). Sealing natural (056). Dark brown sandy silt 0.6m thick. Modern topsoil along roadside verge.

One location (Section 15) recorded the topsoil of the roadside verge.

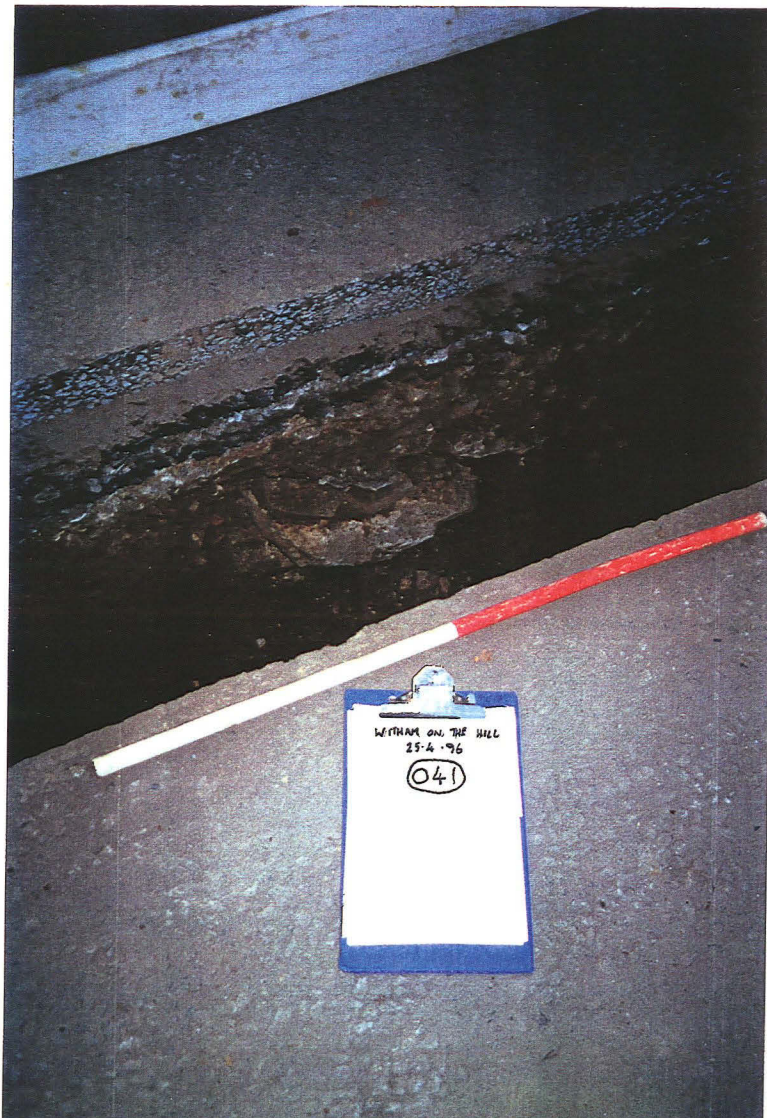
2. Section 11, showing Wall (041).
