**ARCHAEOLOGICAL WATCHING BRIEF  
AT ROMAN BANK,  
BOURNE,  
LINCOLNSHIRE  
(BRB96)**

Work Undertaken For  
Teemo Designs Ltd

Report Compiled  
by  
Paul Cope-Faulkner

A.P.S. Report No. 29/96

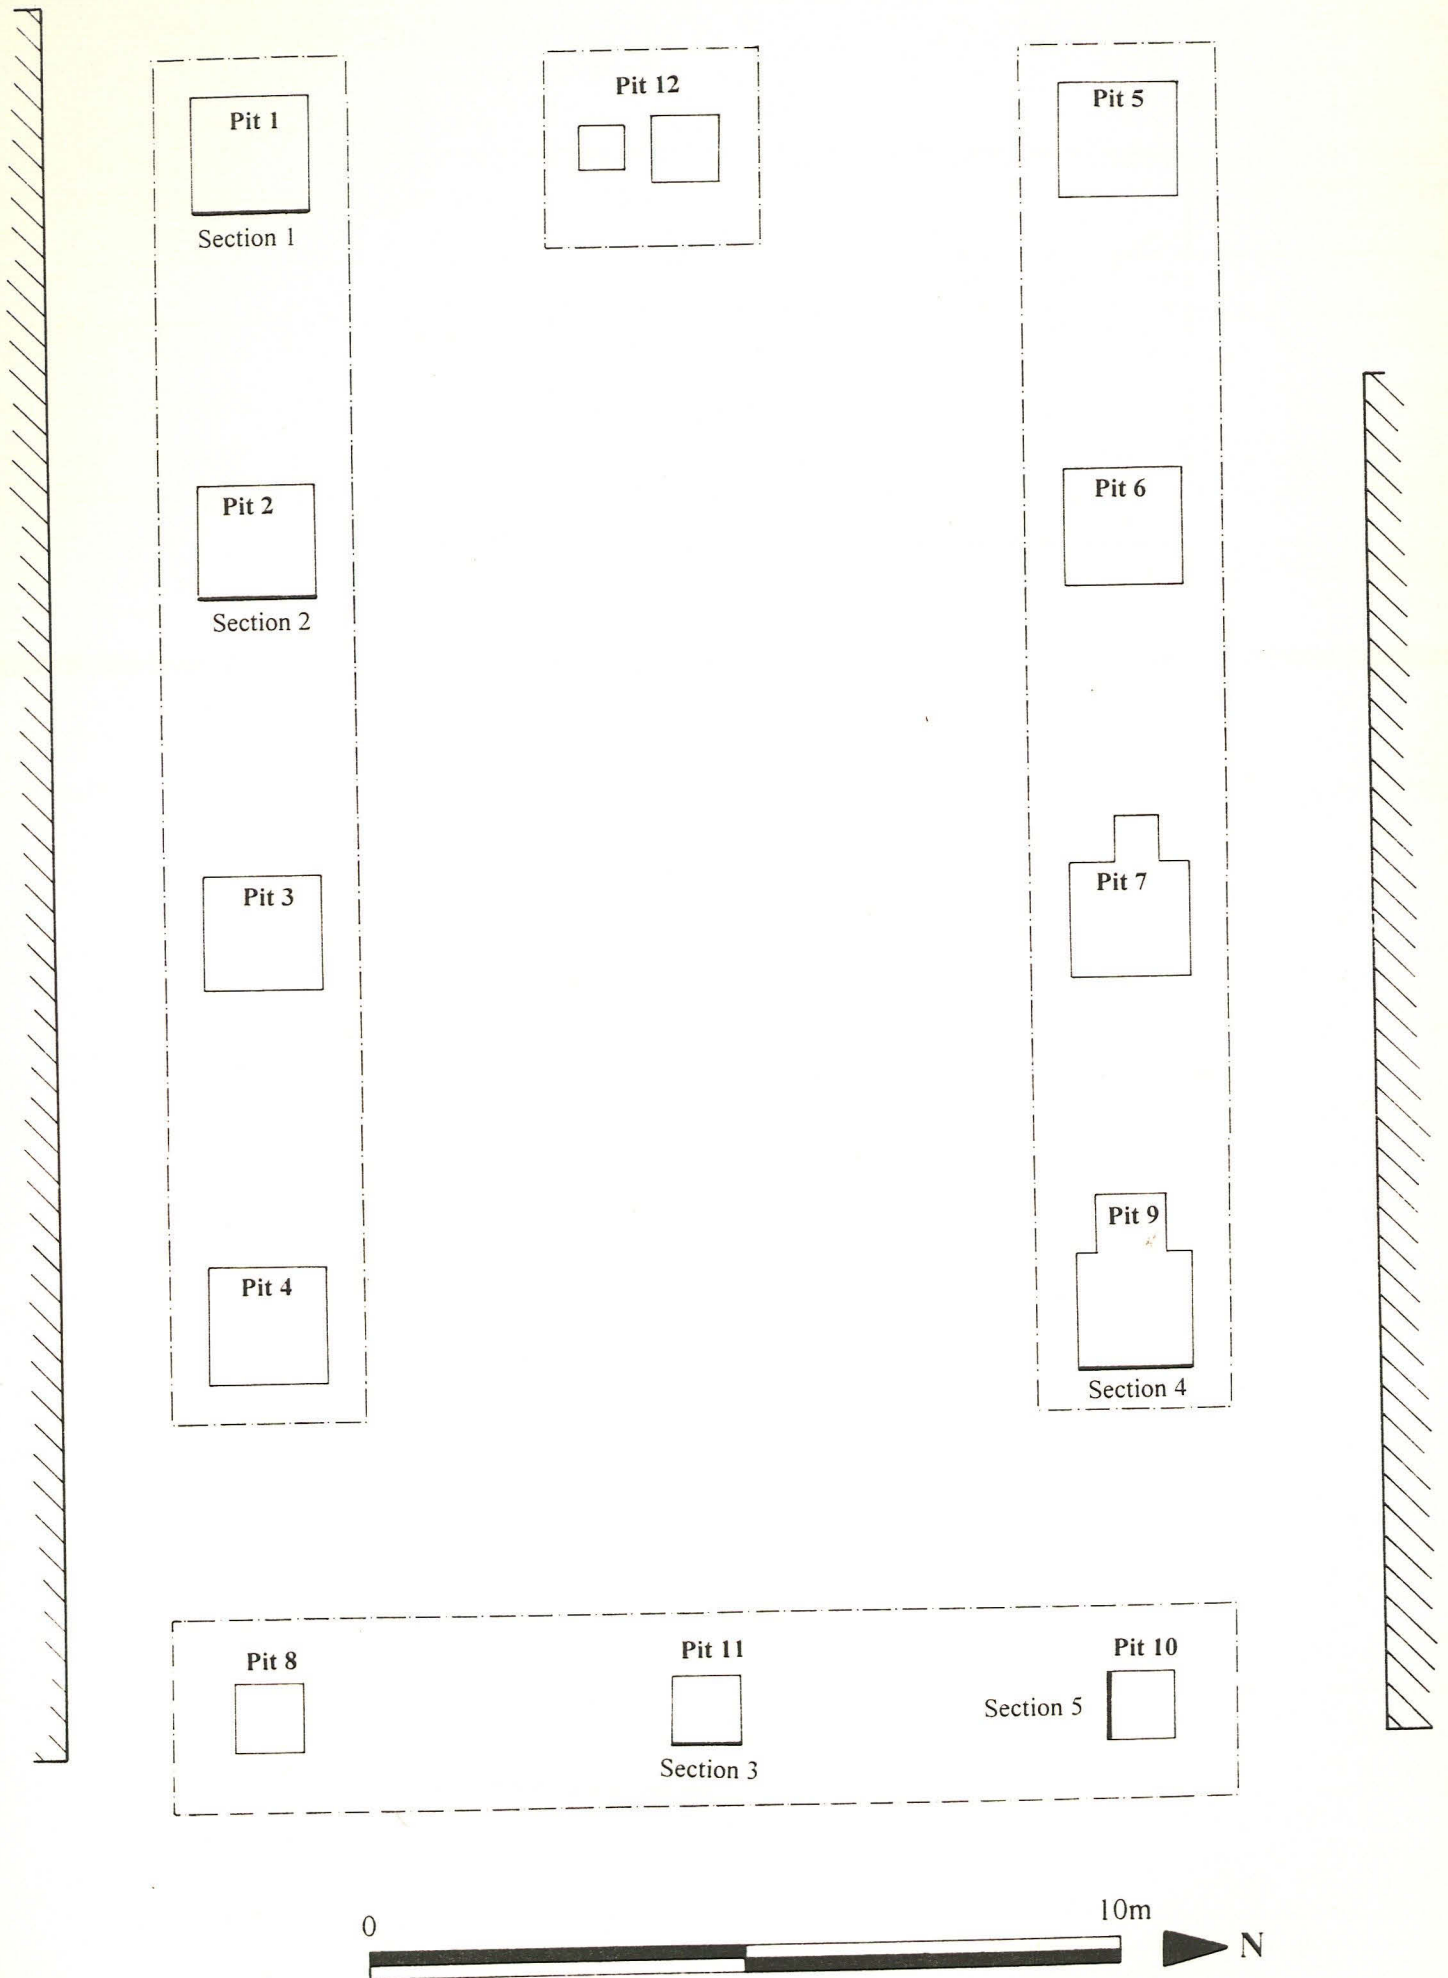
Fig. 5 Sections 1, 2 and 3

Layer (014), Fig. 5 Section 1. Light blue grey clay. 0.38m thick. Natural deposit.

Layer (015). Overlying (014). Light brown sand. 0.27m thick. Natural deposit.

Layer (013). Overlying (015). Mixed light grey, yellow and brown silty sand with small stones. 0.11m thick. Natural deposit.

Layer (011). Overlying (013). Yellow brown sand with small rounded stones. Maximum 0.64m thick. Natural deposit.

Feature (042). Cutting (011). Possibly linear, aligned east to west. 0.7m wide by 0.55m deep. Single fill (012) of brown and greyish brown sand. Former natural water channel.

Feature (041). Truncating channel (042). Possibly linear, aligned east to west. 0.75m wide by 0.4m deep. Single fill (010) of grey clay. Former natural water channel.

Layer (025), Fig. 5 Section 2. Light grey silt. 0.21m thick. Natural deposit

Layer (031), Fig. 5 Section 3. Mix of light grey silt and light grey clay. 0.3m thick. Natural deposit.

Feature (045), Fig. 5 Section 2. Possible east to west aligned linear cut. 0.57m wide by 0.39m deep. Single fill (019) of dark grey clay with sand and silt. Possible drainage ditch.

Feature/deposit (009), Fig. 5 Section 1. Cuts deposit 011 and dissects deposits (007) and (008). Deposit of brownish yellow sand and grit. Mole Drain.

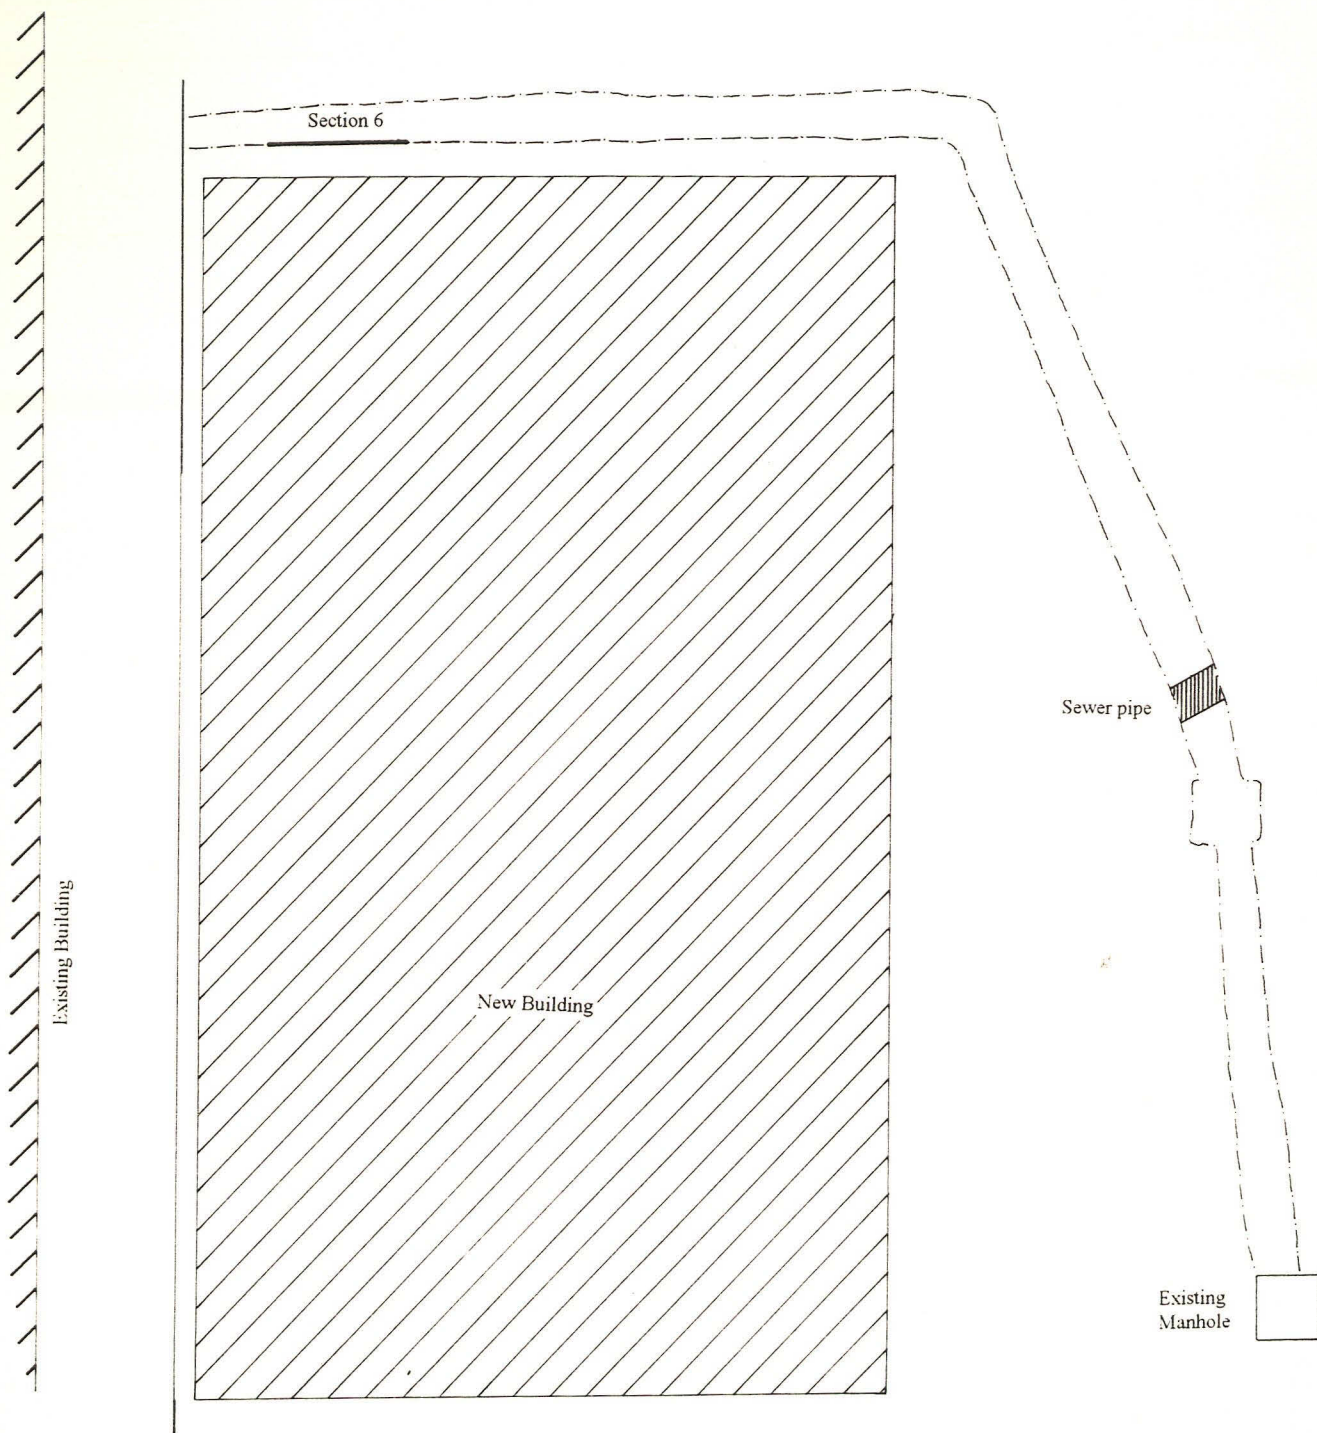
Fig. 8 Section 6

Layer (046), Fig. 8 Section 6. Dark blackish grey clayey silt. 10mm thick. Natural deposit.
