## Ashby de la Launde to Bloxholm Mains Replacement Scheme:

## Archaeological Watching Brief

Report prepared for Anglian Water

**August 1996**

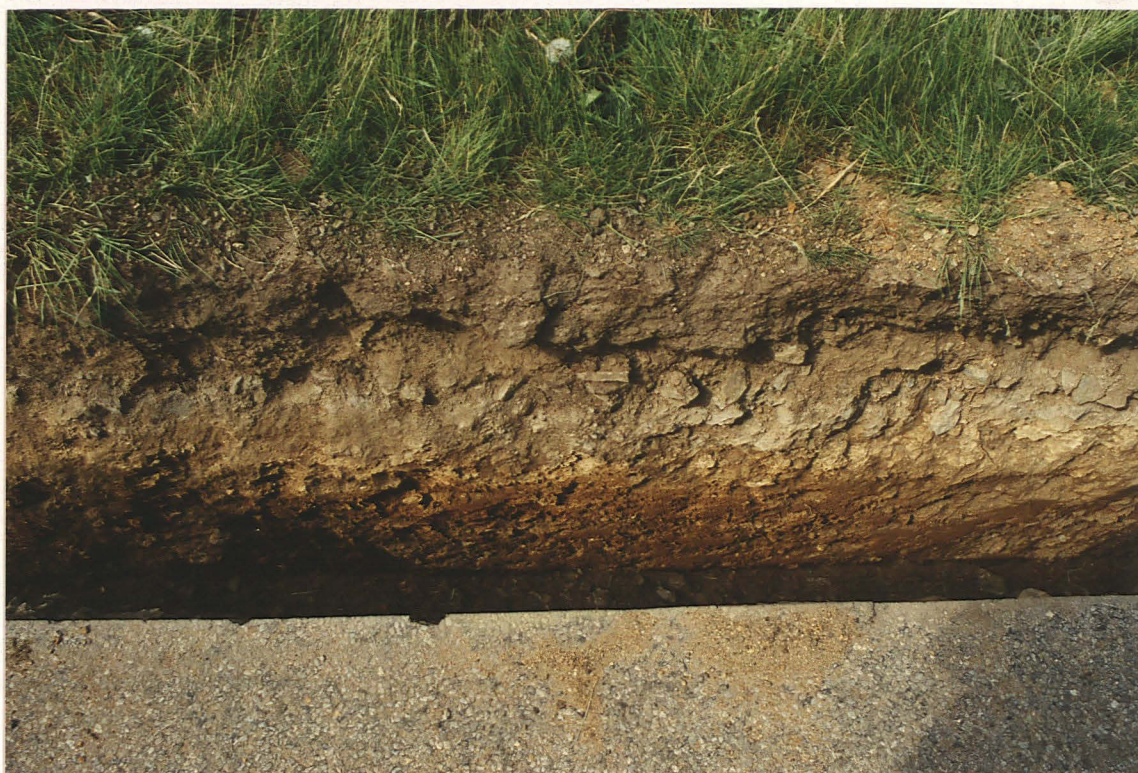
2. 150m west of the boundary, the topsoil in the roadside verge sealed a layer of irregular limestone pieces in a dusty light brown soil (Pl. 1). This layer was traced for about 75m to the east, thinning gradually. There was little compaction to the deposit and it did not seem to be a metalled surface; it could have been spread from the construction of the existing road. Beneath the layer was 0.7m of orange clay loam which sealed a similar clay layer containing much more stone. This underlying deposit appeared to be sloping downwards to the east and may have been within an ancient stream channel.

Pl. 1 Deposits visible in the trench face at 2. The light-coloured layer with limestone may be post-medieval road material.

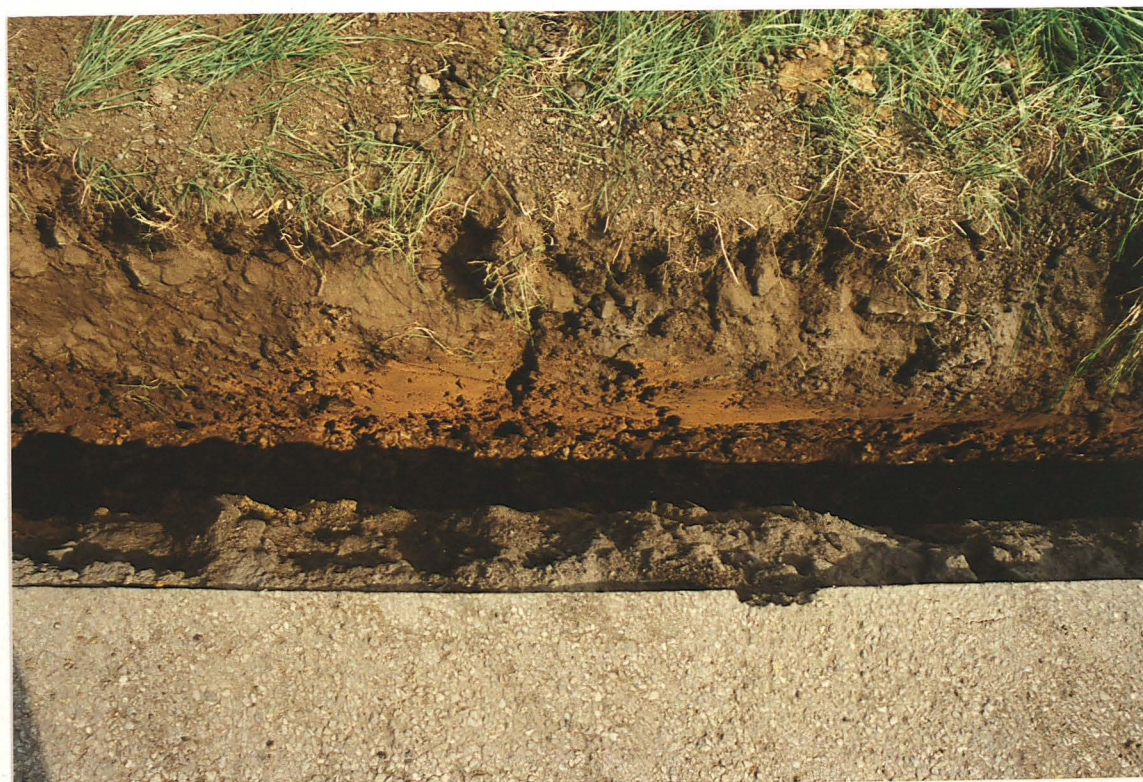
4. East of the boundary the sequence remained little changed. The higher stony layer was thinner but overlay yellow clay containing little stone. A much stony layer, in places with very little clay, was present below 0.9m (Pl. 2).

Pl. 2 The trench face east of the parish boundary at 4. Stony clay was visible close to the trench base.

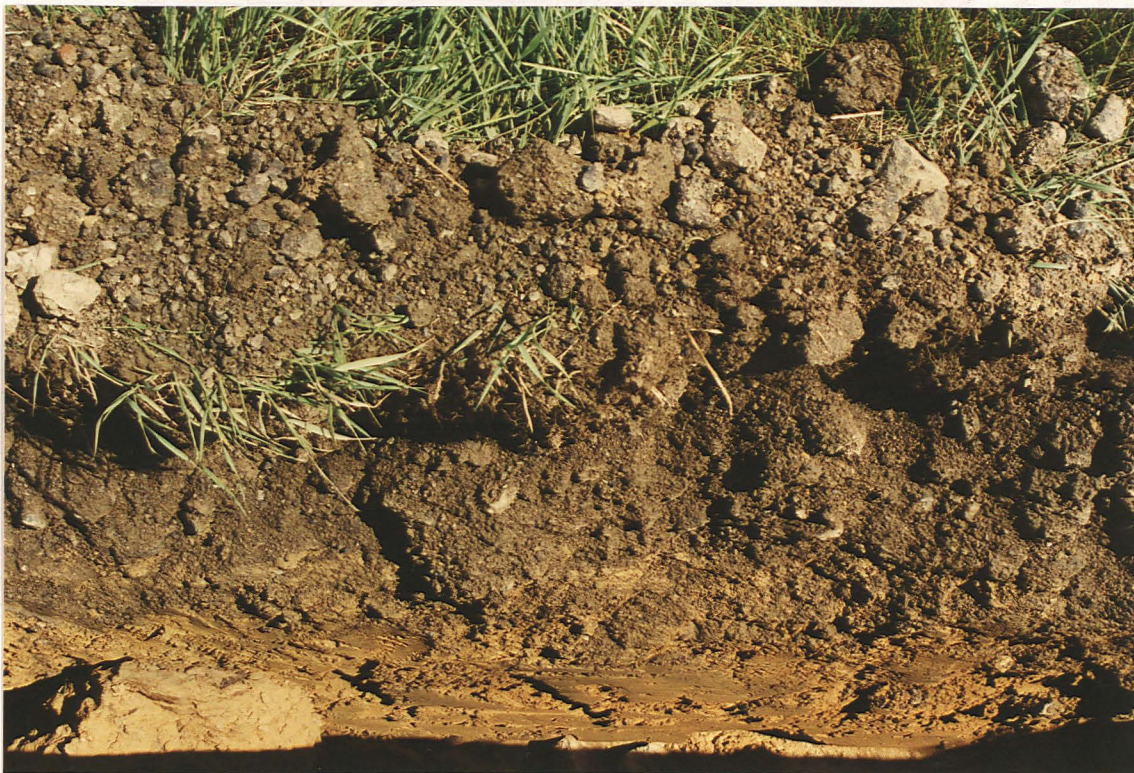
5. Sandy material was visible for about 75m east of 4, beyond which it was replaced by yellow clay. This may have been a post-glacially filled stream channel (Pl. 3).

Pl. 3 Yellow clay at 5, perhaps filling a former stream course.

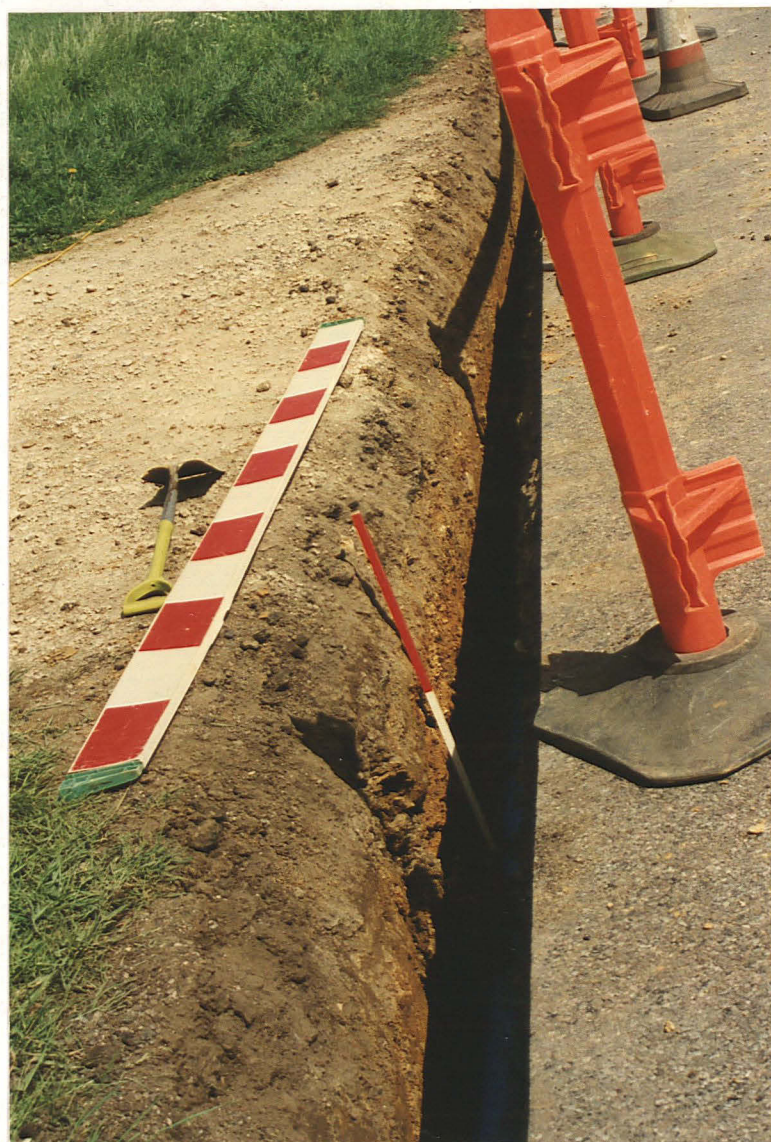
6. The trench was inspected where it crossed the track to the north of the lane from Bloxholm, in case it fossilised the alignment of the anticipated Roman road (Pl. 4). The modern track surface consisted of 0.28m of stone

Pl. 4 View of the pipe trench cutting across the track at 6, north of the Ashy-Digby road (looking east). Scale divisions (h) 0.25m, v 0.5m.

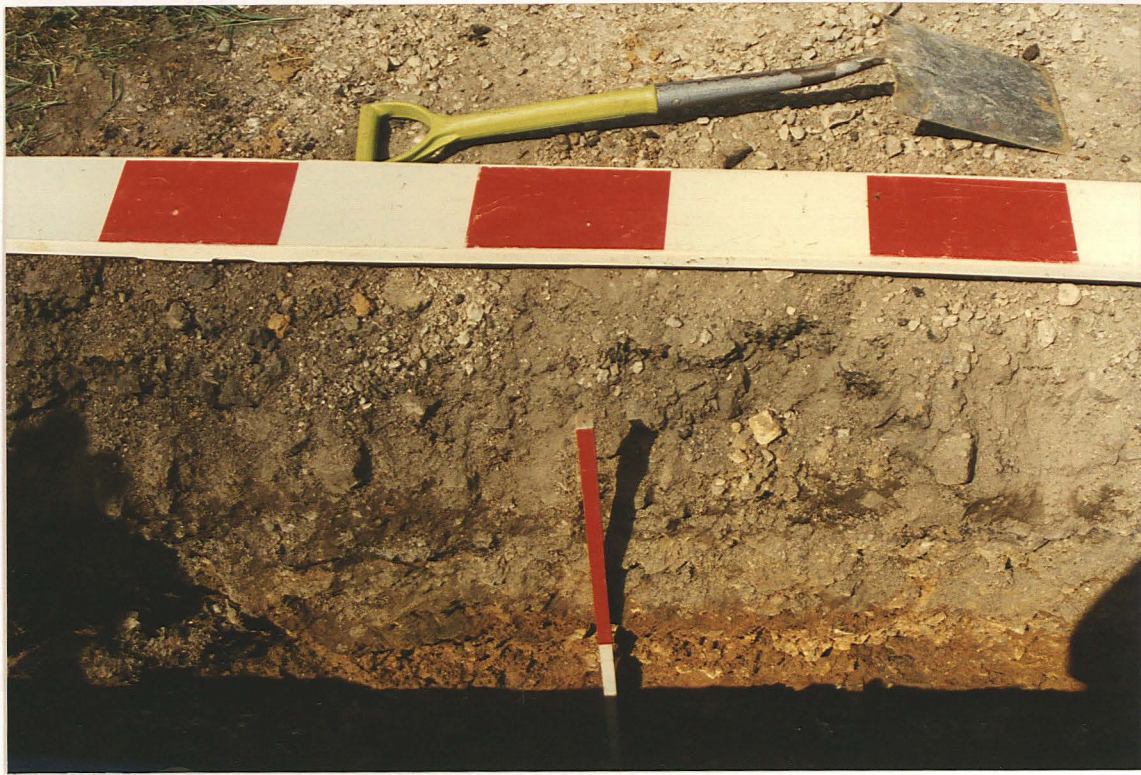
above a thin tarmac layer. Beneath this was 0.2m of stony clay and 0.15m of more gravelly clay before clay with few stones was reached (Pl. 5). None of these deposits seemed suitable candidates for a Roman metallated surface and were interpreted as continuations of extensive naturally deposited layers.

Pl. 5 Deposits visible beneath the modern track at 6. Scale divisions (h) 0.25m, v 0.5m.

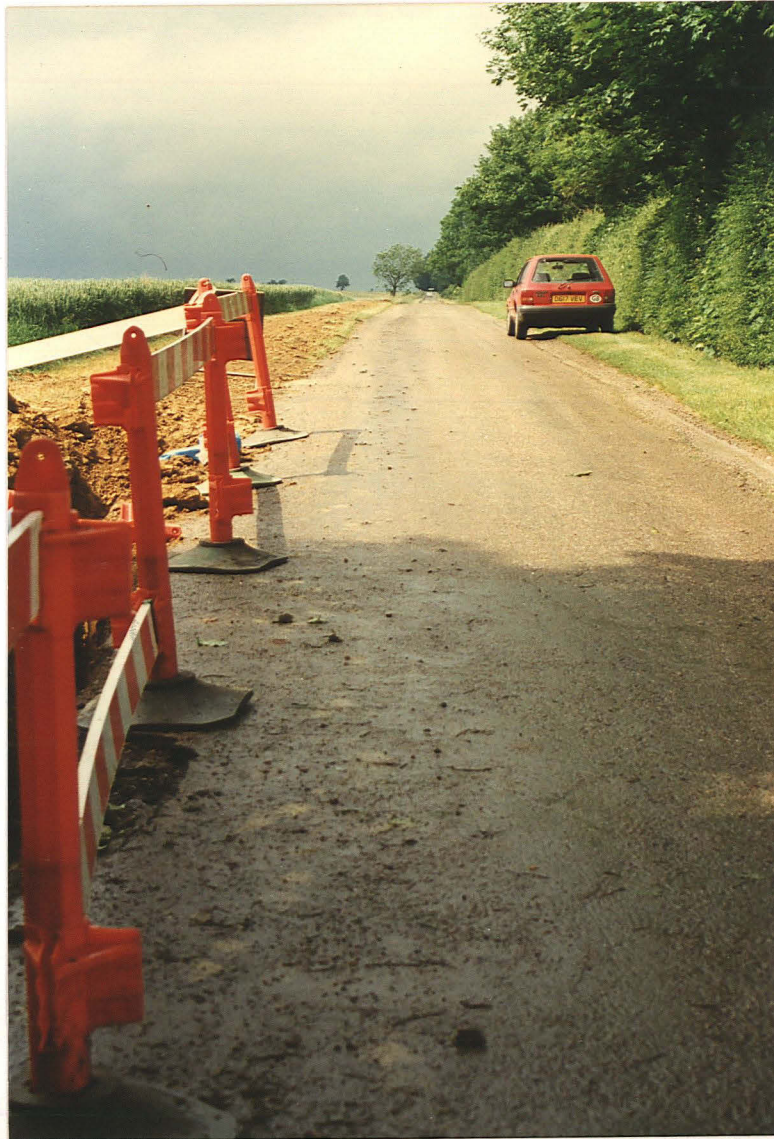
Pl. 6 View north along Bloxholm road from Springwell Plantation.

8. The trench along the roadside southwards to a poultry farm was not monitored; the contractors reported that an intermittent thin rock layer had been encountered 0.5m below the surface (Pl. 6). Further traces of this were observed close to Springwell Plantation and interpreted as a natural bedrock layer between natural clay deposits.

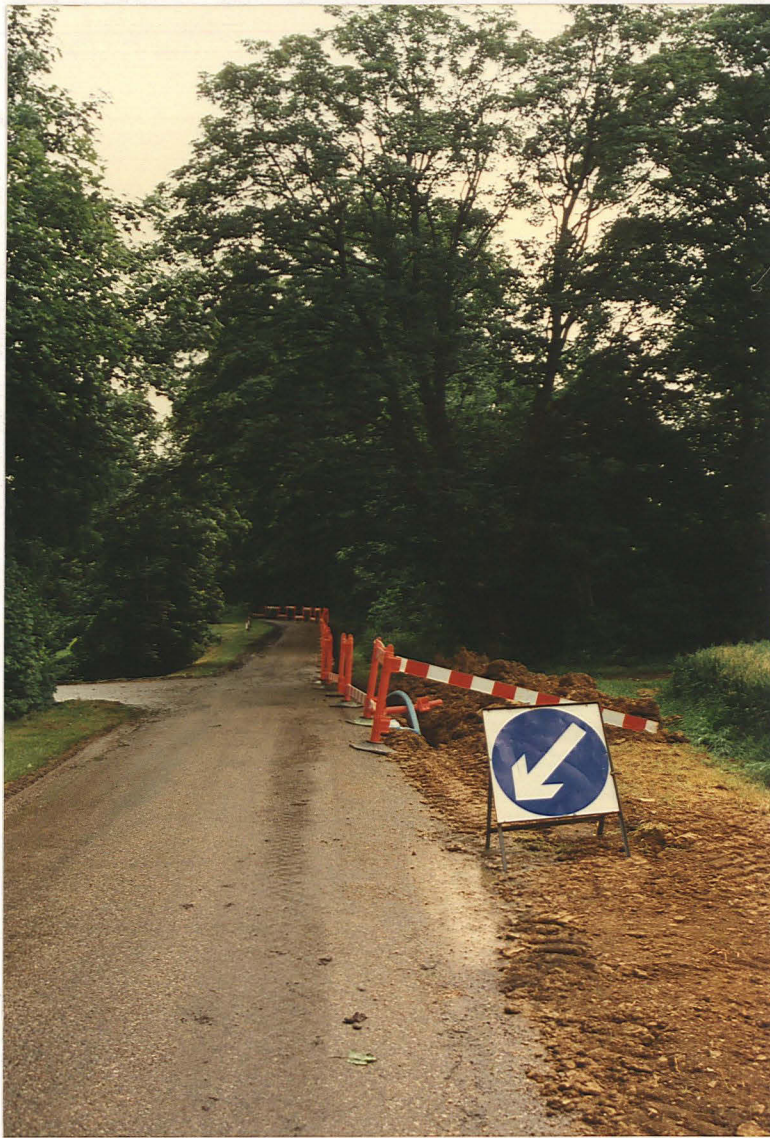
9. Monitoring recommenced as the trenching approached a small stream beside Springwell Plantation (Pl. 7). The tarmac road surface sealed a 0.05m thick gravel metallating layer above 0.38m of light brown loam. This sealed a yellow clay deposit containing a few rock lumps (Pl. 8).

PI. 8 Section of the trench face at 9; vestigial traces of the intermediate thin limestone band are visible halfway down the trench.

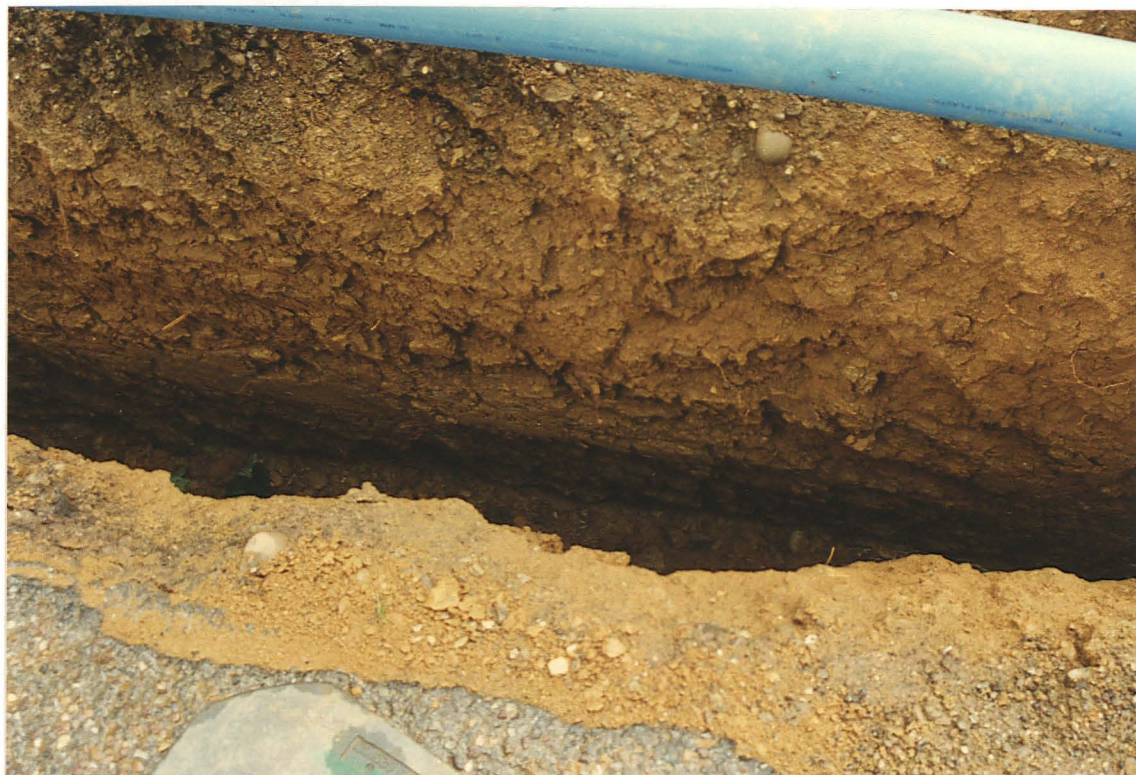
10. Towards the stream, the soil became less rocky. In the verge, the topsoil sealed 0.2m of gravel which overlay dark brown loam; the dark loam extended beneath the trench base (Pl. 9). This may be a backfilled roadside depression but no dating evidence was seen.

Pl. 9 Dark brown soil thought to be a filled natural depression 10, north of the stream.

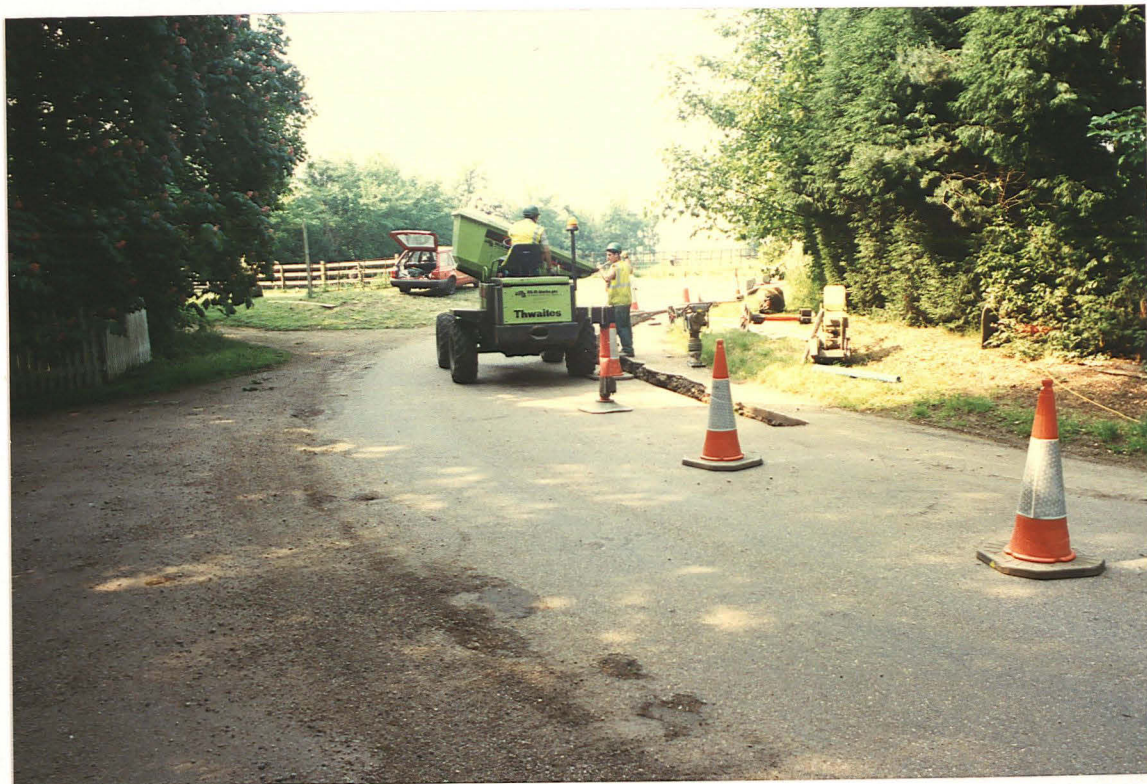
Pl. 10 Junction of the road through Bloxholm with a farm track thought to fossilise the route of King Street. Post-medieval feature 12 was beside the dumper. Looking SW.

12. At the corner opposite South View, an area of disturbed ground containing 18th-19th century ceramic refuse was exposed, extending 0.3m north of the northern trench and visible in the south face (Pls. 10 and 11). This loose rock and soil backfill may have been the fill of a small stone quarry or a roadside ditch backfilled during realignment of the corner (Pl. 12). Considering the close proximity with the track junction it is less likely that it had been a quarry.

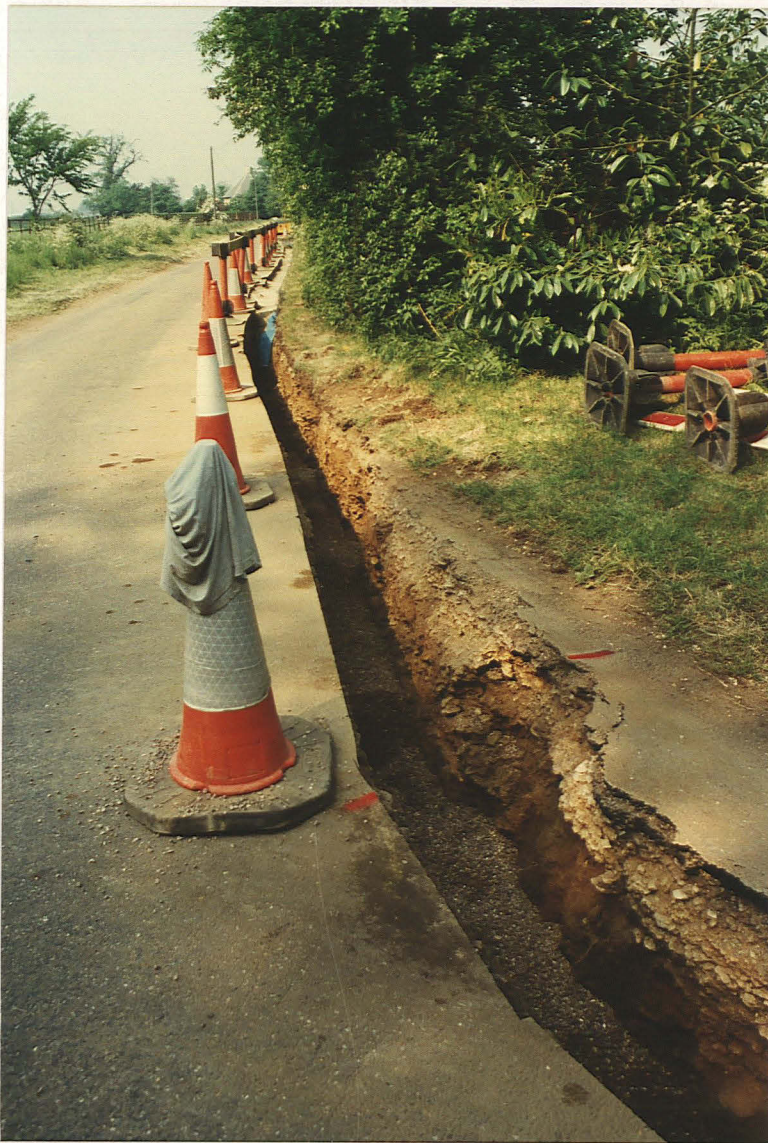
PI. 11 Position of the western corner of post-medieval feature 12 (looking west). From the position, this may have been a west-east roadside ditch.

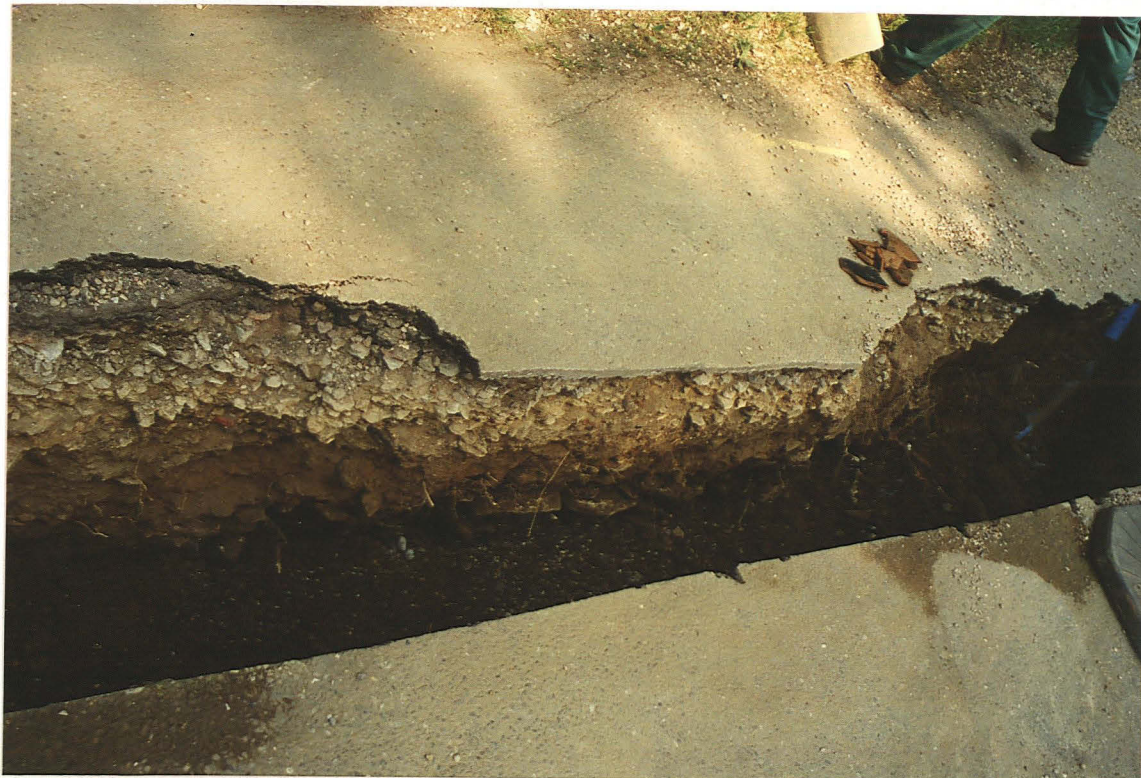
PI. 12 Loose rock fill of 12, with examples of recovered post-medieval pottery (looking NE).

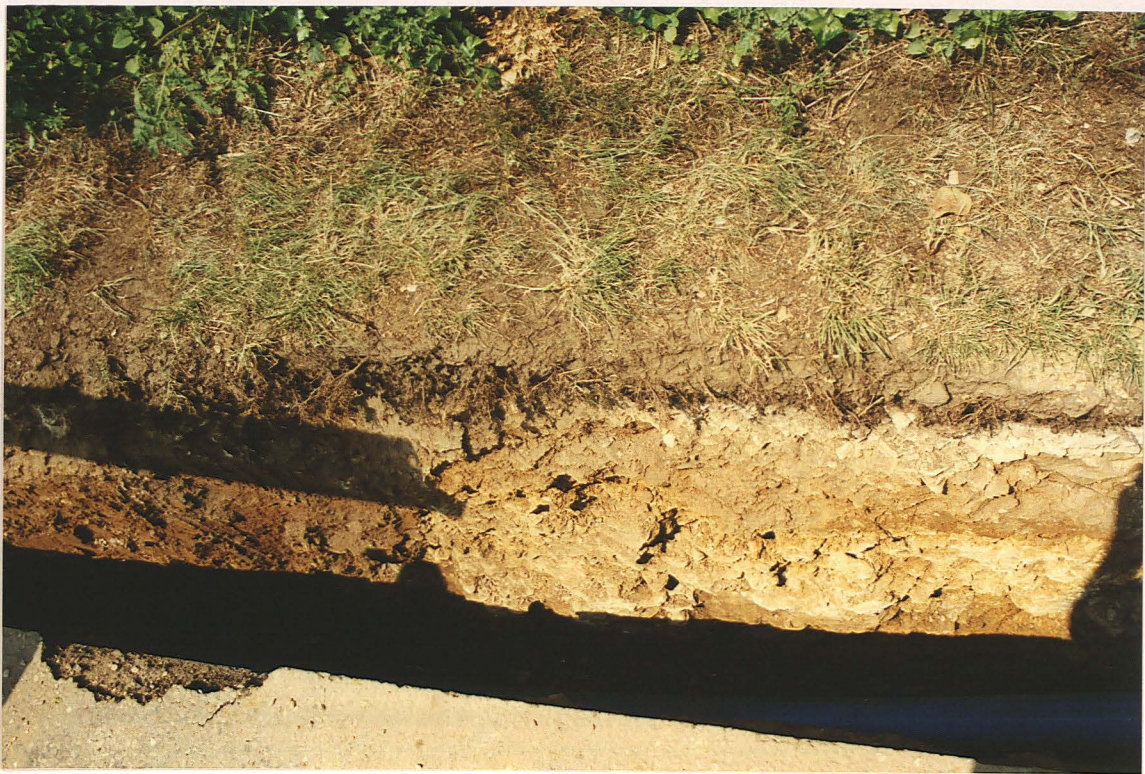
13. A spread of solid limestone about 0.5m thick was recorded immediately to the west of the track (Pls. 13 -15). It extended 10.3m to the west and lay 0.5m deep beneath brown loamy clay and above yellow clay (Fig. 2A); it appeared to have been naturally produced. The coincidence of lower hedgerow trees beside this point was noted but explained as the result of impenetratable ground for tree roots (Pl. 16). The profile of the rock exposure here was

Pl. 13 Detail of western edge of limestone deposit 13 (centre and right) with clay to the west. Looking north.

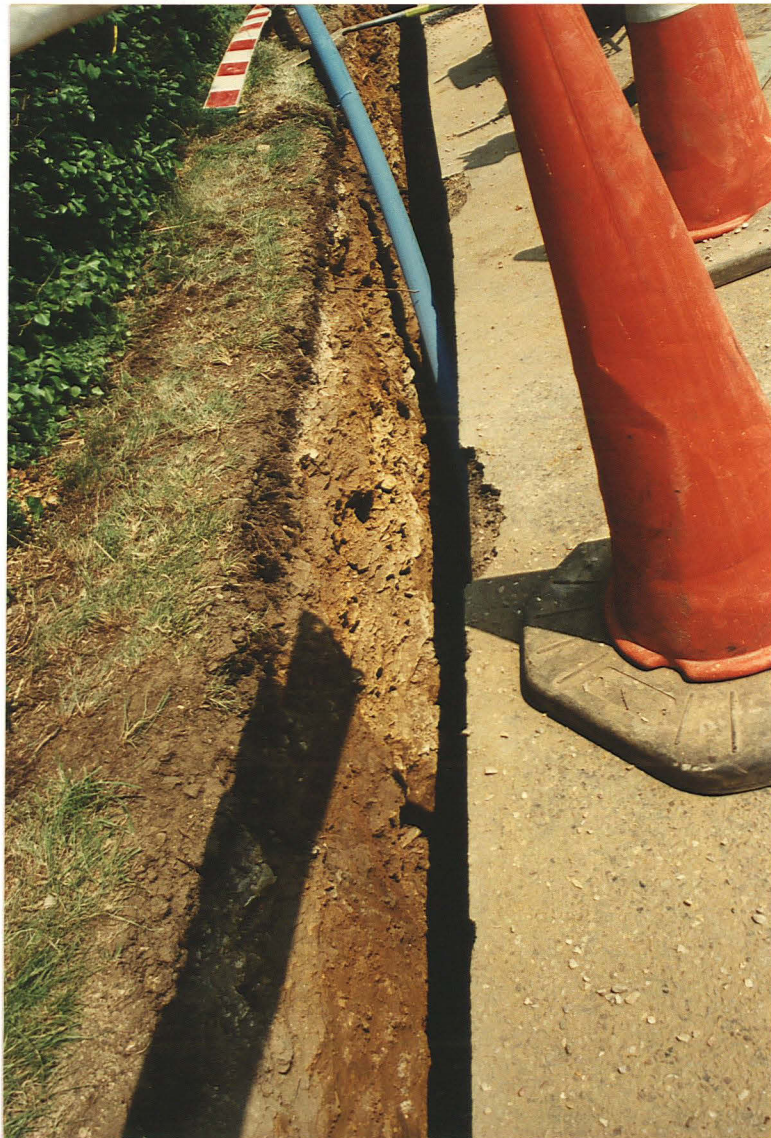
Pl. 14 View of limestone deposit 13 from west. Pl. 15 extends this view further east. Looking east.

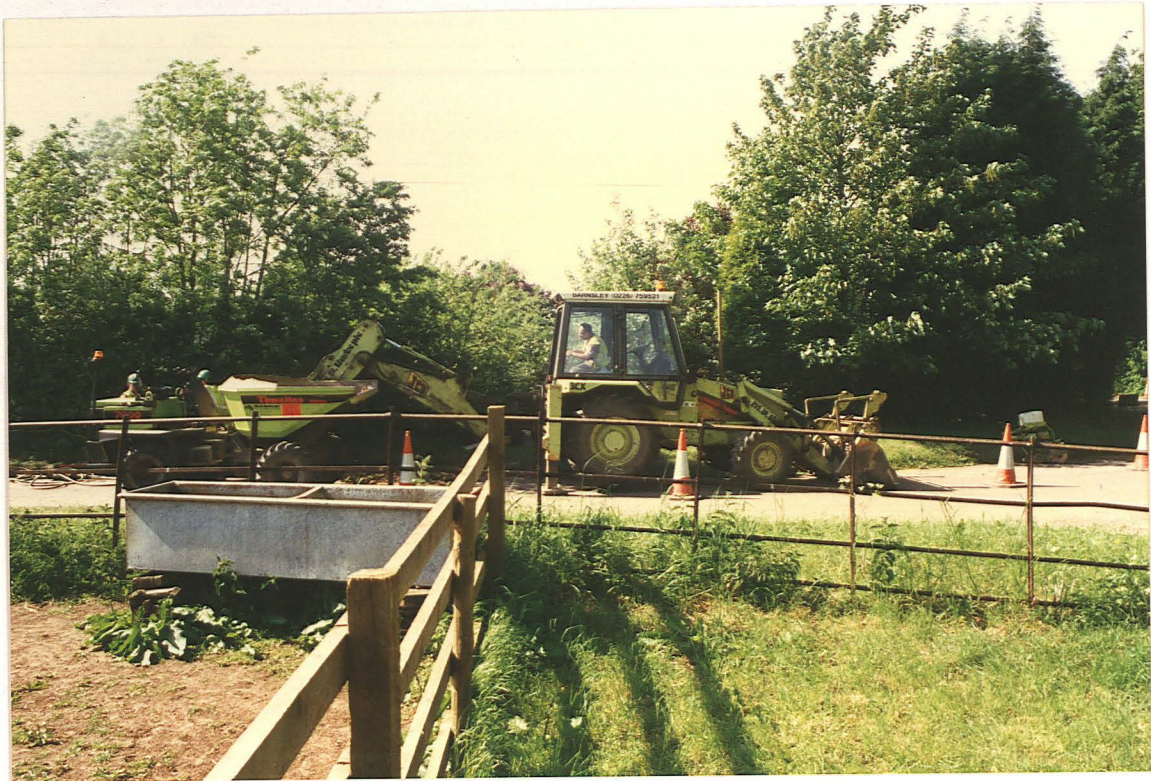
Pl. 16 Location of limestone 13 behind and to the right of the dumper (looking north).
