Former British Legion Club, Bank Lane CAISTOR

NGR : TA 1176 0132
Site Code : CBL 96
LCNCC Accession No. 77.96

Archaeological Evaluation

July 1996

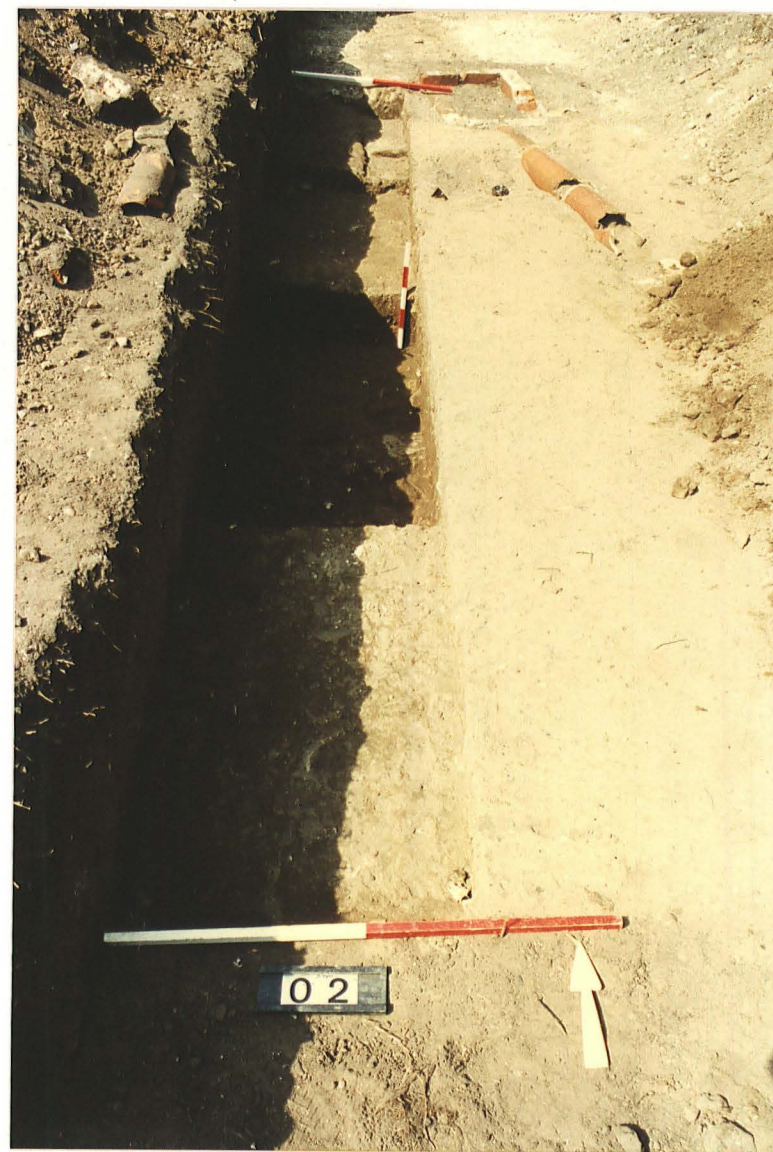
PI.10 Narrow slot within Trench 02, showing metallised surface 77 and, within deepest excavated portion, demolition rubble 80/83. Looking N. Scales 1m.

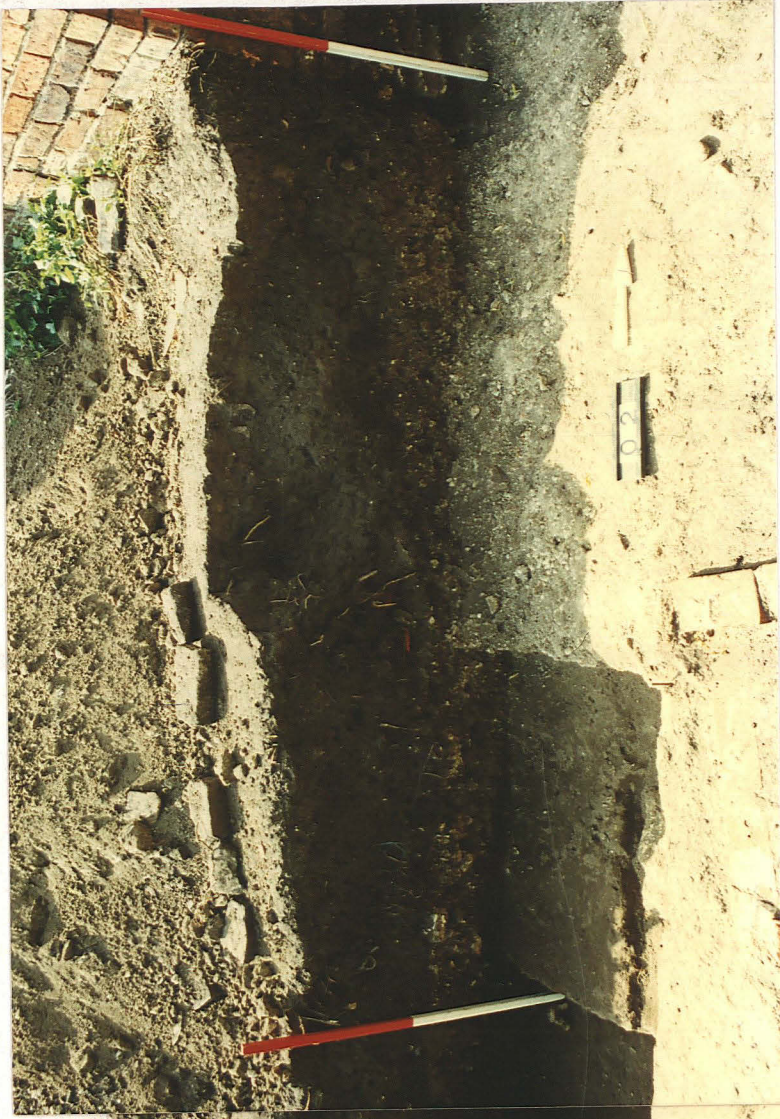
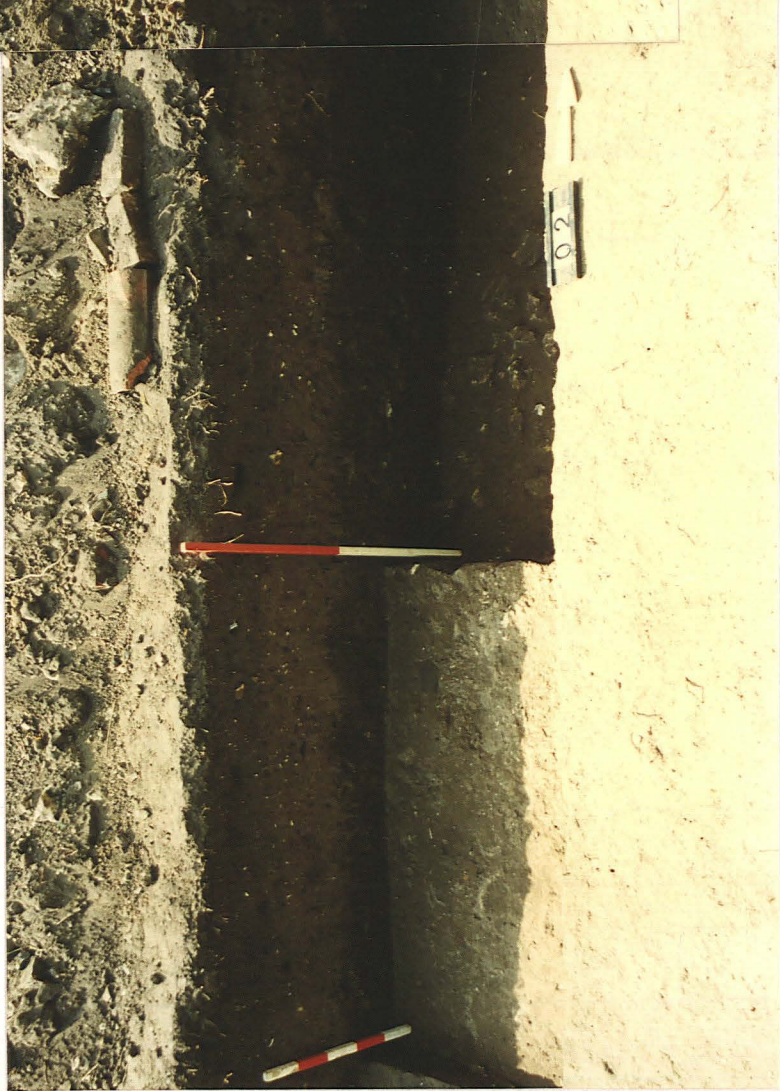
Pl.11 E-facing section of Trench 02. Looking W. Scales 1m and 0.5m.

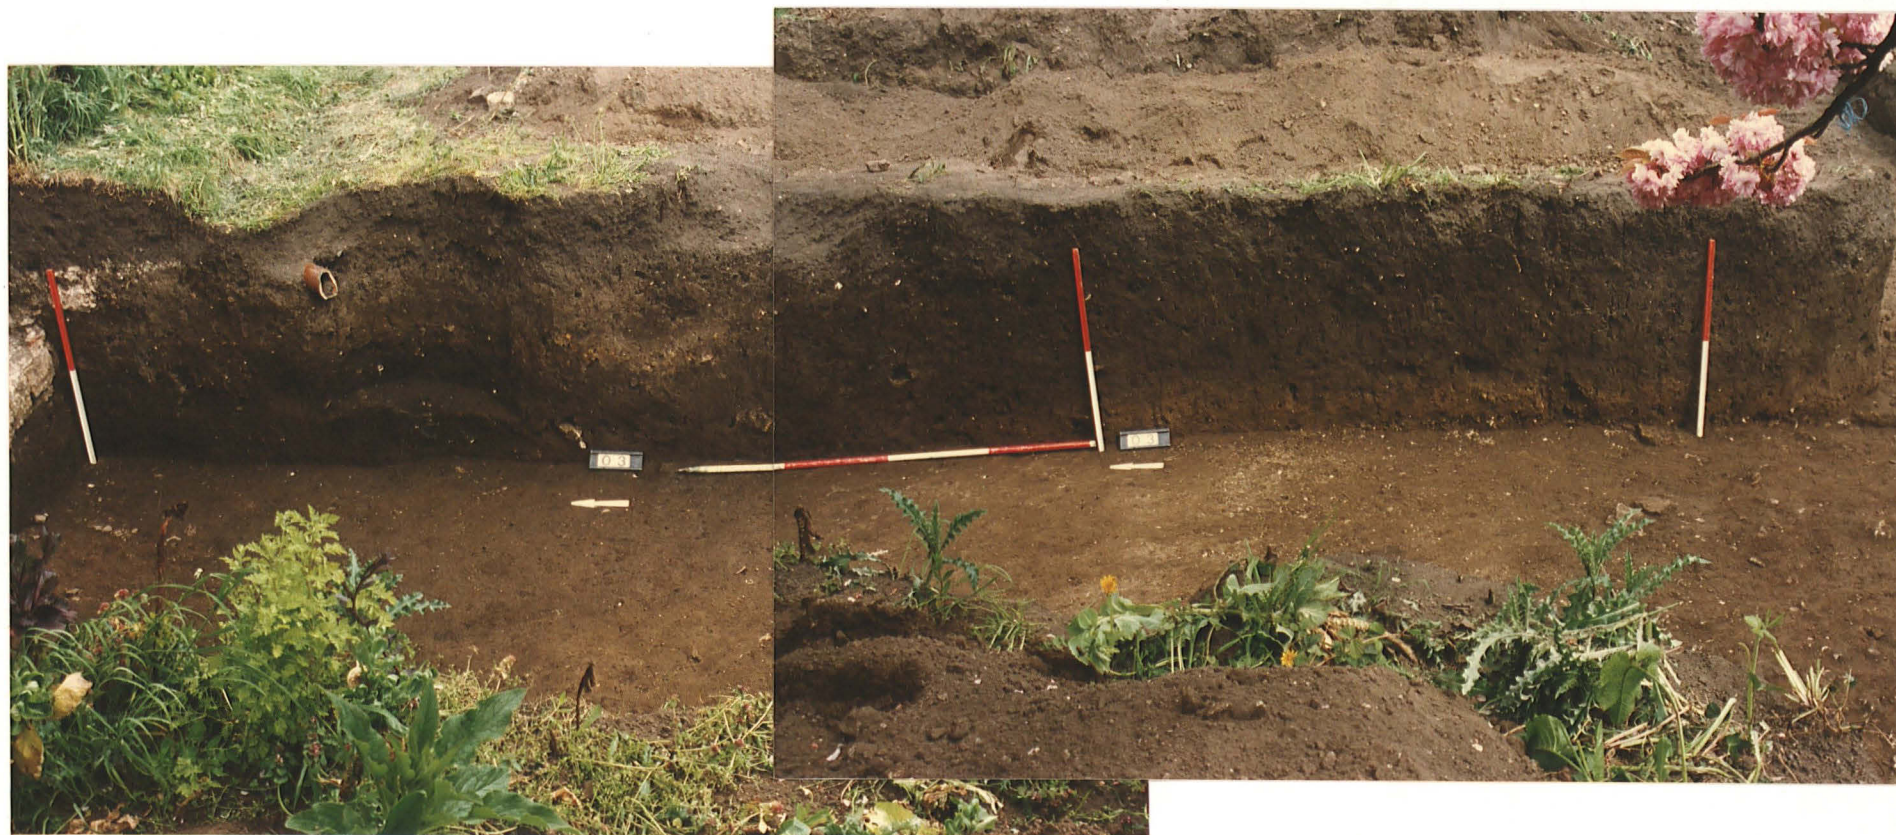
Pl.16 W-facing section of Trench 03 showing depth of garden soil, construction lens 30 (centre left), ashy deposit 37/67 (bottom left), and void of modern soakaway 31. Looking E. Scales 1m and 2m.

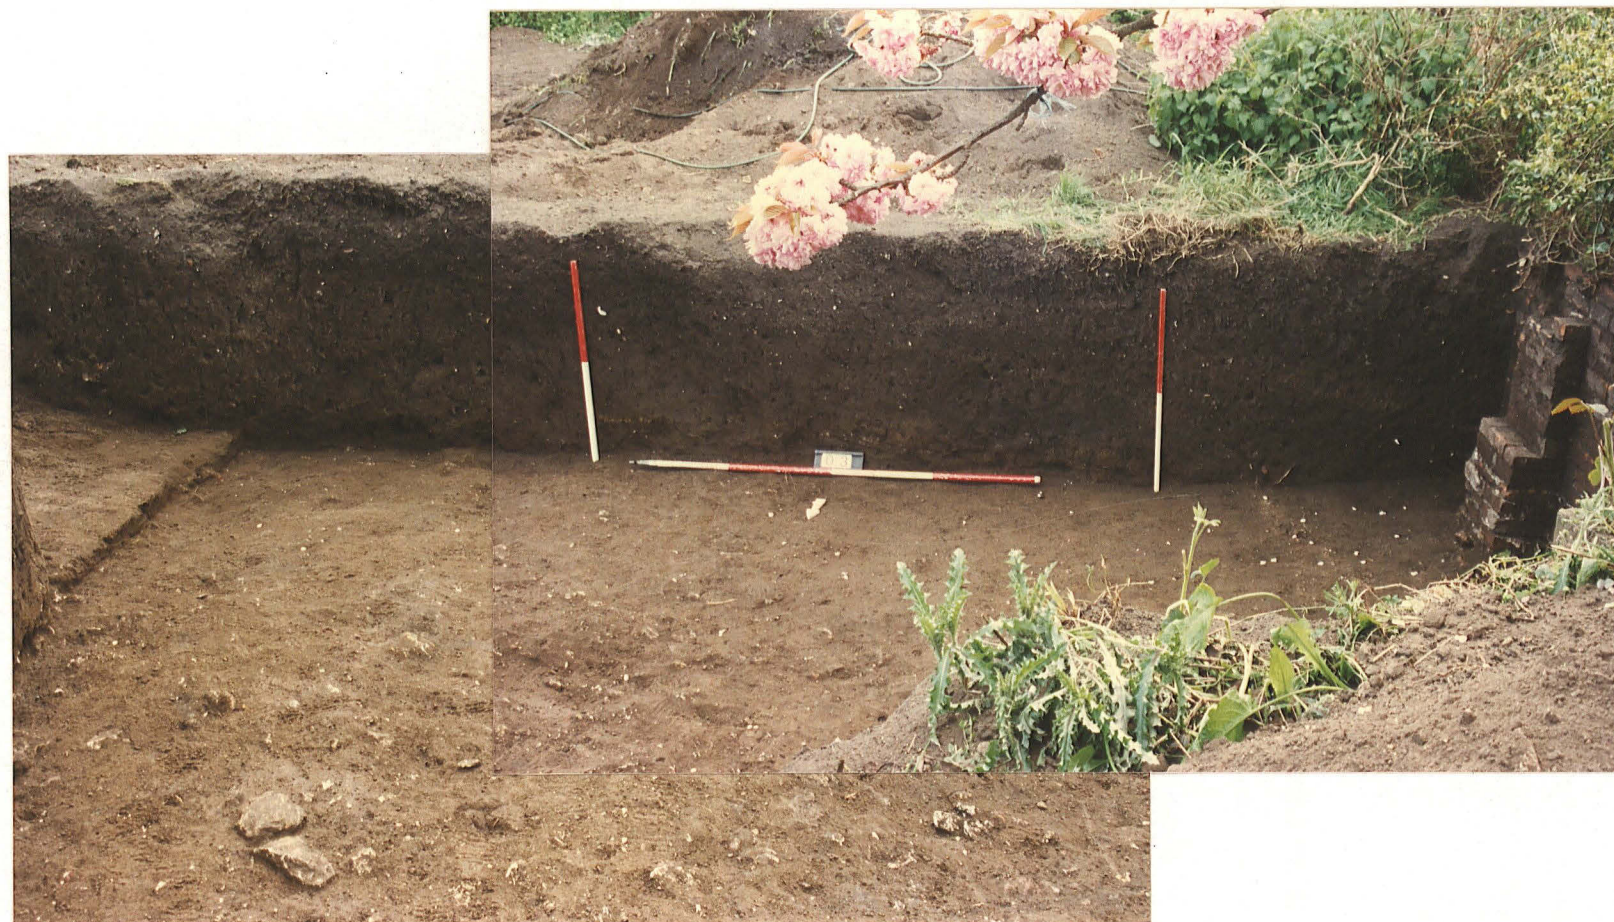
PI.17 N-facing section of Trench 03, showing depth of garden soil and west boundary wall construction trench 43. Looking S. Scales 1m and 2m.

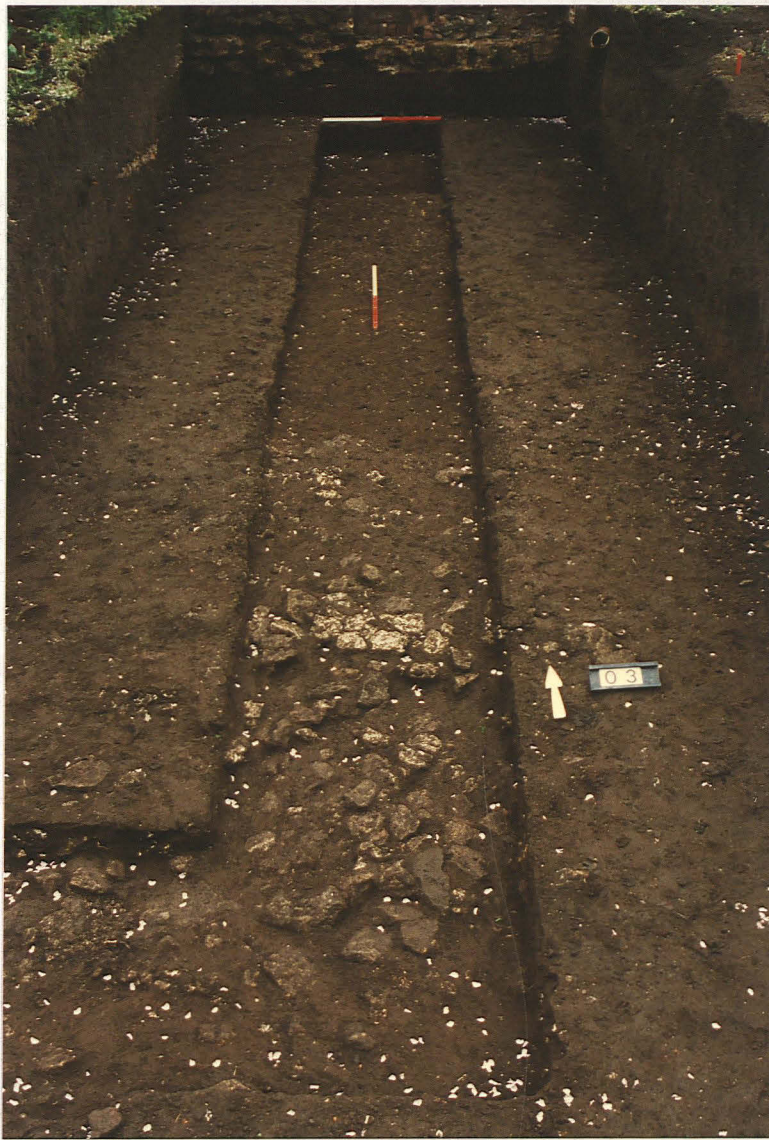
Pl.20 Trench 03, central slot after excavation of remainder of garden soil 24, exposure of metallised surface 41 (background), and partial exposure of demolition rubble 61/62/40/53 (foreground). Looking N. Scales 1m.

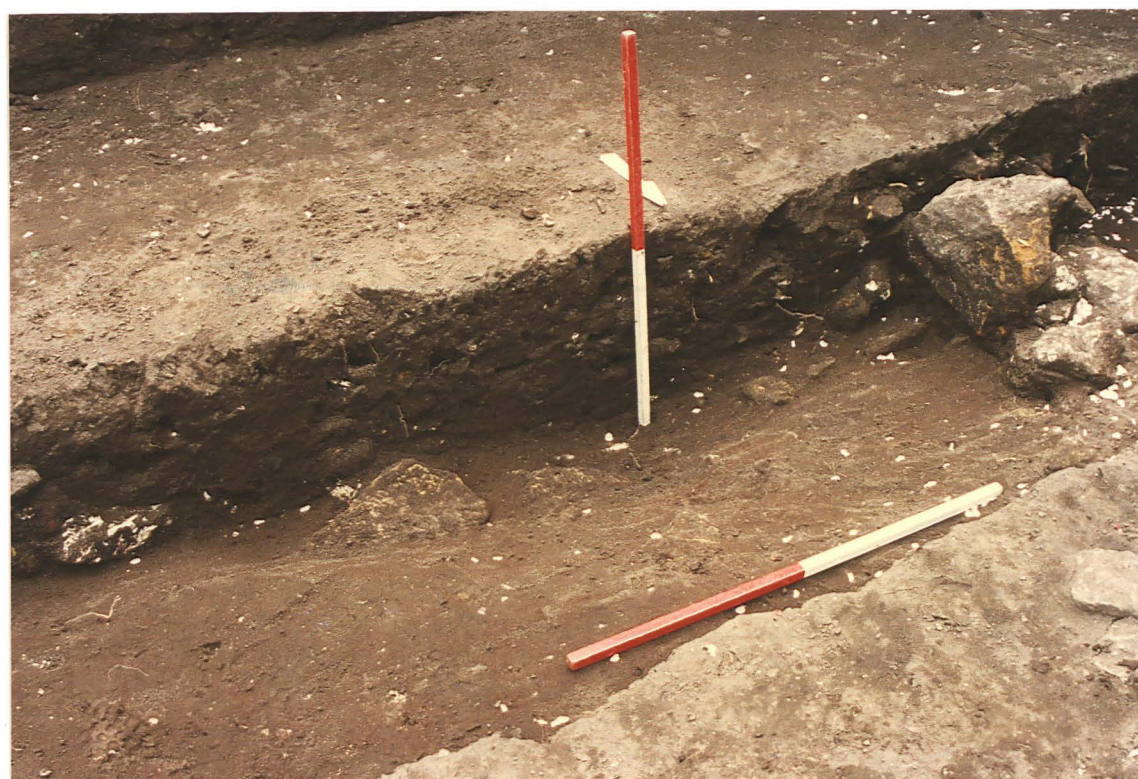
PI.28 Trench 03 after removal of demolition rubble 61/62/40/53, and exposure of metal surface 58 (centre) and underlying reddish soil horizon 50. Looking N. Scales 1m and 2m.

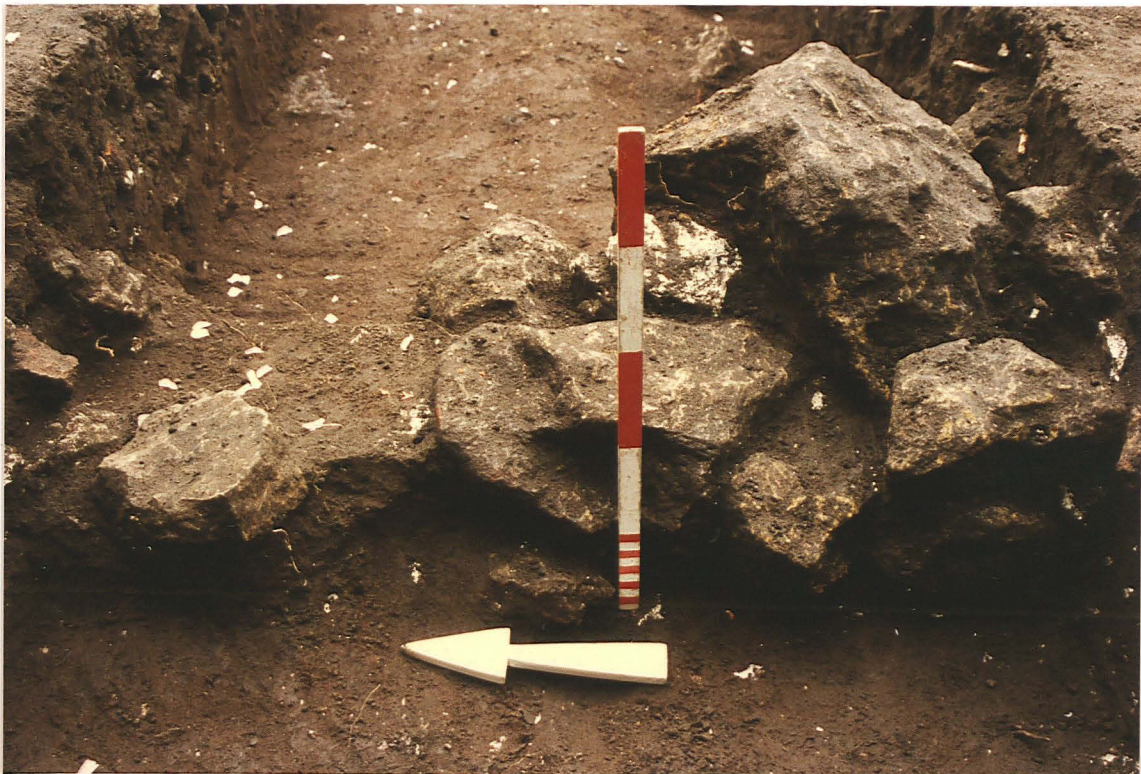
Pl.36 Trench 03, detail of south-east part of central slot, showing rubble within possible robber pit 89 (centre) and possible *in situ* wall foundation and facing stones 59 (foreground). Looking W. Scales 1m and 0.5m.

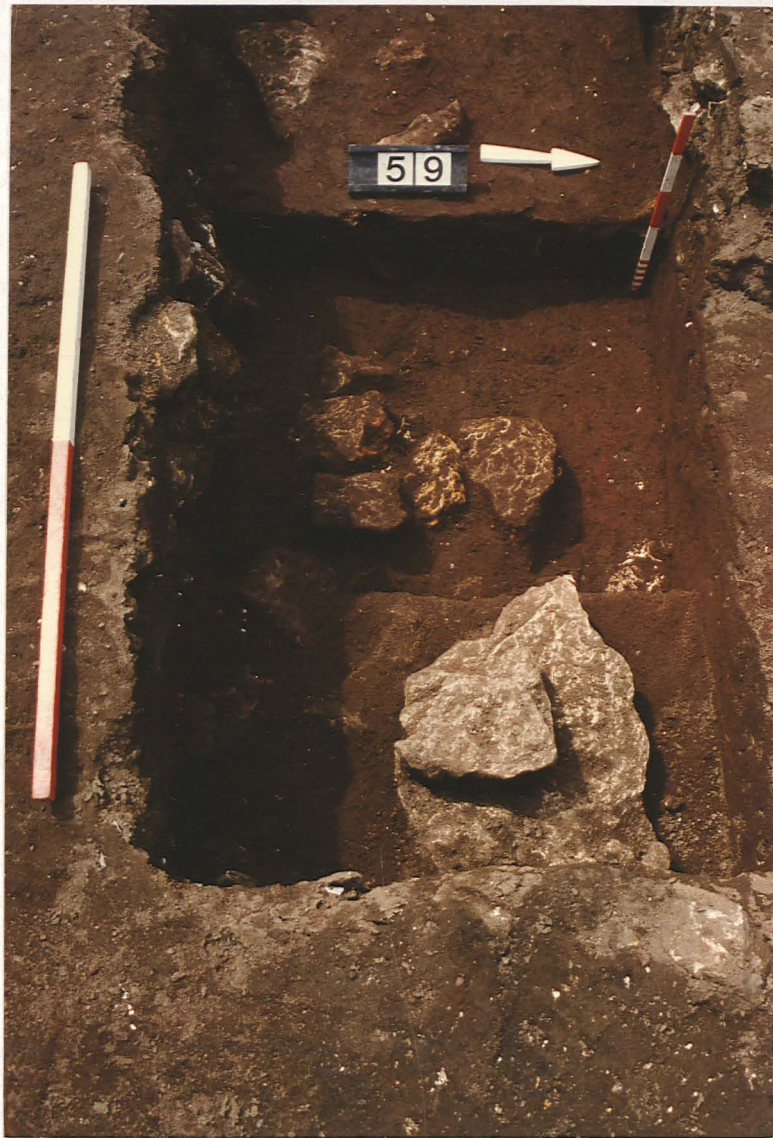
Pl.37 Trench 03, northmost part of central slot with possible Romano-British deposit 72 exposed (mortar-flecked, right half of slot). Looking W. Scales 2m and 0.5m.

In the northmost part of the cutting, two more archaeological deposits were recognised (**57** and **72**) (Figs.5B;6A;Pl.37). Their precise forms and characters were not established because both were only part exposed, and because of confusion caused by later pit **56**. Layer **57**, which was sealed by demolition horizon **61/62/40/53**, comprised a dark orange-brown sandy silt containing occasional small stones. It was most distinctive in that it yielded a high proportion
