## **Bourne to Morton Mains Replacement Scheme:**

### **Archaeological Monitoring at Dyke and Morton**

Report prepared for Anglian Water

**October 1996**

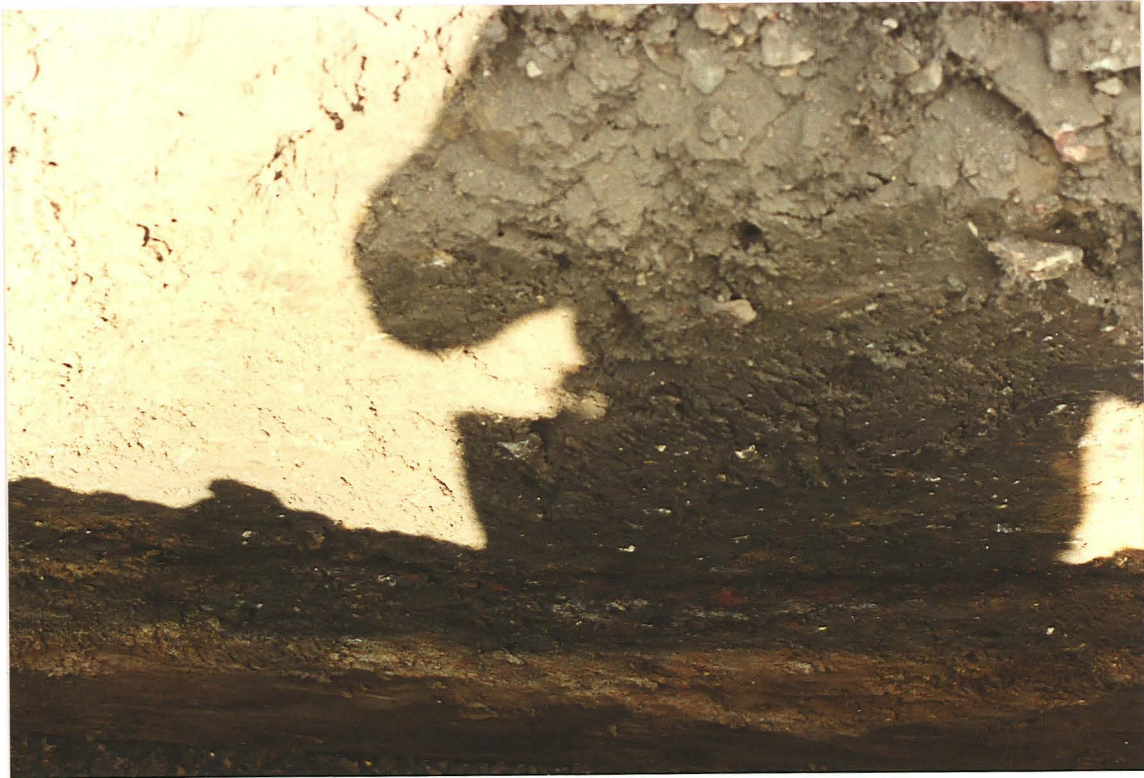
Pl. 3. Dark soil backfill of Ditch 1, showing position of water supply pipe (looking east; scale divisions 0.5m).

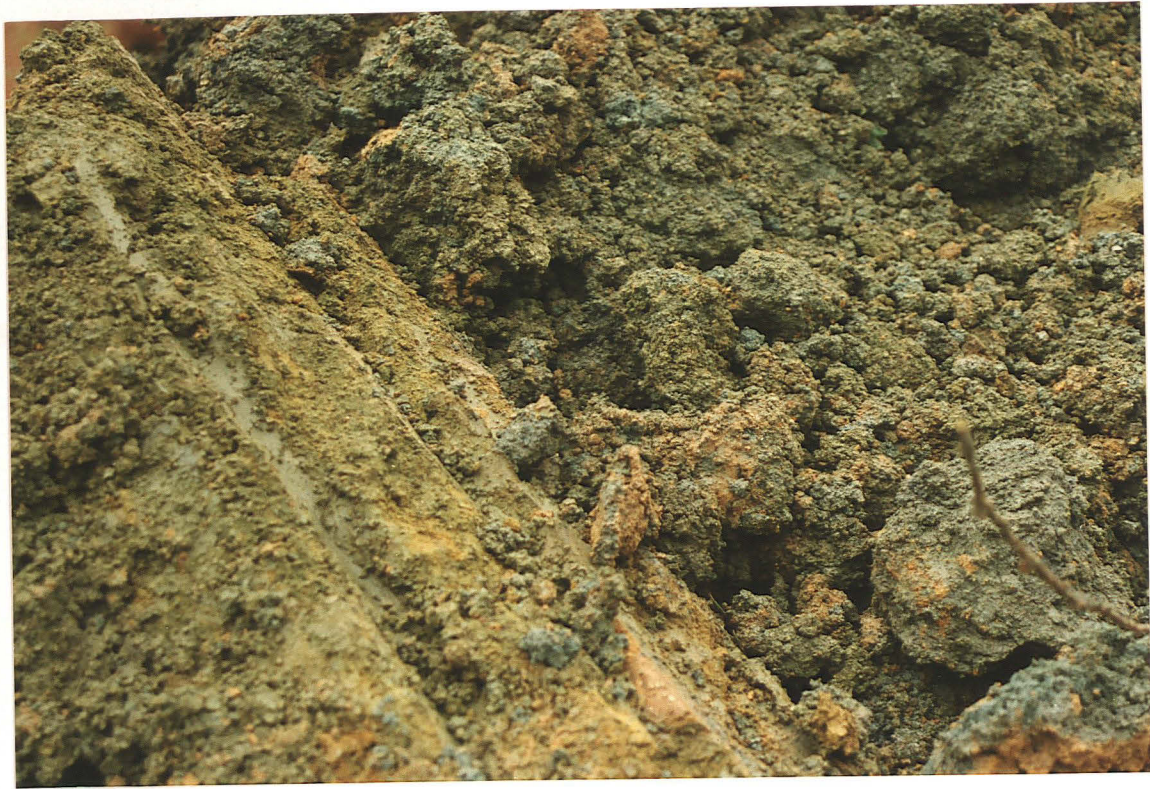
Pl. 5. Green clay loam on the trench spoil heap, from which 209 pottery sherds were collected.

290 pottery sherds were recovered from the nearby trench spoil, in a green-brown clay loam deposit **2** (Pl. 5). There were several sizeable sherds with recent breaks, implying that they had been broken by the machine bucket. This pottery assemblage (interpreted as a domestic rubbish deposit) has regional importance because it contained previously unreported fabrics and the earliest identified occurrences of other wares (App. 2; Fig. 8). A search of the trench faces found very few traces of this deposit remaining visible as fill **12** of Pit 11. Here a lens of green clay loam near the base of this pit was interpreted as possibly cess although no environmental sample was taken. The green soil overlay an ashy fill **18** and was sealed by fill **17**.

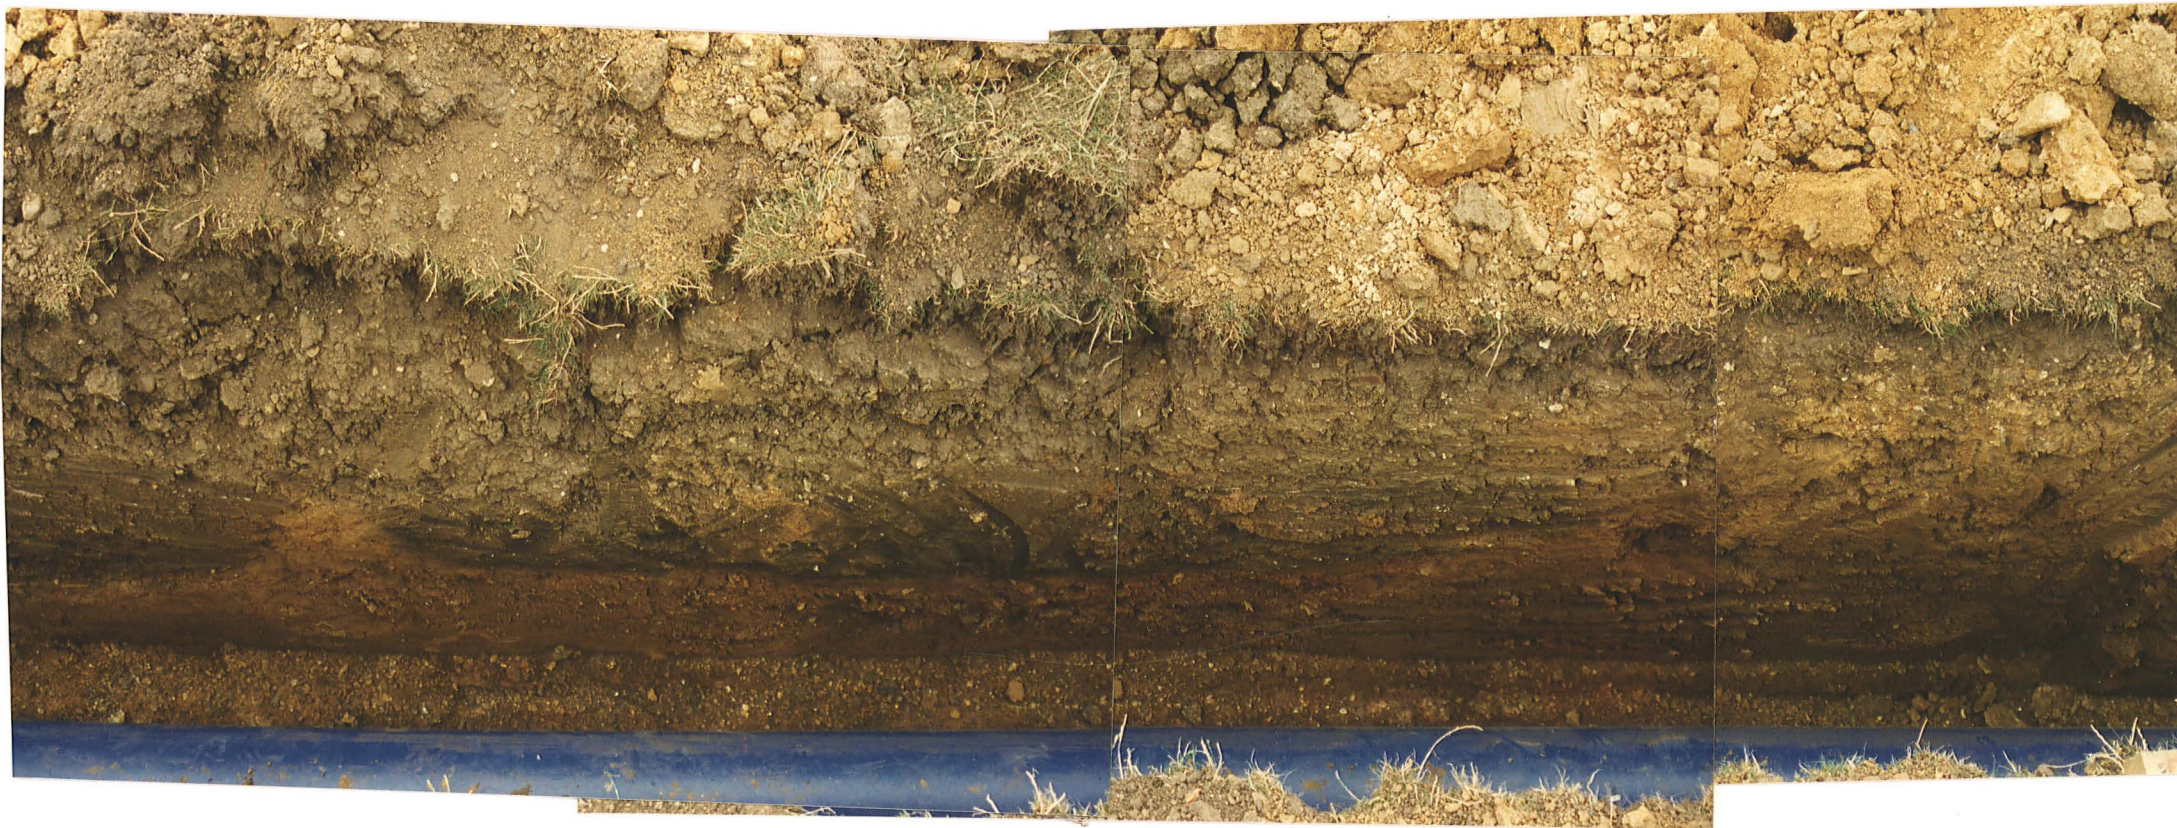
**Pl. 6. Composite view of pit 5 in the eastern trench face (central) with layer 23 to the right and pit 7 to the left. The clay with stone levelling layers 14 and 4 are visible beneath the turf (trench depth 1.2m).**

**?Bank 23.** A layer of yellow chalky clay was found beneath the levelling deposit **14** at the southern edge of the pit complex; it had been cut by pit **5**. This layer was not apparently a naturally produced buried topsoil or subsoil (as the underlying layer **24** is gravel and sand) but was perhaps an upcast bank from excavation of (or a deposit from cleaning) the Car Dyke.

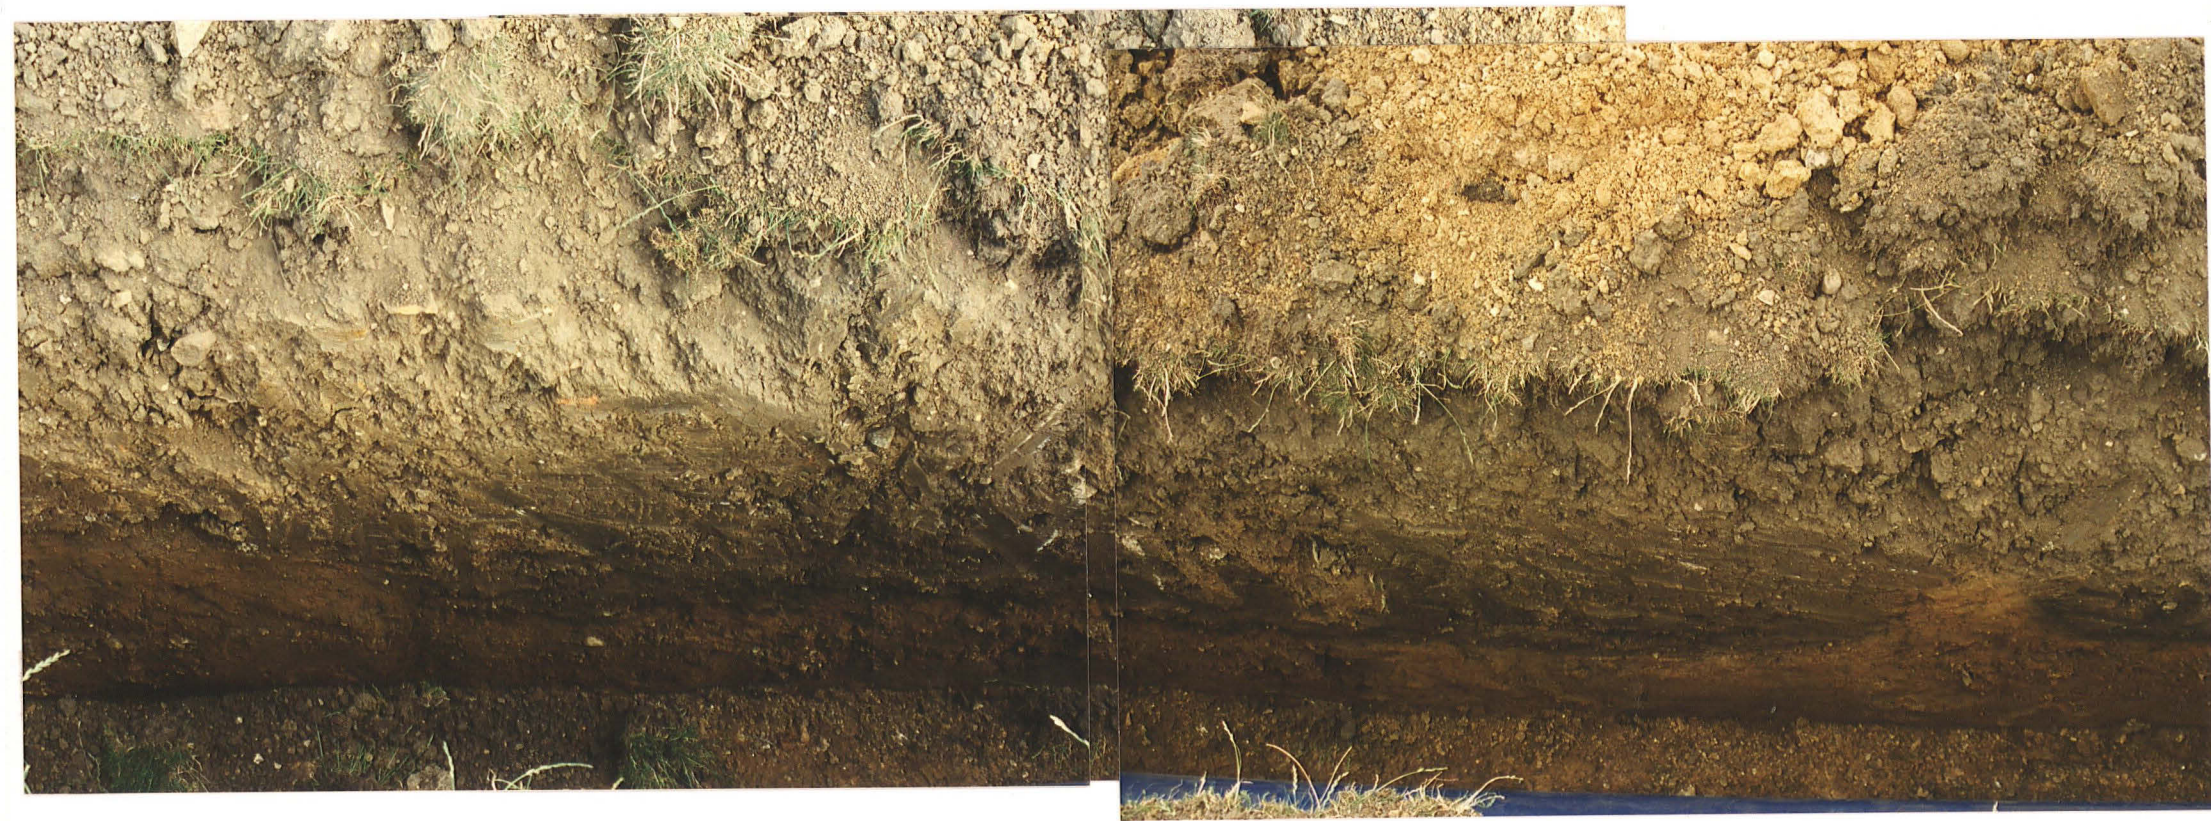
Pl. 7. Composite view of pit 7 in the eastern trench face (central) with pit 5 to the right and pit 9 to the left. The clay with stone levelling layers 14 and 4 are visible beneath the turf.

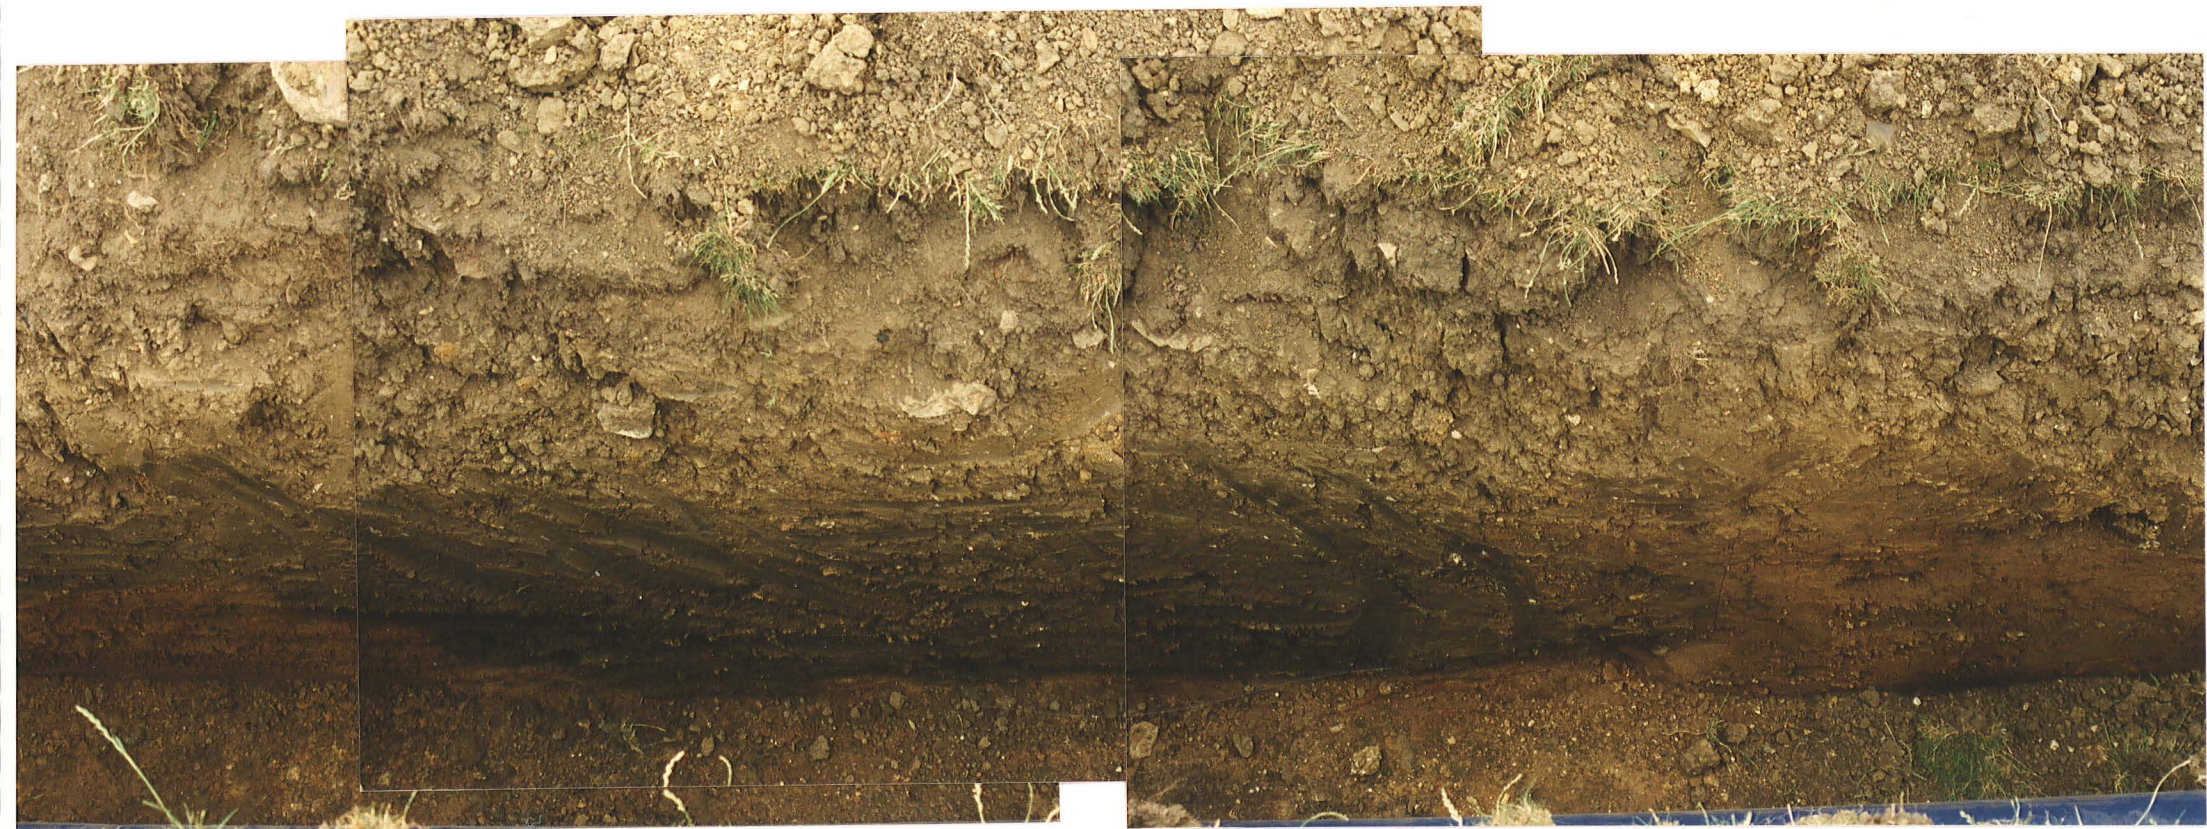
Pl. 8. Composite view of pit 11 in the eastern trench face (central) with pit 9 to the right and pit 16 to the left.

**Pit 11.** This 2.1m wide pit was the deepest identified but its base (0.7m deep, 1m below the present ground surface) remained within layer **24**. The southern face was almost vertical but the northern side sloped steeply to two slight shelves and the deepest point. Green soil (possibly cess-derived) and ash was present covering these profile shelves, together with more pottery than found anywhere else on the site. These observations suggests that this corner of the pit was specifically excavated deeper for disposal of domestic refuse. The pit cut fills **10** and **15** and contained fills **12**, **17** and **18** (Pls. 8 and 9).

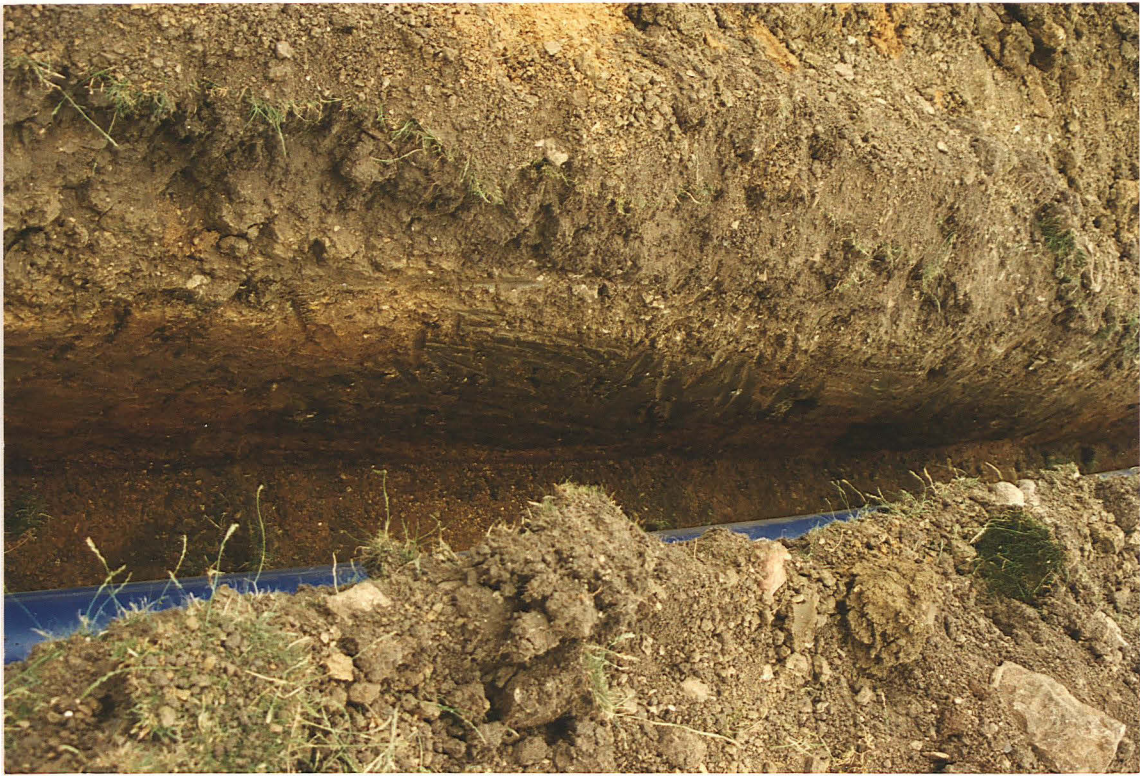
Pl. 9. The dark fills of pits 16 and 11 in the eastern trench face (looking SE).

**Pit 19.** A shallow pit of unknown width and 0.3m deep was found, containing fills **20** and **21** and cutting fill **15**. This pit was not recognised during excavation but was identified from the photographs at the northern side of the other pits; it is possible that other pits were present but not seen (Pls. 9 and 10).

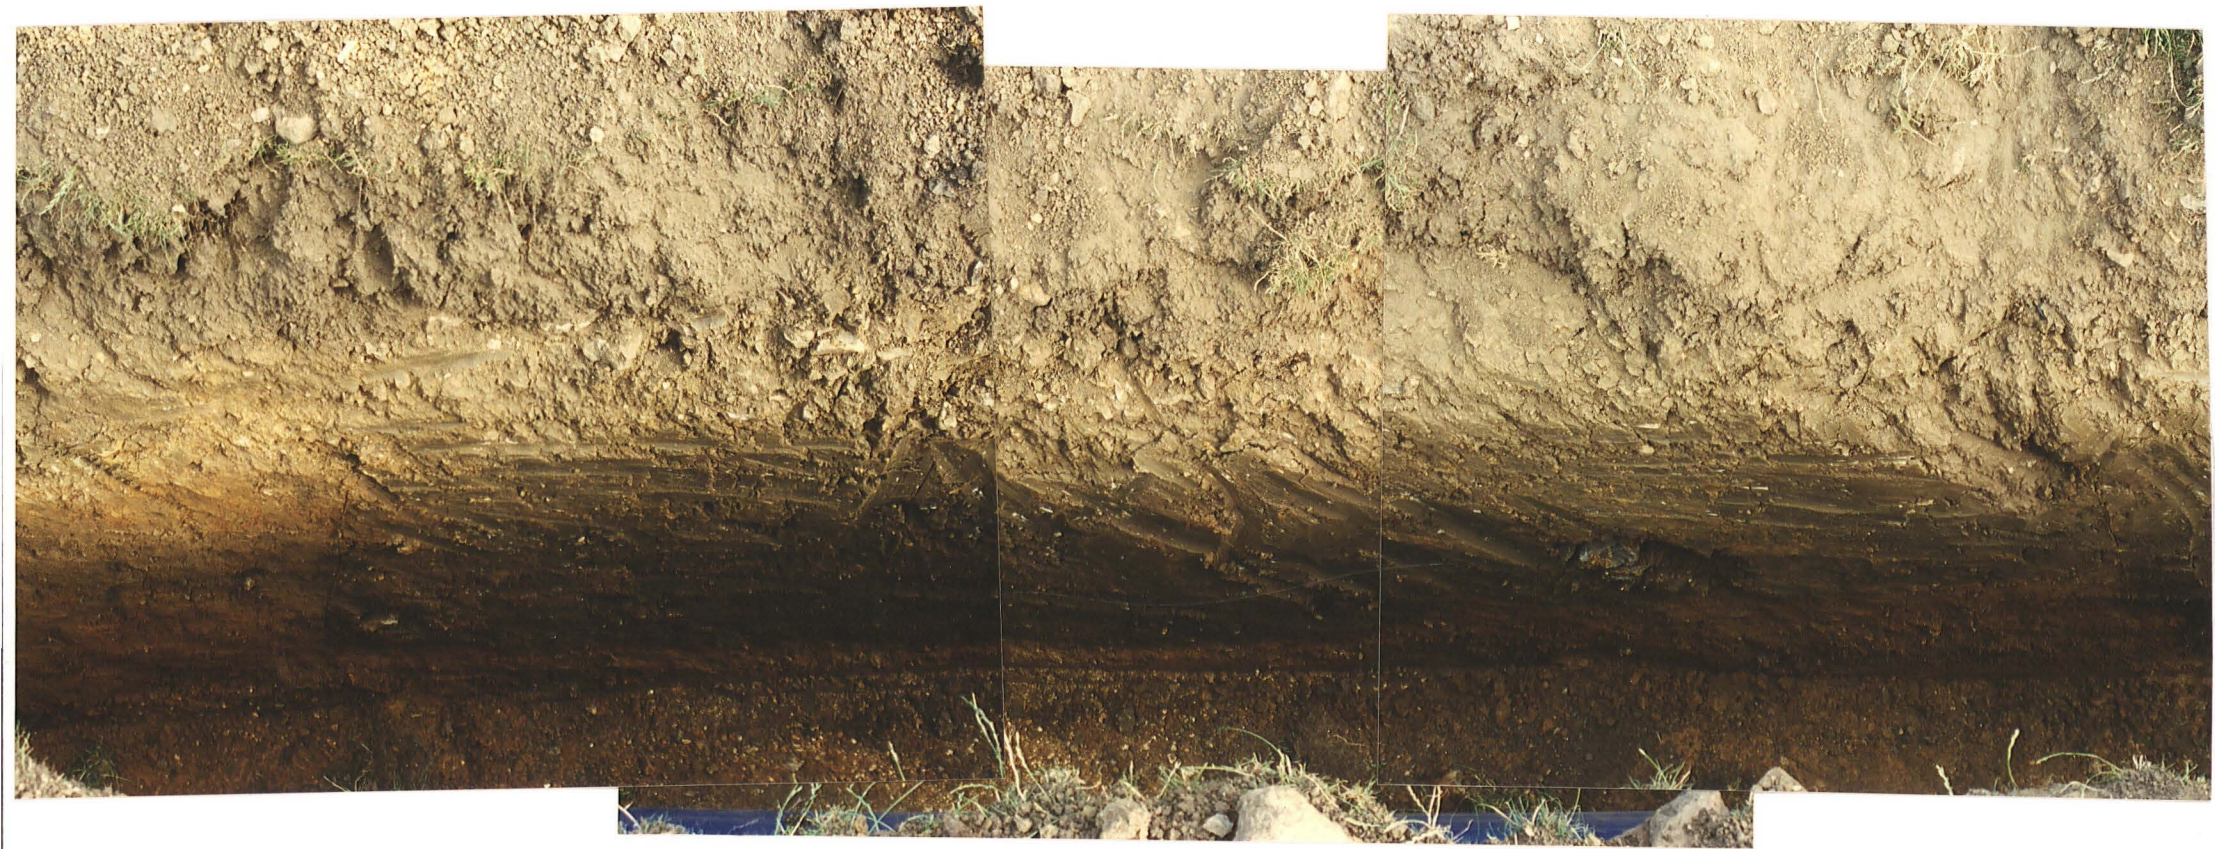
Pl. 10. Composite view of pit 16 in the eastern trench face (central) with pit 11 to the right and pit 19 to the left.

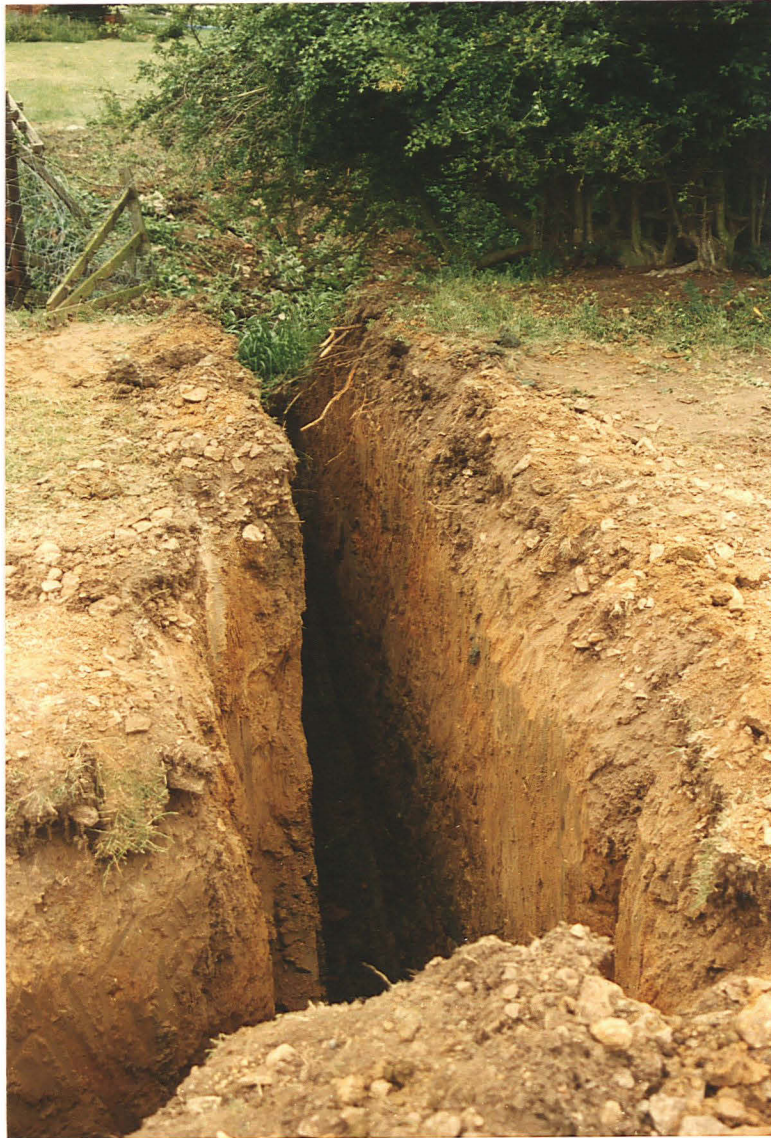
Pl. 11. View of the deeper pipe trench south of the stream crossing during excavation. The thick orange sandy clay with gravel layer overlies darker deposits (looking north).

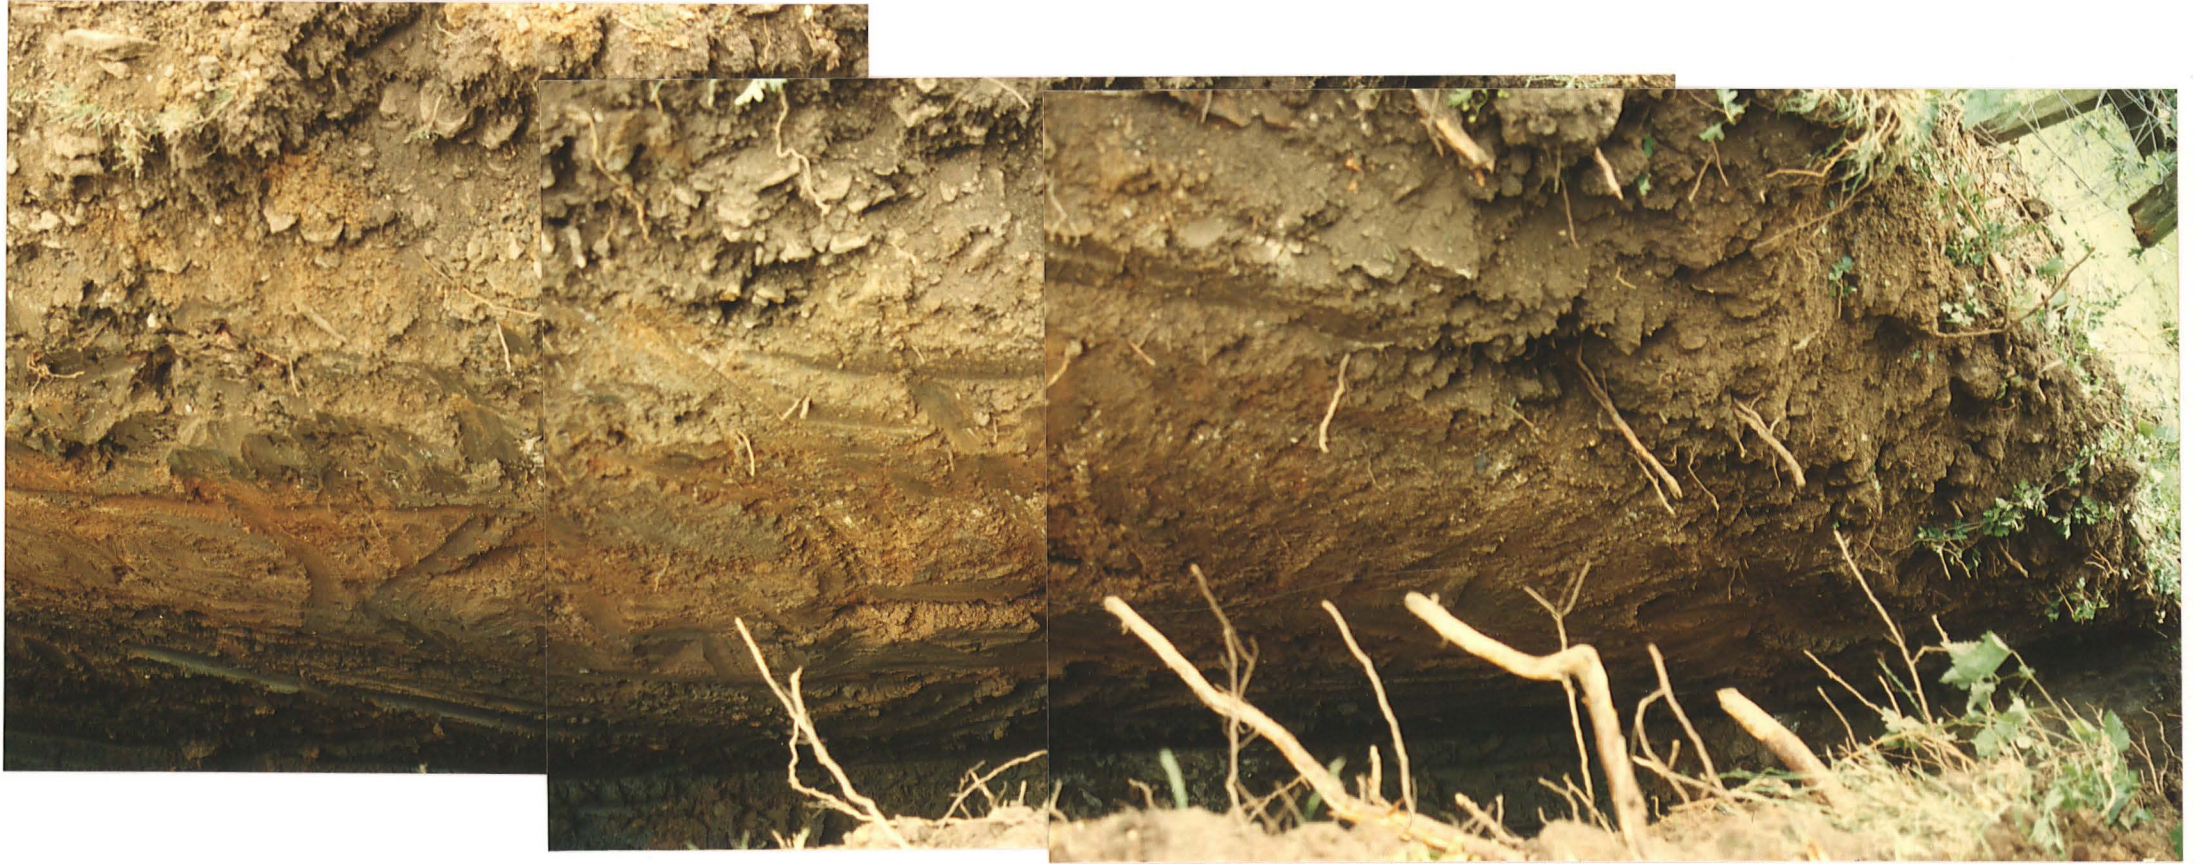
Pl. 12. Composite view of deposits in the trench face south of the stream. The rubble levelling deposit 14 follows the stream edge profile (looking NW).

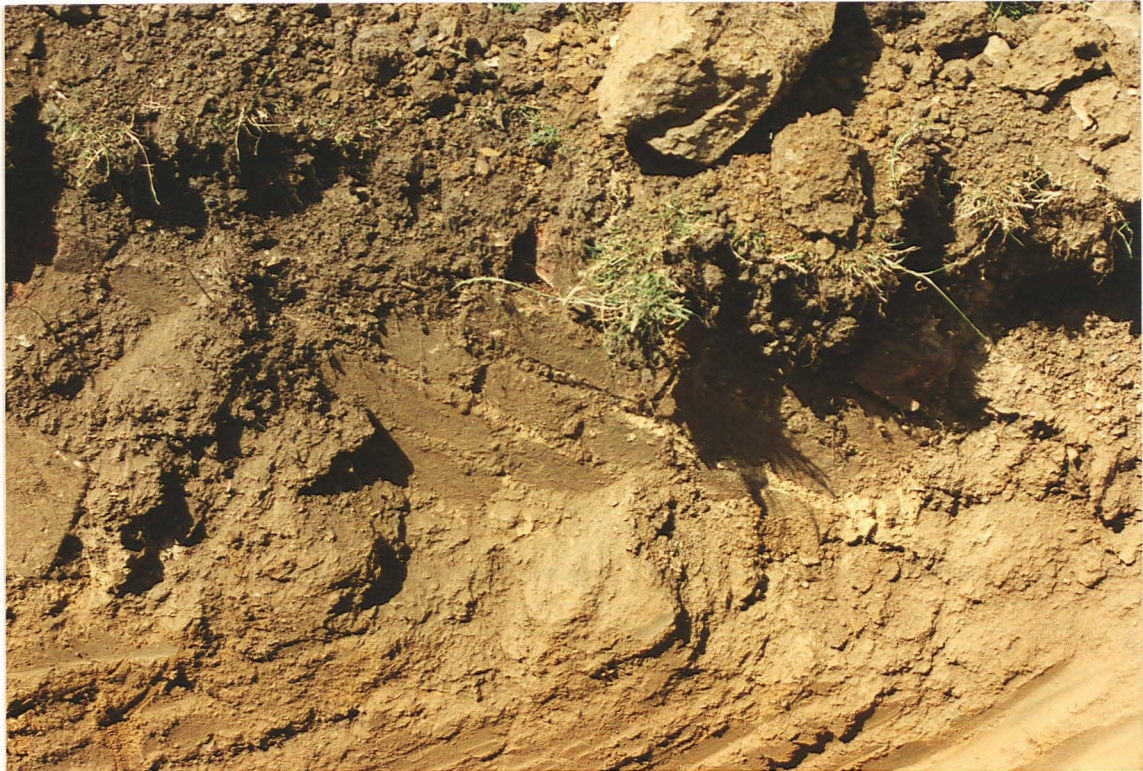
Pl. 13. Part of the in situ foundation of a removed brick structure 29 in the western trench face.

**29.** To the east of the backfilled pits on the south side of the stream, a mortared block of brickwork was seen in the north face of the trench. At first this was thought to be a large piece of redeposited demolition rubble within the levelling spread **14** but it may have been the *in situ* foundation of a removed brick structure (Pl. 13).

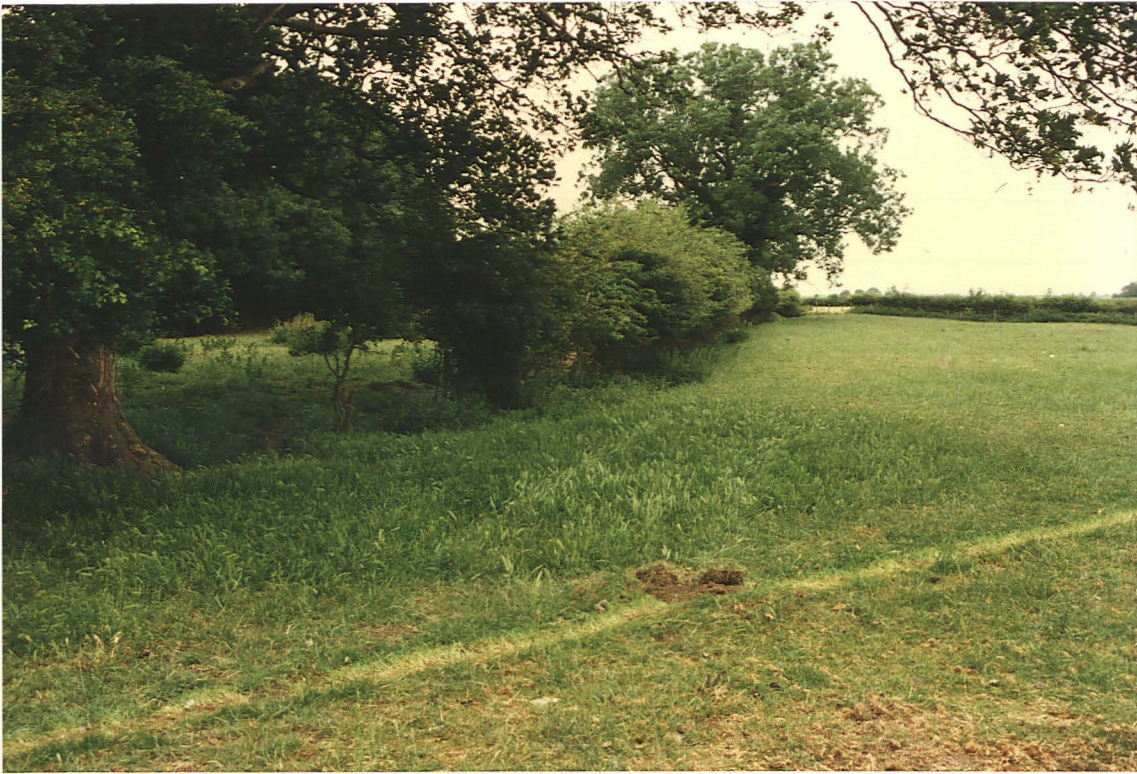
Pl. 14. Earthworks of ridge and furrow cultivation 30 in the pasture east of the pipe trench (looking NW towards Dyke village).

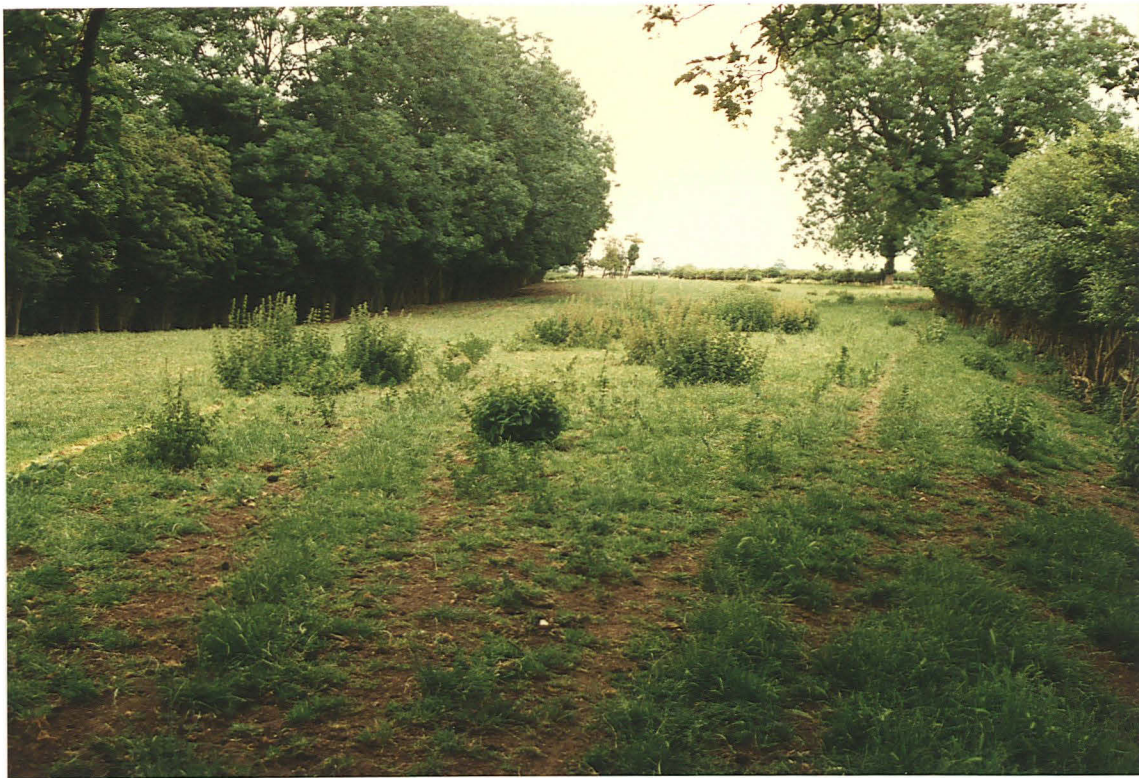
Pl. 15. Post-medieval ditch 31 cutting across (and backfilling) earlier plough furrows to the east (looking north).

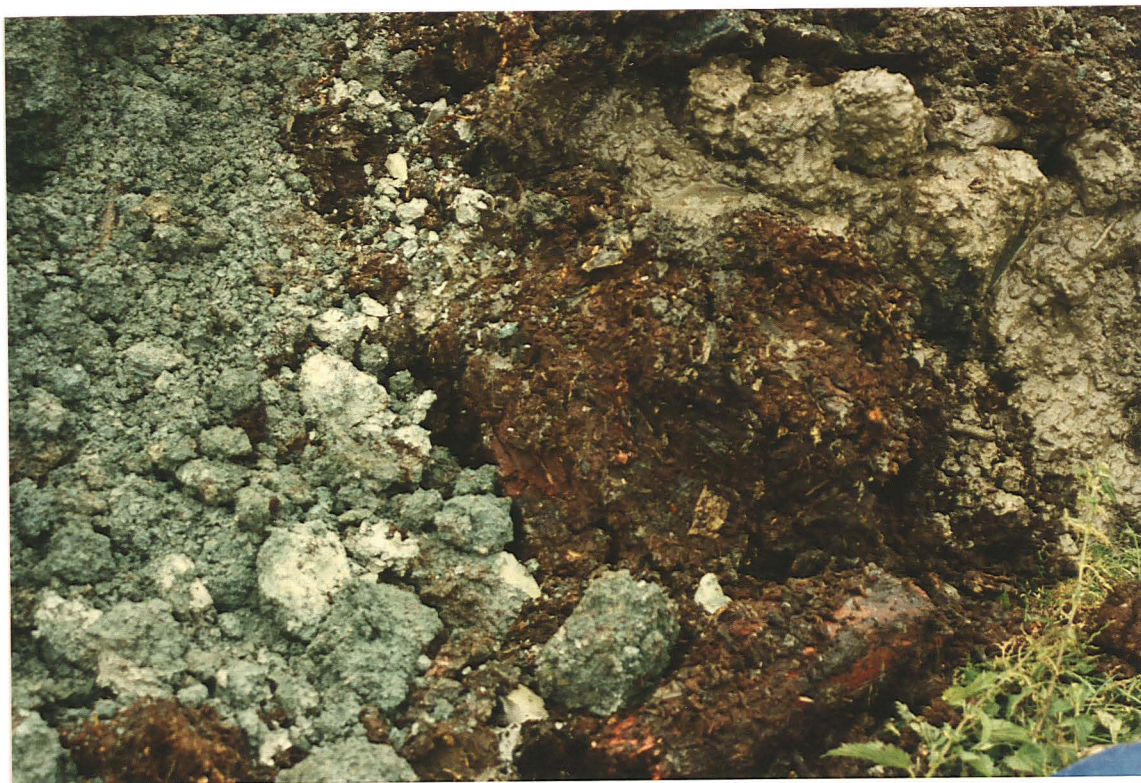
Pl. 17. Thick recent peat deposit 33 and underlying chalky silt 34 beside Car Dyke stream (looking north).

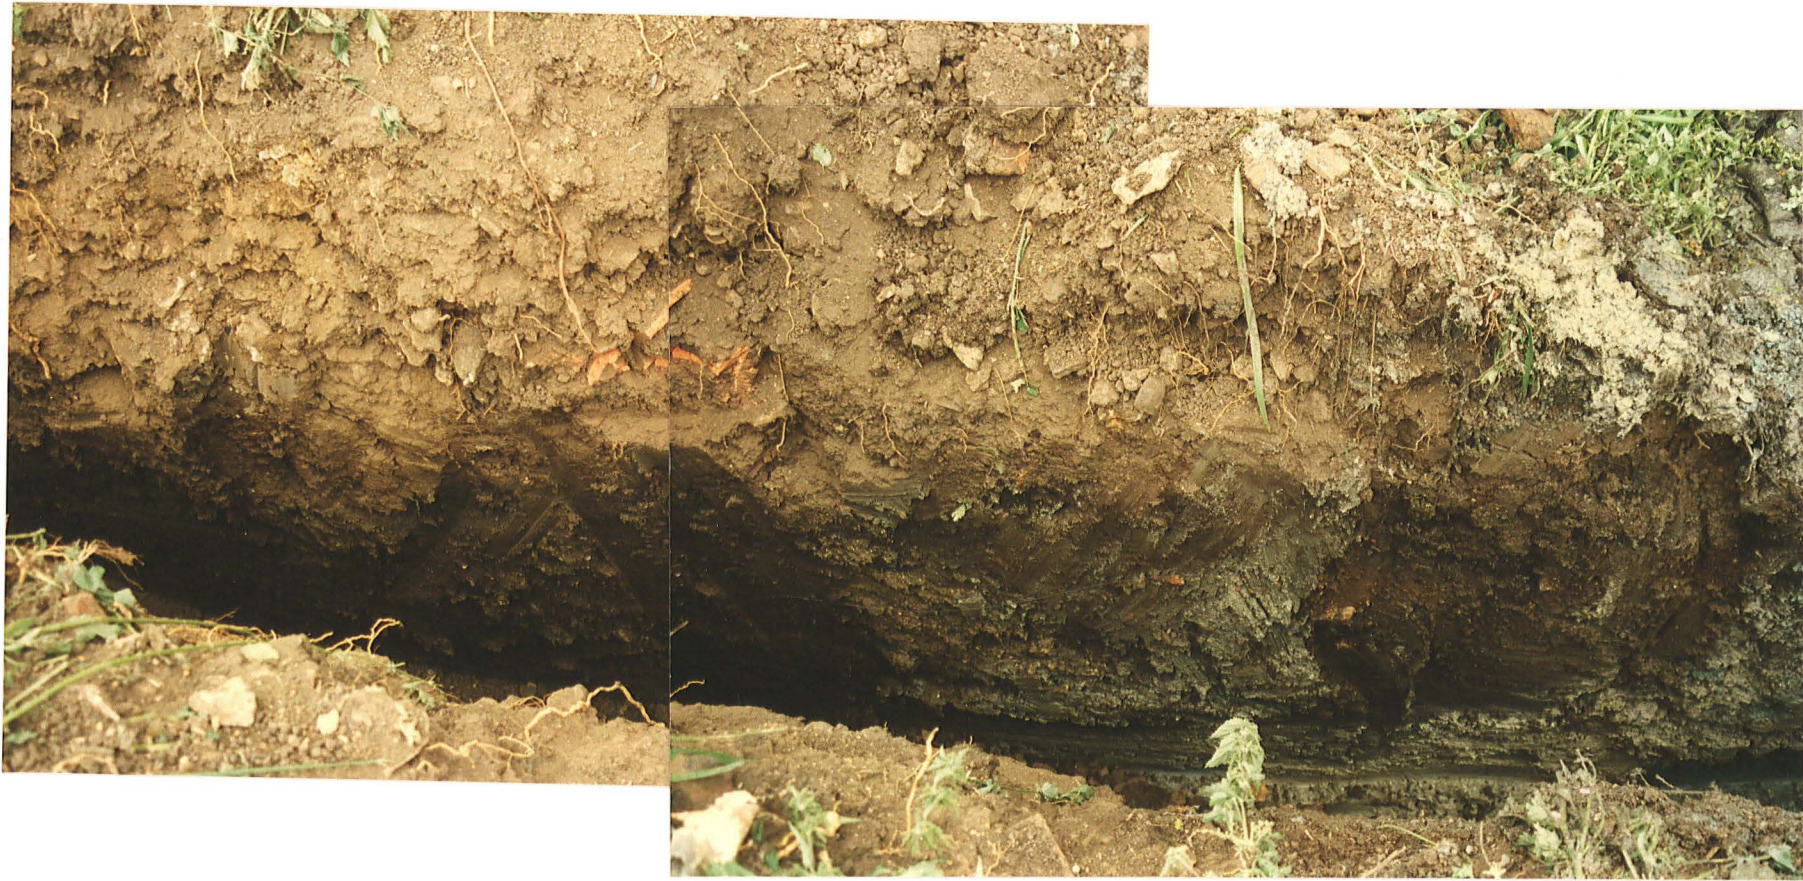
Pl. 19. Composite view of deposits in the northern trench face north of the stream. The stone and tile rubble layer 37 overlies dark clay 35, which may be fill of the Roman canal (looking NE).

**Channel 36.** A large deep ditch-like feature, aligned west-east, was observed on the north side of the present stream, cut into orange sandy clay **24**, the uppermost layer in a series of natural deposits numbered **24**, **25**, **26**, **27** and **28**. It had a steeply sloping north edge; the base was below the bottom of the excavated trench. Its south edge was recorded in the base of the trench but merged with the recut containing **34**. It was seen in both trench faces for 22m north of the stream side, probably about 17m perpendicular to the stream (Pls. 20 and 21). This was interpreted as possibly the actual course of the Roman Car Dyke canal. It contained fill **35**, a dark brown clay deposit with some limestone (Pl. 19). No finds were seen.

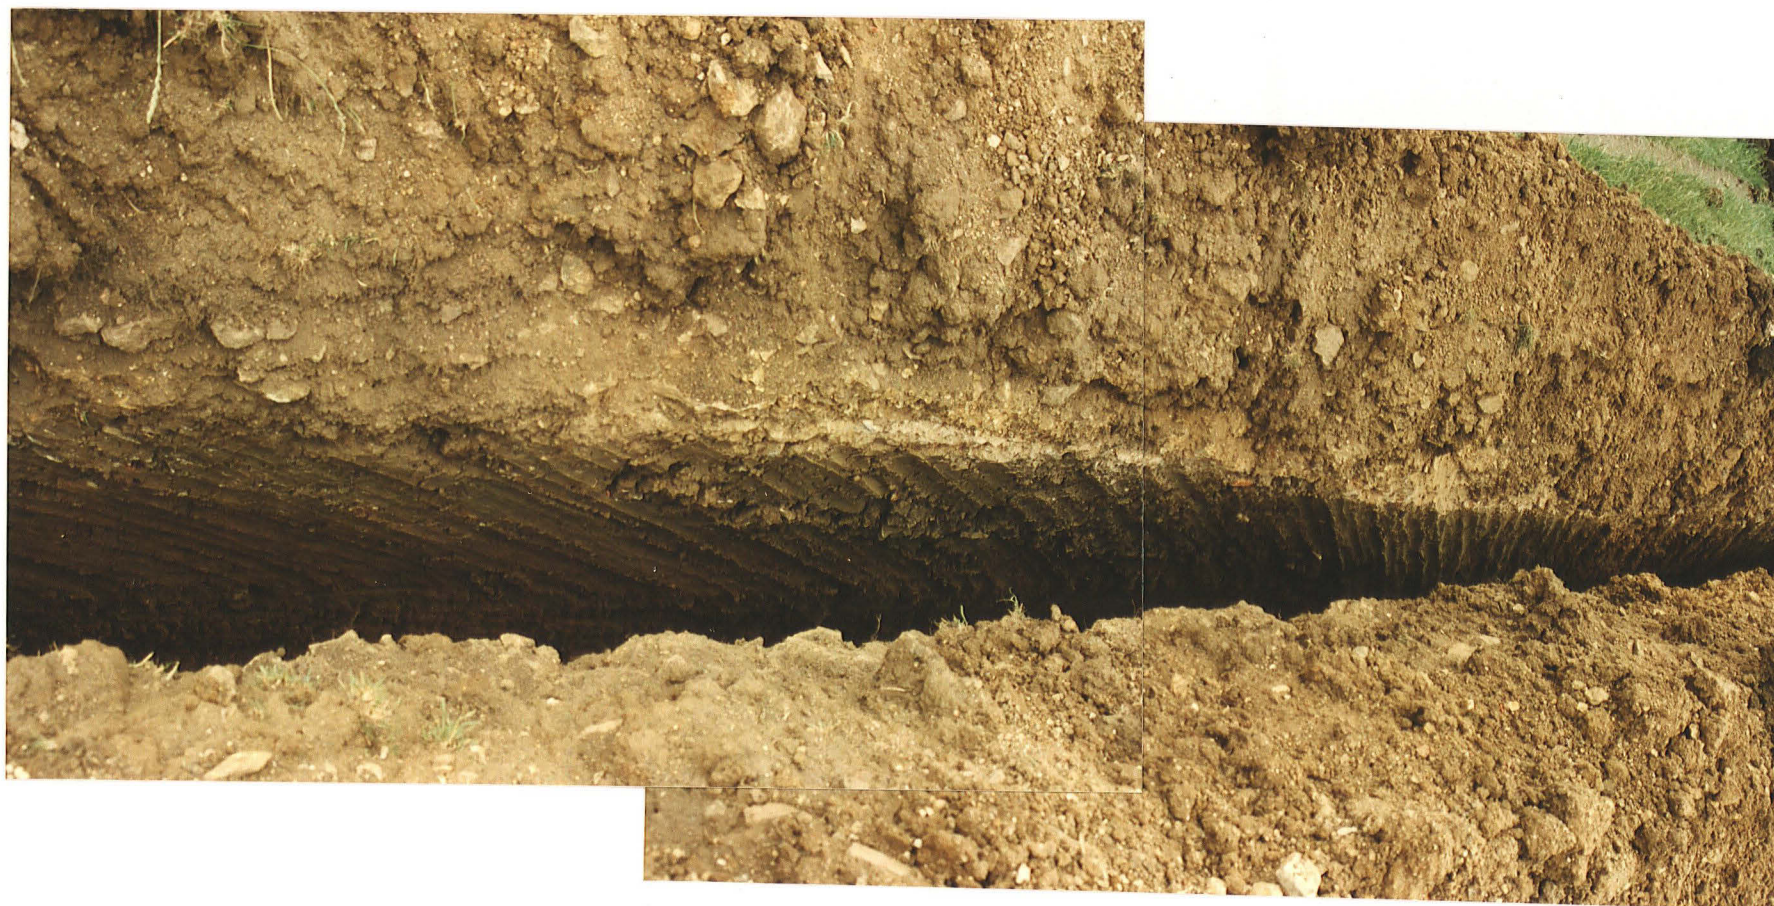
Pl. 20. Dark fill 35 within the feature thought to be the Roman canal (looking NE with stream at extreme right).

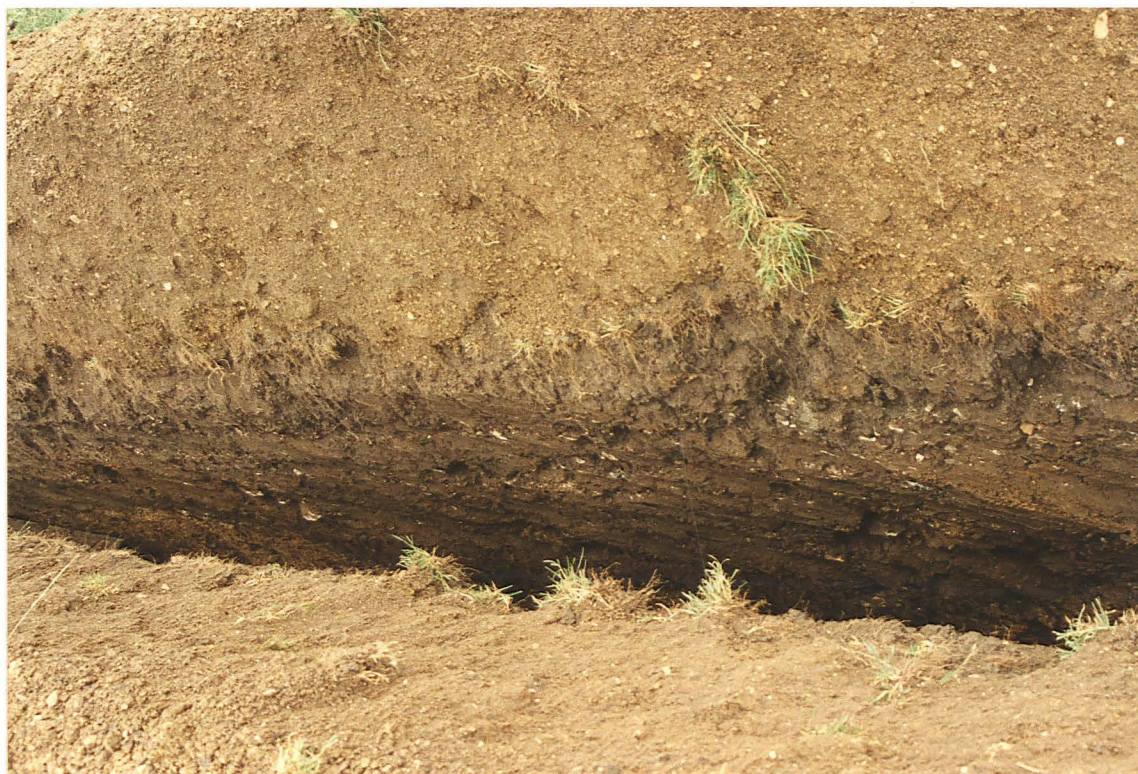
PI. 21. Western edge of feature 36 (the possible Roman canal) with the underlying yellow sandy clay 24 visible to the left (looking NE).

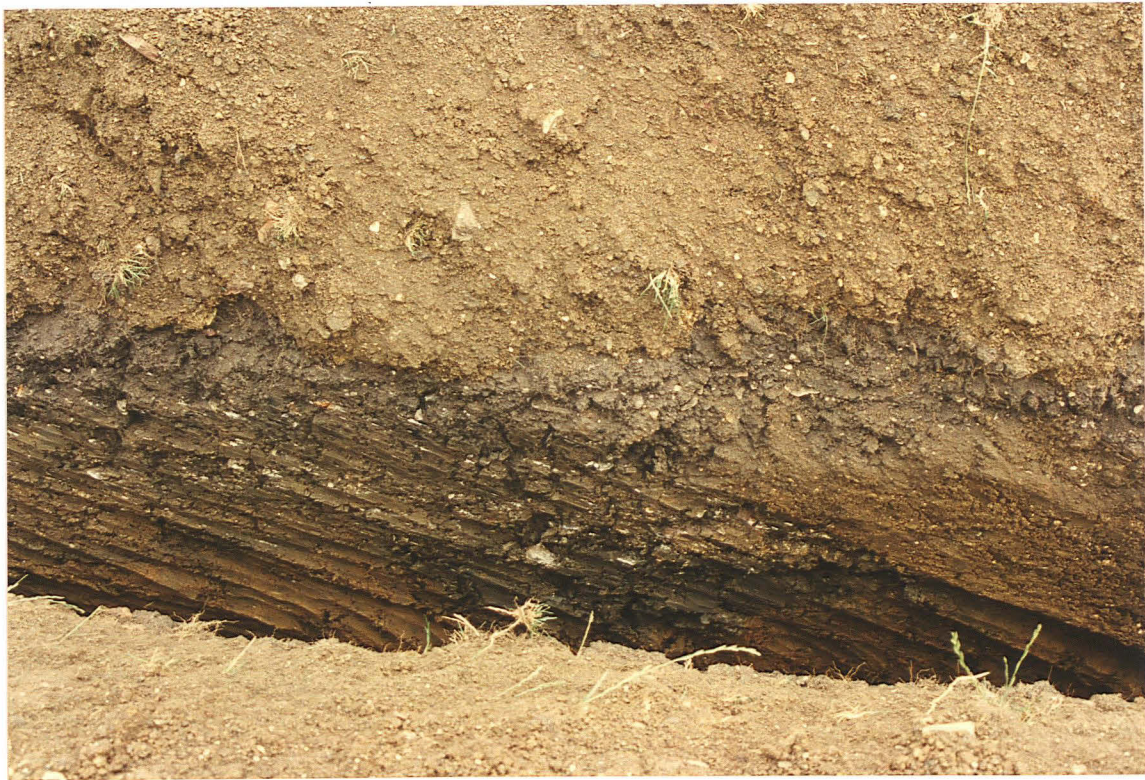
Pl. 25. Small undated pit 39 showing in trench face north of the stream.
