## **Bourne to Morton Mains Replacement Scheme:**

### **Archaeological Monitoring at Dyke and Morton**

Report prepared for Anglian Water

**October 1996**

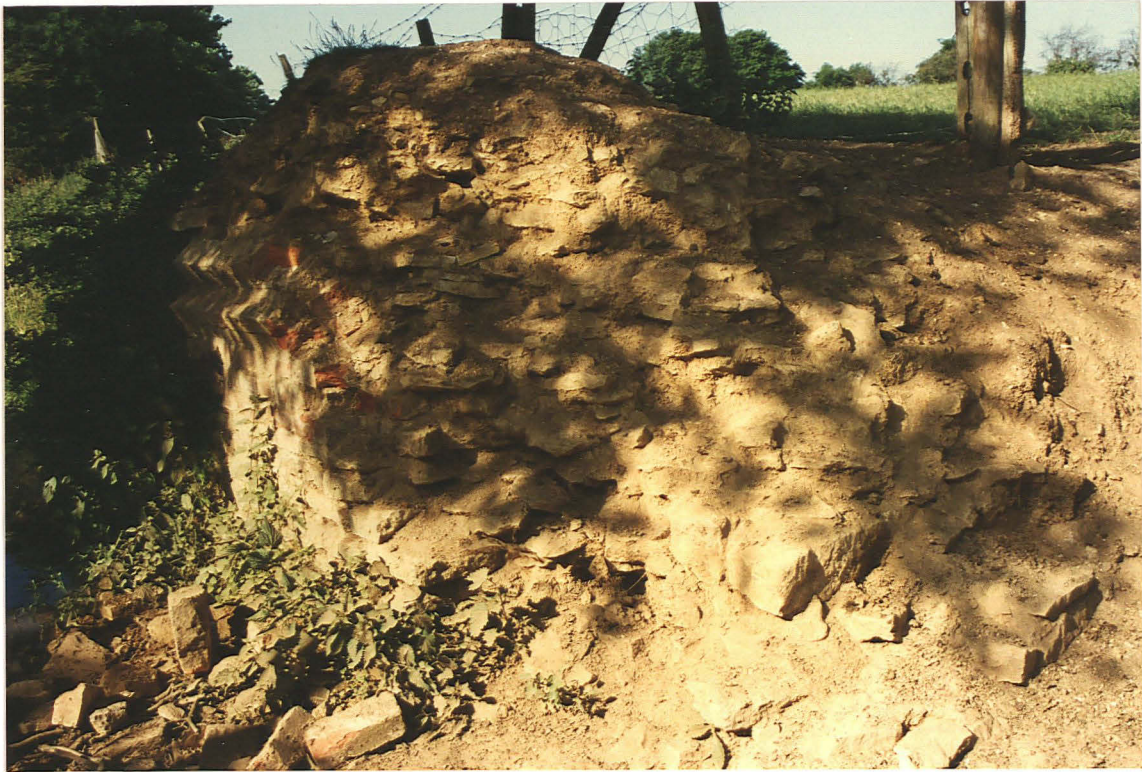
Pl. 27. Stone rubble marking site of eastern side of bridge 41 (looking east).

**41.** 160m NE of the pipe trench crossing the stream, the stone and brick remains of a collapsed bridge were seen either side of Car Dyke. The remains on the northern bank were most substantial and incorporated a few large limestone blocks within a matrix of thin limestone (Pl. 26). The inside of the arch had been faced with two courses of brick, possibly as a later repair. On the southern bank only the last traces of core rubble were visible and no bricks were seen. The photograph shows the turf covering layers of stone and mortar which might be a track surface, but as these overlie dark brown clay (which appears to be slumped topsoil or alluvium sealing the rubble core) they may represent demolition material (Pl. 27).

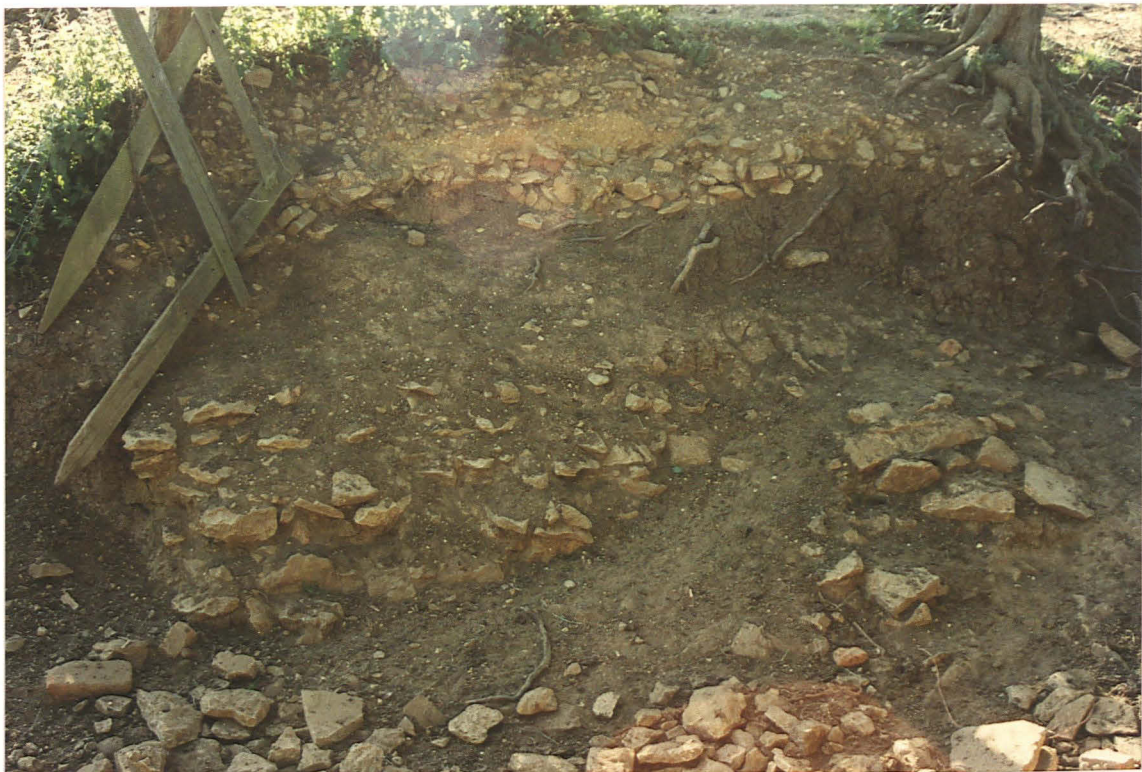
Pl. 26. Western side of demolished stone bridge 41 (looking west). Note the brick arch facing.

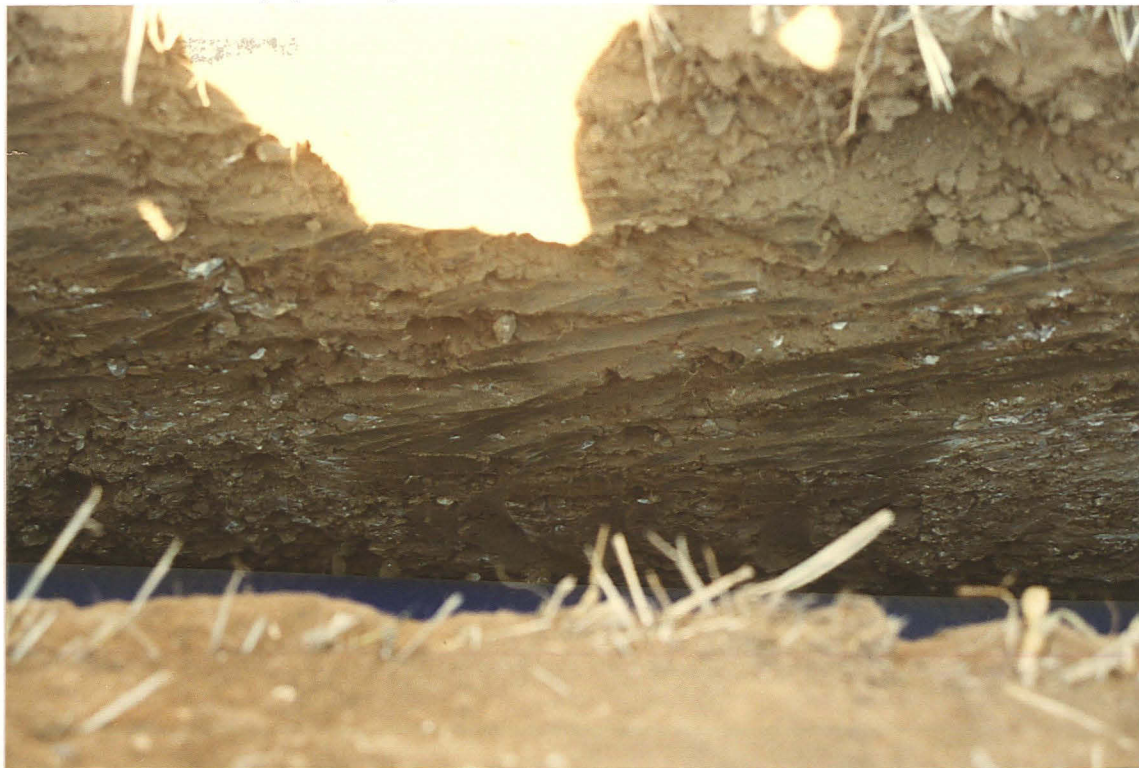
Pl. 32. Variations in the deposits cut by the pipe trench at 48, marking the southern limit of a natural stream channel (looking west).

**48.** On the south side of the stream, the subsoil exposed by the trench was markedly different from further south (Pl. 32). In place of the stony yellow-brown clay, 16m south of the stream dark brown or dark yellow-brown clay was revealed; this dipped beneath the trench base despite the greater depth of the trench where it passed beneath the stream. At the stream base, grey mud (possibly slightly peaty) was noted (Pls. 33 and 34).

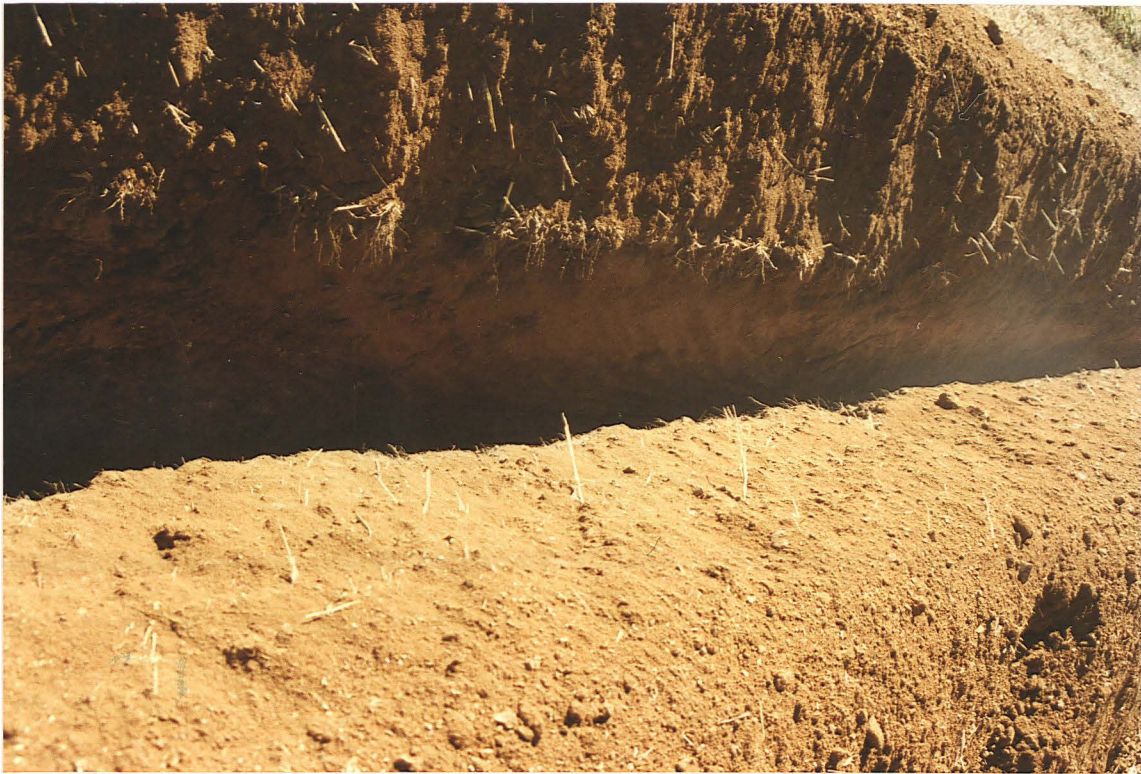
Pl. 33. Peat at the trench base at 48 where the trench revealed a palaeochannel.

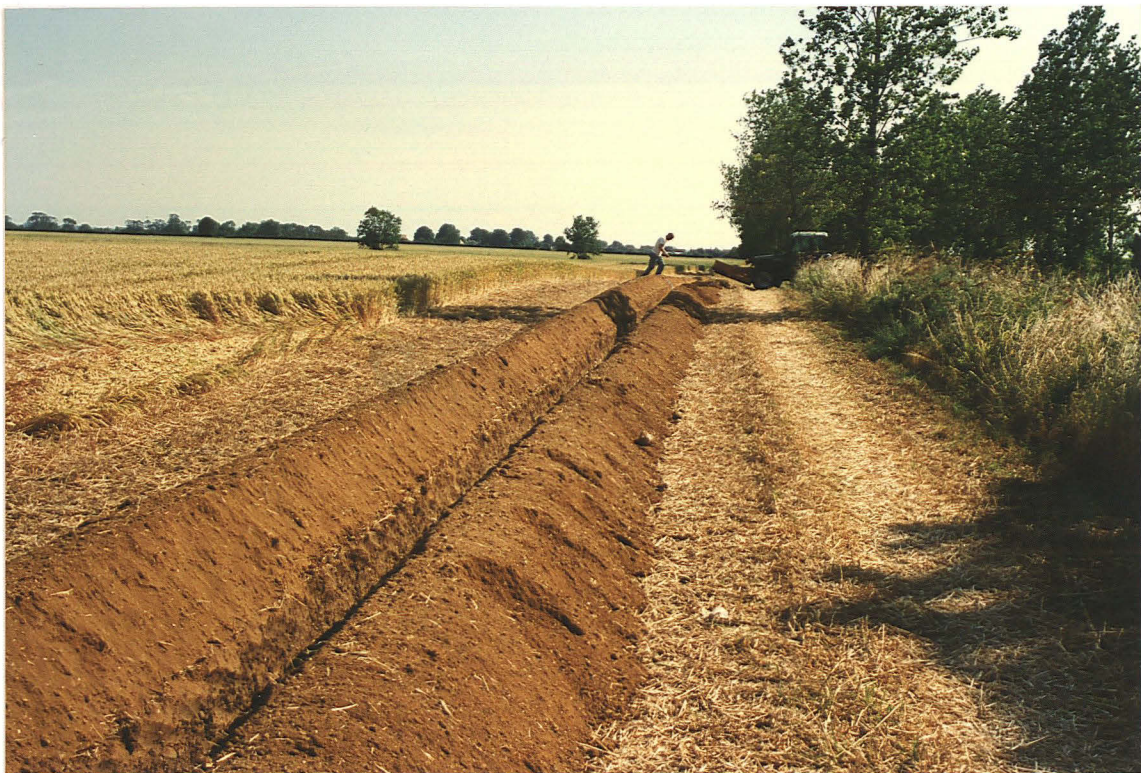
Pl. 36. Limestone mixed with clay in backfill of ditch 50, thought to be a Romano-British feature.

**50.** 10m north of the base of ridge **49**, a 1m deep ditch was seen in the trench faces, aligned west-east. The 5m wide ditch was filled with clay and limestone lumps, some of which had been burnt (Pl. 36). It seems certain that this is an artificial feature but no dating evidence was seen. From its position close to

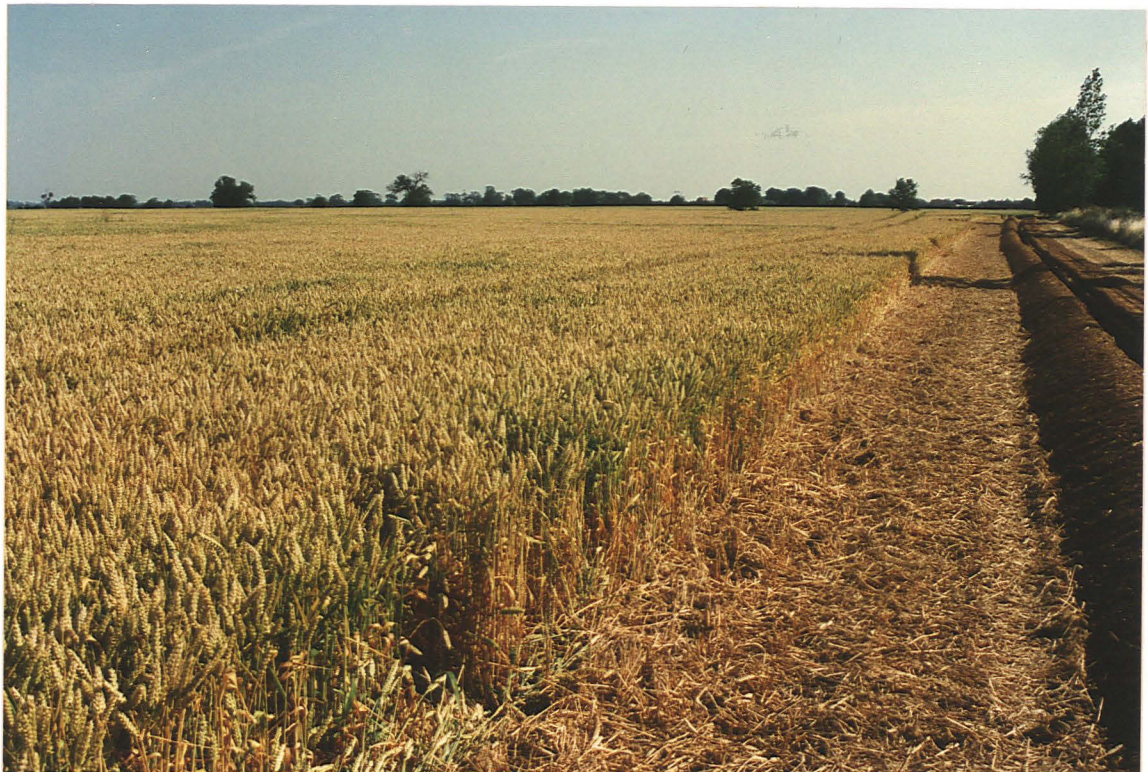
Pl. 37. Differential ripening in wheat crop perhaps indicating archaeological pit and ditch features in area of known cropmarks; ridge 49 and ditch 50 are at the furthest end of the visible trench (looking south).

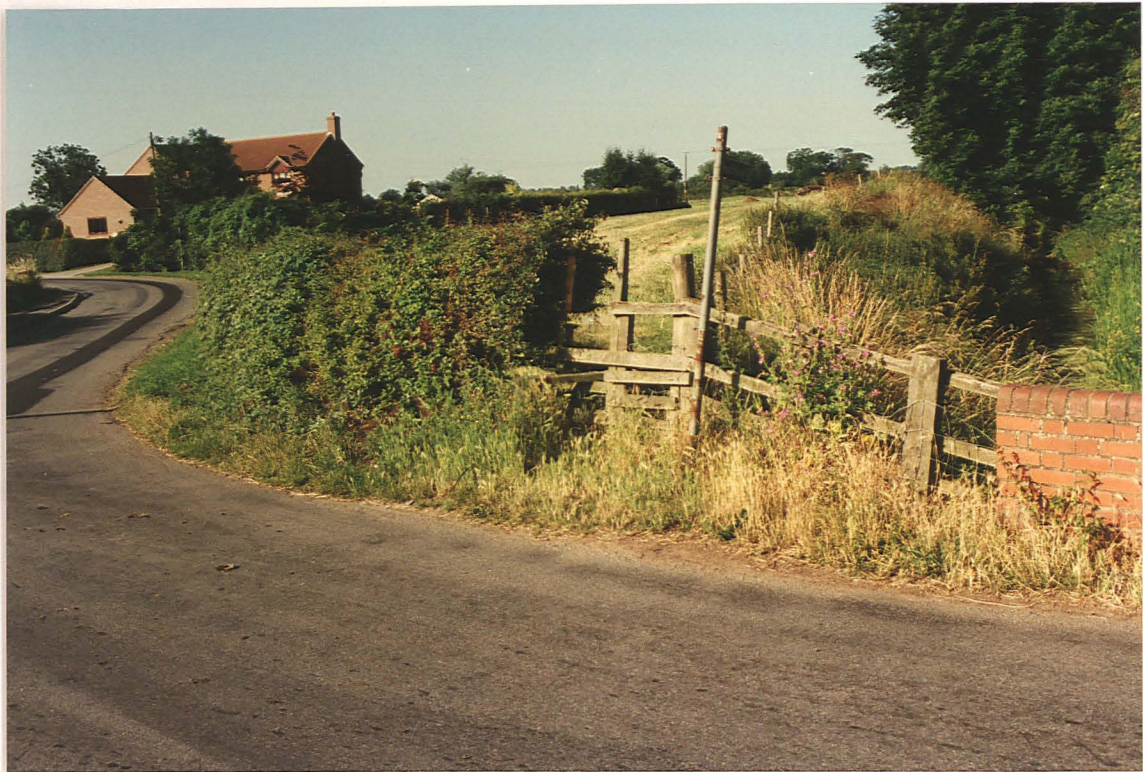
Pl. 38. Upcast bank on south side of Car Dyke at edge of Dyke village (looking SW).

It was observed that the Car Dyke retains a bank on the south side to the west of the Wath Bridge but no trace is visible to the east (Pls. 38 and 39). The trench stratigraphy was inspected but a possible upcast bank at **42b** was the only hint of a surviving bank. Assuming that a bank had existed along this side, it had probably been removed before excavation of the rubbish pits in the late 12th century. The material was presumably incorporated into the soil and subsequent plough ridges by the date of local Enclosure. Removal of the bank would have created ready access along the side of the watercourse to the east of Wath Bridge. There is no visible raised upcast bank along the south side of the dyke beneath the hedge further to the east.

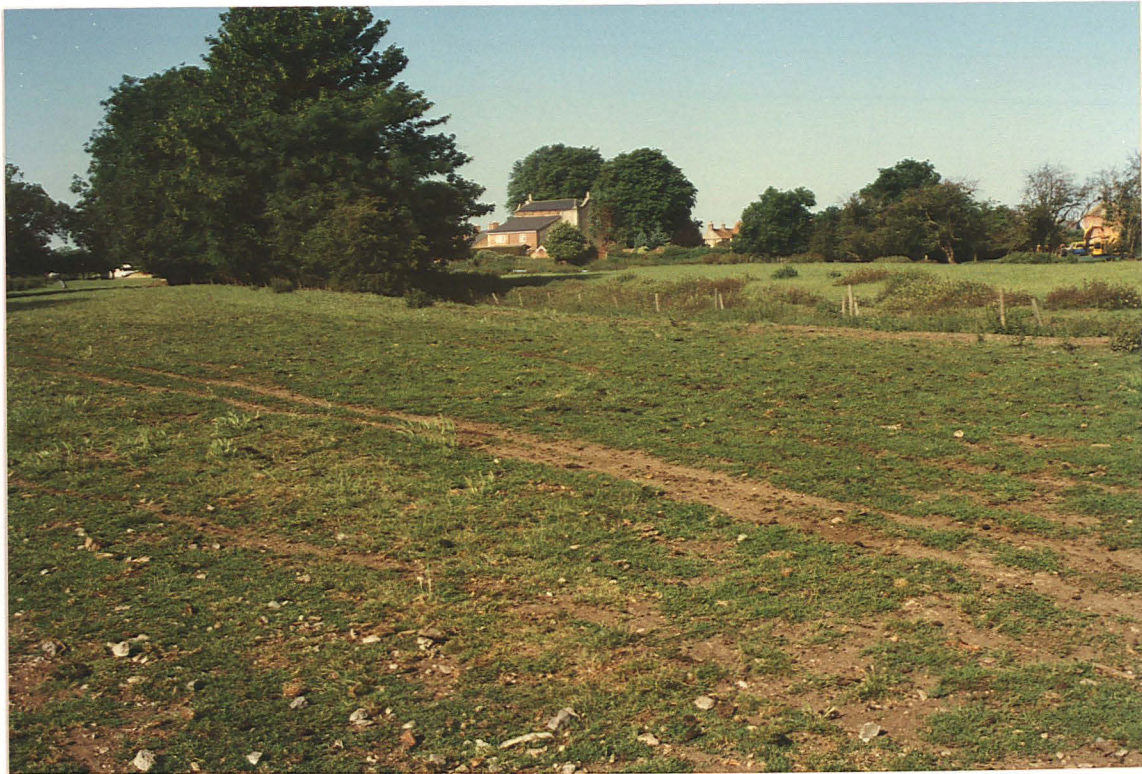
Pl. 39. Course of the Car Dyke to NW of Dyke village, with no surviving bank. A possible vestigial ridge was seen in the far pasture field (looking SW).
