## **Lindsey Court Enhancement Scheme**

## **Archaeological Watching Brief Report**

**East Lindsey District Council**

**September 1996**

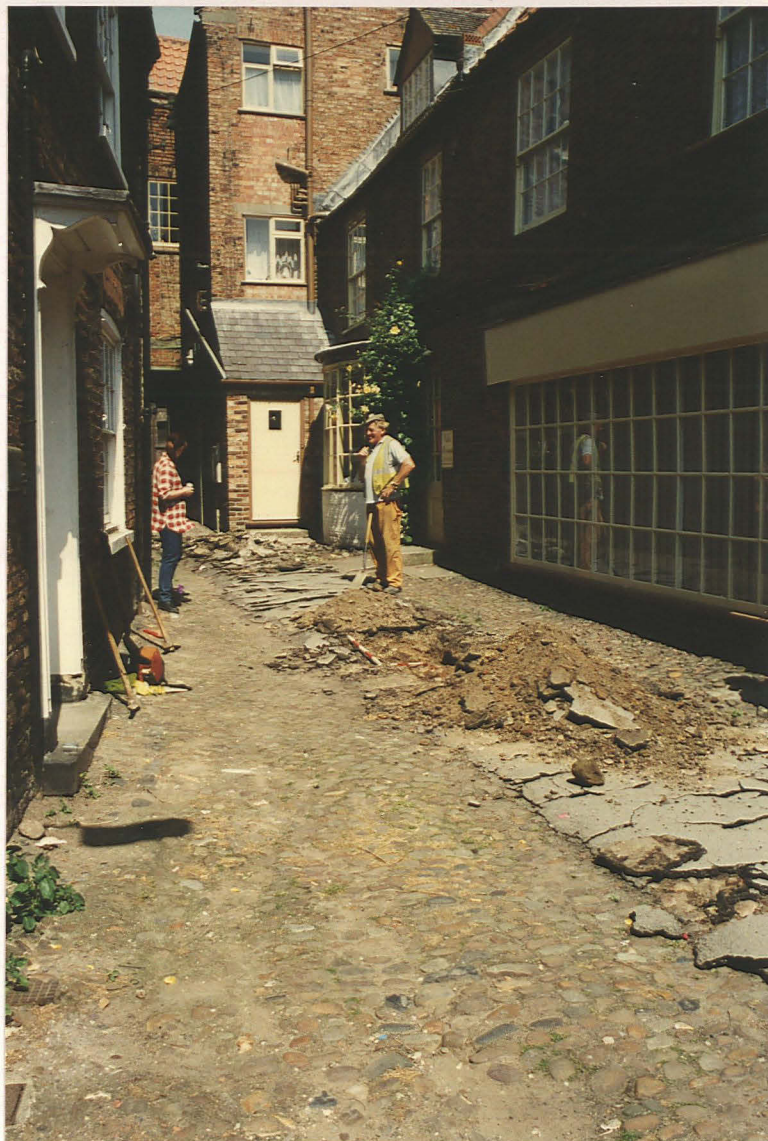
Pl. 1 Lindsey Court, view north, showing tarmac ready for removal. Trial excavation marked by small red and white photographic scale.

Delay in the arrival of the mini-excavator on the first day provided an opportunity to clear a small area at the north end of Lindsey Court (Pl. 1). Removal of the tarmac revealed part of a sandstone foundation with brickwork adjacent on its east side (Pl. 2). The top of these features lay just beneath the 250mm horizon and the associated pottery finds were of recent date. Subsequent monitoring of tarmac removal confirmed that no significant archaeological horizons were disturbed by the resurfacing programme (Pl. 3).

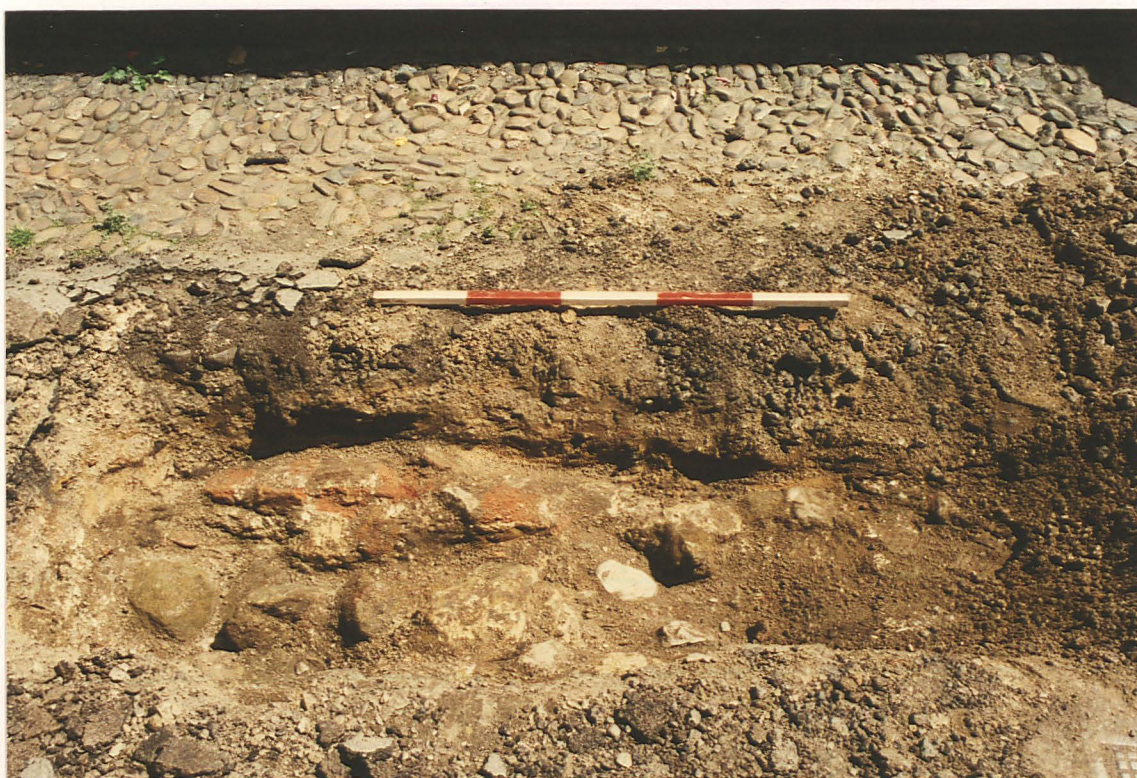
Pl. 2 Lindsey Court, trial excavation view east, showing brick and stonework. Scale 0.5m.

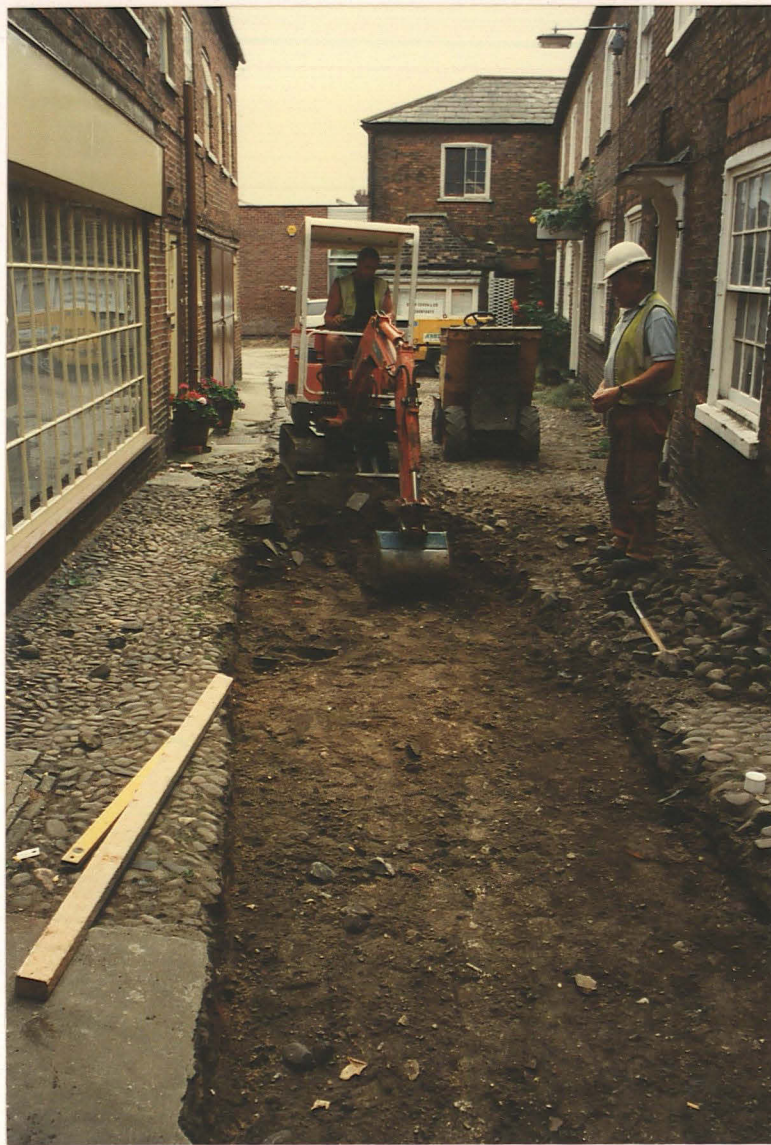
Pl. 3 Lindsey Court, view south, clearance of tarmac in preparation for resurfacing. No visible archaeological remains.

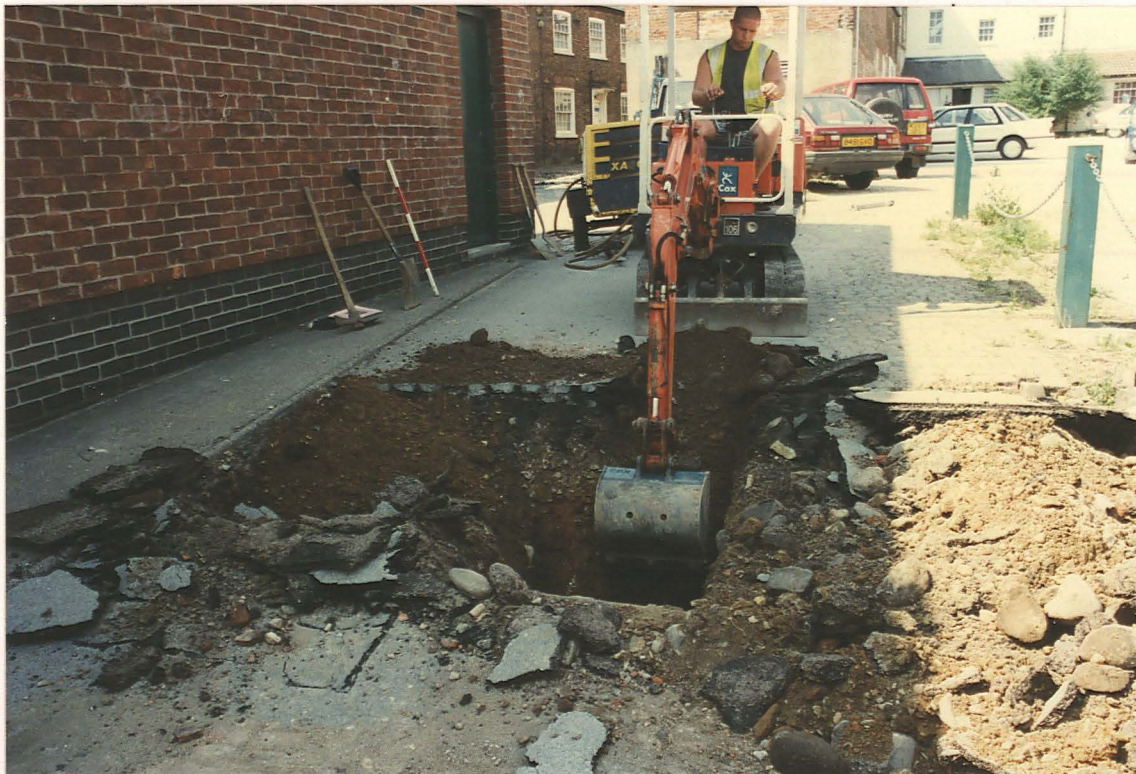
Pl. 4. Excavation of second trench with mini-excavator east of library, view north.

to a depth of 1.25m but nothing was seen. A second trench, parallel to the first, was excavated to ensure that the absence was not just localised (Pl. 4) .

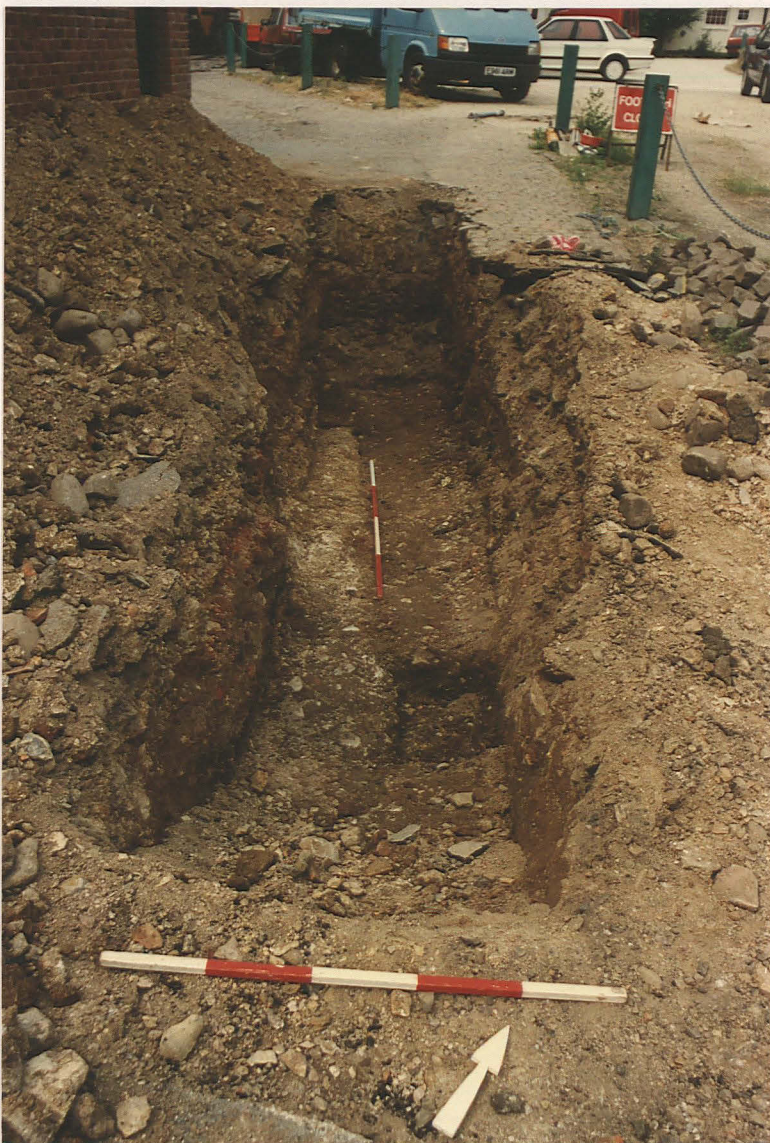
Pl. 5. Enlarged trench east of library excavated by JCB, view north, showing remains of Roman chalk foundation raft, left, and modern service trench, right.

The trenches were backfilled at the end of the day for safety reasons and re-excavated using a JCB with a wider bucket on the following morning with extending the trench to 7.5m long and 1.5m wide (Fig. 2). The JCB operator was asked to excavate to the top of surviving wall remains; no wall was found but the underlying foundation raft comprising compact crushed white chalk (6 and 10) was encountered at a depth of 1.35m (28.33m OD). The northern edge of the raft was 1.1m from the NW trench corner extending beyond the southern limit of the trench so that its full width could not be recorded (Pl. 5) .

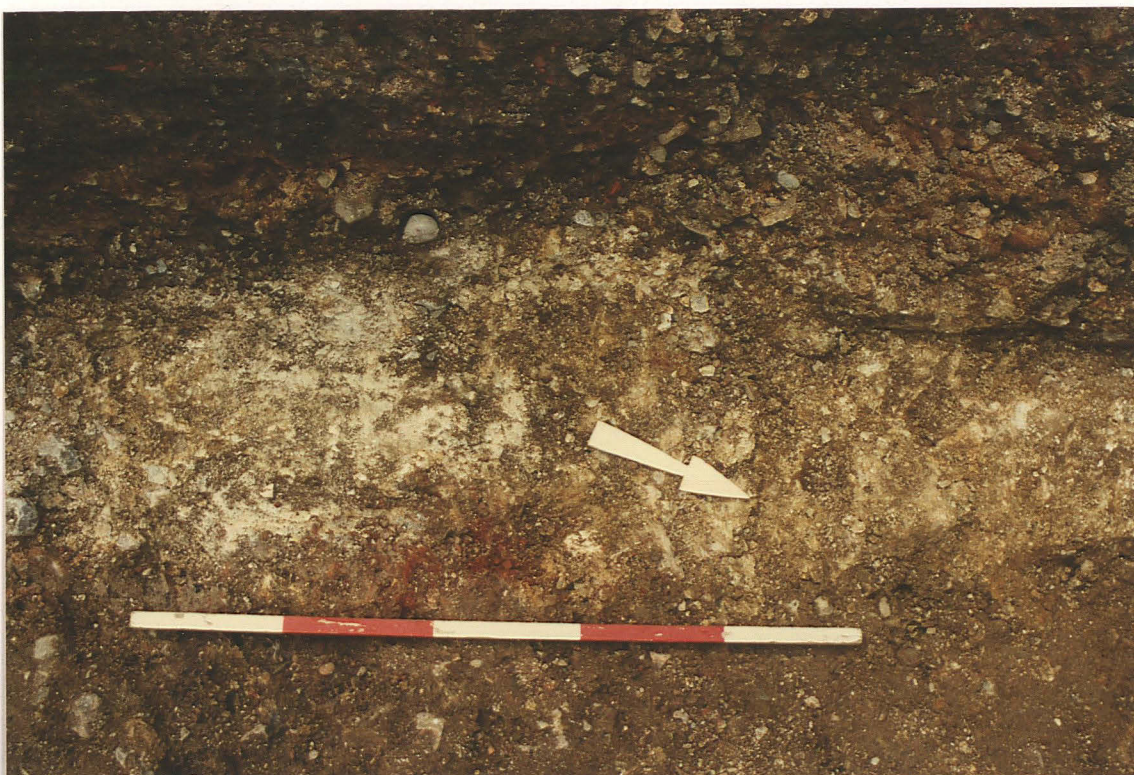
Pl. 6 Junction of clean and stained areas on chalk raft, marking presumed position of wall

The northernmost 1.8m of the chalk raft contained inclusions of limestone and sandstone fragments up to 0.1m diameter, giving a grubby appearance to the material (Pl.6). When the alignment of the internal edge of the Roman wall inside the library was projected through to the trench, the junction between the clean and discoloured chalk corresponded with the calculated position of the facing stones. The discolouration of the chalk raft at this point may therefore be the result of rampart material mixing with the wall foundation material of the wall whilst the cleaner part of the raft is presumed to have been beneath the wall itself.

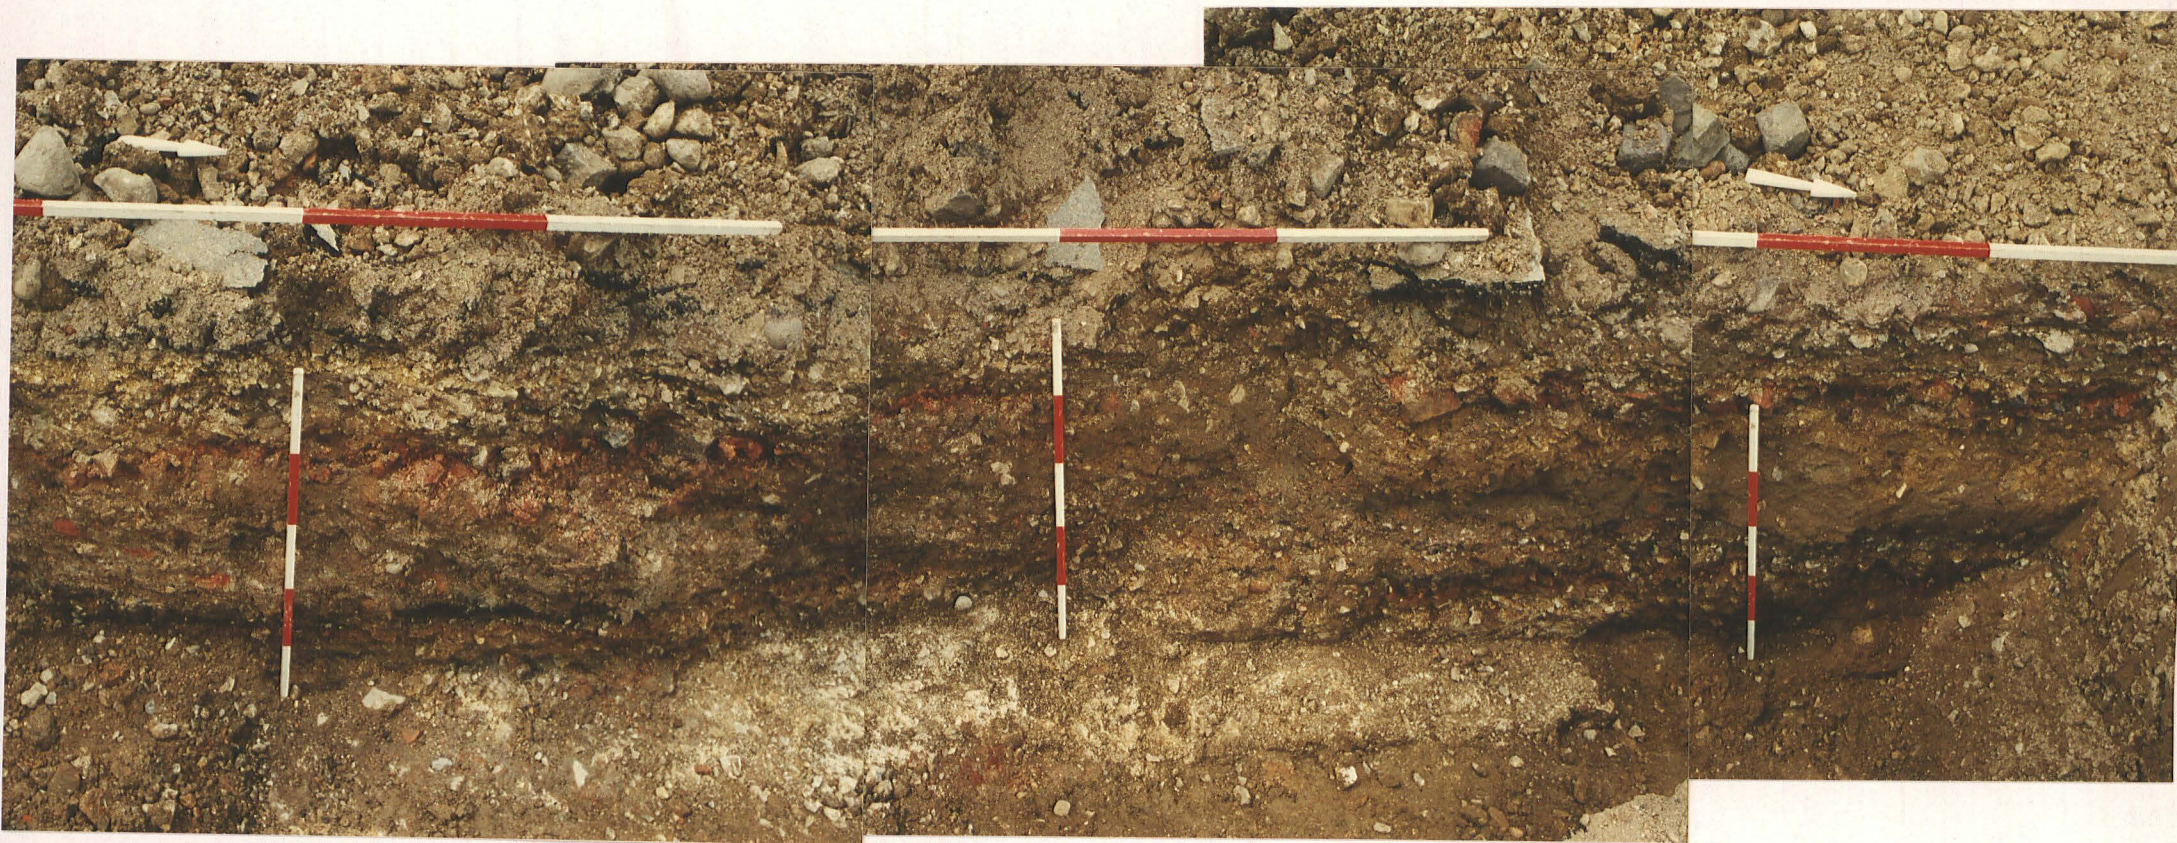
Pl. 7 West side of machine trench, showing disturbed deposits containing brick rubble (left) and possible remnants of rampart at north(right) end. Scales 2m and 1m.

A grey sandy layer, 8, 0.05m thick, was recorded overlying the chalk raft which may represent a trampled surface. This was sealed by red chalk fragments (chippings?) within a red matrix, 0.10m maximum depth, 16. A compact yellow sand 5 overlay 16 and in turn was below a mixed grey sand and flinty layer 4. These may represent debris associated with the construction of the wall. Undulating layer 21, a brown grey sand, with overlying layer 3, a compact yellow sand, a maximum of 0.26m thick, may be the surviving remnants of the associated rampart, which was recorded at the
