SS PETER and PAUL CHURCH, CAISTOR

SITE CODE: CCT 95

ARCHAEOLOGICAL RECORDING

October 1996

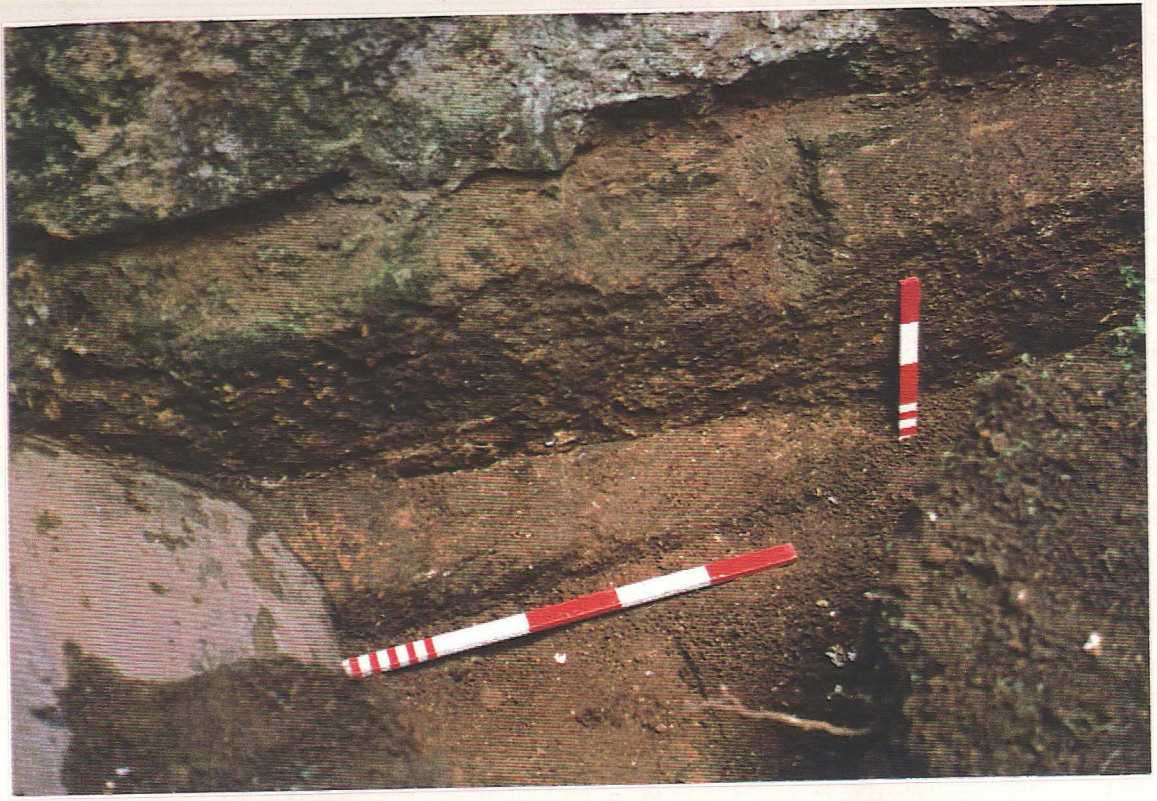
Pl. 2 Close-up view of two-stage chamfered plinth.

Excavation on the north side of the tower for the insertion of a water main revealed a two-stage chamfered plinth (Fig. 2, Pls. 1, 2) which runs from the nave junction. Any return angle was obscured by a large run-off along the base of the north aisle west wall. There was no observable relationship to the nave. The plinth continued uninterrupted along the north wall beneath the blocked north door (Pl. 3) suggesting that the door may have been inserted.

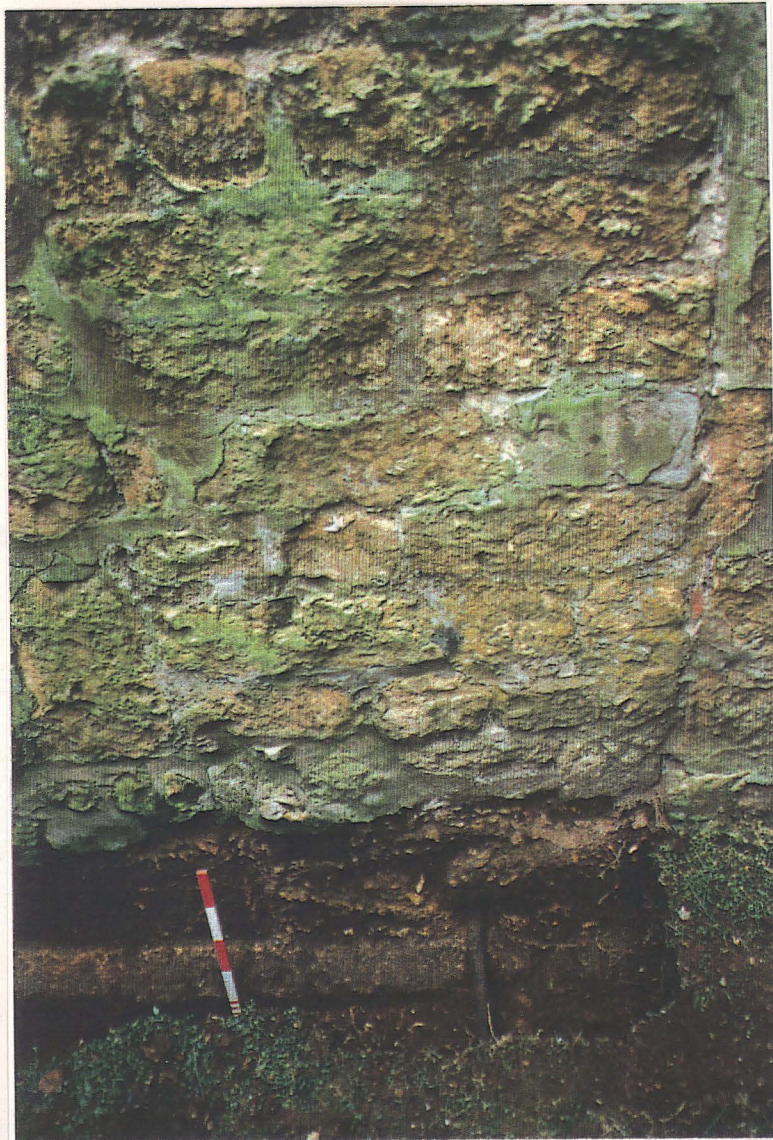
Pl. 3 Chamfered plinth runs uninterrupted beneath blocked door.

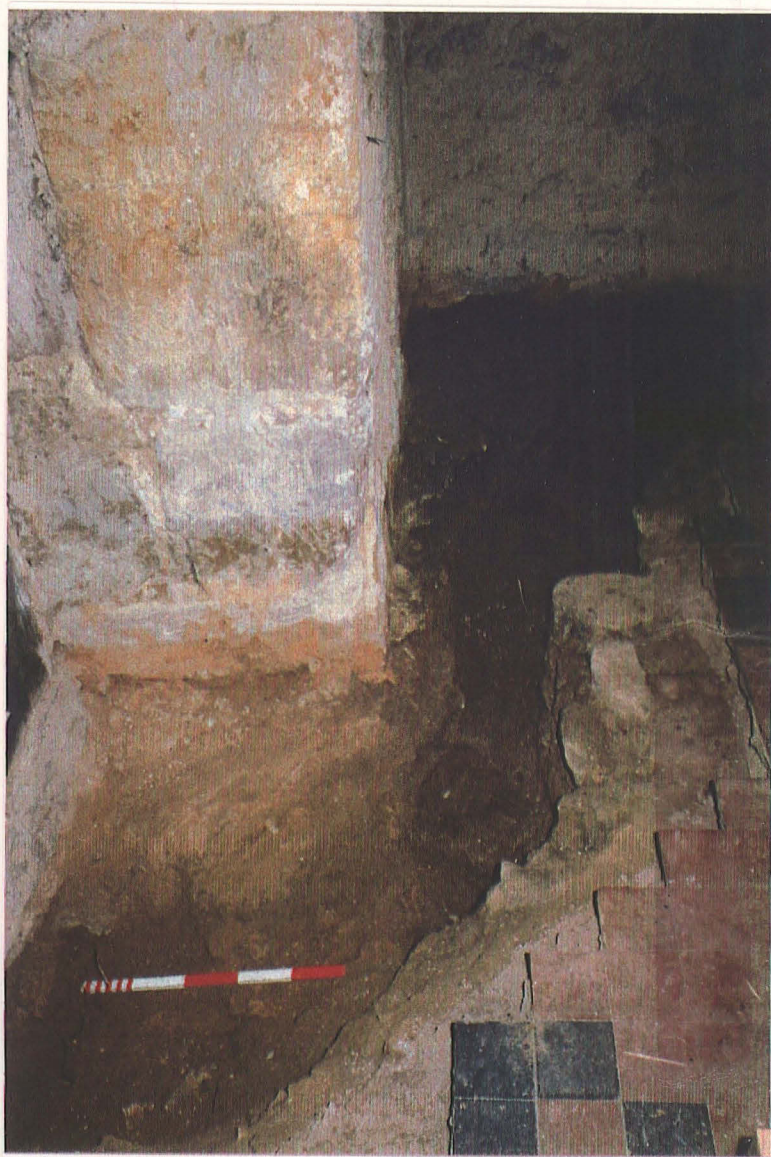
Pl. 4 Trench 2. General view looking N , scale 50cm.

Beneath the modern tile floor and its bedding were the remnants of a mortar floor **3** which had signs of burning in the NW corner of the tower (Pl. 4). It is possible that a stove may have been positioned in this area. Immediately beneath the mortar floor was a thin layer of charcoal **4** which contained a pottery base sherd from a vessel of 17th or 18th century date. It sealed a series of ashy layers **11, 12, 13** which filled a shallow pit **15** c.0.25m deep (Pl. 5). The pit lining **14** was a bright red sand which indicated burning *in situ* to a high temperature (Pl. 6). Fill **12** contained large quantities of lead waste which suggests that the pit was a small hearth used for making lead window comes or castings for roof repairs.

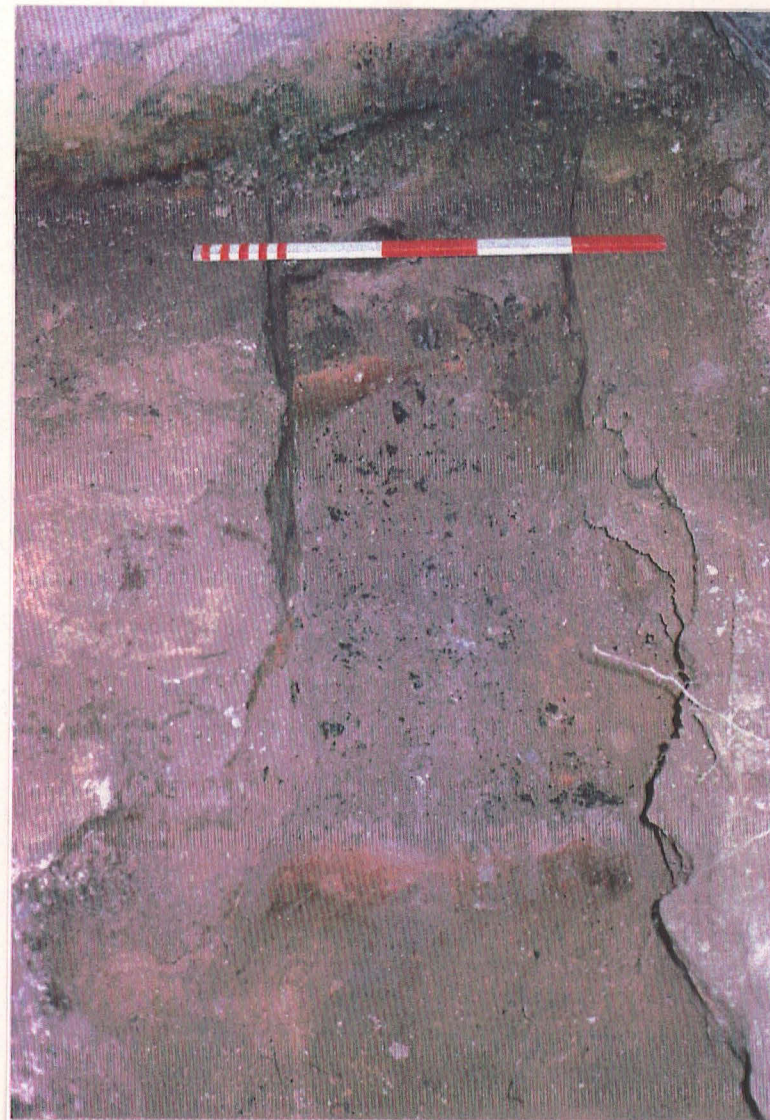
Pl. 5 Lead melting hearth 15, prior to excavation showing that it extended beyond the limits of the trench. View looking N, scale 50cm.

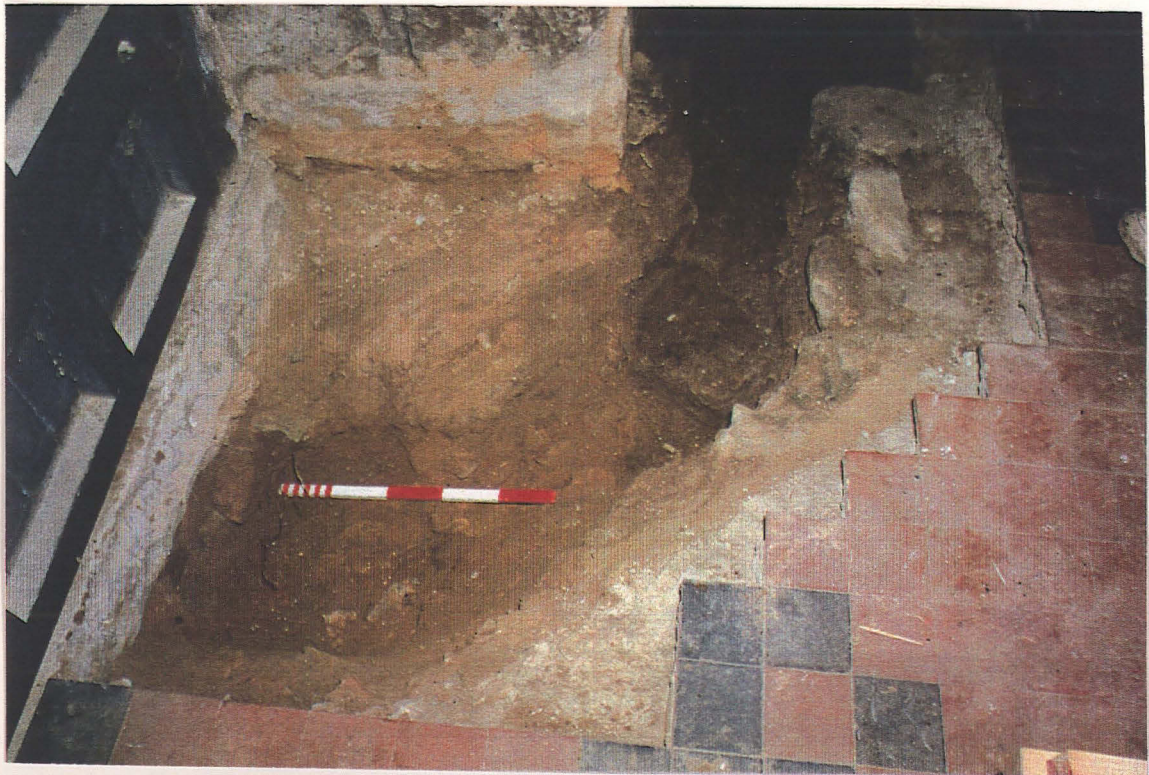
Pl. 7 Tower foundations 19, with pit 16 to right of wall line. Scale 50cm.

The trench cut across the middle of the hearth and its full dimensions could not be determined. Its south side overlaid a small pit **16** of unknown function which contained a loose fill of mortar with pieces of sandstone, a few fragments of human bone, an oyster shell and a single sherd of medieval pottery, **17**. It was sealed by the mortar floor **3**. The pit had cut through a sandstone rubble **19** deposit which formed the tower foundation (Pl. 7). A single rim sherd of 12th century pottery was found in **19**. It was difficult to distinguish foundation material from the redeposited rubble in pit **16**.

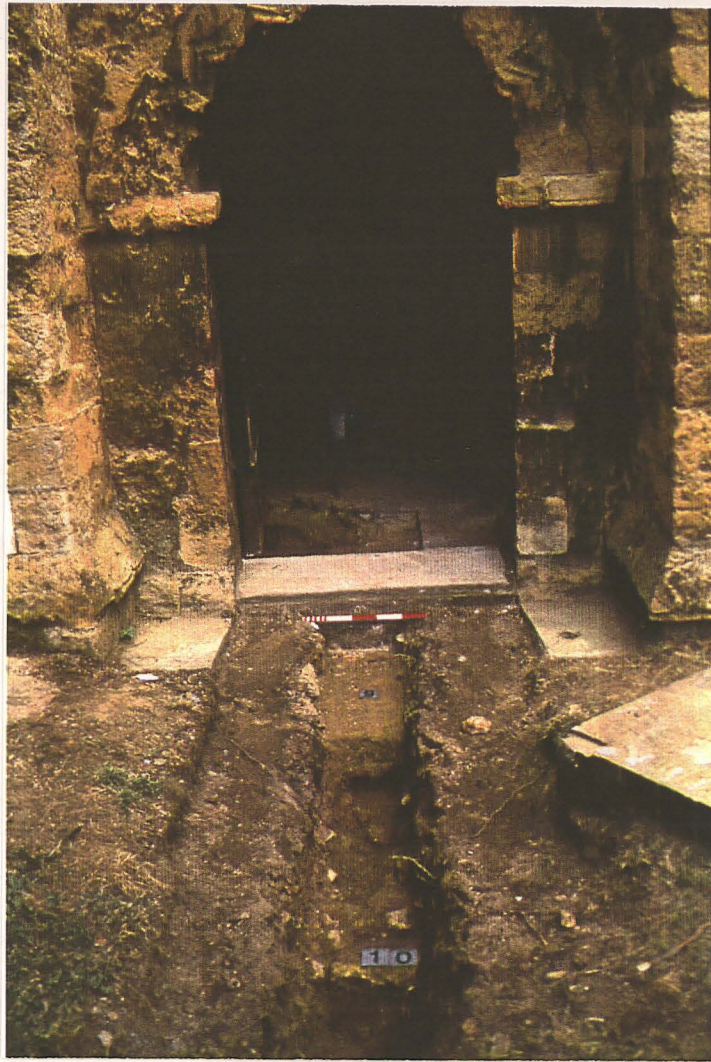
Pl. 8 Modern mortar deposit 9 overlying wall foundation 10. Looking E, scale 50cm.

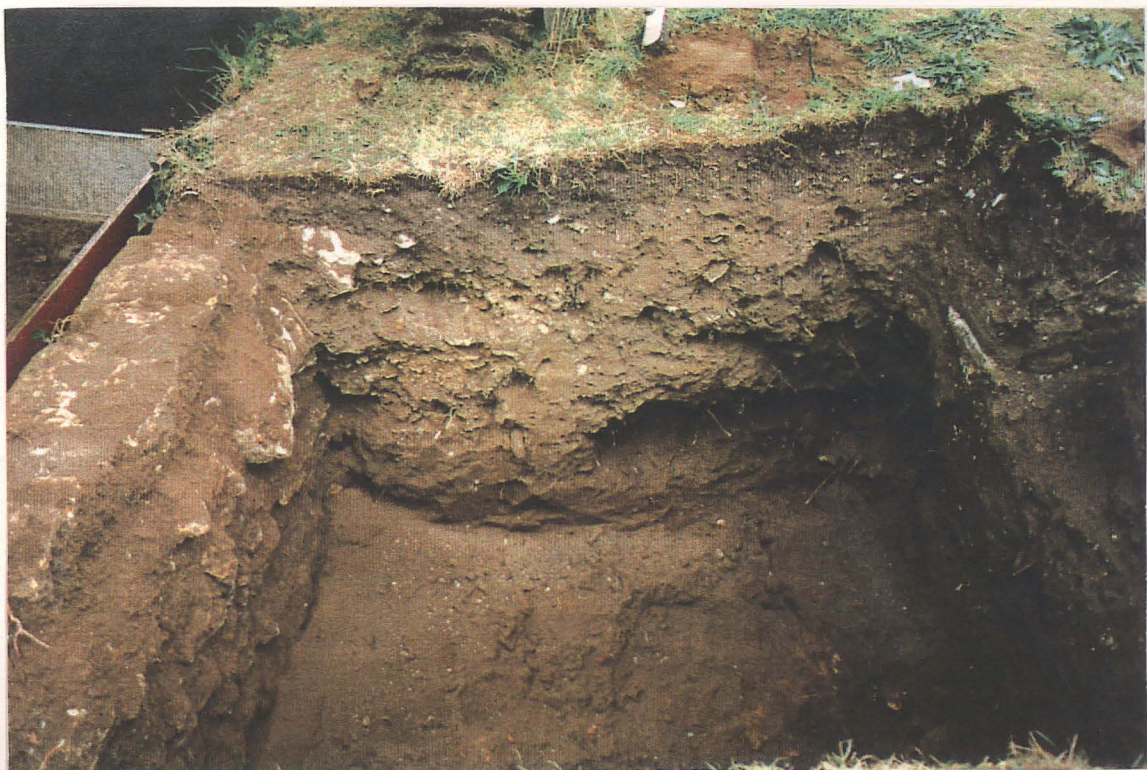
Pl. 9 Excavation of inspection chamber against churchyard wall which forms back of pit (left).

The service trench beyond the tower entrance was excavated by the contractors. Its depth increased to a maximum of 0.50m at its entry into the large pit for the inspection chamber next to the boundary wall of the churchyard. The pit (Pl. 9) was excavated to a depth of 2.70m to enable connection with the mains sewer in Church Street. The trench sides were not stable and detailed archaeological recording was not possible. Several burials of post-medieval date were encountered in this pit. They were dated by their associated coffin fittings (handles, nails etc). An assorted collection of pottery sherds was retrieved from the pit including six Roman, three medieval and four of seventeenth-century date. No undisturbed horizons were observed, nor any indication of any earlier boundary to the churchyard.

from a few human bones which were reburied. The deep pit dug for the inspection chamber adjacent to the churchyard wall showed that the ground was disturbed by post-medieval burials to a depth of over 2m. There was no indication of any boundary pre-dating the existing stone retaining wall.
