**LANGTOFT HALL, LANGTOFT,  
LINCOLNSHIRE:**

## **AN ARCHAEOLOGICAL WATCHING BRIEF**

May 1996

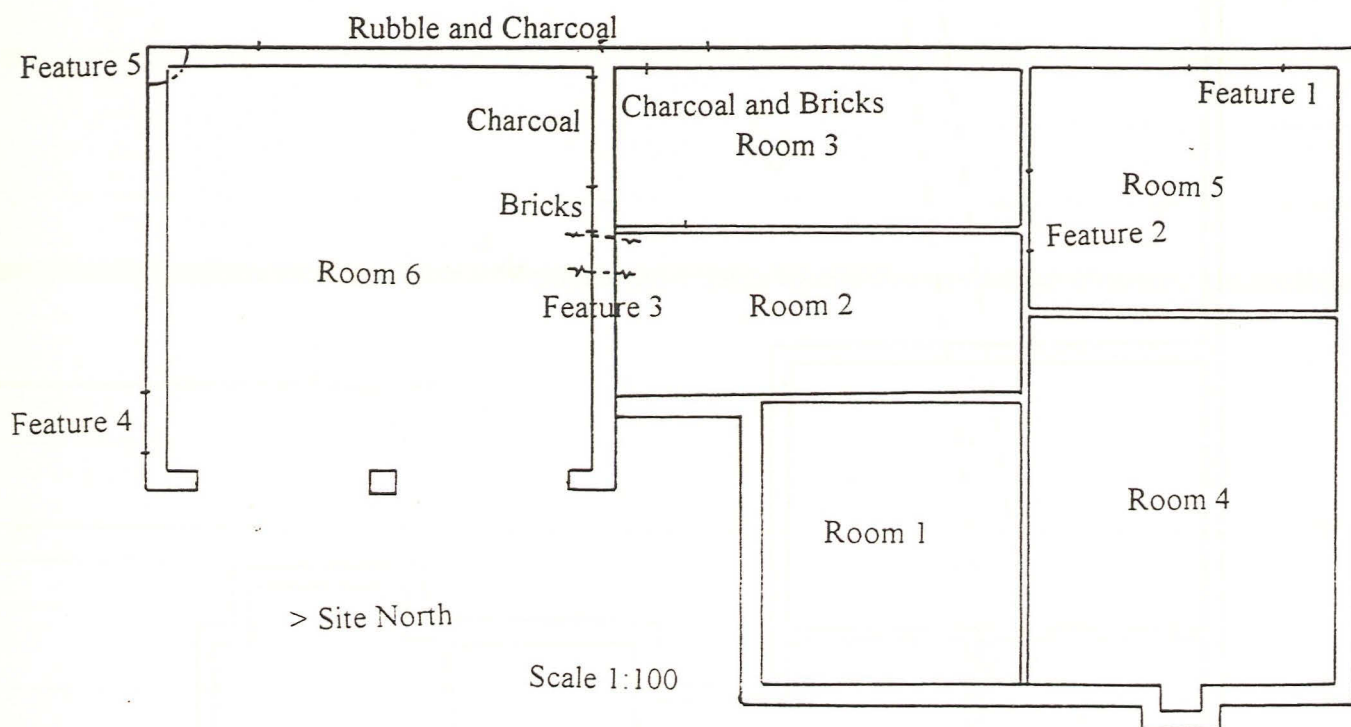
By: John Samuels Archaeological Consultants	Figure Number: 3
Job Number: JSAC/24/96/02	Title: Plot 1 Foundation Trench Plan
Date: May 1996	Scale: 1:100

The foundation trenches were 0.60m wide and 1.30m to 1.70m deep. Examination of the trenches revealed 5 features (see figure 3).

3.10.1 Feature 1 was a pit observed in the south-west facing section of Room 5. The pit measured 1.65m in depth, with a round base with no perceptible break of slope. The pit contained a grey-brown sandy silt.

3.10.2 Feature 2 was a 1.70m deep pit, observed in the south-east facing section of Room 5. The cut had a round base with sides sloping at an angle of 65°. The pit contained a grey-brown sandy silt.

3.10.3 Feature 3 was observed in two facing sections, the south-east facing section of Room 2 and the opposite north-west facing section. This 1.60m deep pit contained a grey-brown fill and the cut had a round base with moderately steeply sloping sides (approximately 45°).

3.10.4 Feature 4 was a pit approximately 1.50m deep, with a round base and sides that sloped at a 45° angle, observed in the north-west facing section of the south-easternmost trench. It also was filled with a grey-brown sandy silt.

3.10.5 Feature 5 was a large pit observed in the northern corner of the plot and was also visible in the south-west corner of Room 6. It measured 1.70m in depth, with a round base.

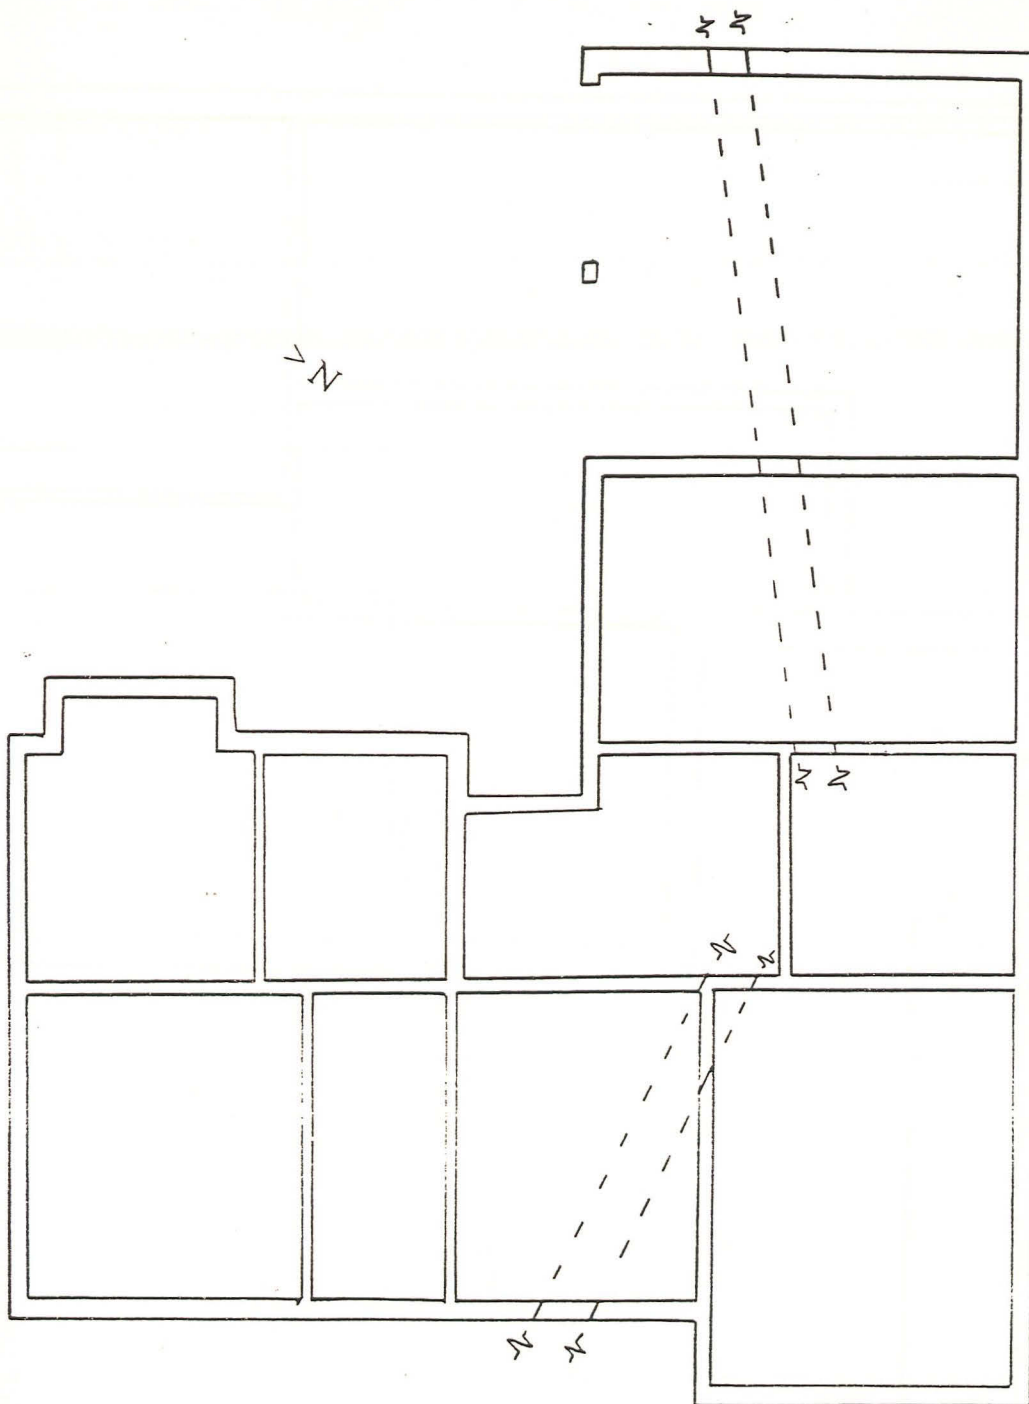
By: John Samuels Archaeological Consultants	Figure Number: 4
Job Number: JSAC/24/96/02	Title: Plot 6: Foundation Trench Plan
Date: May 1996	Scale: 1:100

The foundation trenches for Plot 6 measured from between 1.1m - 1.3m deep. The topsoil had been stripped, but 20 - 30cm of subsoil remained. Natural yellow sandy gravel was observed in the base of the trenches. Examination of the bases of the each trench revealed a gully running north-east / south-west across the south-western half of the plot (see figure 4 and photographs 31 and 32). In the north-eastern half of the plot a similar feature was recorded running approximately east-west. It was not possible to ascertain if these gullies were in fact the same feature that turned at an angle. The gully in the eastern half of the plot measured 0.70m in width and 0.20m in depth, as did the gully in the western half of the plot. The cut for both gullies was rounded and shallow. Both gullies were filled with a mixed orange/brown silty sand that was moderately compact.

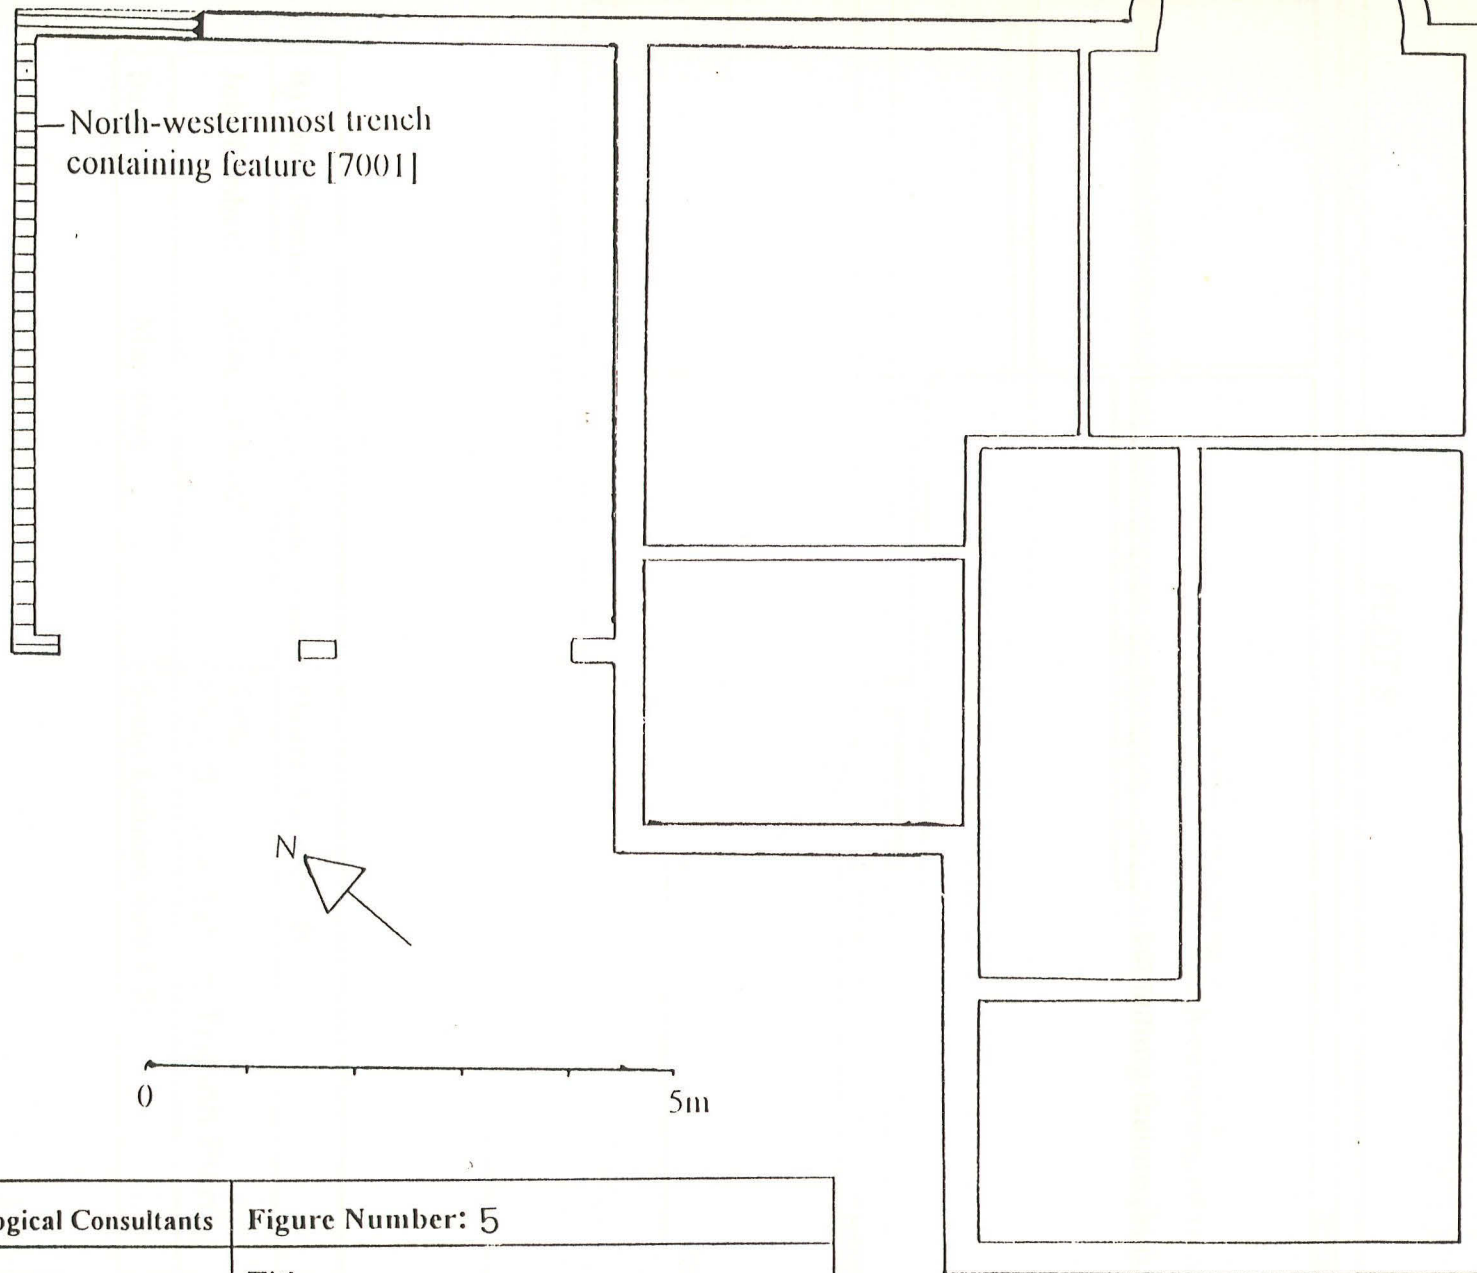
By: John Samuels Archaeological Consultants	Figure Number: 5
Job Number: JSAC/24/96/02	Title: Plot 7 Foundation Trench Plan
Date: May 1996	Scale: Reduced from 1:50

The foundation trenches for Plot 7 measured 0.60m in width and were excavated to a depth of 1m (see figure 5 and photographs 33 and 34). The topsoil measured 1m in depth and consisted of a mid-brown sandy silt. The natural consisted of a yellowy orange clay. Examination of the base and sections of the foundation trenches revealed a linear feature [7001] running north-east / south-west, half sectioned by the north-westernmost foundation trench. The feature measured 2m in depth. The profile, alignment and fills of this features were similar to feature [9001] on Plot 9 (see 3.19.2), and may represent the remains of the same feature.

Features [7001] and [8001], observed in the north-western most trench of Plot 7 and the south-eastern most trench of Plot 8 had similar fills, profiles and both measured 2m in depth. It is highly likely that these features represent the north-west and south-east sides of a large linear feature running north-east / south-west. Geophysical survey of this area of the site revealed a large linear feature running north-east / south-west across this section of the site. The projected alignment of the earthwork remains of a medieval moat that lies to the north-east of the site, shows the moat running through the south-eastern side of Plot 8 (see figures 13 and 14), corresponding well to the alignment of the linear feature observed in the foundation trenches on Plots 7 and 8. Wessex Archaeology located a similar linear feature, recorded as feature [102] in Trench 1 and and feature [1011] in Trench 10 of their excavations (see figure 14), which they identified as a western extension of the medieval moat to the north-east of the site. The profile, alignment and fills of this feature corresponds well with the linear feature(s) observed on Plots 7 and 8.

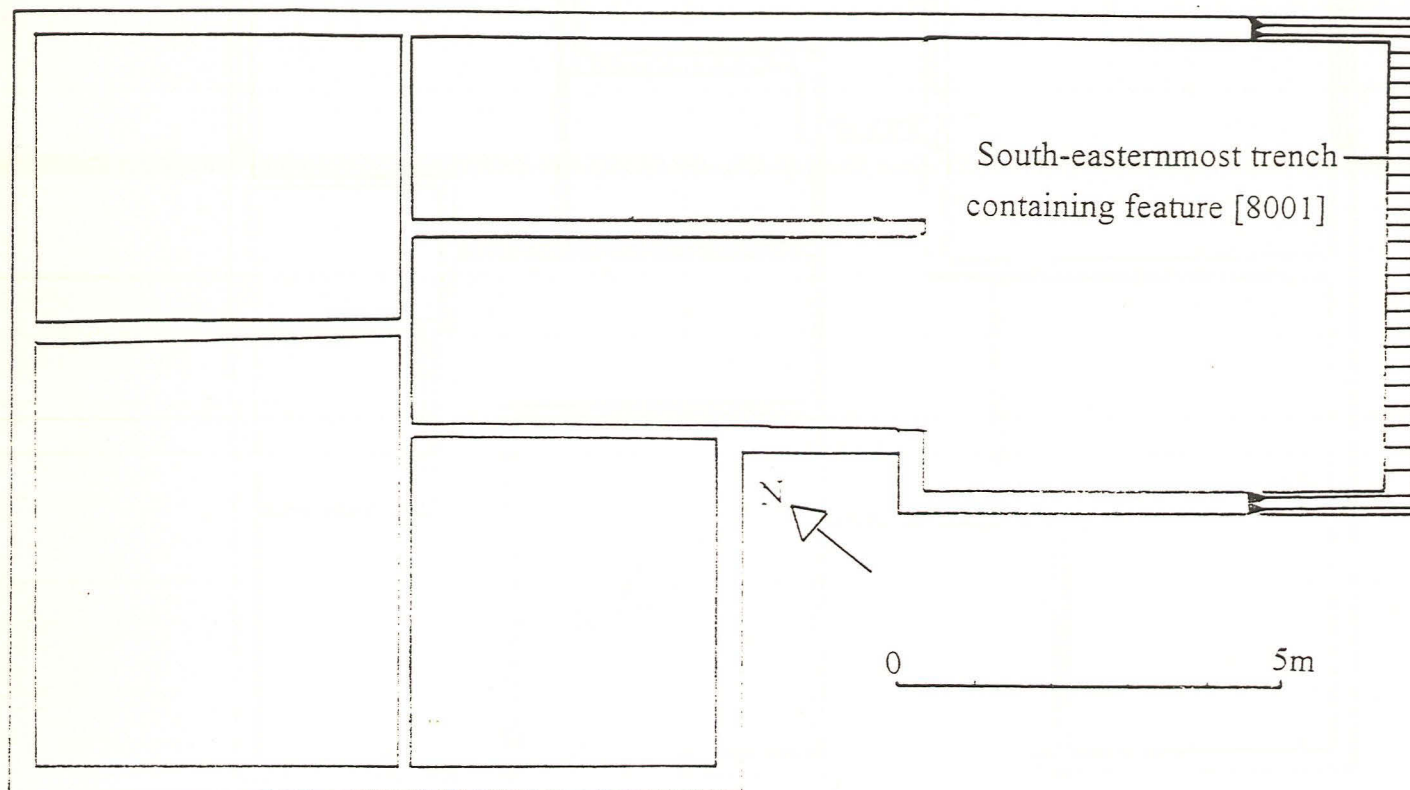
By: John Samuels Archaeological Consultants	Figure Number: 6
Job Number: JSAC/24/96/02	Title: Plot 8 Foundation Trench Plan
Date: May 1996	Scale: Reduced from 1:50

The foundation trenches for Plot 8 measured 0.60m in width and were excavated to a depth of 1.30m (figure 6 and see photograph 35). The natural consisted of an orange clay and the topsoil, measuring 1.20m in depth, was a mid-brown silty loam. Examination of the base of the foundation trenches revealed a linear feature [8001], half-sectioned by the south-easternmost trench. This feature measured 2m in depth. The nature of the profile, alignment and fills of this feature suggest it was a similar or the same feature as [9001] (see 3.19.2) on Plot 9.

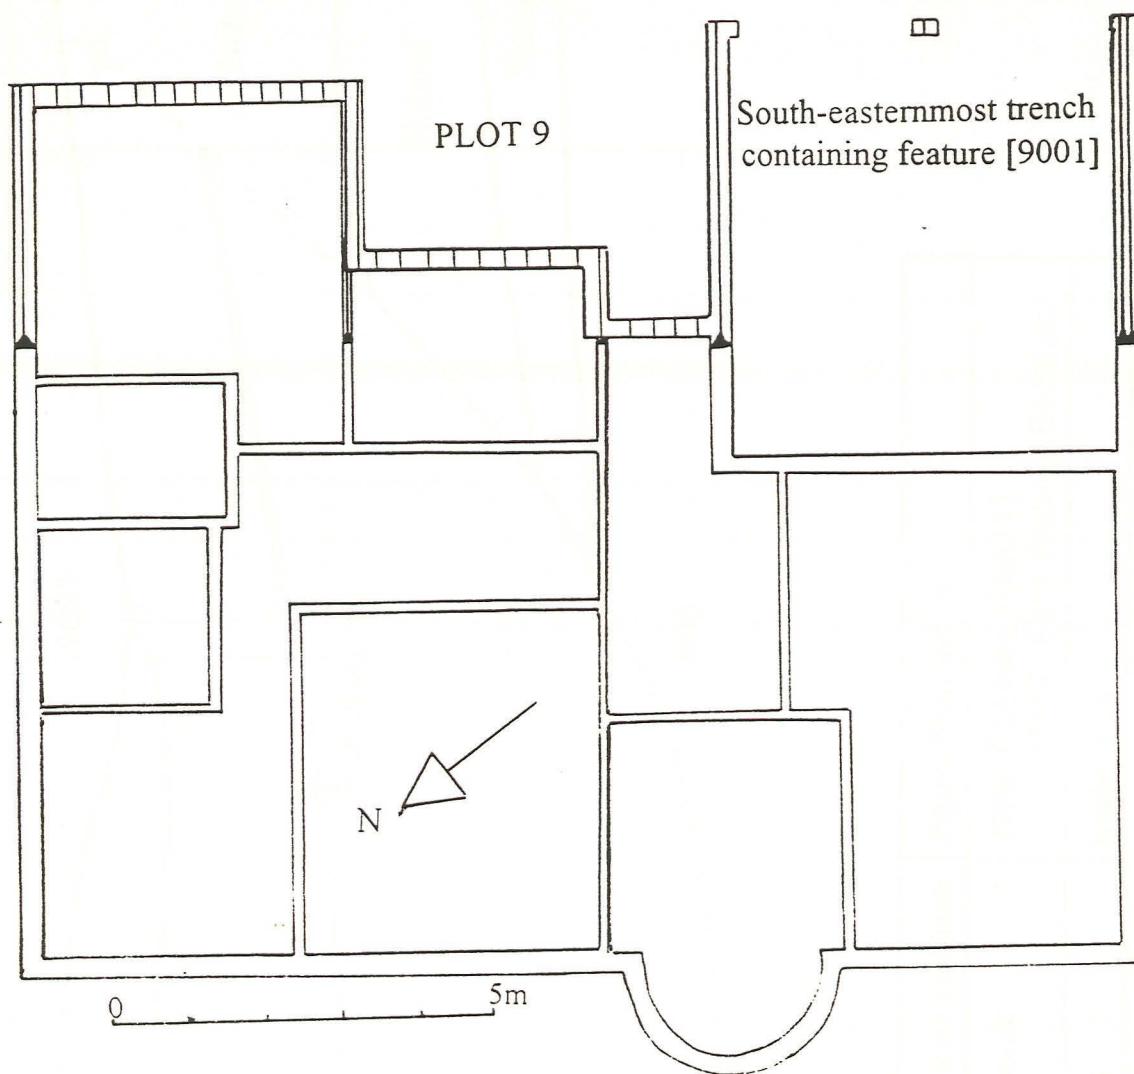
By: John Samuels Archaeological Consultants	Figure Number: 7
Job Number: JSAC/24/96/02	Title: Plot 9 Foundation Trench Plan
Date: May 1996	Scale: 1:100

3.19.1 The foundation trenches on Plot 9 (see figure 7 and photograph 36) measured 0.60m in width and were excavated to natural pale orange gravelly sand. The trenches were excavated to a depth of 1.50 - 1.60m (except in the south-easternmost trench where feature [9001] was located). The topsoil was a mid-brown silty loam and measured 20 - 30cm deep. A linear feature was observed in the south-easternmost trench (see photograph 37). This feature, ([9001]) was recorded by measured drawing (see figure 8) and colour photography. Unstratified finds from this plot included a brick fragment with straw impressions and sheep's skull fragments (see Appendix C).

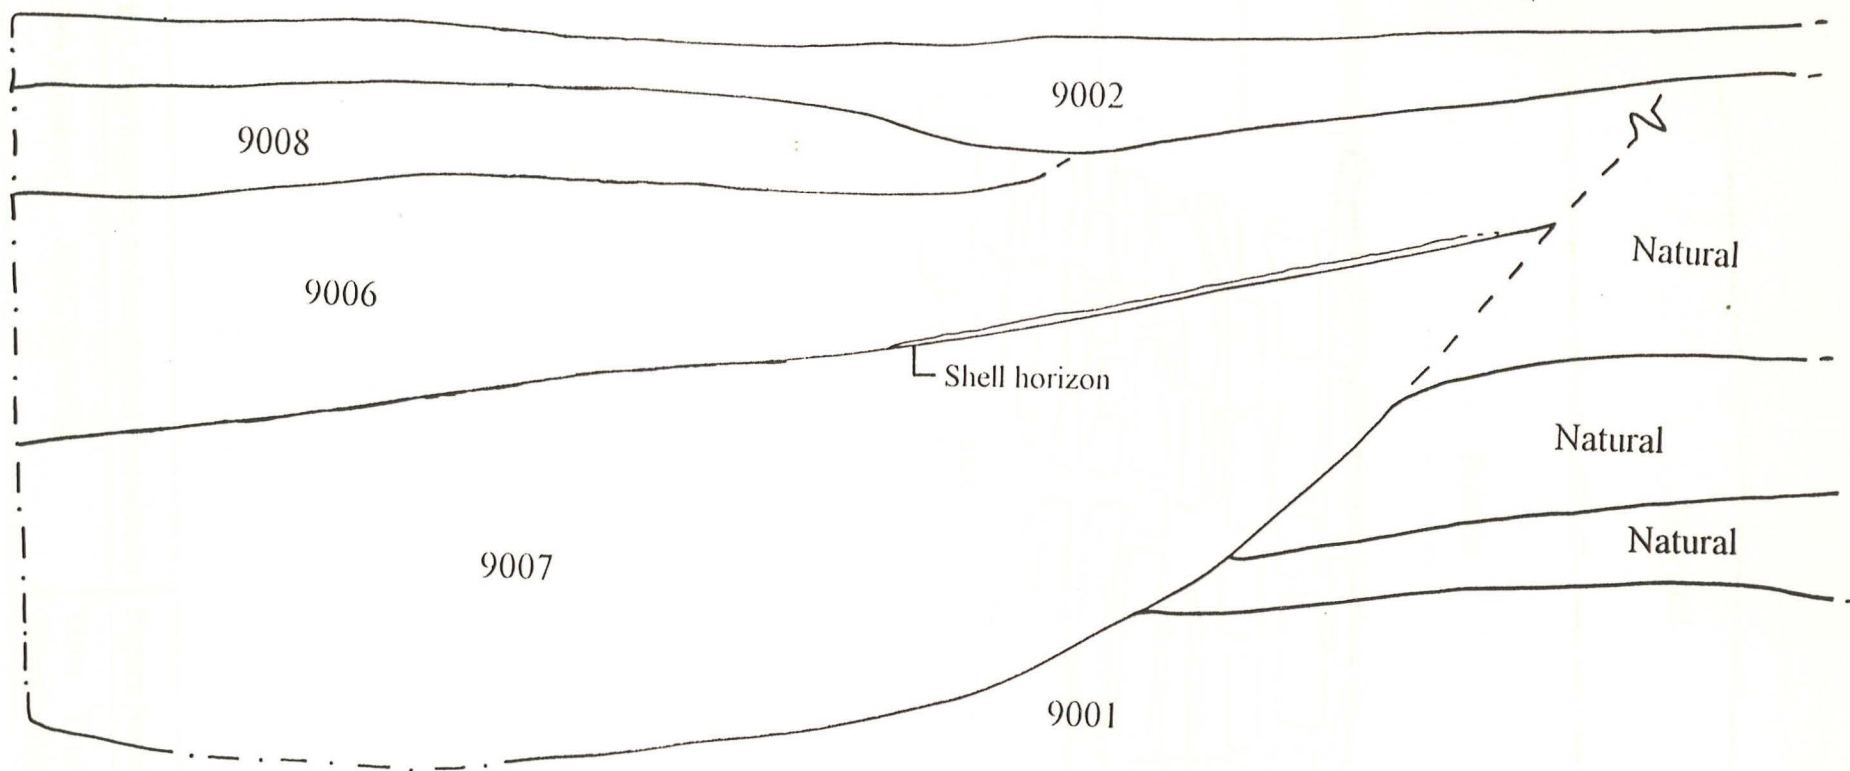
By: John Samuels Archaeological Consultants	Figure Number: 8
Job Number: JSAC/24/96/02	Title: Feature [9001] North-East Facing Section
Date: May 1996	Scale: 1:20

*An undated linear feature [9001] was observed running north-east / south-west across Plot 9. Although no dating evidence was recovered from this feature, the nature of its fills and profile were closely comparable to a linear feature recorded by Wessex Archaeology in their Trench 1 (feature 102) and Trench 10 (feature 1011), which they identified as a continuation of the medieval moat that can be seen as an earthwork feature to the north-east of the site.*

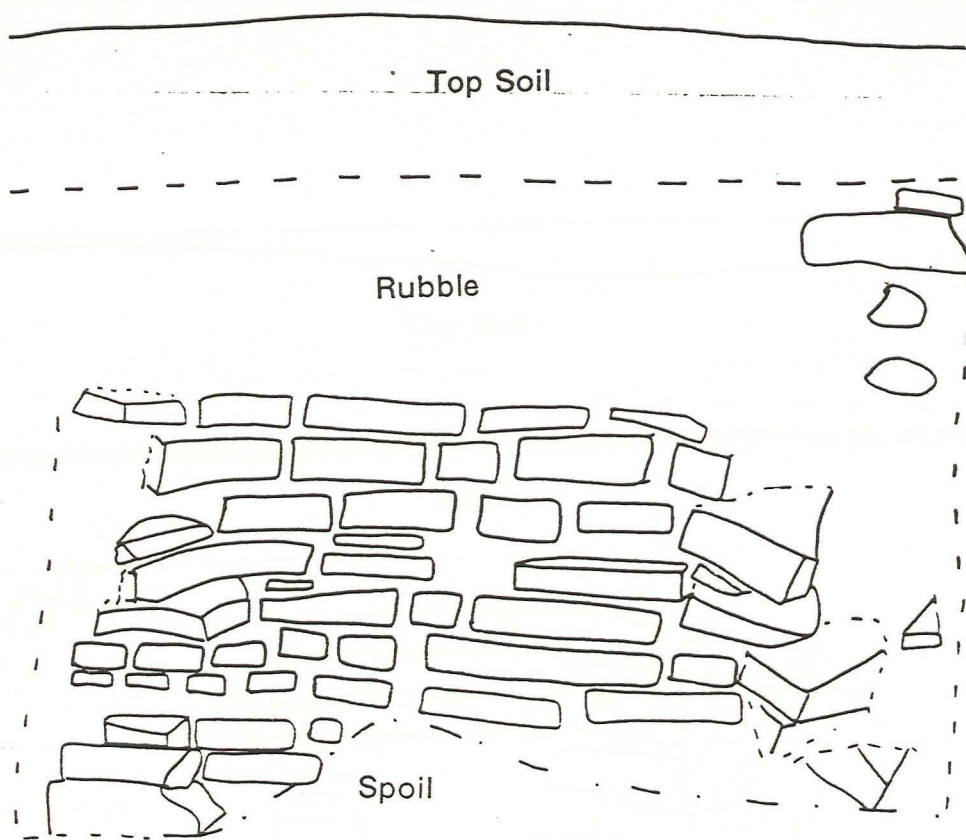
By: John Samuels Archaeological Consultants	Figure Number: 9
Job Number: JSAC/24/96/02	Title: The Stone-lined Well North-West Facing Section
Date: May 1996	Scale: 1:20

This 35m long portion of the trench ran in a south-westerly direction and measured 1.59m in width and 3m in depth (see photograph 4). Nineteen shoring plates were used, obscuring 23% of each of the sections. 13.74m west of manhole S4, a well was observed in section (see figures 9 and 10 and photographs 8 - 12). The well was stone-lined and measured 1.70m in width. The north-west facing section revealed 0.40m of subsoil overlaying a loose brown/grey sandy silt containing rubble. Below this rubble fill, 7 curved courses of masonry were visible. Lower courses of masonry could not be recorded as the base of the drainage trench had been filled with a large drain pipe and gravel. The south-east facing section revealed the same subsoil and rubble deposits overlaying 5 curved courses of masonry, which overlay 4 straight courses.

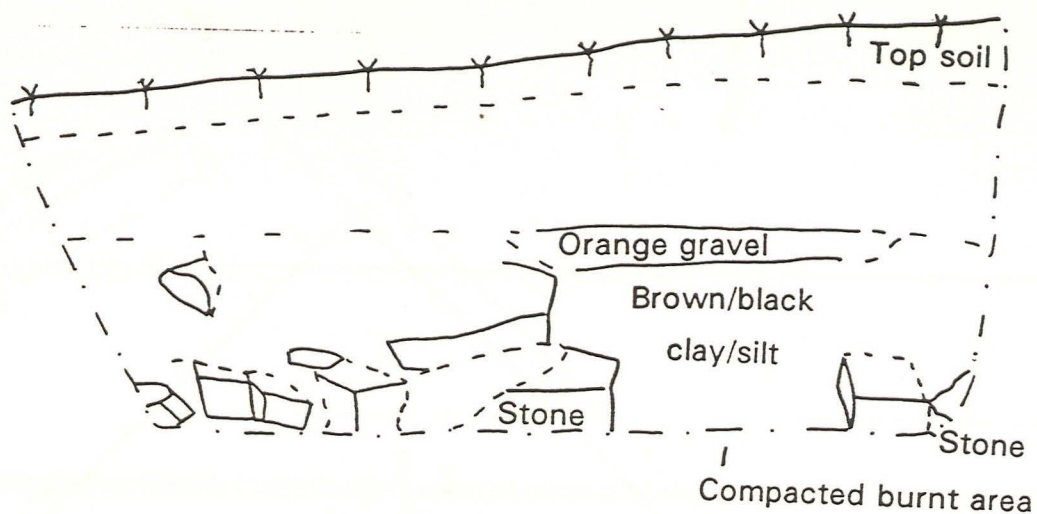
By: John Samuels Archaeological Consultants	Figure Number: 11
Job Number: JSAC/24/96/02	Title: Pit Excavated For Manhole F8 North-East Facing Section
Date: May 1996	Scale: 1:20

Examination of the base and the sides of the pit dug to contain manhole F8 revealed a two features. The north-east facing section of the pit revealed two large faced stones that formed the two sides of a 0.60m wide gap. Staining of this area was indicative of burning, suggesting that the area had possibly been used as a hearth (see figure 11 and photographs 16, 17 and 18). To the south-east of the hearth, medium sized (10cm) chunks of stone were overlain with a loose mid-brown sandy silt that contained stone rubble. The west-facing section revealed a disturbed cut for a pit. The cut measured 1.30m in depth with a round bottom. The pit contained a subsoil fill of brown sandy silt (see figure 12 and photograph 19).

- 4.4 Masonry was revealed in the north-east facing section of the pit dug for manhole F8. A burnt rectangular area observed in the base of the pit was possibly a hearth. The south-west facing section revealed a disturbed round bottomed pit, which produced no dating evidence.

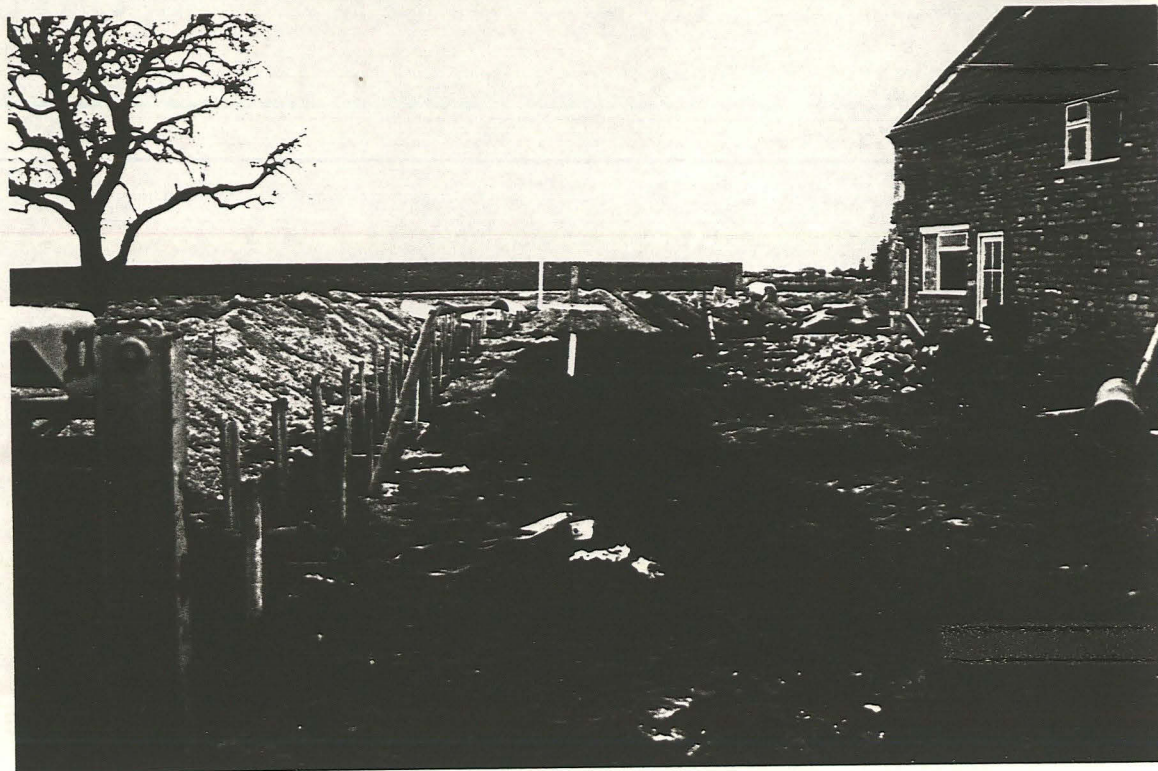
This 40m long portion of the trench ran in a south-westerly direction and measured 1.59m in width and 3m deep (see photograph 3). Twenty one shoring plates were used in this portion of the trench, obscuring 22% of the section face. Bands and flecks of a natural white deposit were observed in both sections. The foundations of the wall that had connected the existing farmhouse to the buildings of the crewyard were observed in both sections of the trench (see photograph 5).

3. Deep drainage trench from manhole S3 to manhole S4, looking north-east.

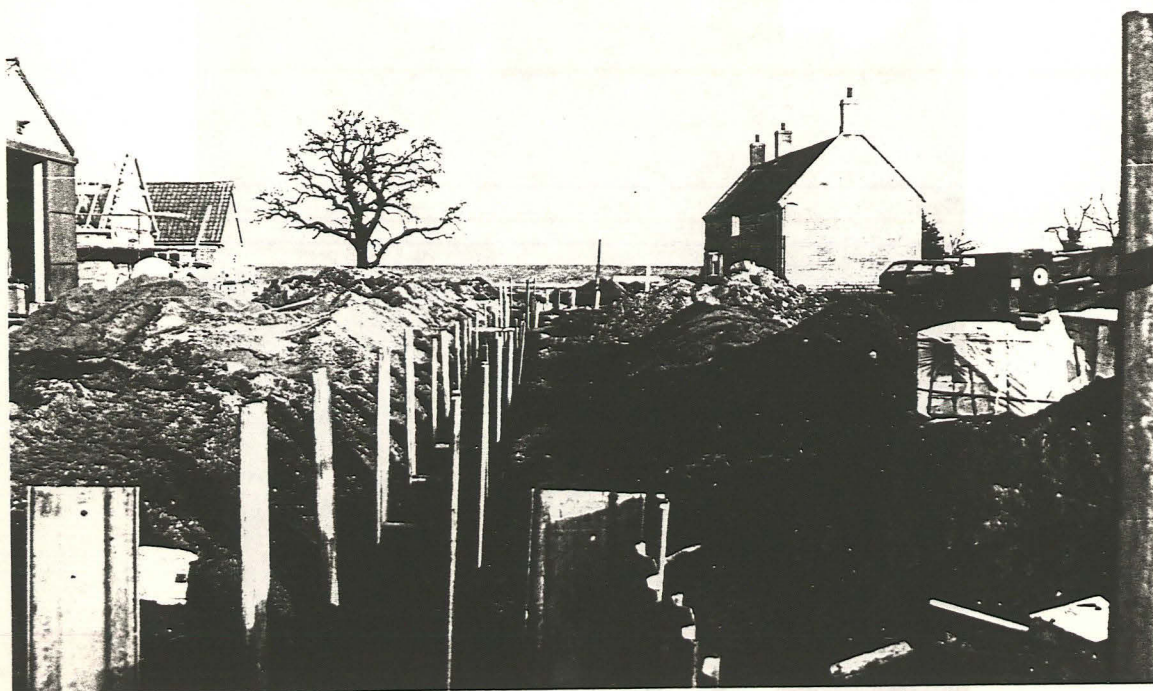
4. Deep drainage trench from manhole S4 to manhole S5, looking north-east.

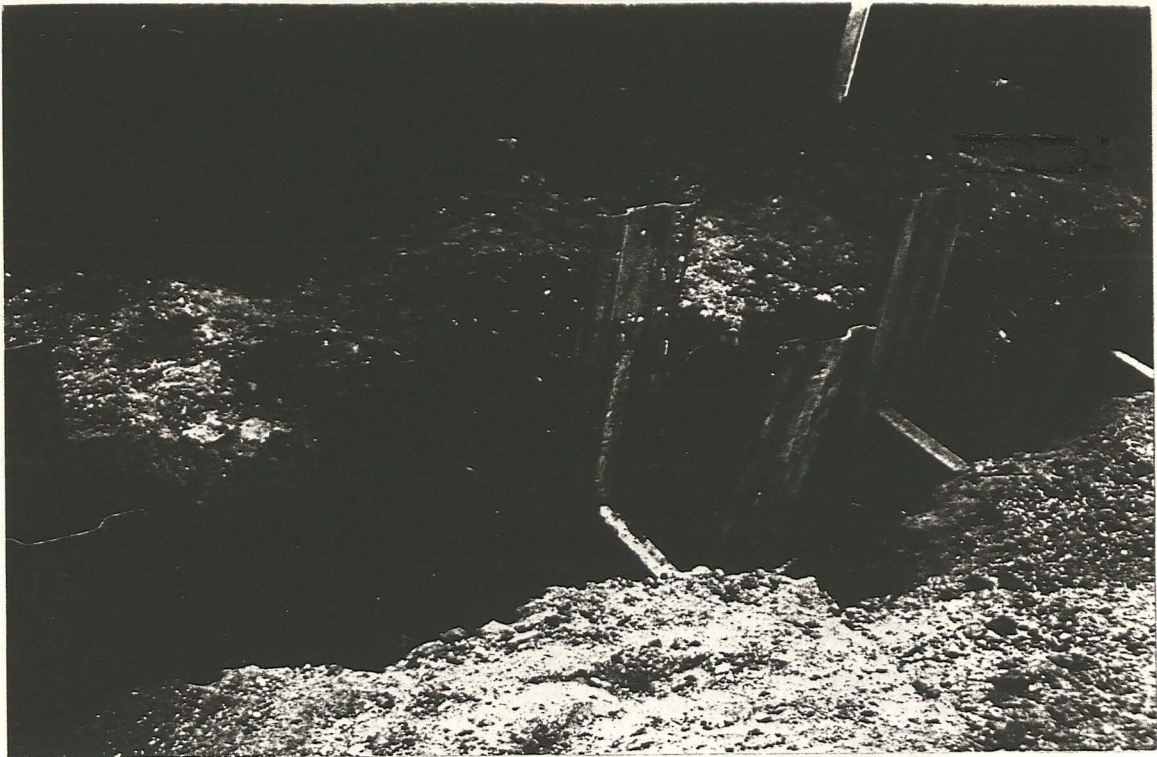
5. Foundations of the stone wall that joined the existing farmhouse to the crewyard.

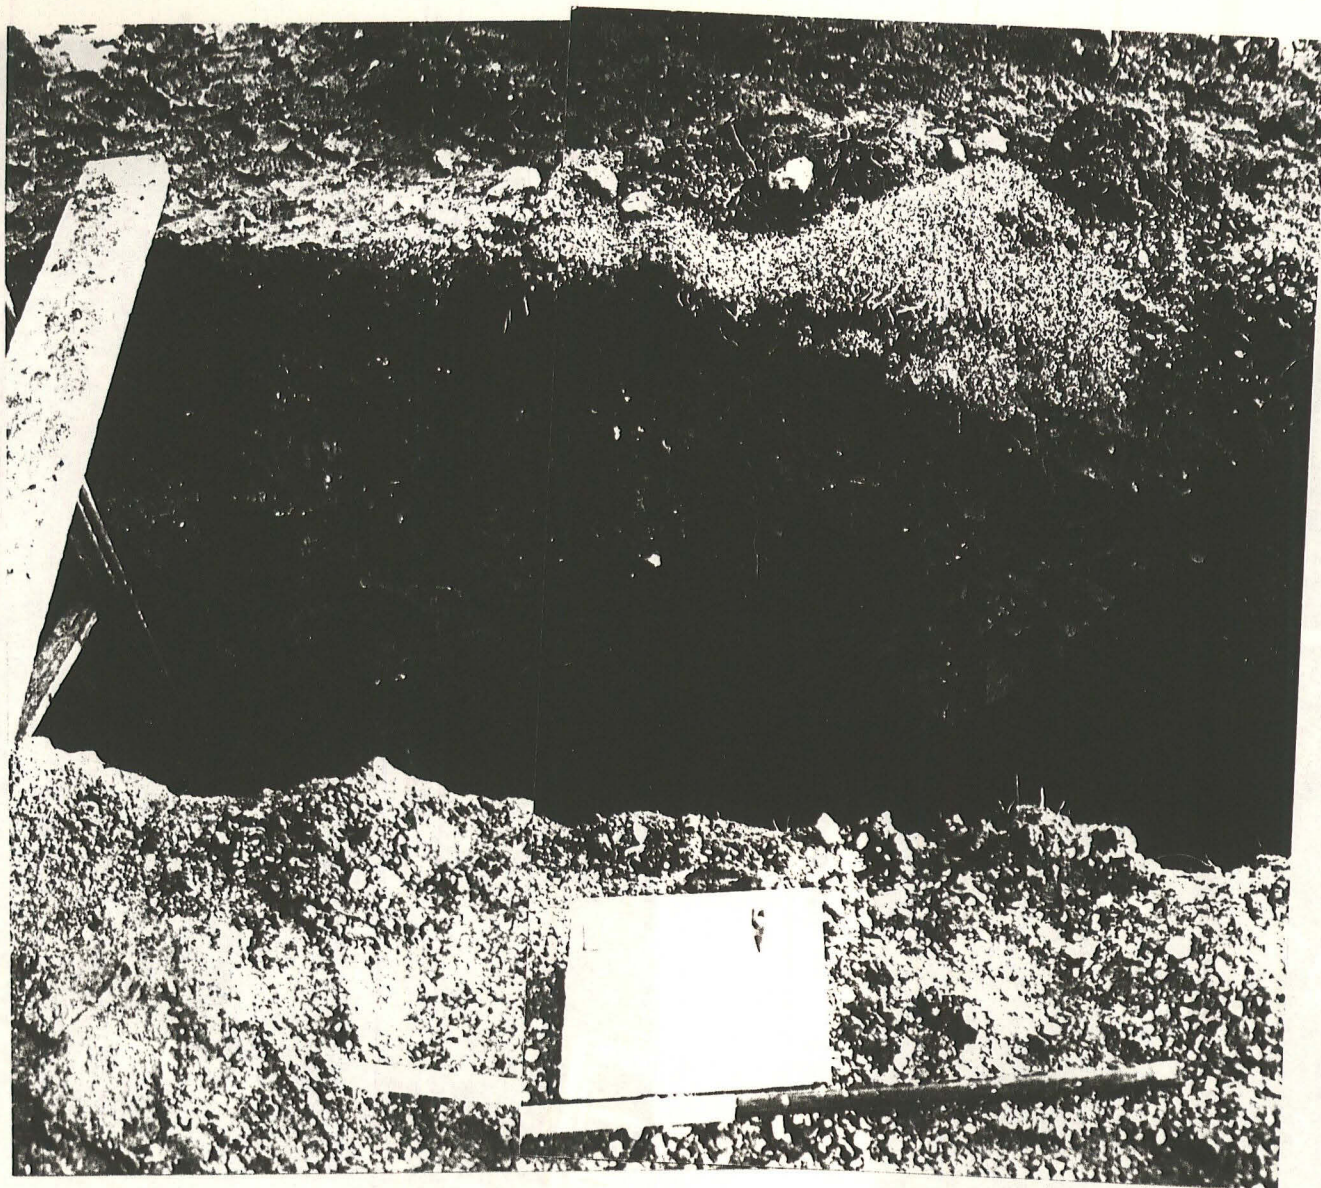
8. Stone-lined well - north-west facing section.

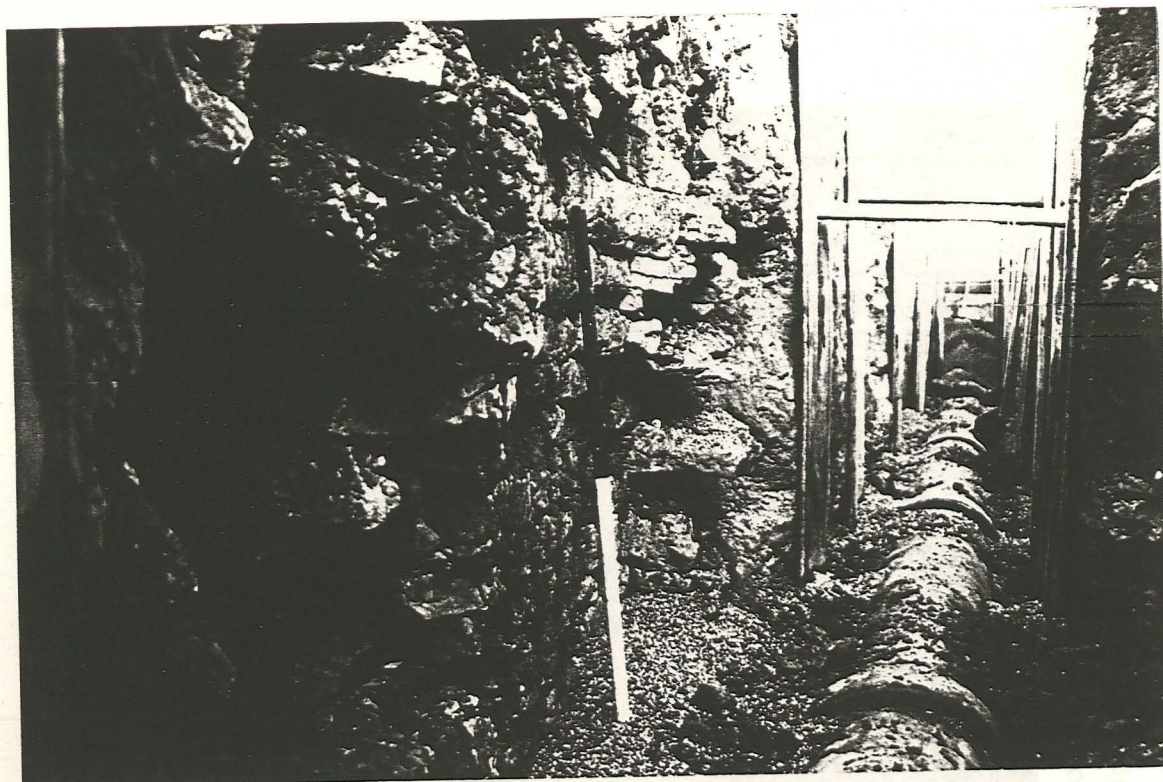
12. Stone-lined well - south-east facing section, close up.

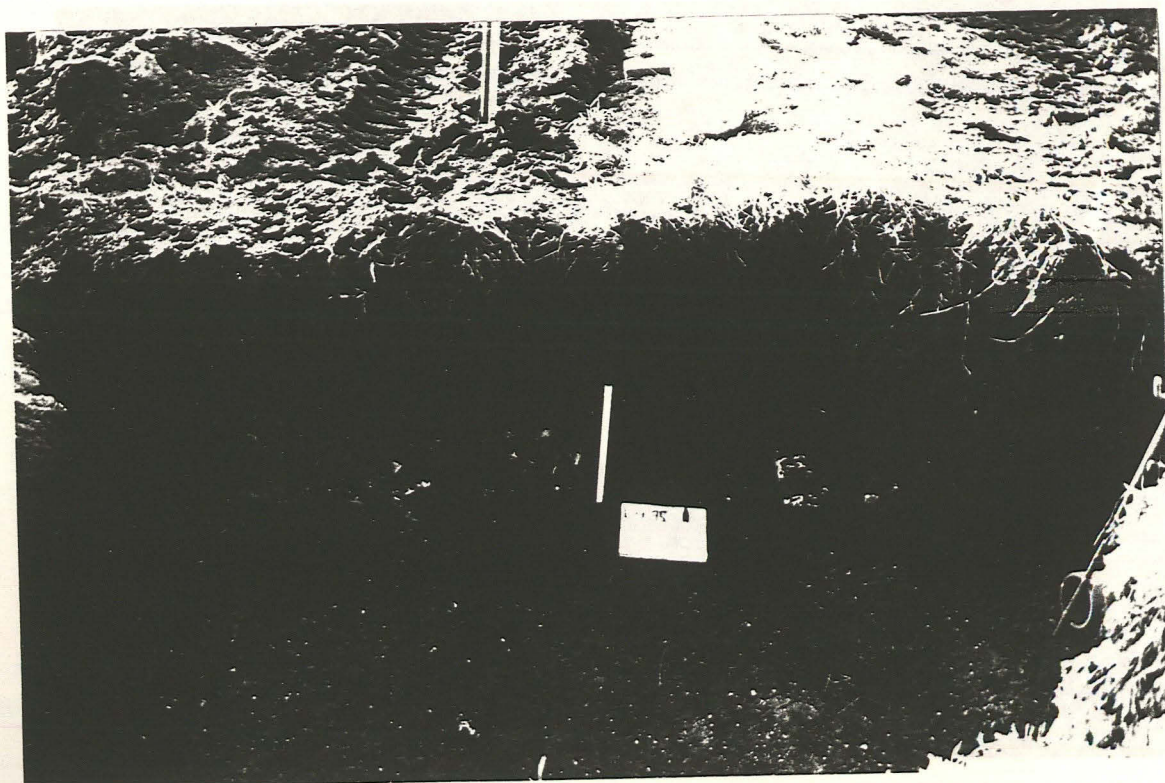
16. North-east facing section of pit dug for manhole F8, showing possible hearth.

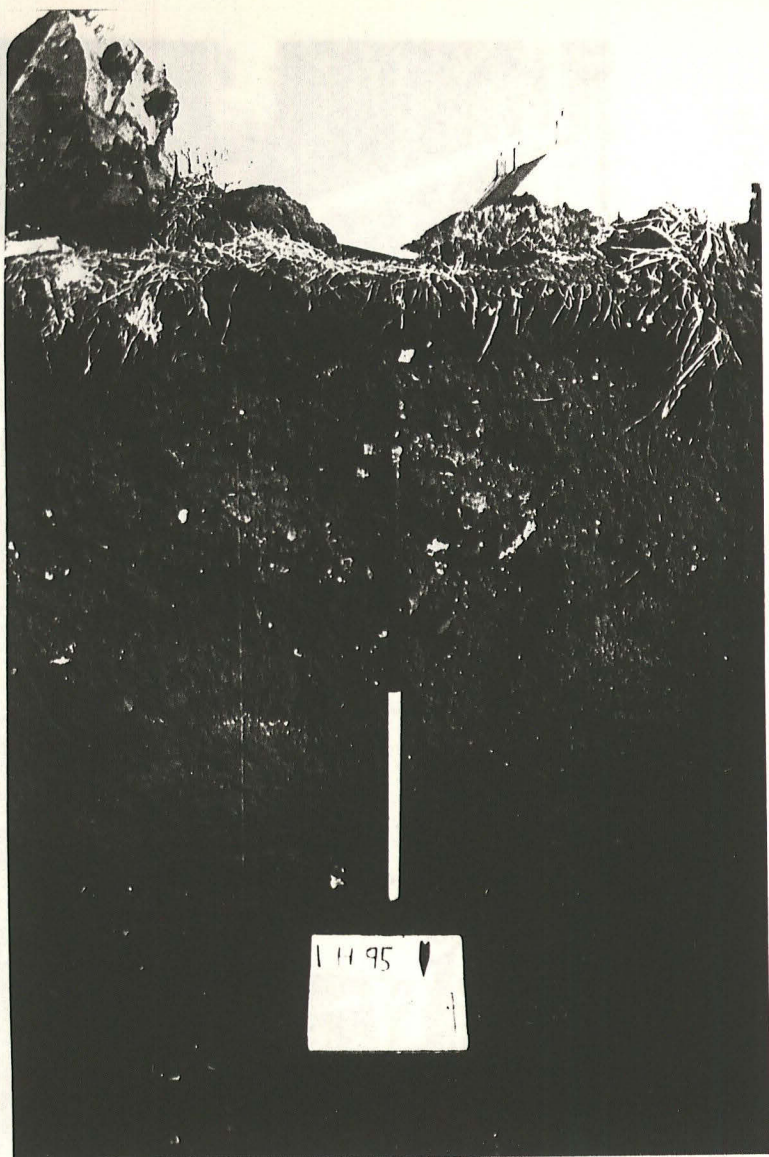
19. South-west facing section of pit dug of manhole F8, showing pit feature.

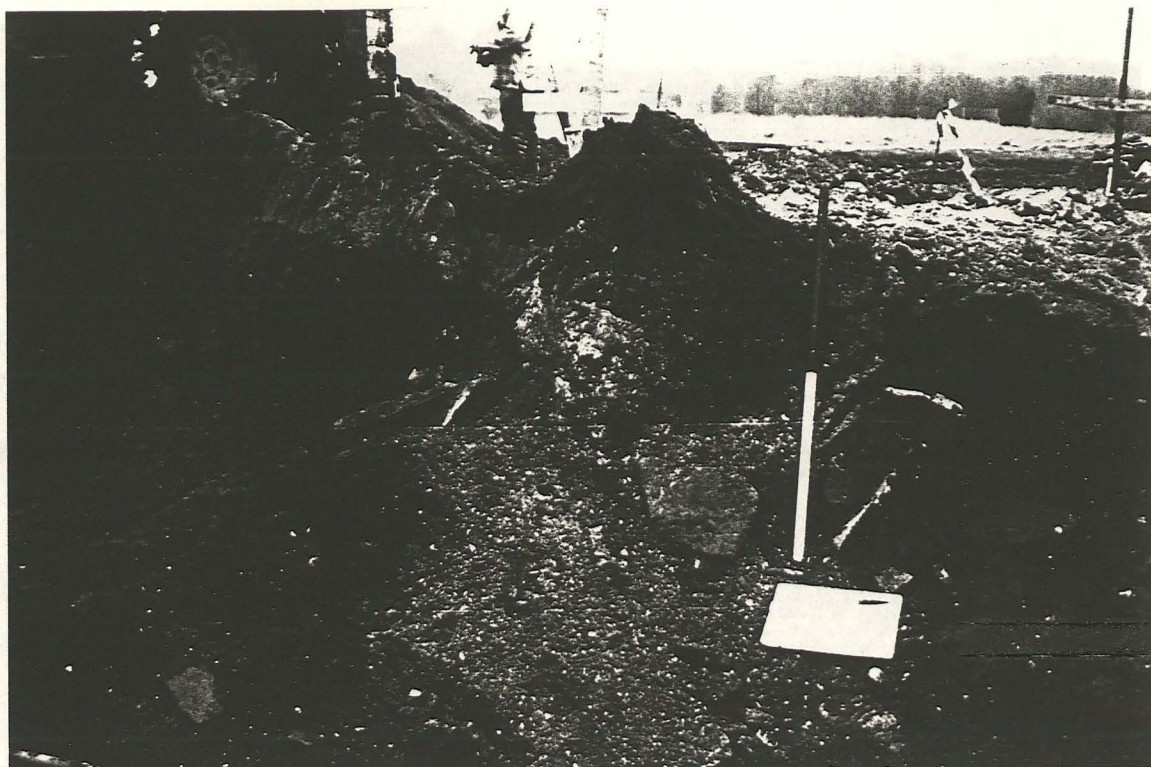
In this section the trench measured 0.90m in depth and 6.2m in width (see photograph 24). Examination of the base and side of the trench revealed no archaeological features. However, at the west end of the trench, approximately 19m west of manhole S4, an area of charcoal and ash measuring 0.60 x 0.30m was observed in the base of the trench. In section a 10cm thick layer of charcoal rested on 2 courses of modern bricks. To the north of this were 4 large flat stone slabs (0.40 x 0.20m), behind which was a single modern brick (see photograph 25).

25. Masonry found in the trench excavated for the road to the north-east of the existing farmhouse.

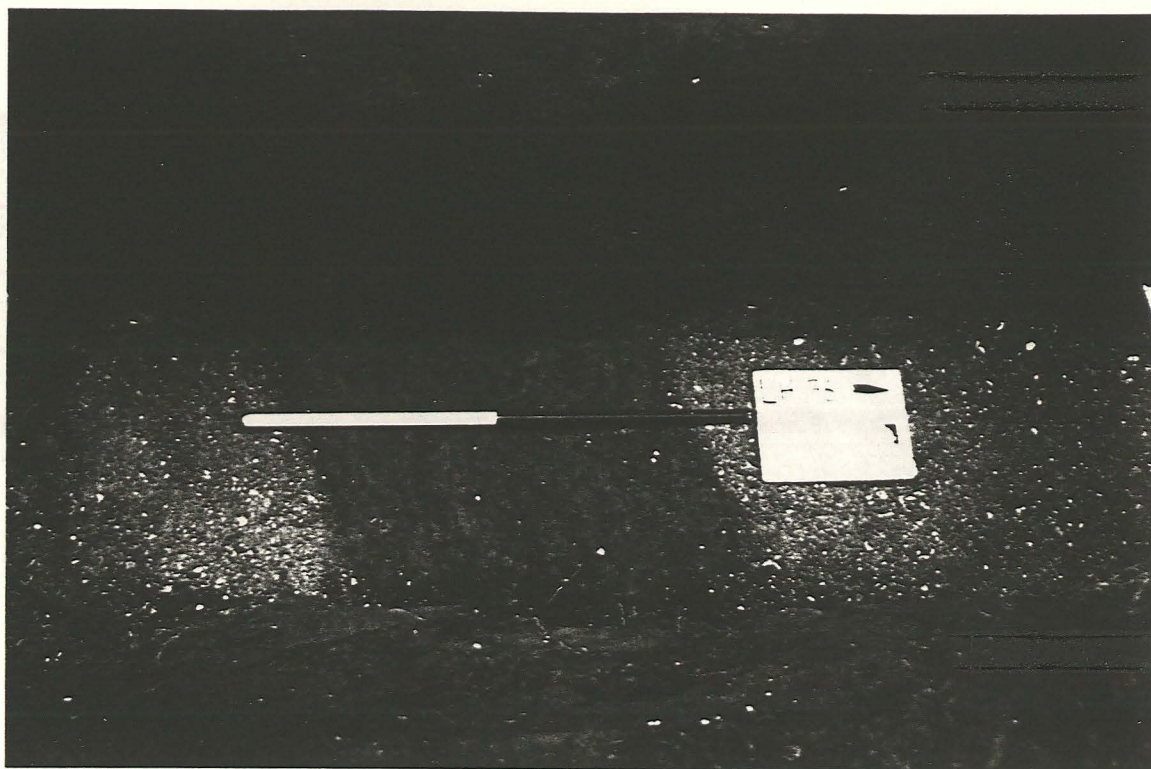
31. Linear feature observed on Plot 6, prior to excavation.

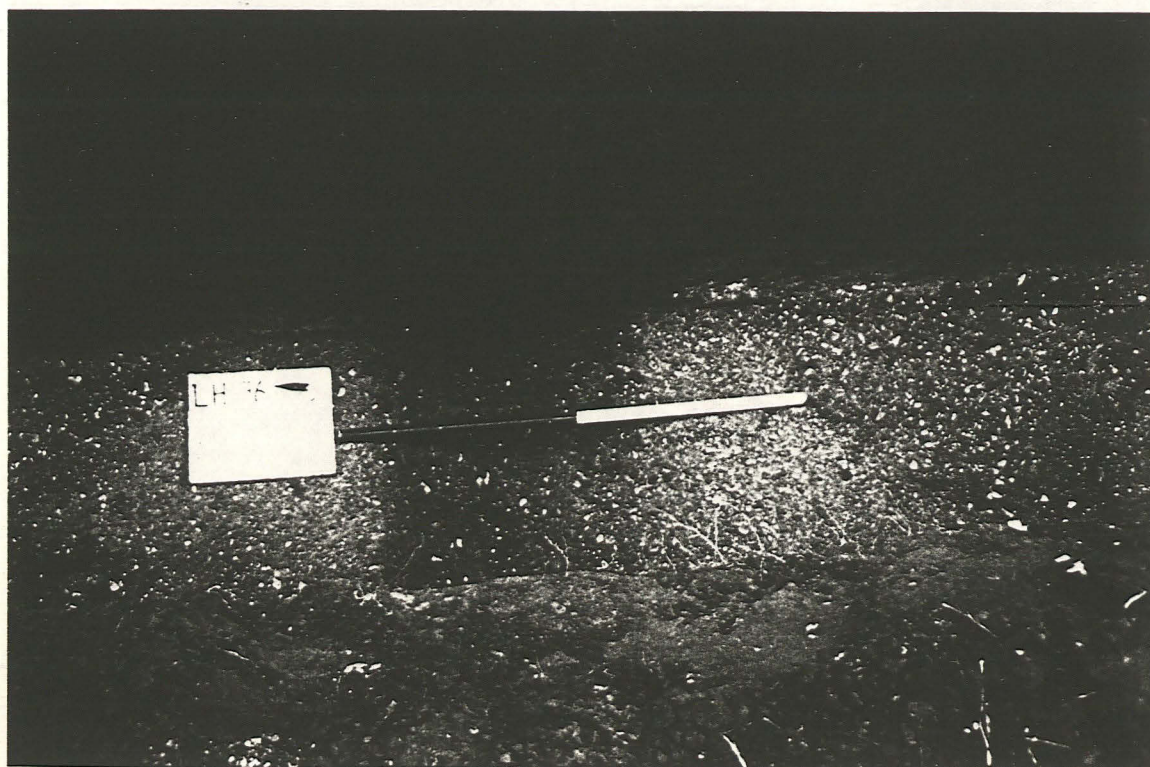
32. Linear feature observed on Plot 6, post-excavation.

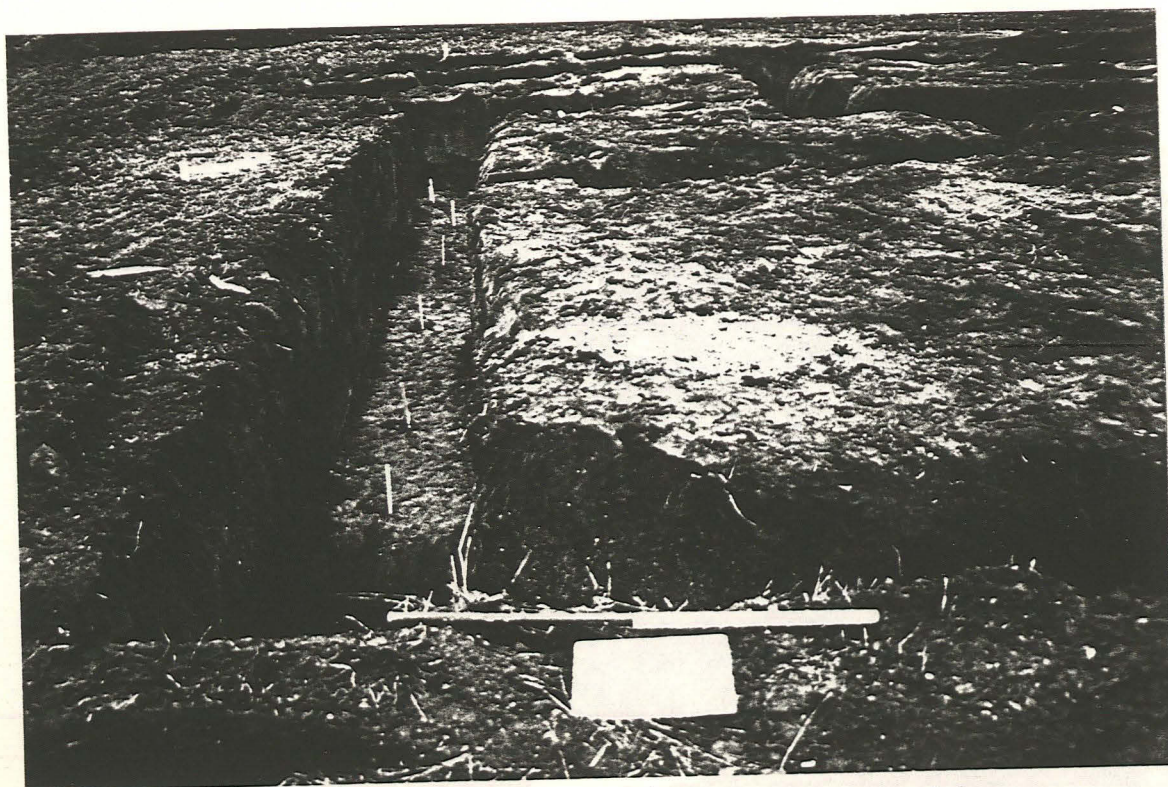
34. Plot 7, close up of linear feature in northern most trench.
